PDS Report on APA 3 Colbox

Manuel Arroyave¹, on behalf of the PDS

November 14th, 2022

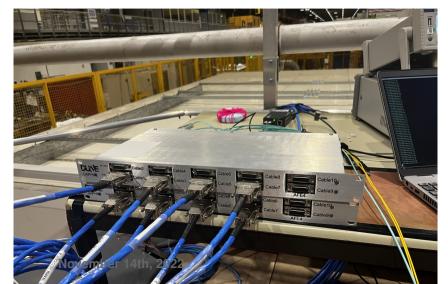
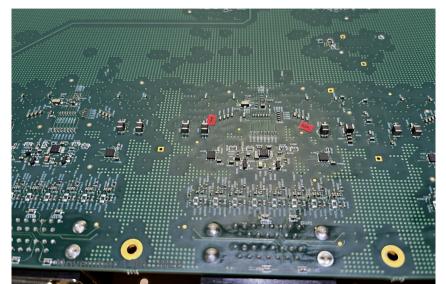
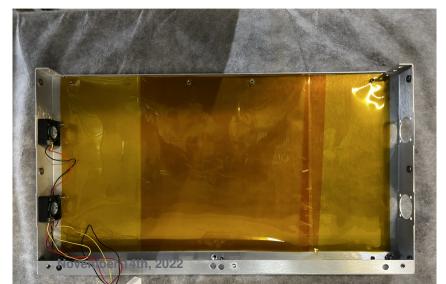
Chassis

1. We must make correct isolation between the chassis and the board to prevent short circuits.

2. We should develop a mechanism for isolation between the connector's housing and the chassis.

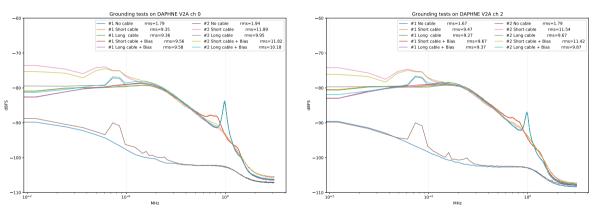
5. Short cables on the warm side are desirable, but we couldn't demonstrate a significant impact in the s/n.

Noise studies with short and long cables properly shielded
