# Preliminary Results of CRP5A Cold Runs

Shanshan Gao on behalf of BNL CE Team

12/13/2022

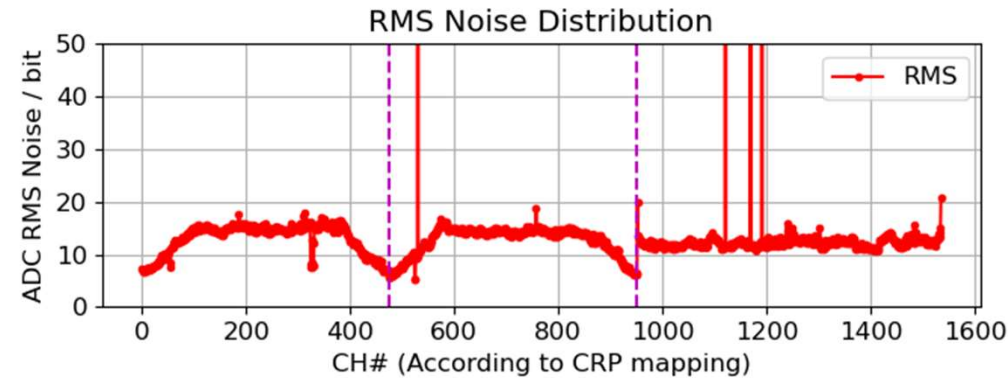
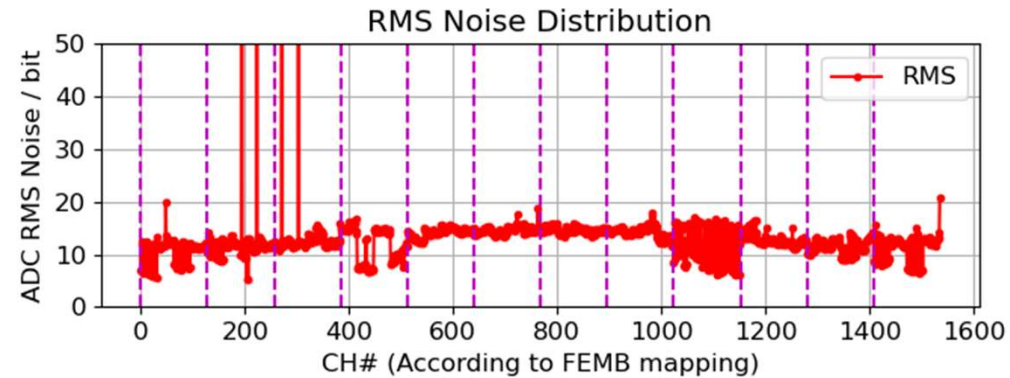
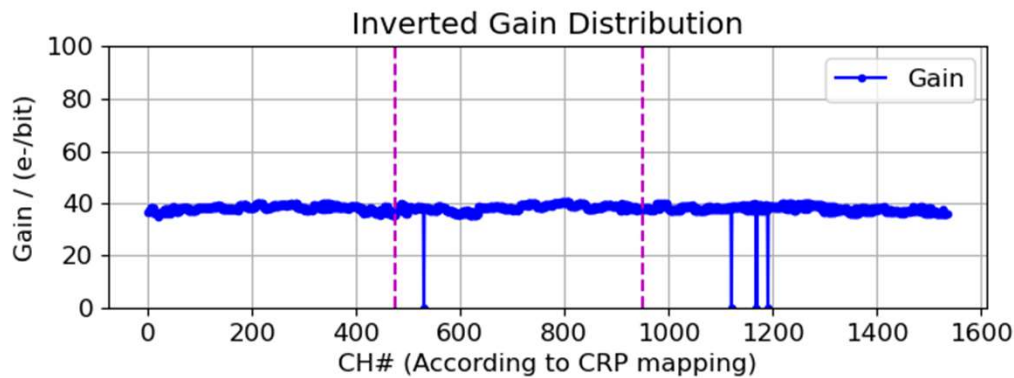
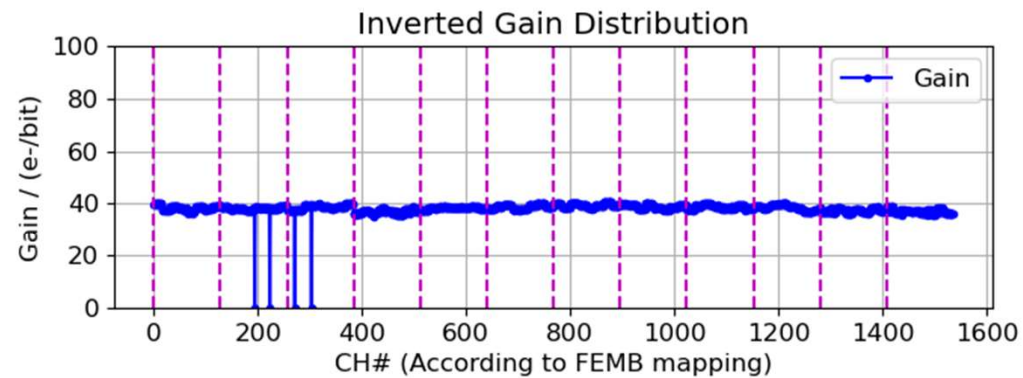
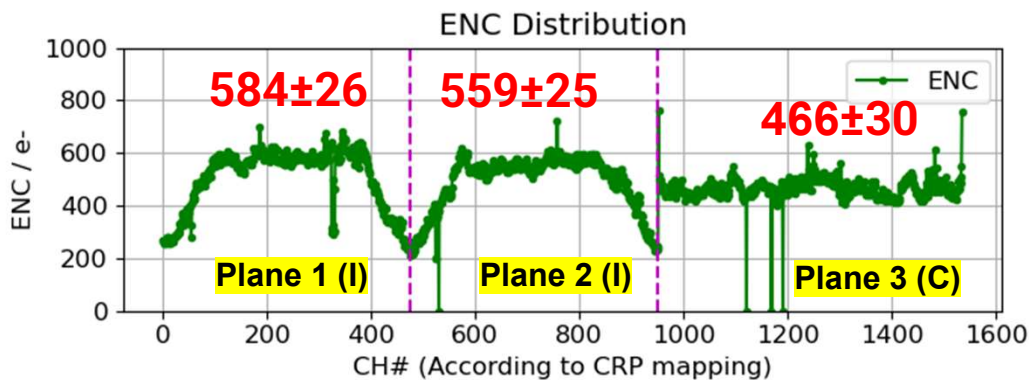
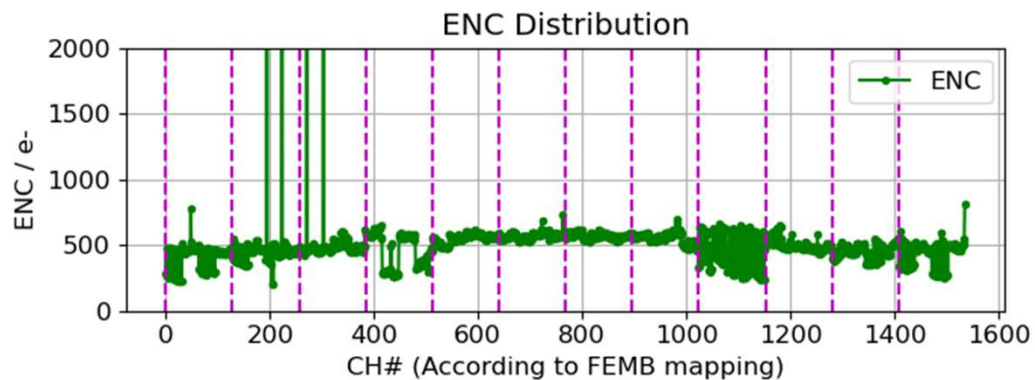
**HV BIAS on**, 900mV baseline, 14mV/fC gain, 2.0us peak time

note: observed extremely large noise and abnormal gain on ch#194, 223, 271, 303. Set them gain to 0.

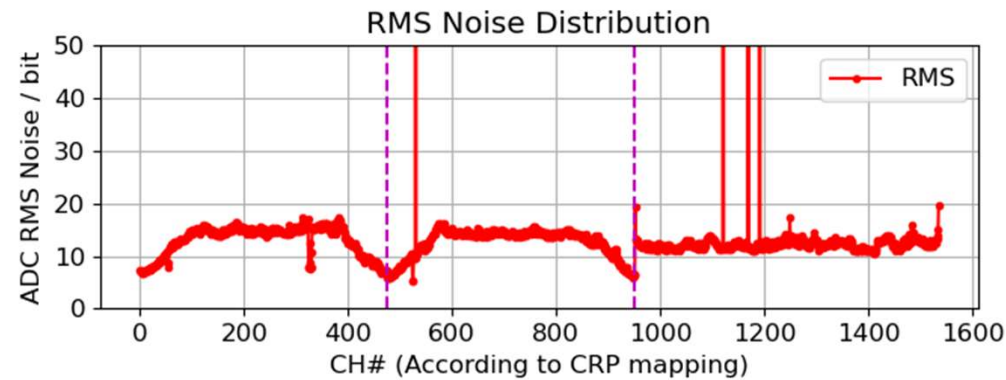
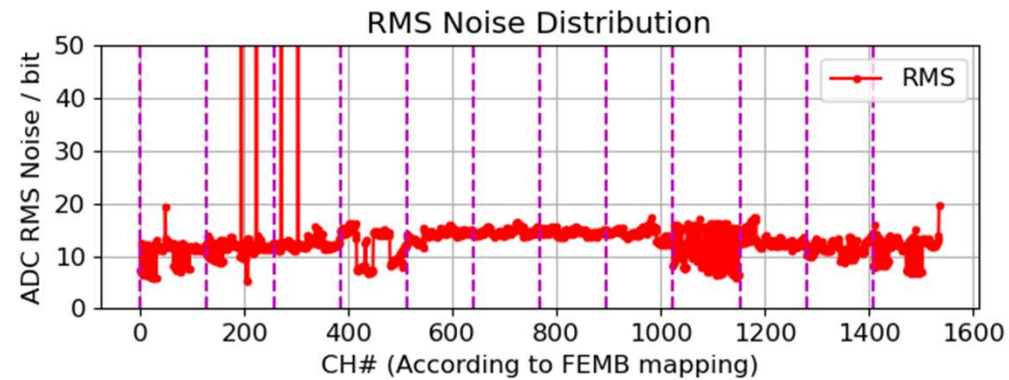
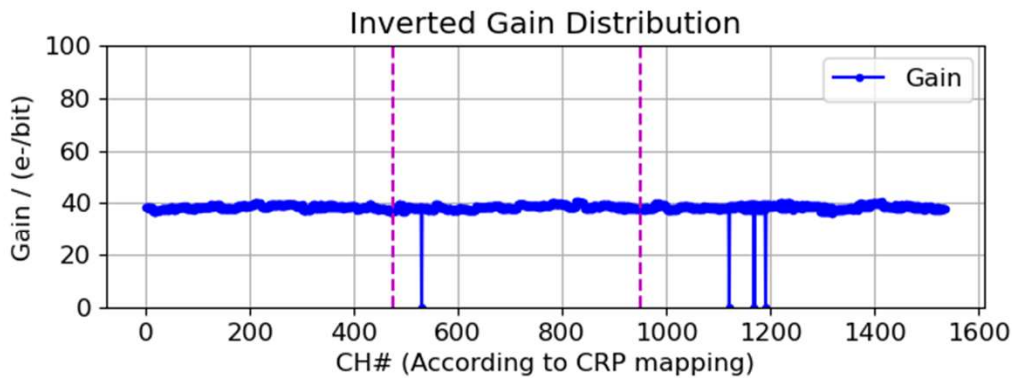
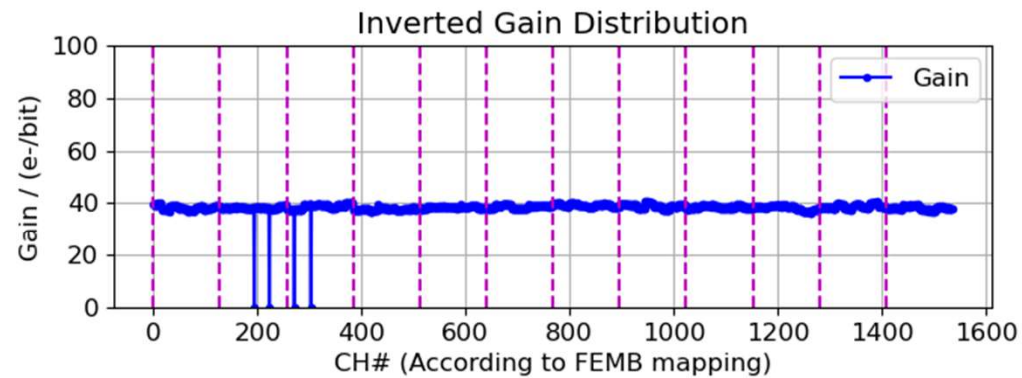
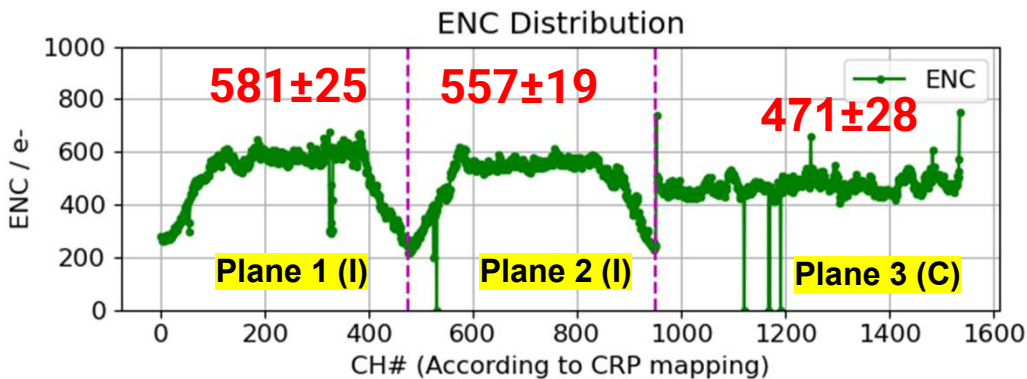
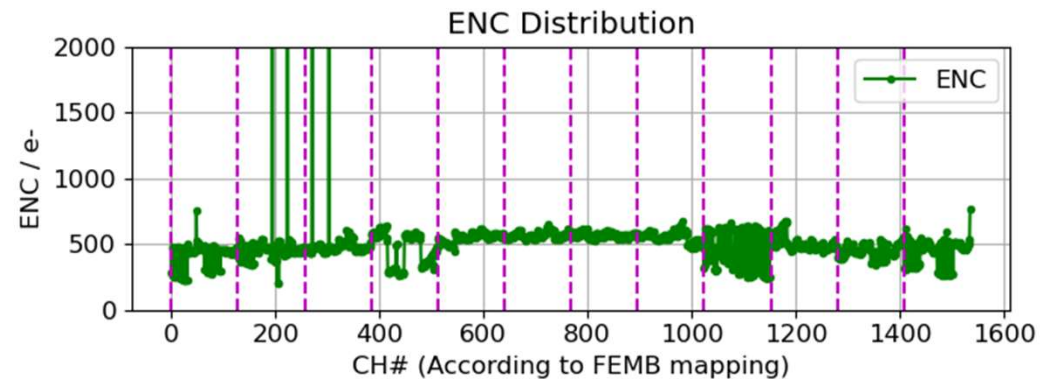
**HV BIAS on**, 200mV baseline, 14mV/fC gain, 2.0us peak time

note: observed extremely large noise and abnormal gain on ch#194, 223, 271, 303. Set them gain to 0.

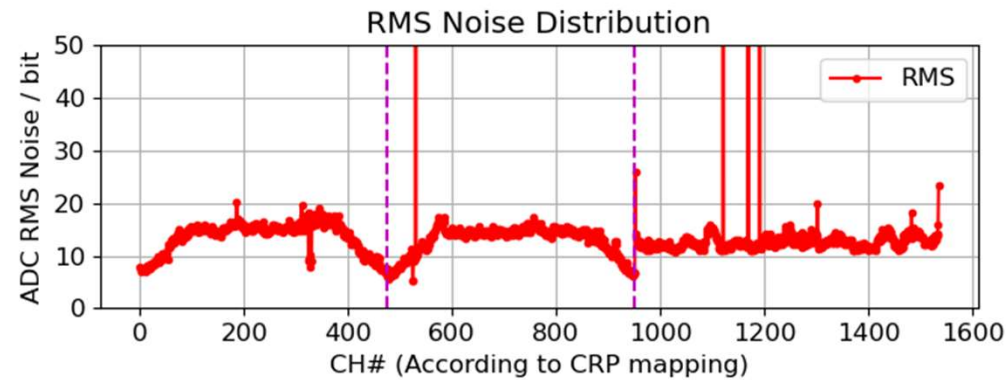
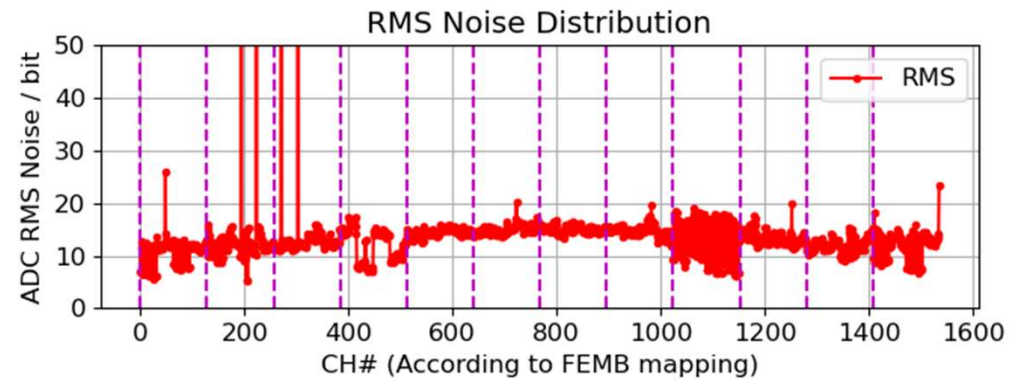
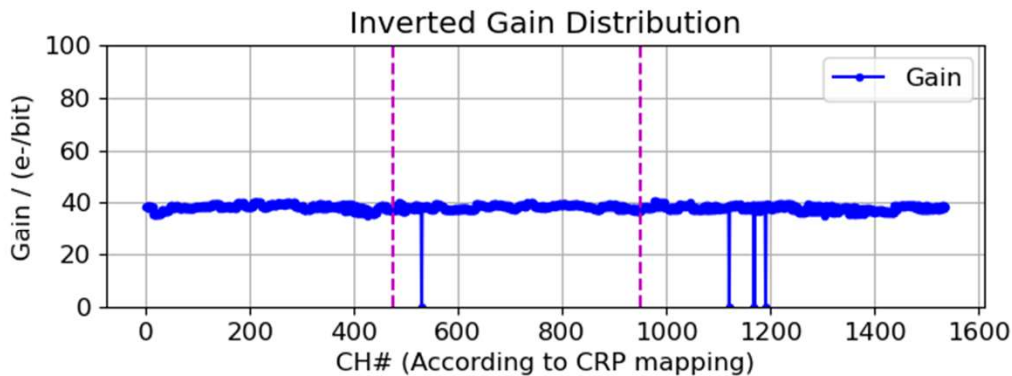
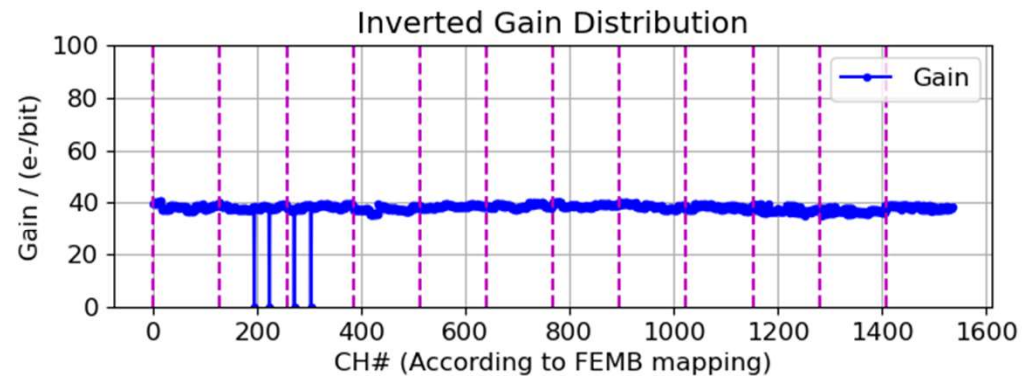
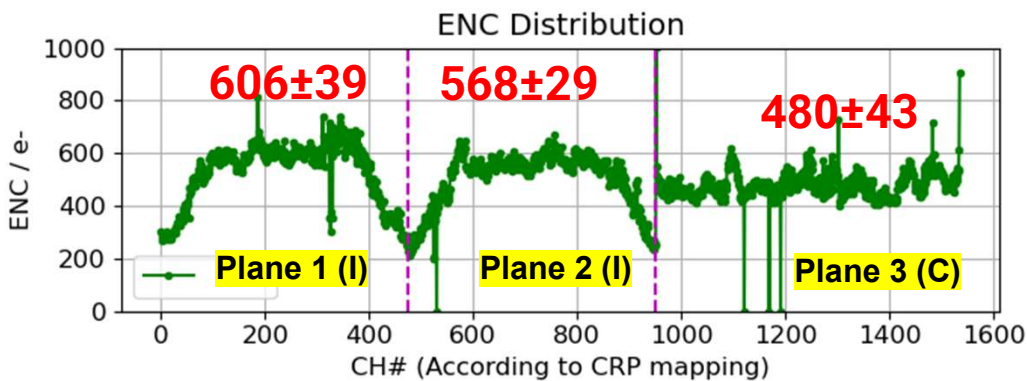
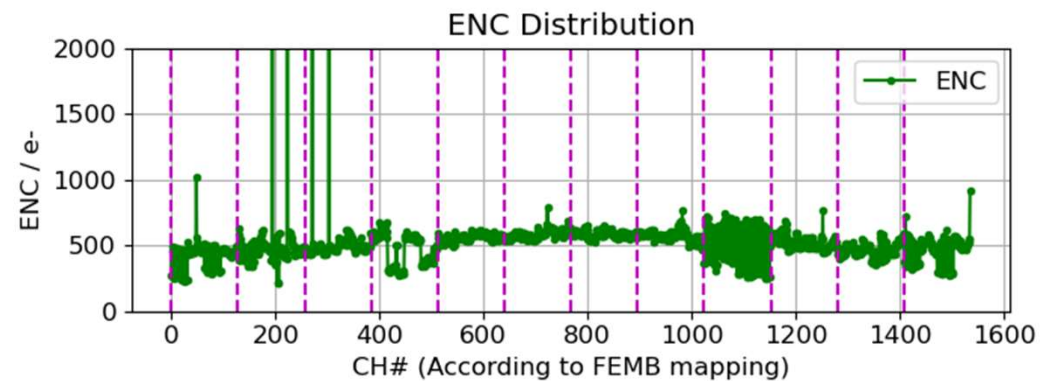
**HV BIAS on**, 900mV baseline, 14mV/fC gain, 3.0us peak time

note: observed extremely large noise and abnormal gain on ch#194, 223, 271, 303. Set them gain to 0.

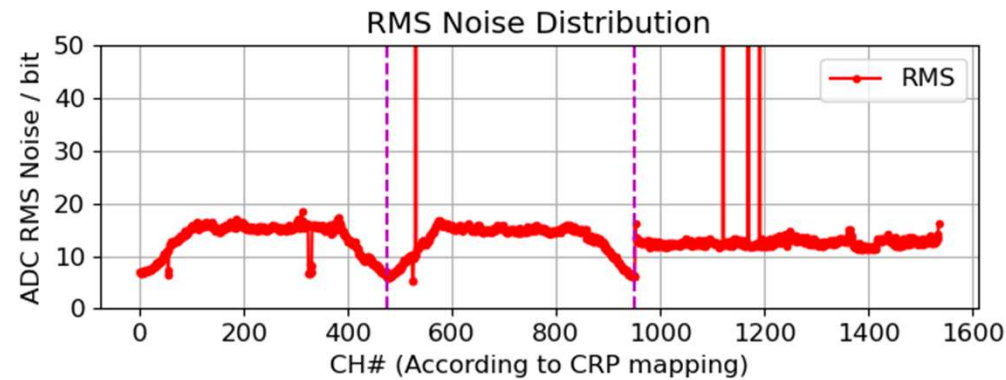
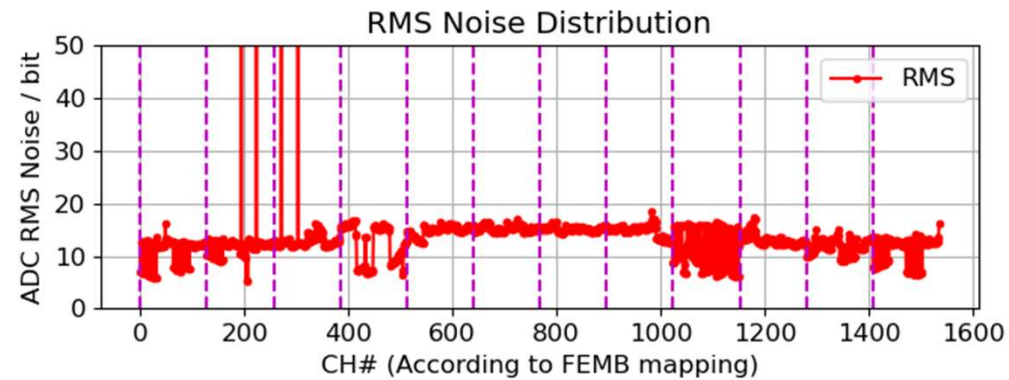
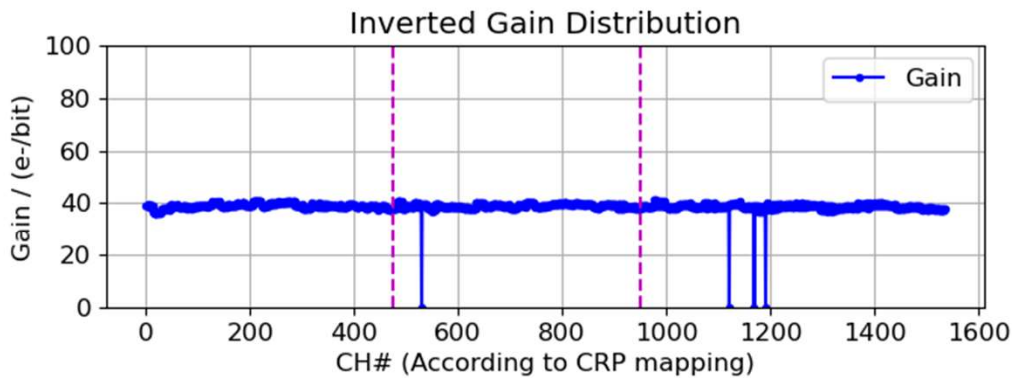
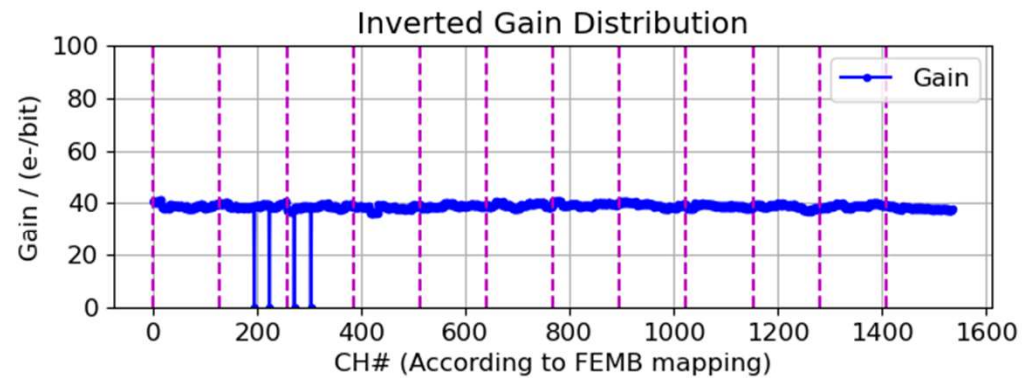
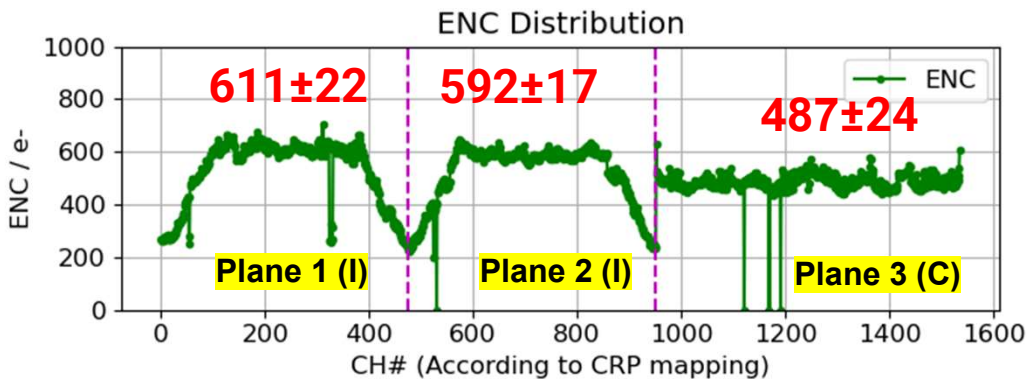
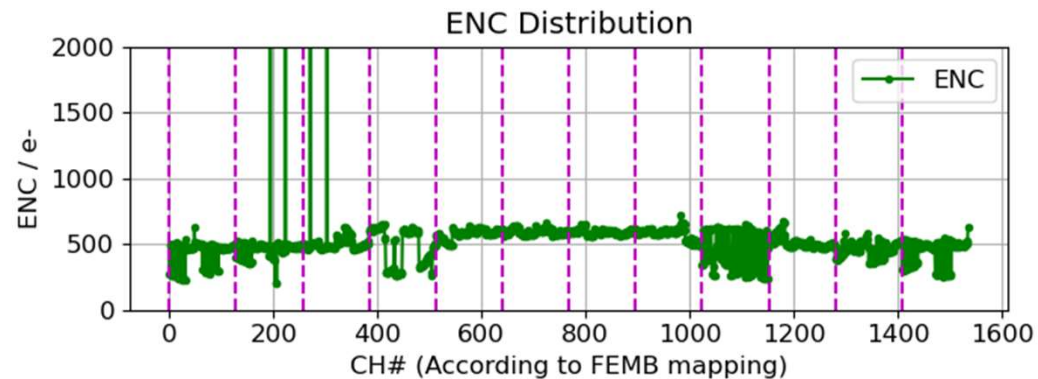
**HV BIAS on**, 900mV baseline, 14mV/fC gain, 1.0us peak time

note: observed extremely large noise and abnormal gain on ch#194, 223, 271, 303. Set them gain to 0.

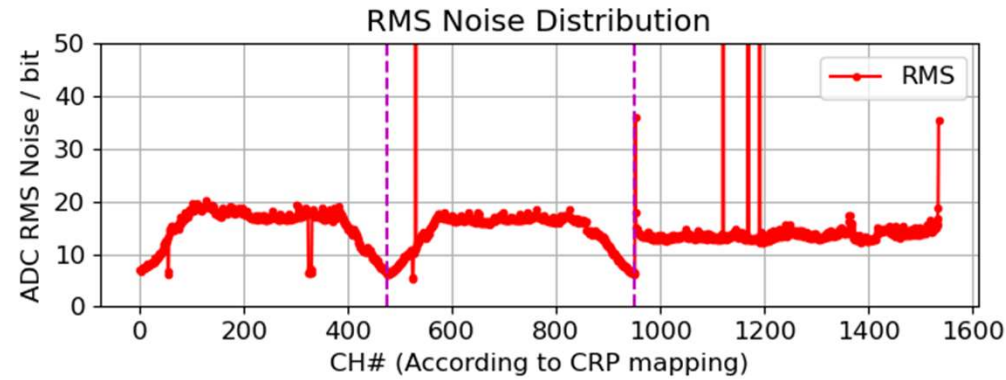
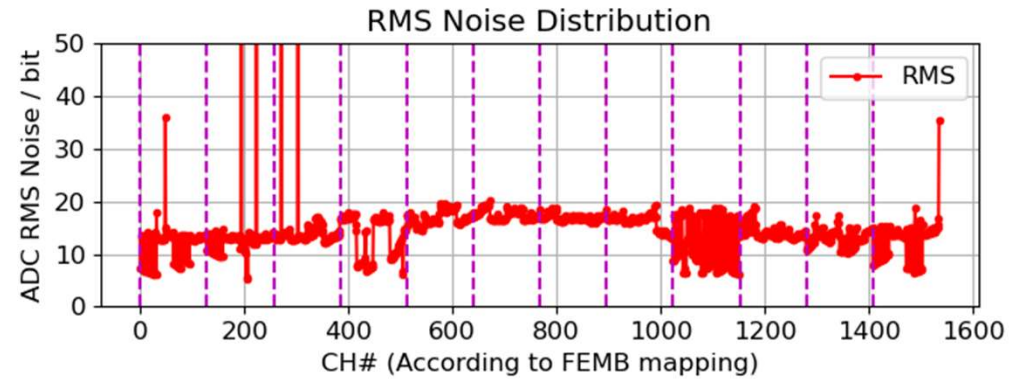
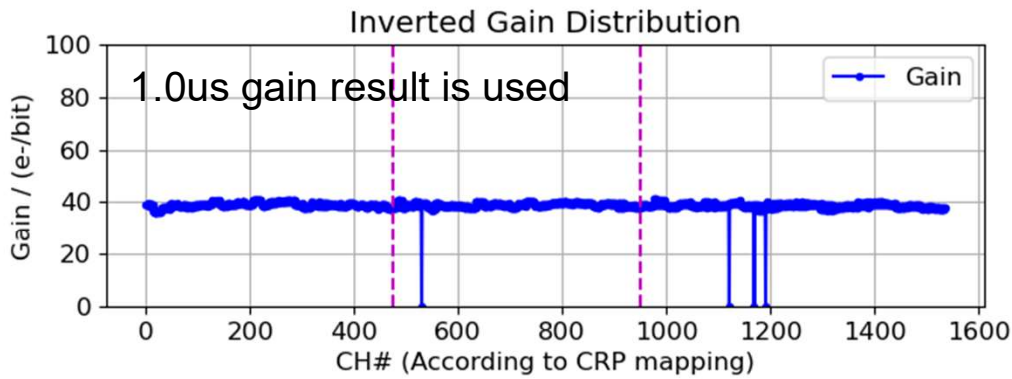
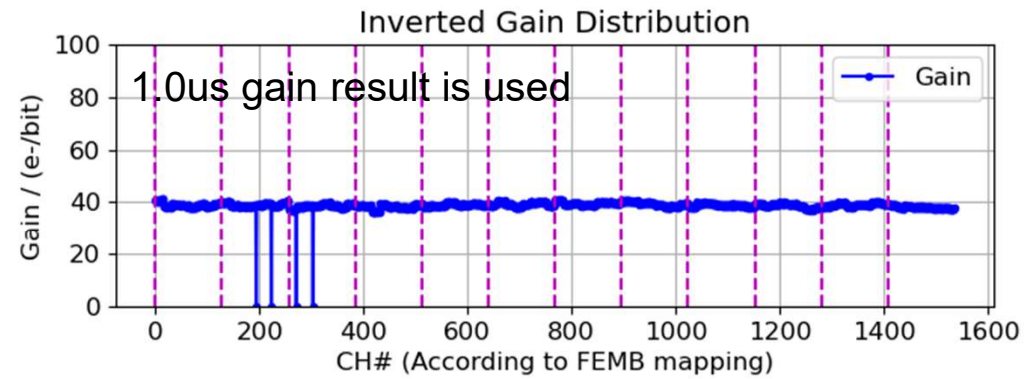
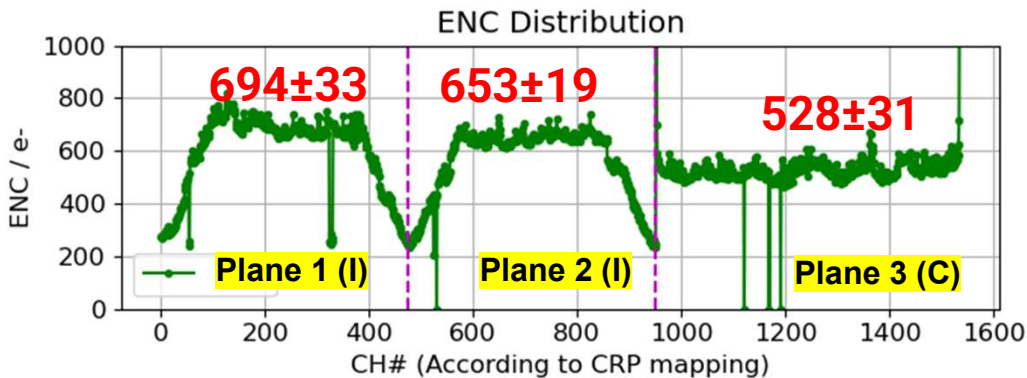
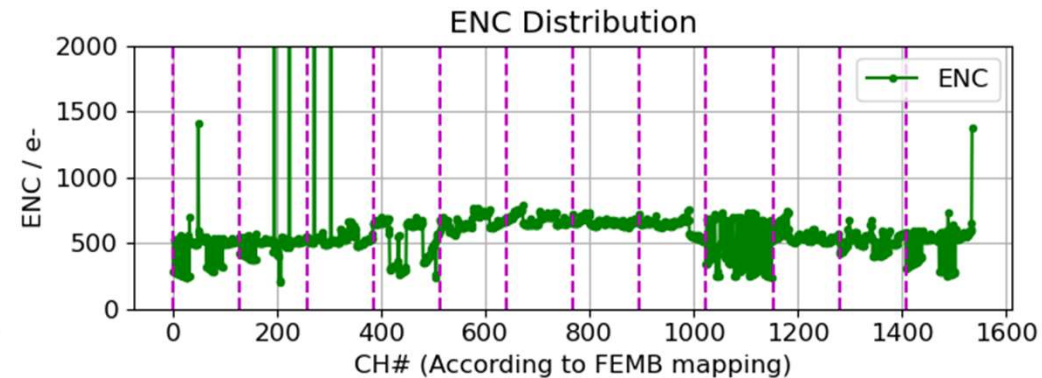
**HV BIAS on**, 900mV baseline, 14mV/fC gain, 0.5us peak time

note: observed extremely large noise and abnormal gain on ch#194, 223, 271, 303. Set them gain to 0.

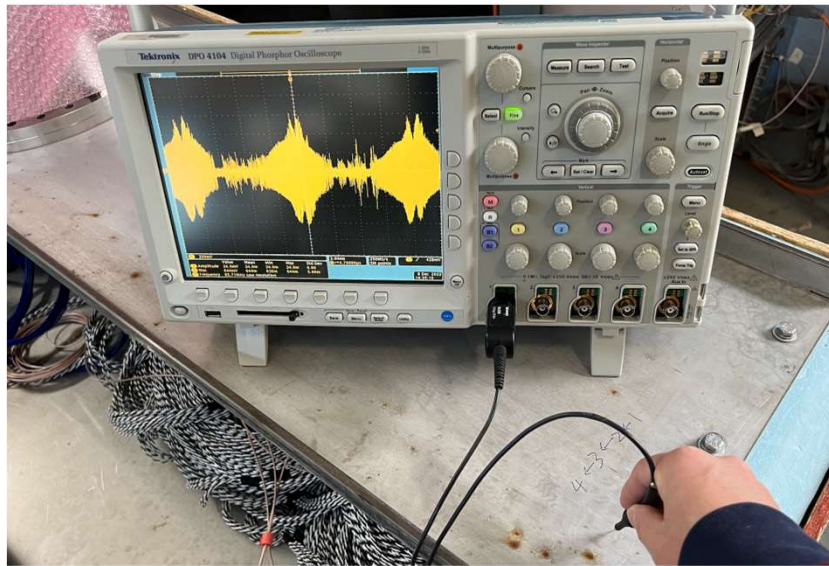
~60Hz, when ceiling lights are on

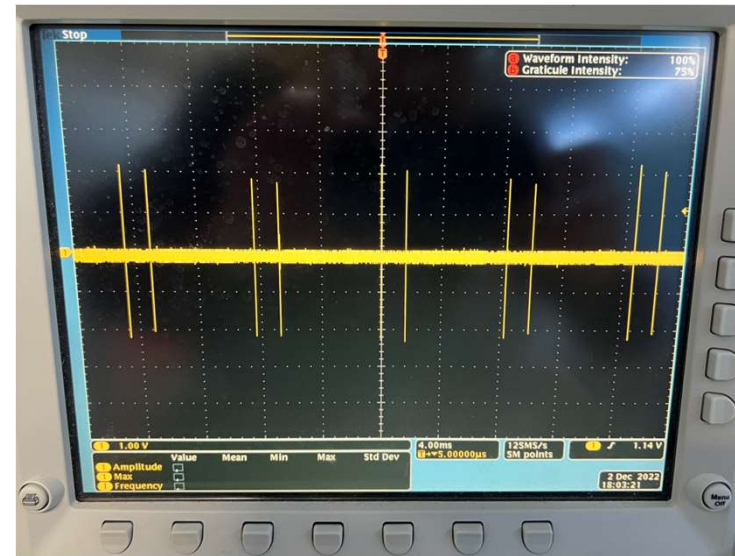
~120Hz noise spikes, unknown source

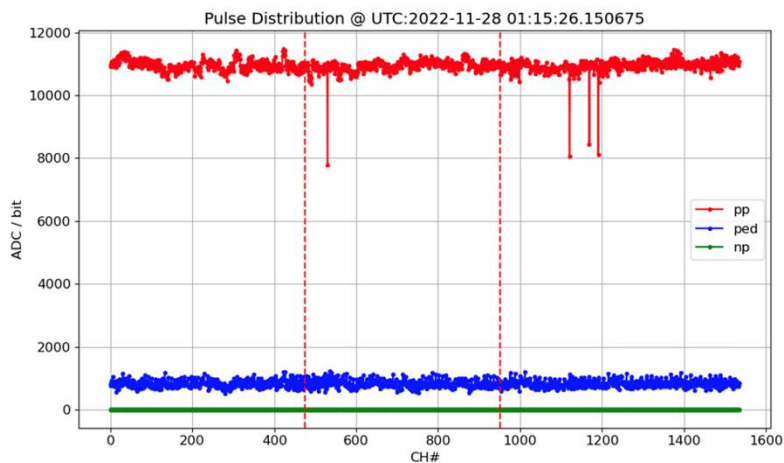
send calibrate fast command twice
