## **FAST Facility / IOTA**

### **Status Report**

Daniel R. MacLean  
AD Operations Meeting  
Friday 0900  
30 December 2022

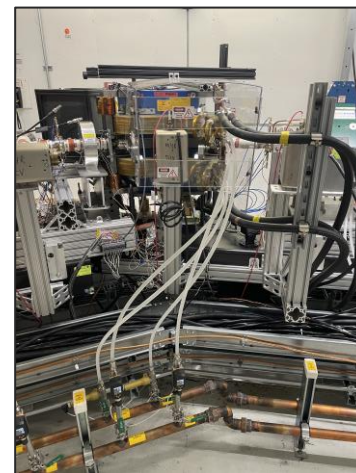
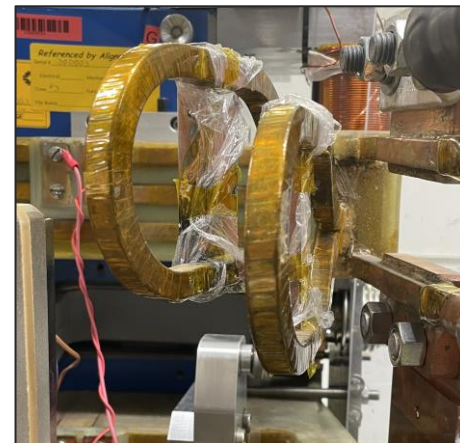
- 30° IOTA bend dipole M4R has an apparent LCW leak from within its top coil
  - Discovered Tuesday during an access for an unrelated issue
  - Unclear exactly where leak is; need to locate to determine extent of disassembly required to repair

- Seems to be coming from the coil itself, as opposed to the bulkhead where it is fed from the main LCW line
  - We have 1 spare 30° bend dipole at FAST but it has no coil...

- **Top priority is to troubleshoot M4R LCW leak as efficiently as possible**
  - There are no accesses scheduled or requested at this time
