APA Winder Upgrades
Dune UK Collaboration Meeting
July 2023

Winder development program

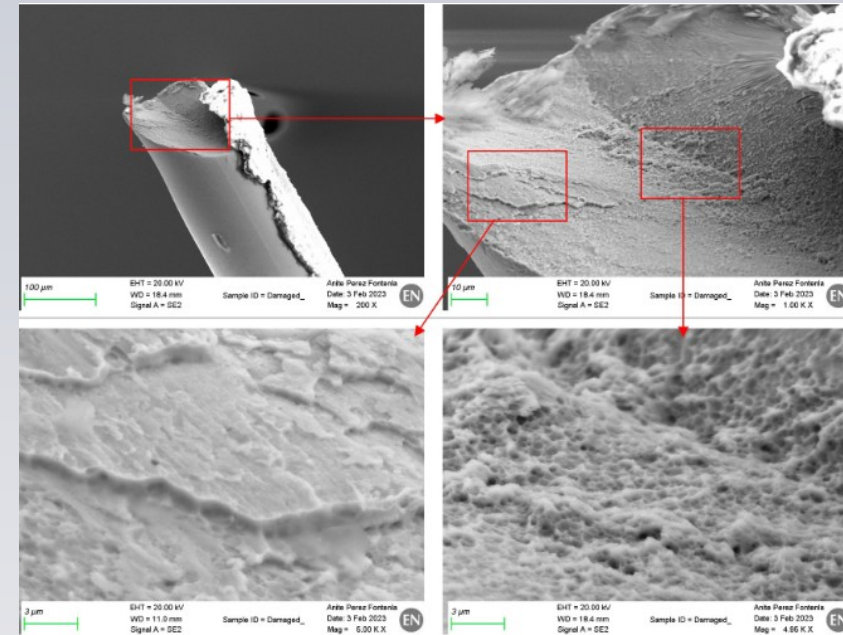
Broken wire on APA 3

- A V-layer wire on APA 3 in ProtoDUNE II broke
 - After the cold box tests in October and before late November when the first CE readout was done in the cryostat
 - Broken wire was removed from APA and analyzed
 - Report on EDMS
 - <https://indico.fnal.gov/event/58720/>
 - Cause of brake concluded to be most likely a fracture surface
 - Excessive tension applied on wires when winding?

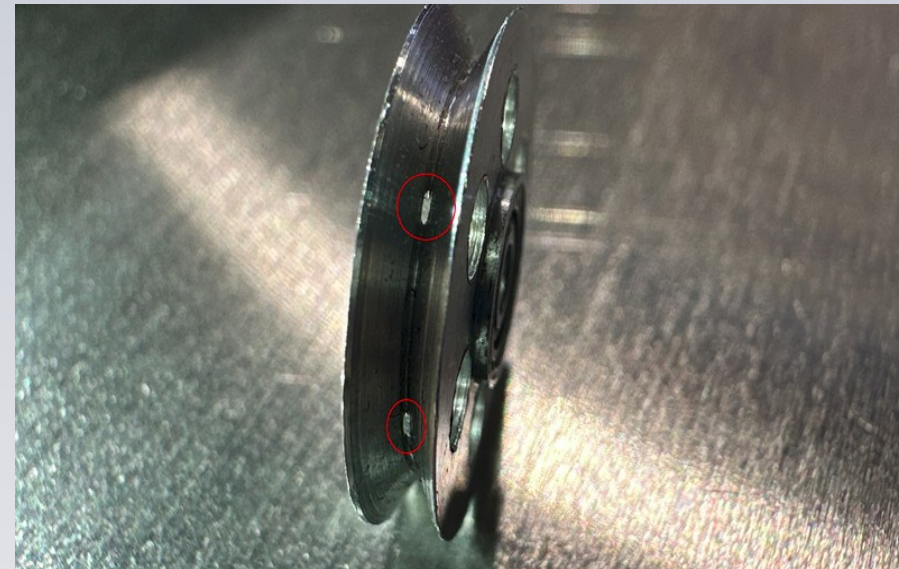
Winder 2 pulley problem

- When winding G-Layer on APA 6 in early March
 - It was observed that a guide pulley has excessive wear and has broken through material of pulley possibly causing a "crinkled" effect on the laid wire.
- Several possible causes
 - Manufacturing problem and/or build up tolerances
 - Wire over tension (wearing off surface)
 - A high Set Point was used in this winder (#2)
 - Load cell calibration was not right
- Action taken
 - APA 6 scrapped and started again
 - New pulleys were designed and manufactured (more smaller holes, more material)
 - More regular inspections and replacement of pulleys (moving parts in the head)

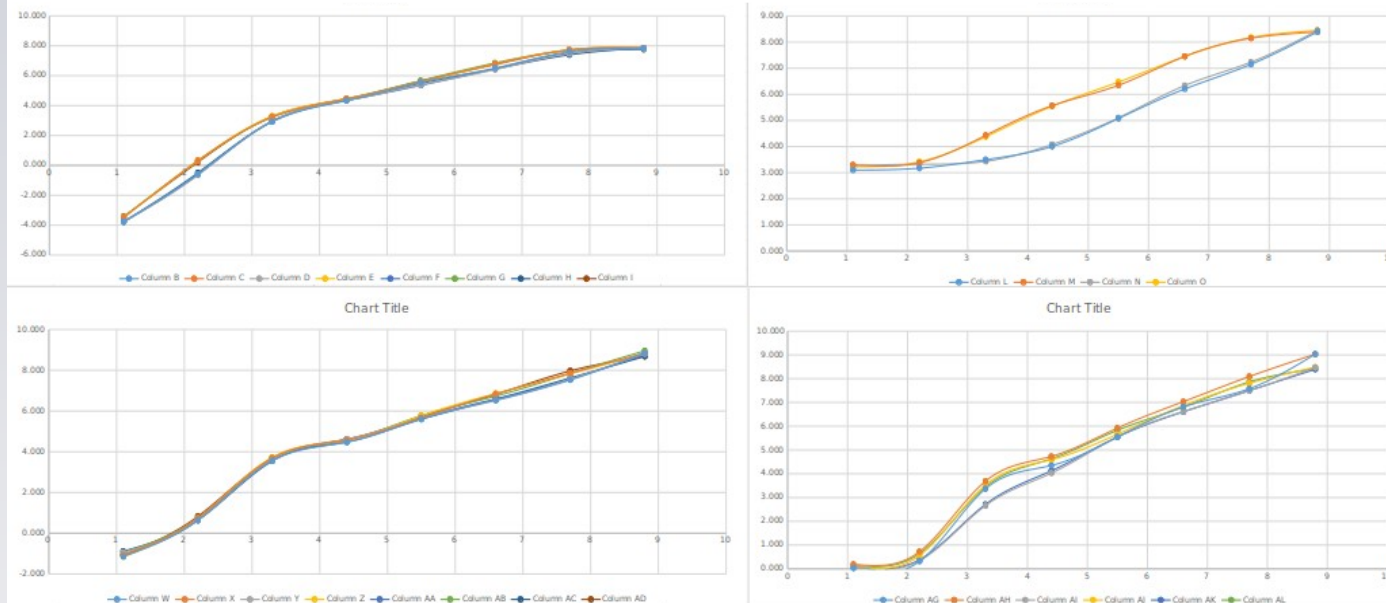
Winder 2, load cell calibration attempts in January 2023

- Some problems with its performance (had the pulley worn off, APA 6 scrapped)
- Load cell calibration was not right, several attempts showing it (Jan 2023)
- After comparing with W#1 load cell location, it needed to be moved by 3 mm (May 2023)

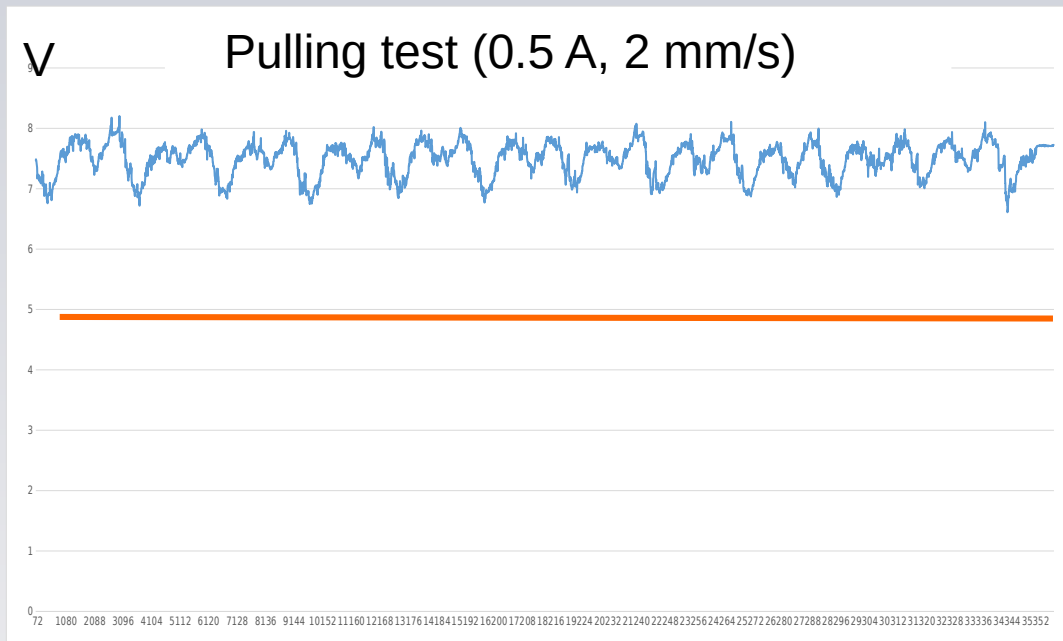
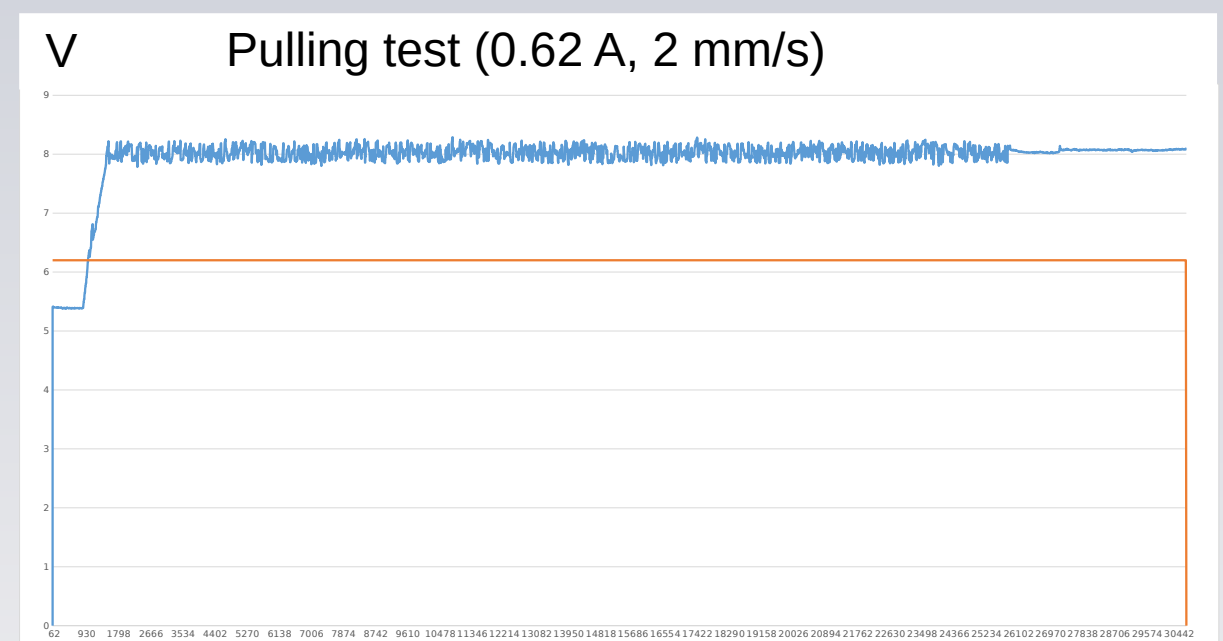
- Pulling wire from a fixed point for a fixed distance (1000 mm)
- Driving motor at constant current (constant torque)
- Moving at a constant low speed, the load cell amplifier output (in Volts) expose mechanical problems
- In this particular case the smaller variations (at 6.2 A test) is a clear indication of the system hitting the high hard stop (at 8.3 V)
- This prompted the compare the position of the load cell wrt winder 1 and 4 , then change its location and calibrate

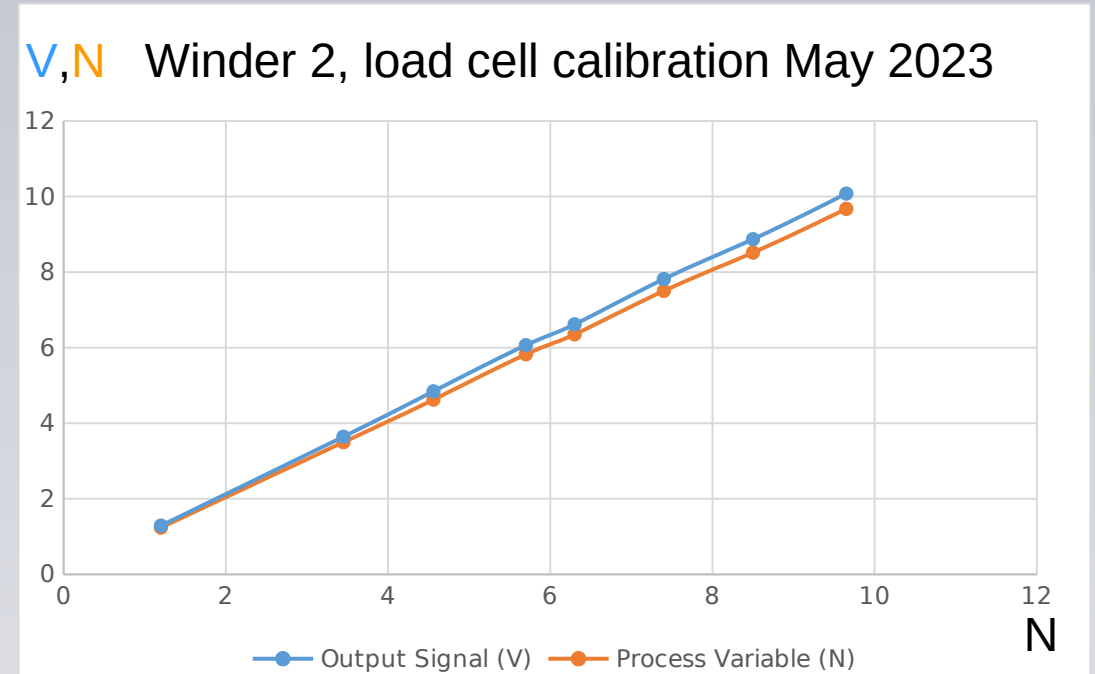
■ Much Improved calibration

- We now know the linear range reliably
- We know the hard stop is beyond the max amplifier output of 10 V
- The amplifier output is always slightly higher than the tension measured by load cell (in N), **10 V := 9.7 N**

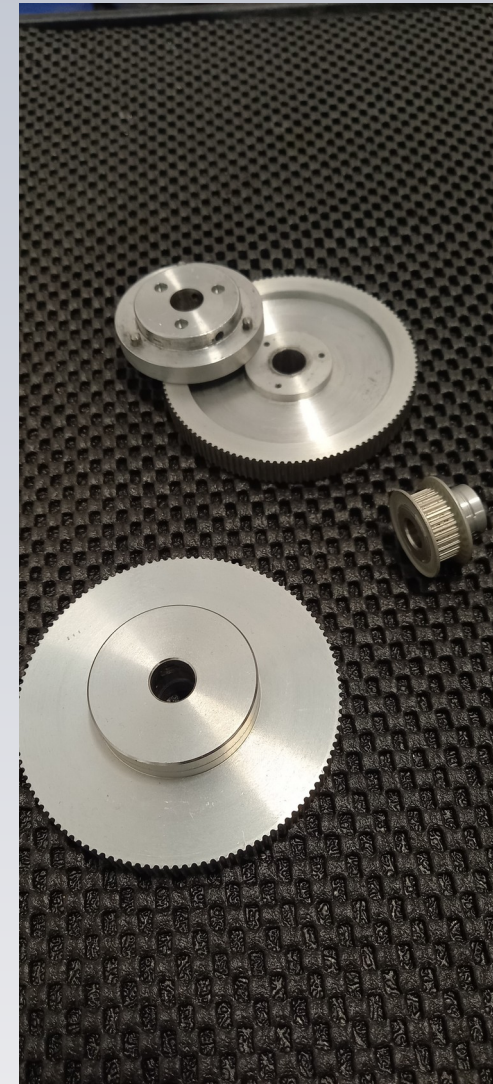
- Changes to old sprocket
 - Used to make substantial modifications to the manufacturers sprocket
 - Old sprocket used to have two pieces
 - Now only one
 - New design only has on single piece
 - The small sprocket for belt was clocked and showed run off
 - It was machined to reduce run off

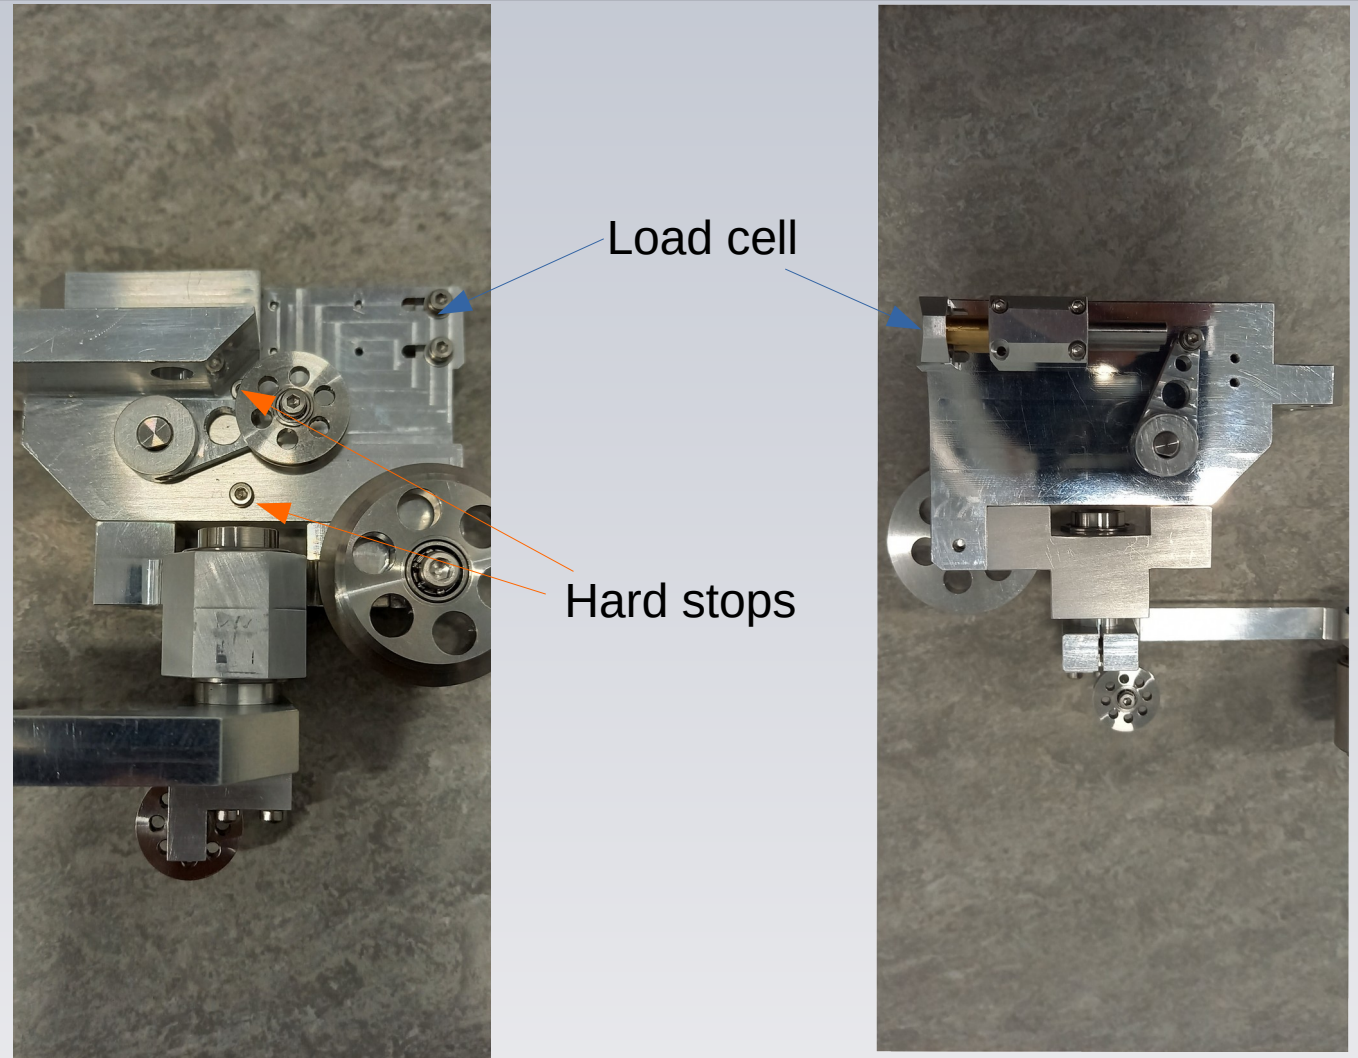
- Changes to load cell location
 - Moved load cell 3mm to match winder #1
 - Avoiding hitting the hard stop before 10 V output

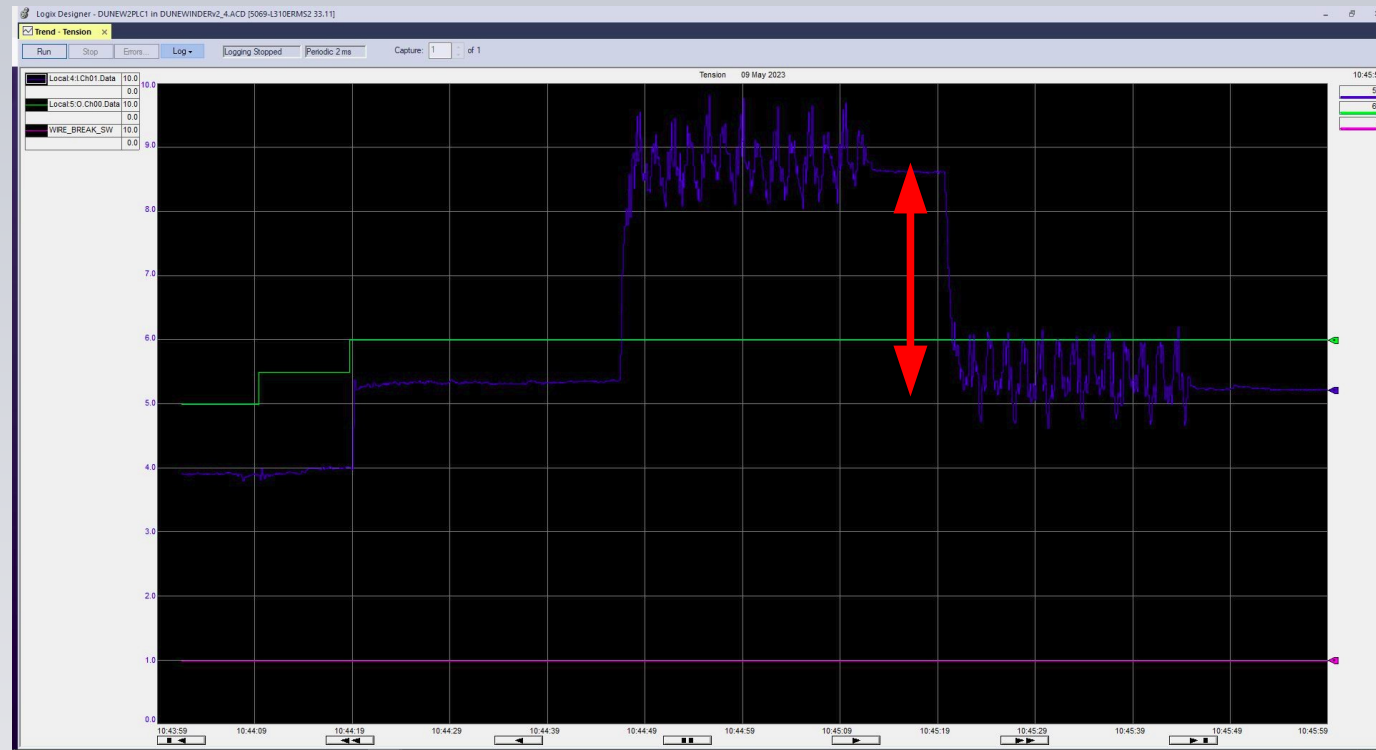
Winder 2, test 1

- Unwind to rewind test
 - Wire end is fixed to the winder frame and winding head is in constant current mode
 - Winder is moved horizontally
 - Large offset observed from unwind to rewind
 - A significant amount of ripple was observed, but from experience can be considered good, but there is room for improvement

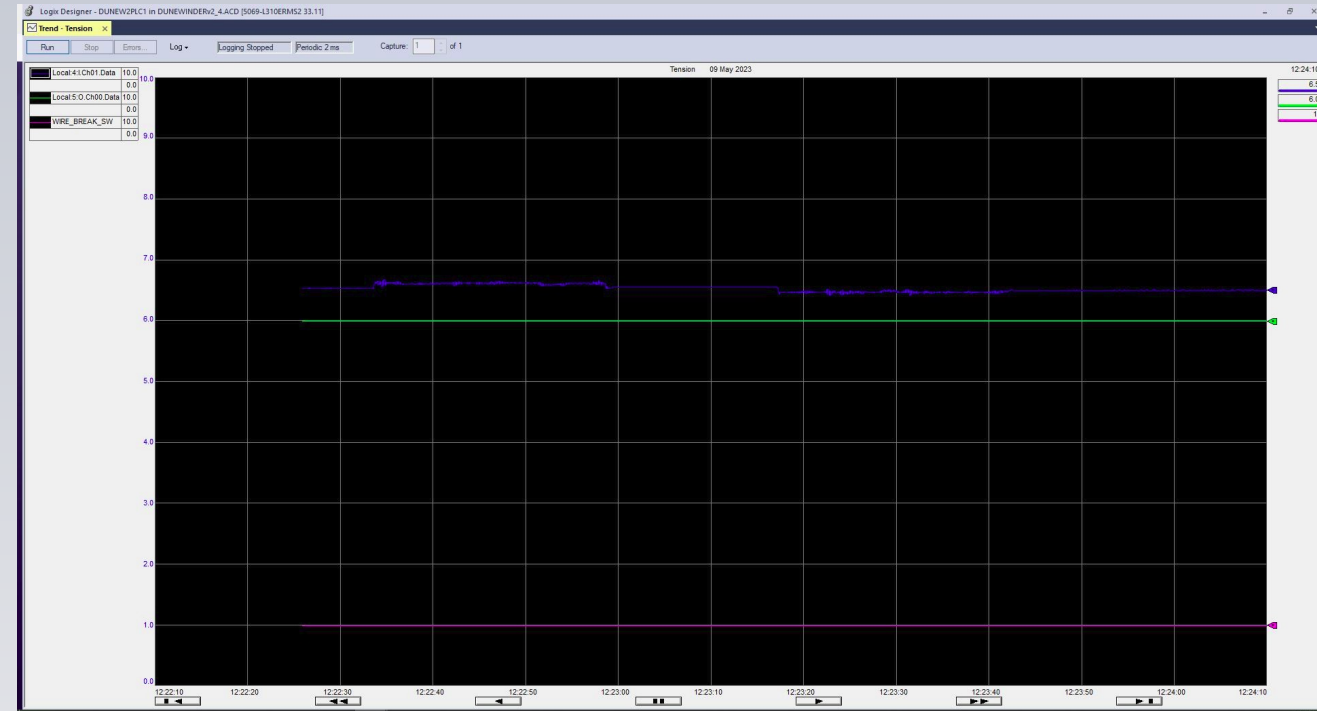
Winder 2, test 2

- Section of wire cut. One end tied to winder frame. Wire is routed through all of the winding head including everything except the spool, timing belt, and motor. Other end has 6.5N weight hung.
- Winder is moved up and down.
- Small amount of offset from unwind to rewind,
- Which indicates the offset seen on previous slides is from the spool, timing belt, or motor.
- Almost no ripple was observed, which is very good

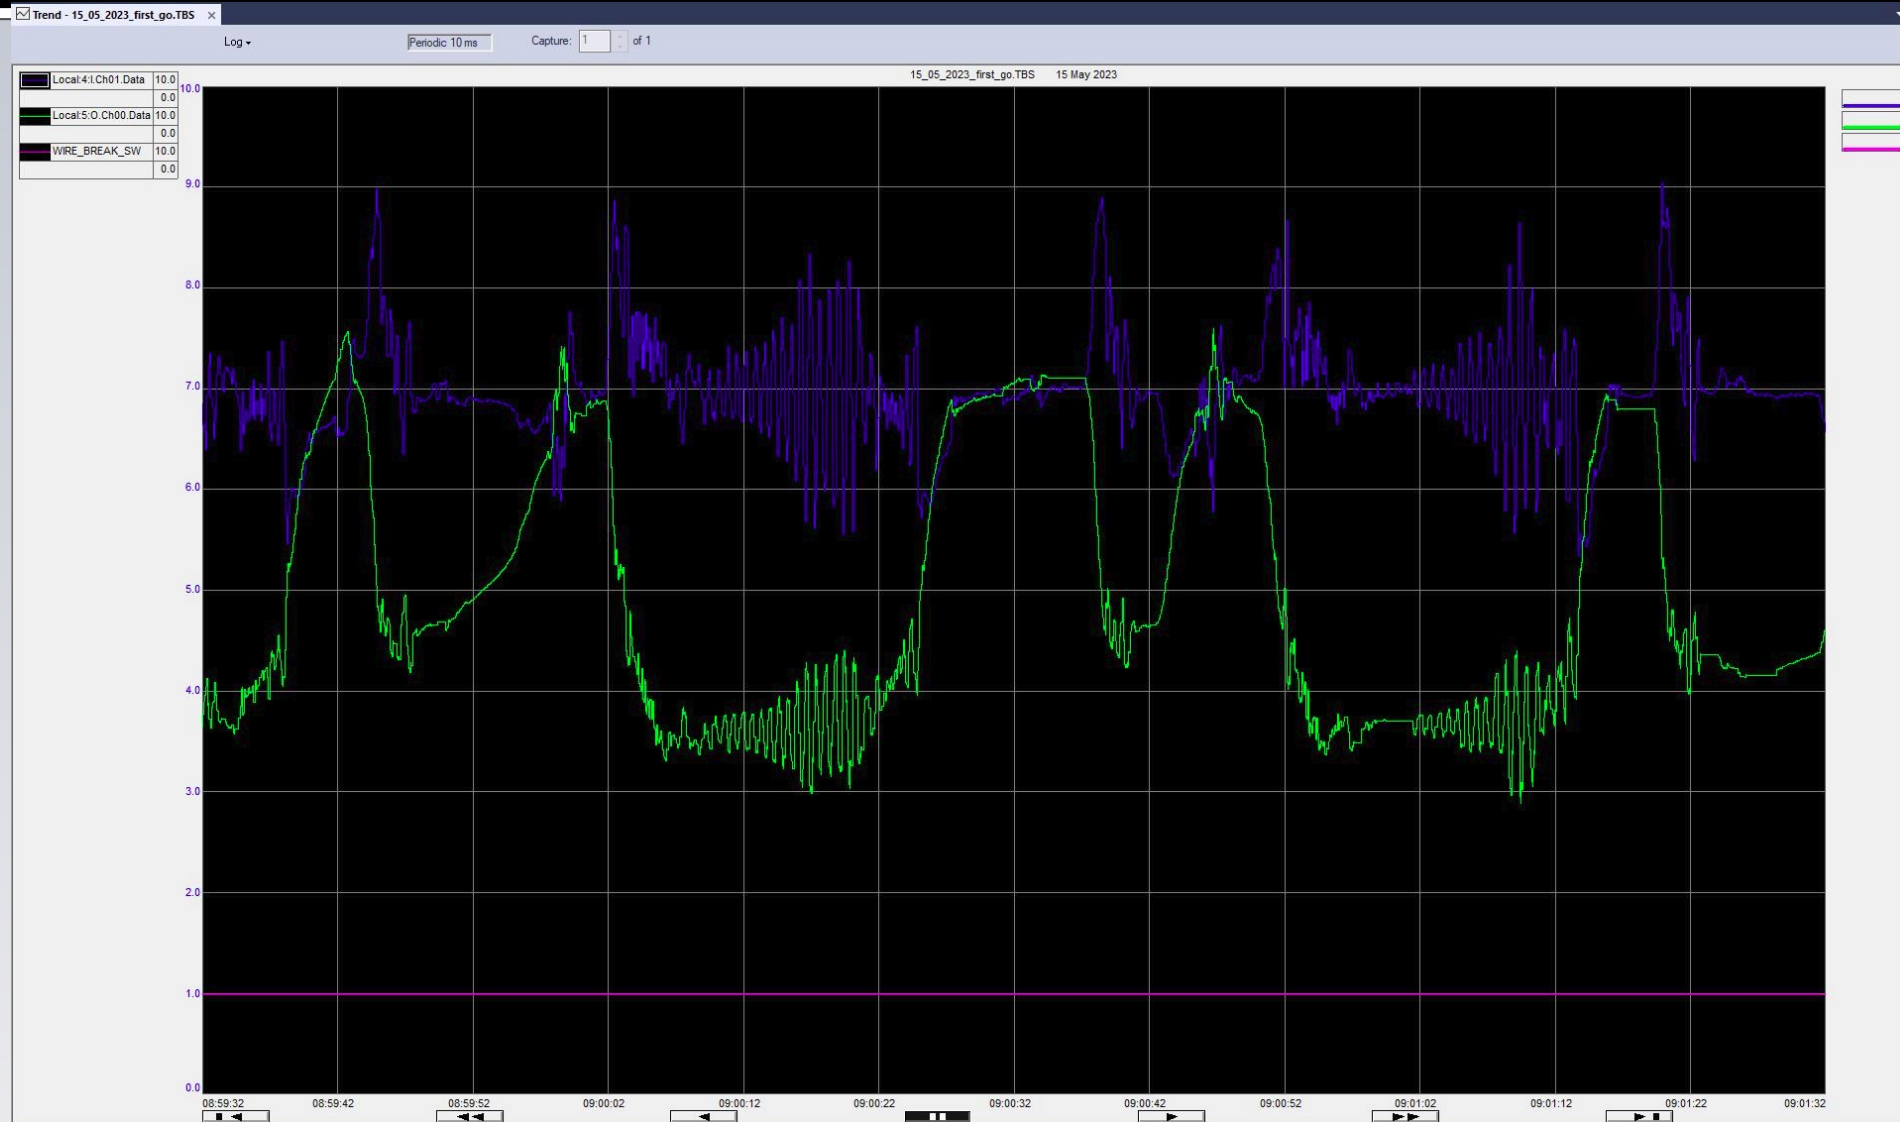
Winder 2, before PID loop tuning

- Before PID loop tuning
- Quick build up of oscillations when laying the long wire horizontally
- Peaks observed when laying the wire during the first tenths of milliseconds during acceleration, also when moving head from Side A to B and vice versa.
- Need for PID loop tuning

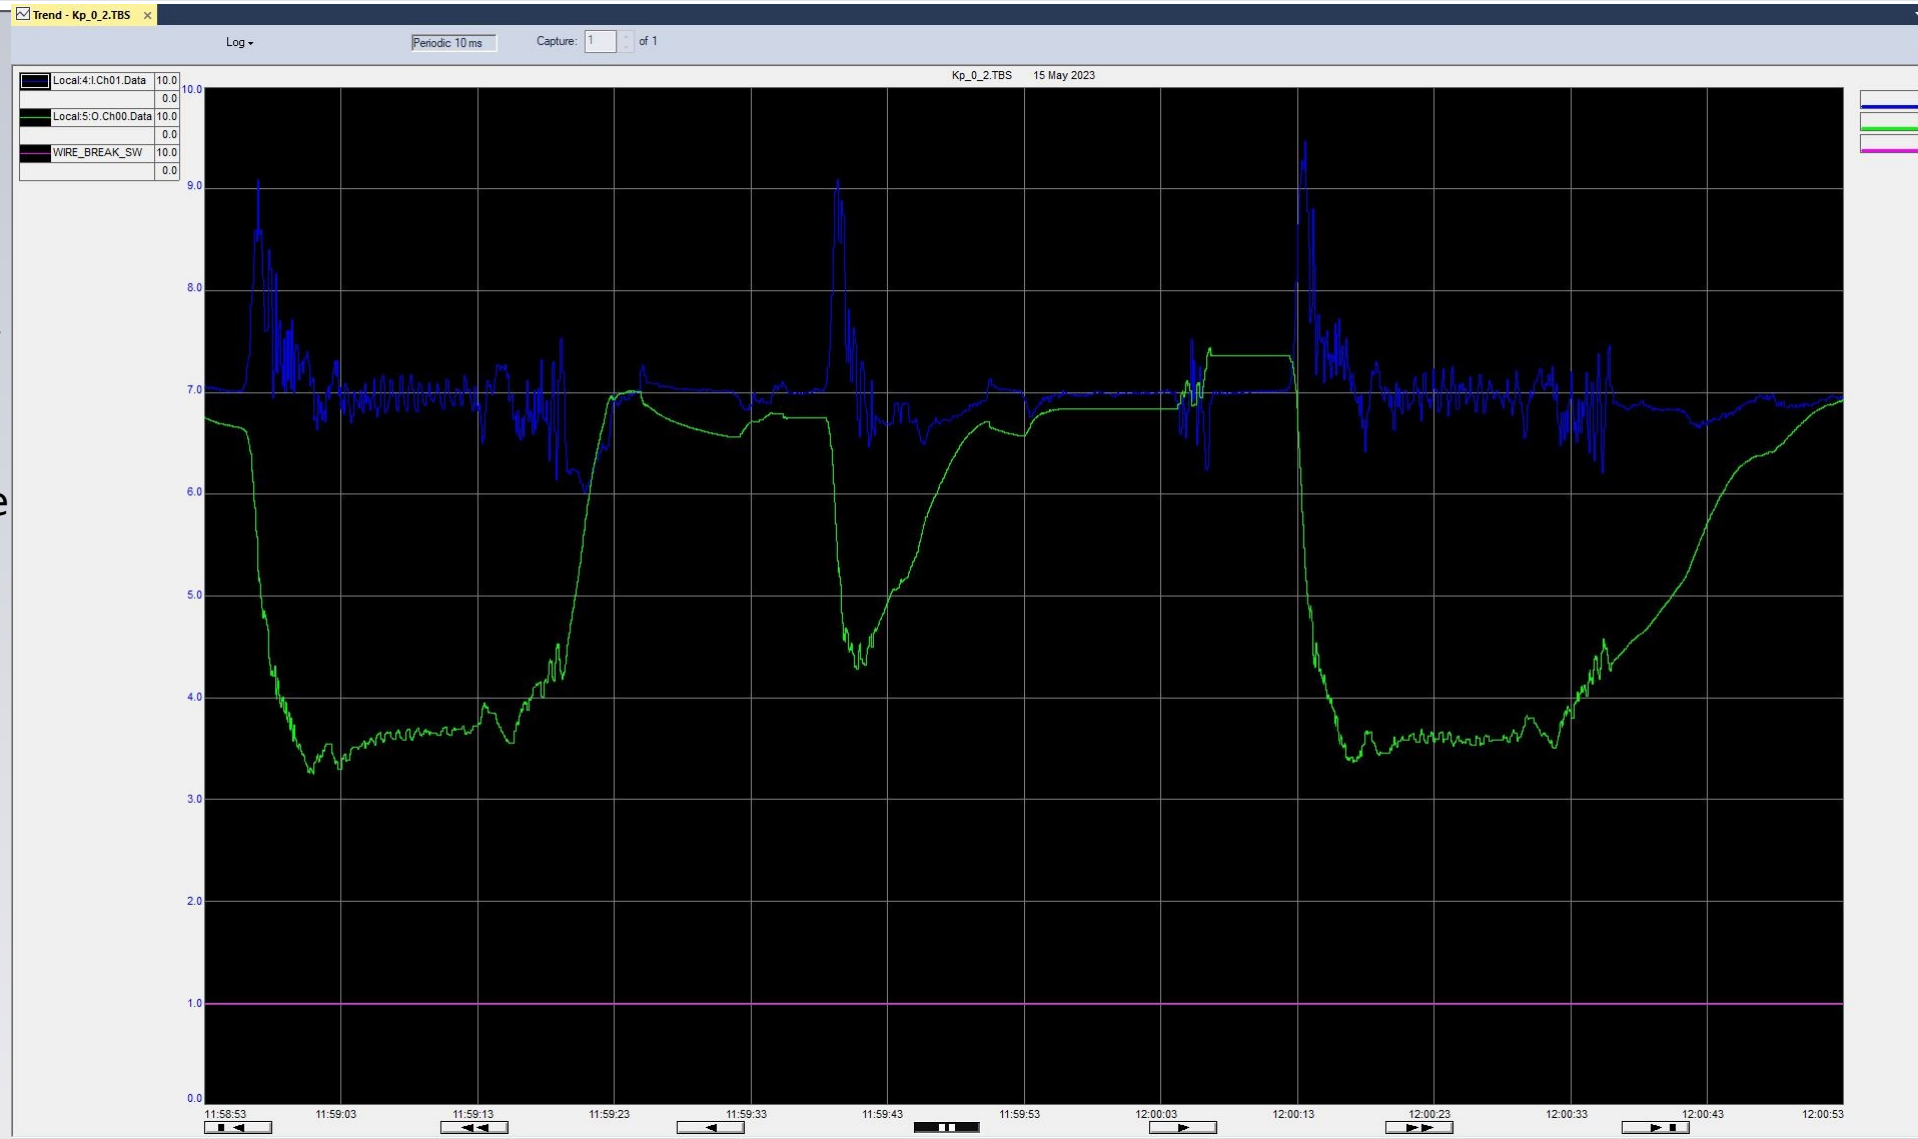
Winder 2, after PID loop tuning

- After PID loop tuning
- Oscillations when laying the long wire horizontally under control
- Peaks observed when laying the wire during the first tenths of milliseconds during acceleration only when moving head from Side A to B and vice versa.
- Need for change in winding recipe

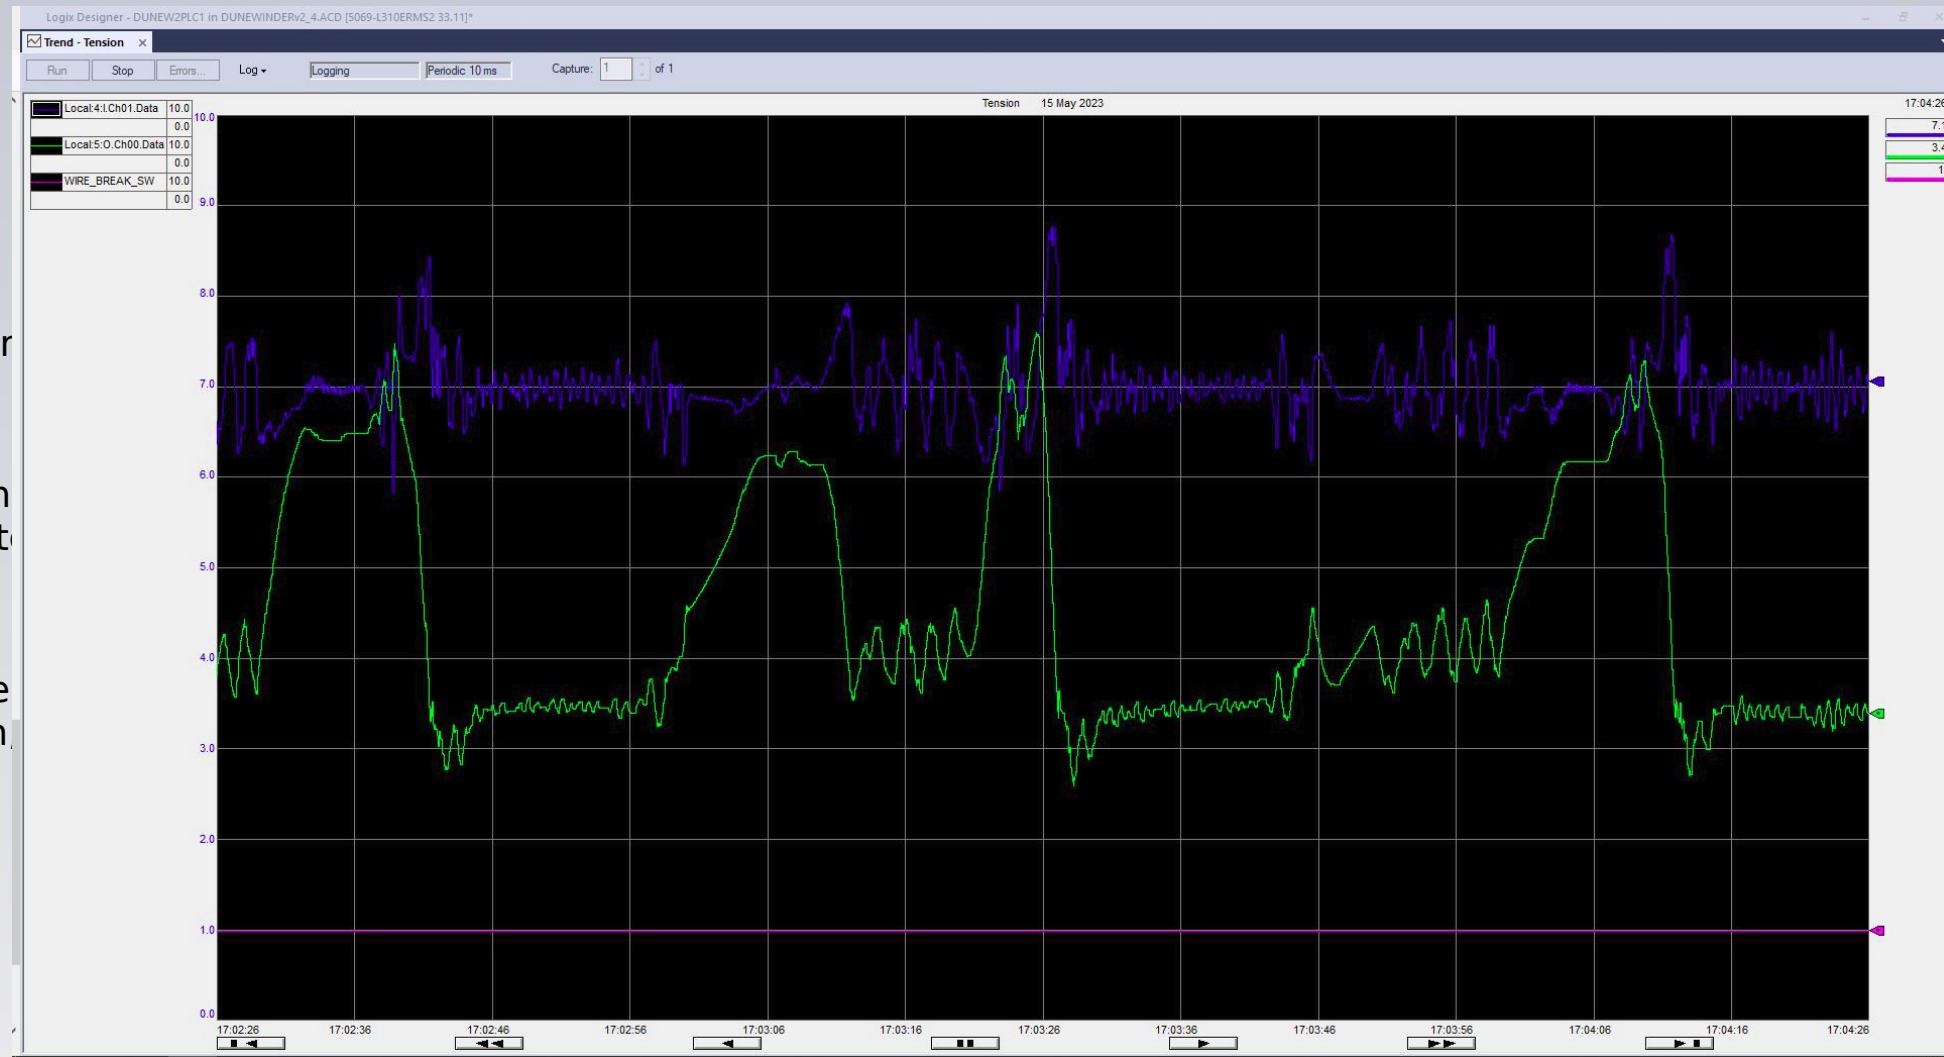
Winder 2, after change in recipe

- After Change in recipe
- Slowing down the transfer head movement only
- Oscillations on the long wire horizontally under control
- Peaks now much reduced when laying the wire when moving head from Side A to B and vice versa.
- Next is to adjust the set point to reduce the number of wires needed re-tension, and aiming to be closer to the target tension.

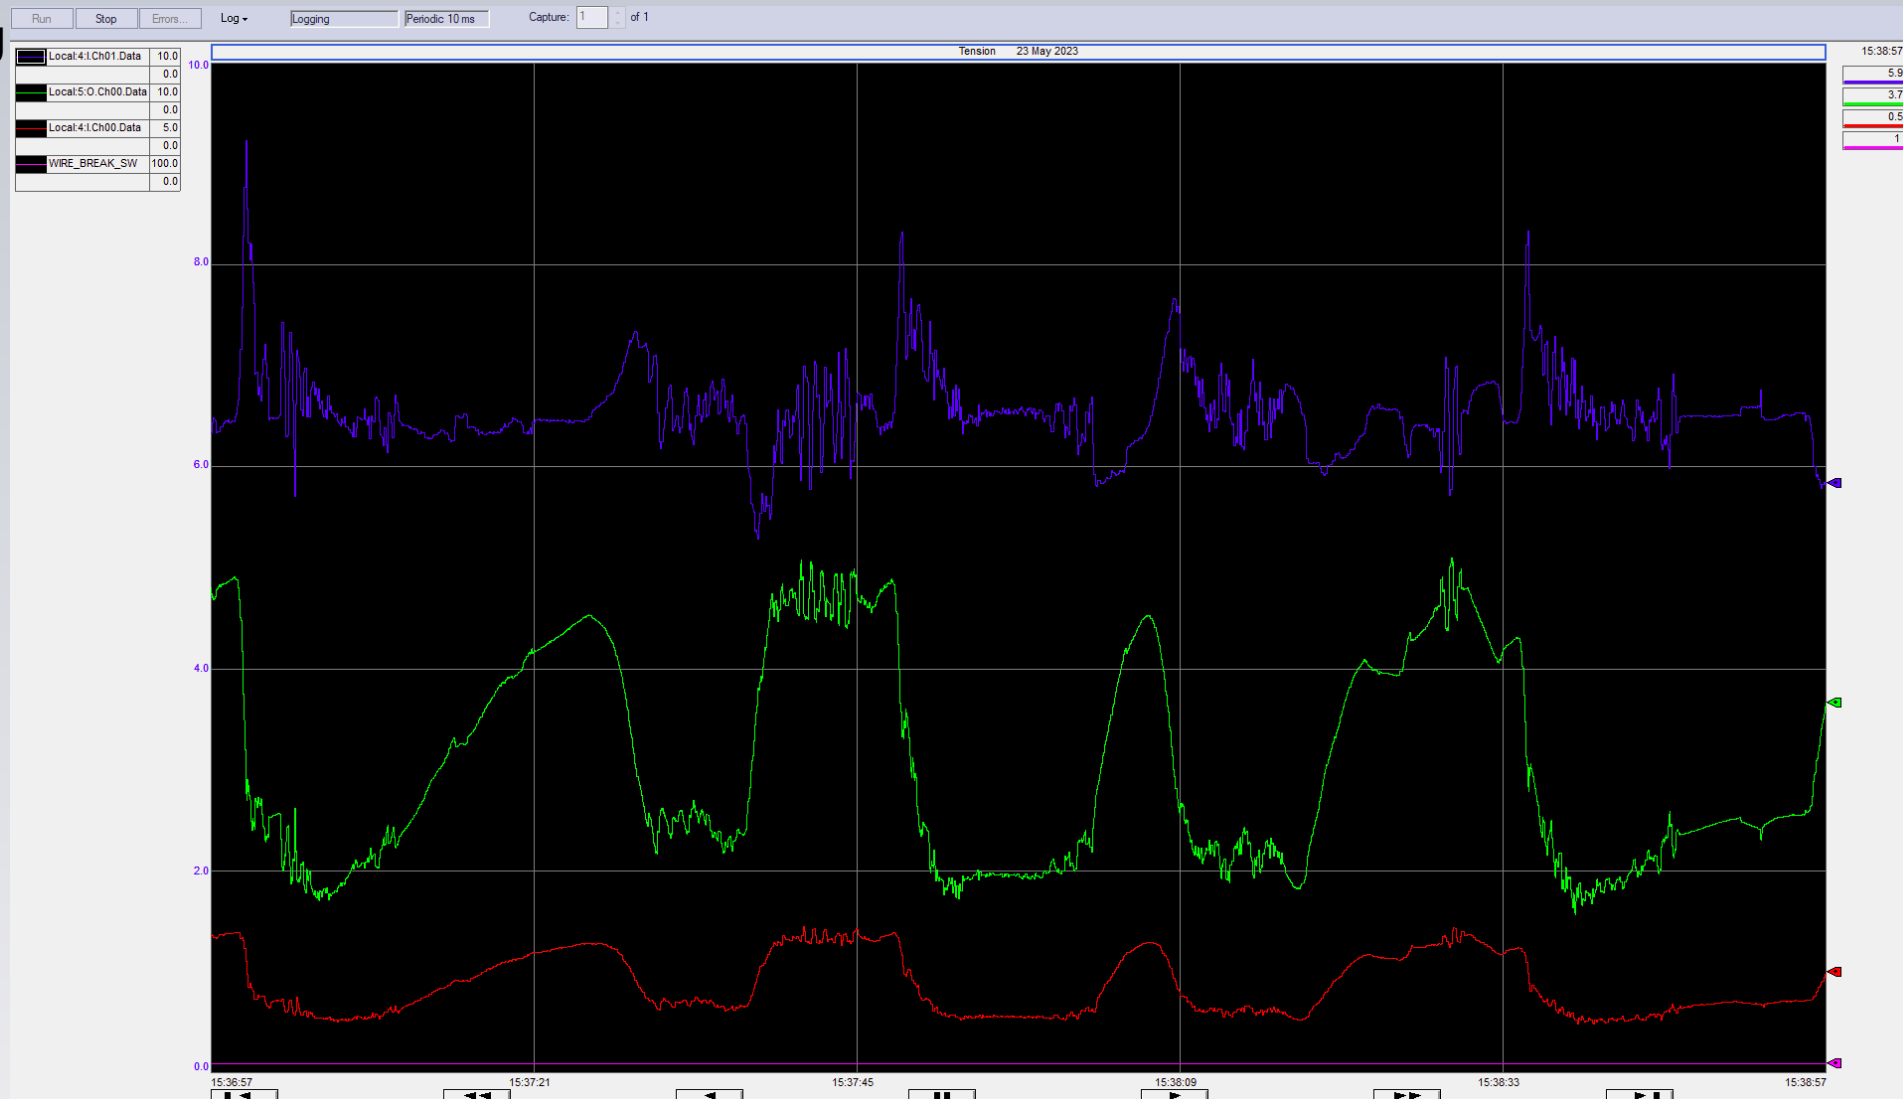
Winder 1, APA 8 U-Layer (Timed)

- Shows controlled behavior
- Not hitting hard stop
- No exceeding max load cell amplifier output

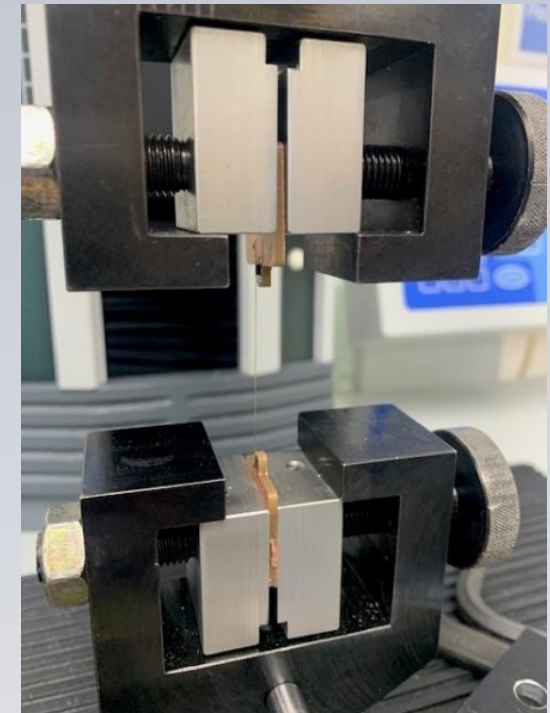
- The PCB end-tabs are not properly positioned such that the wire emerges from the soldered region at an angle and that this creates a 'kink' in the wire as it is pulled, raising the stress and promoting early failure

- MATWEB indicates an 'Ageing temperature' of 260 °C for (one form of) Cu Be
 - We currently use 340 °C for AW1 wire (320 °C LFA)
- There is a significant discontinuity in the stress in the wire between the soldered and free regions and this rapid change in stress leads to early failure

- The standard geometry for test tokens for tensile testing is the 'dog-bone' in which there is a gentle reduction in the sample width between the clamped and free regions.
