APA Cold Tests at CERN

Recent Works

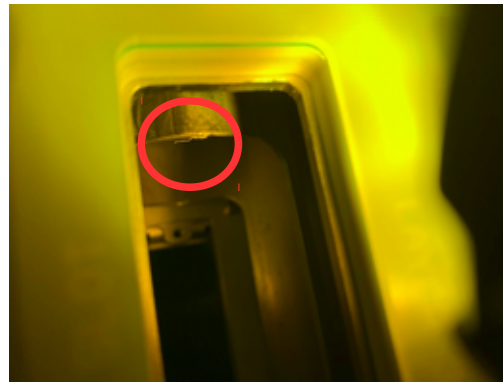
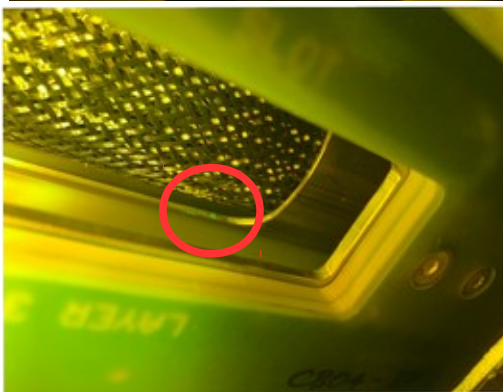
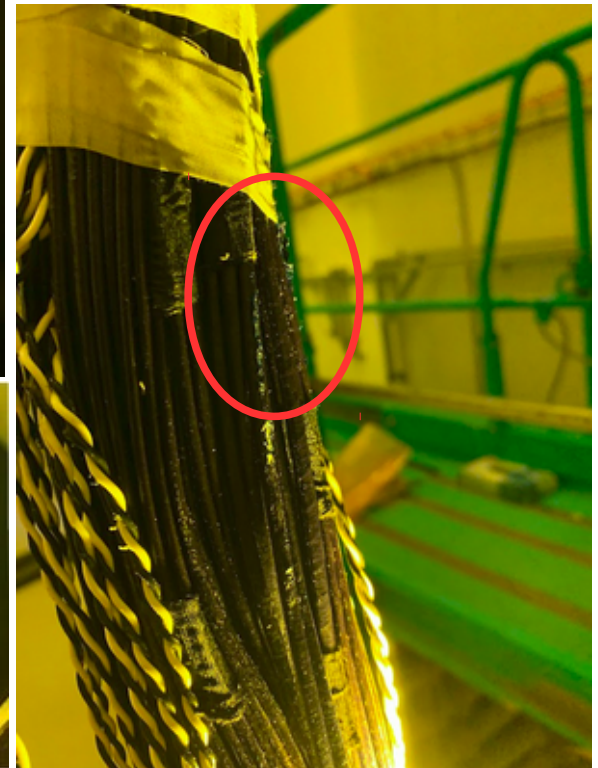
QC Issue: Conduit Burrs

- The steel conduits inside the long tubes of the APA frame had sharp burrs on the slots cut for PD installation.
- We discovered this when we attempted to install the cold electronics cable through the conduit, and observed it came out damaged.
- The only defined procedure for removing/installing conduits is on a process cart \Rightarrow the frames have gone back to Daresbury.

The conduits should be deburred by the manufacturer, and inspected at Daresbury (Procedure: <https://edms.cern.ch/document/2881119/1>). Suggestions have been made to make this procedure more rigorous:

- Having an example length of conduit on the factory floor to show the standard to which edges should be smoothed.
- Having a final clean-up for all conduits at Daresbury as standard (not just inspection).

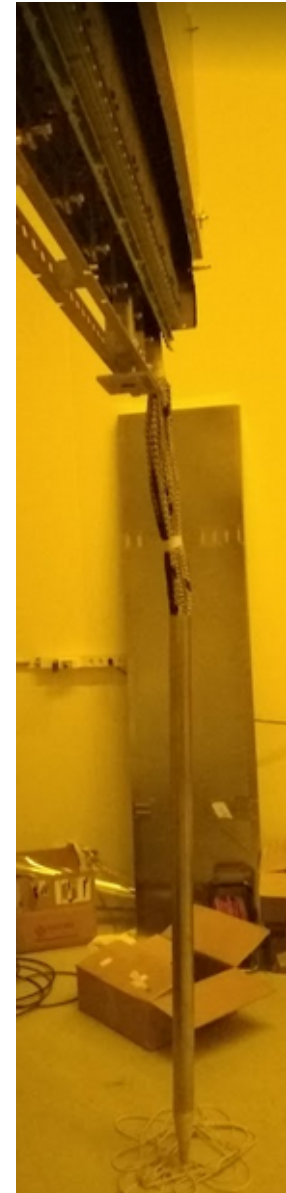
A number of further suggestions have been put forward to eliminate this hazard for future production and testing.

- Temporary covers for the unprotected cable section during installation.
- Modifications to cable installation to avoid friction against the conduit opening.

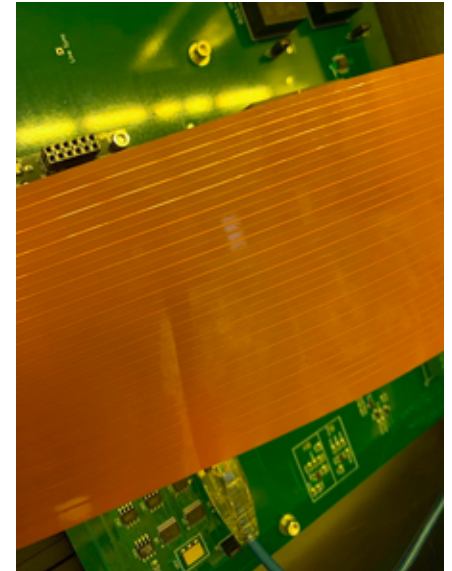
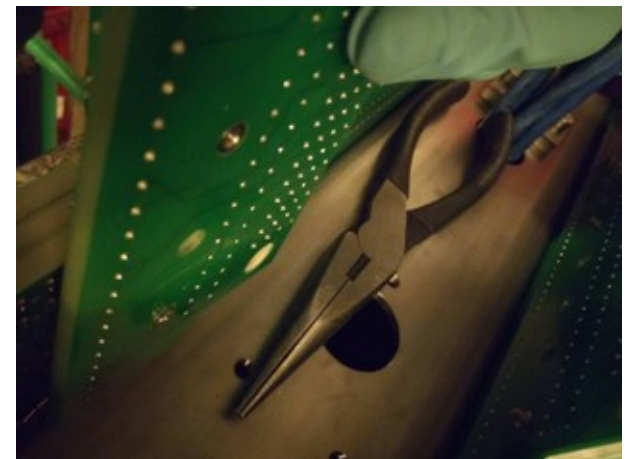
Our tests required 2 full cycles of DWA measurement, carried out by Anyssa and Shion. These measurements proved challenging for multiple reasons.

- 1) Damage to the flex cable of the DWA unit at CERN disabled half its channels, doubling data collection time for the first cycle of testing.
- 2) The DWA power supply overheated during the second cycle, damaging one of its boards and preventing further tension measurements.
 - See Anyssa's slides for further details.
 - Design under review; any DWA units returning to CERN will require electrical inspection before being authorised for use.
- 3) Due to their spring-loaded pins, the DWA boards on APA5 became stuck when mounted with long screws, and had to be seriously damaged to be removed.

- 1) Spare parts should be kept on hand at sites where DWAs are deployed.
- 2) The DWA boards would benefit greatly from captive screws, as this would eliminate any concerns about dropping small screws into the APA volume at heights.
- 3) A set torque level for attaching the DWA boards would also allow novice users to make good electrical connections without the risk of over-tightening.
- 4) Deploying the DWA through both the base frame and the ASF is not impossible, but challenging – would recommend this be avoided where possible.

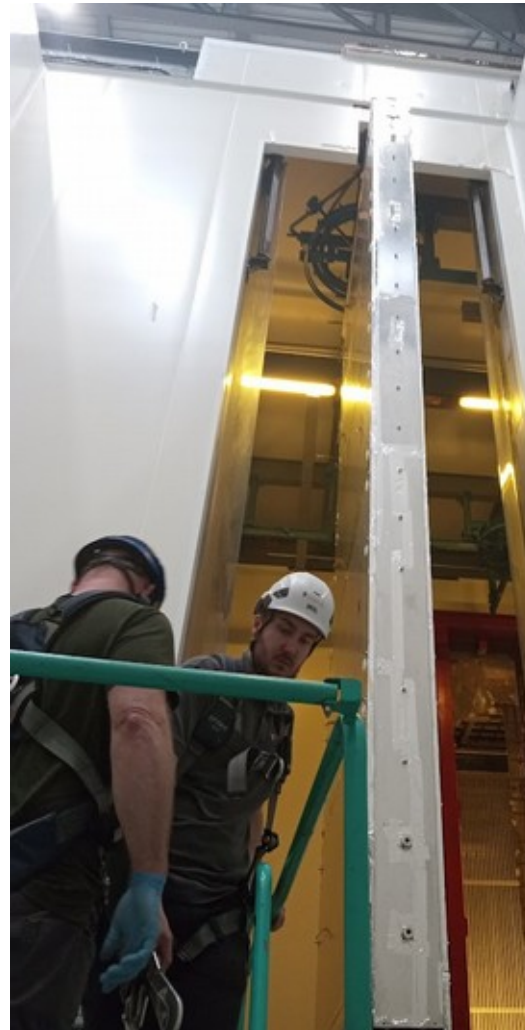
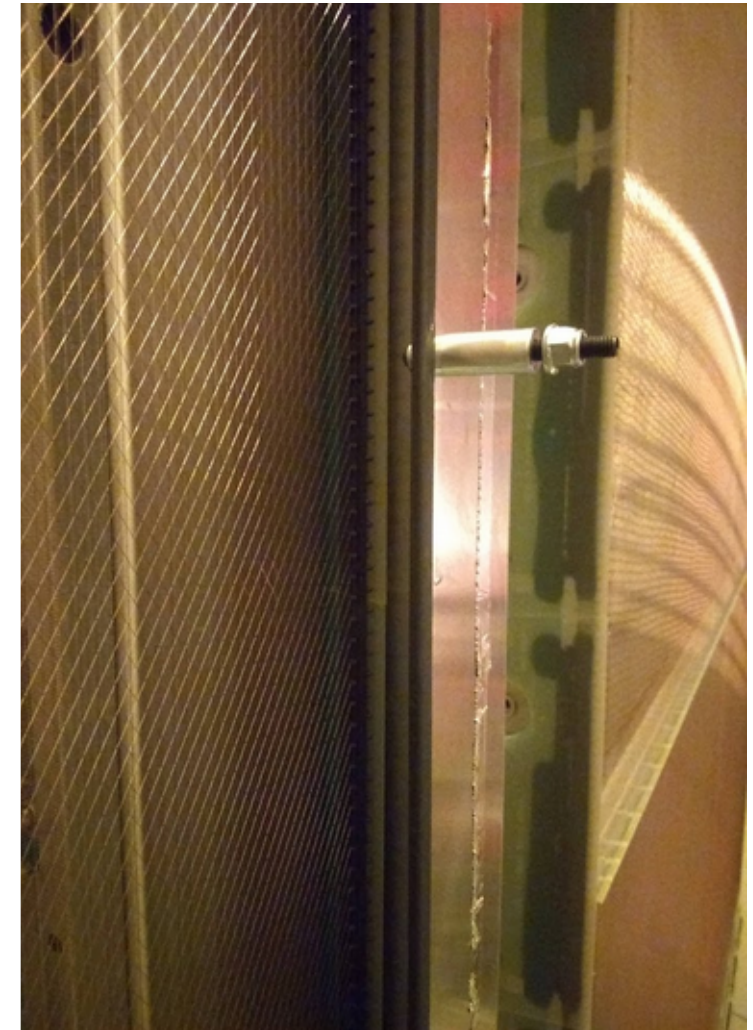
Removing protection panels by hand at height requires **extreme care** not to strike wire planes (either with the panel or your hands). This could be made easier and safer by developing tools for manipulation (e.g. attachable handles).

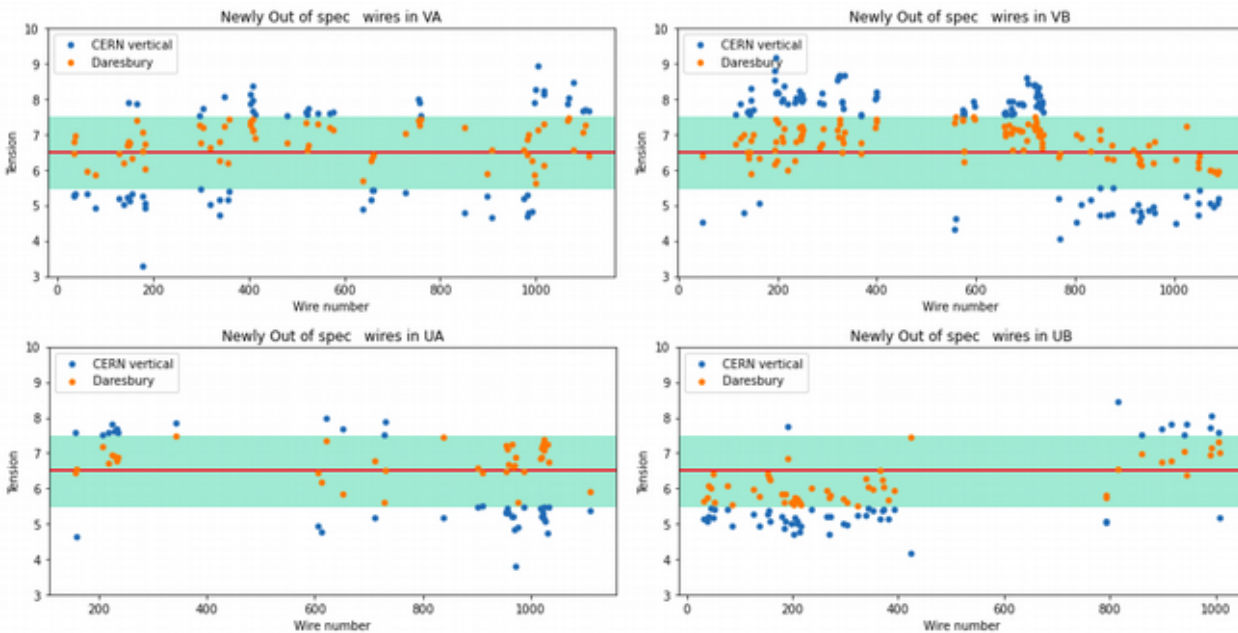
Vertical Tension Results (Bottom APA)

Measurement	Daresbury (horizontal orientation)	CERN (vertical orientation)
No. of wires out of spec	550	967

- Almost all wires measured to be **newly** out of spec at CERN are in the U & V planes.

- Migration goes in both directions.
- Daresbury measurement was simultaneous for U, V, X, but not G.
- See **Anyssa's talk** from Tuesday for deeper analysis.
