Update on APA broken wires

FD1 Technical Board Meeting

15 March 2023

APA 3 wire analysis

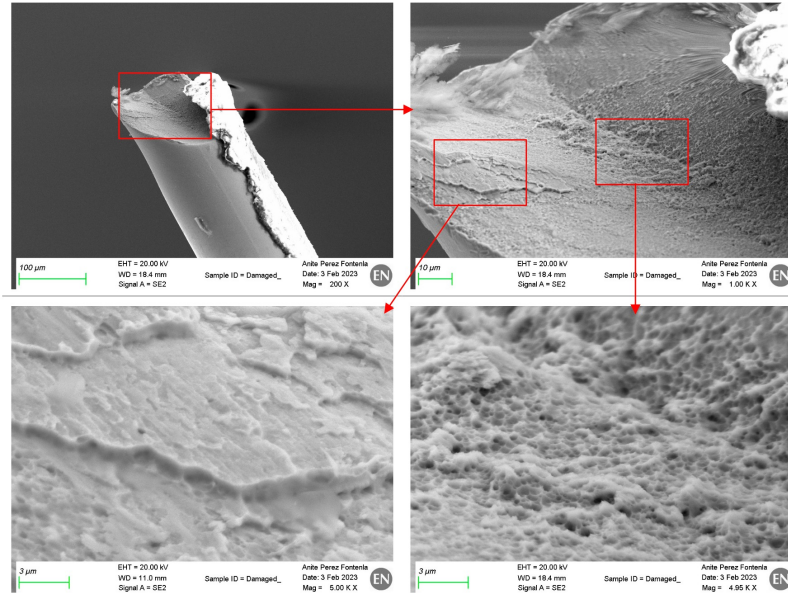
The extremity suspected to be broken presents indeed a concave shape and the features observed on the centre (equiaxed dimples) are characteristic from a fracture surface.

The residue visible attached to the wire was analyzed and is rich mainly in C and O with traces of other elements. They correspond most probably to cross contamination and not with soldering residues.

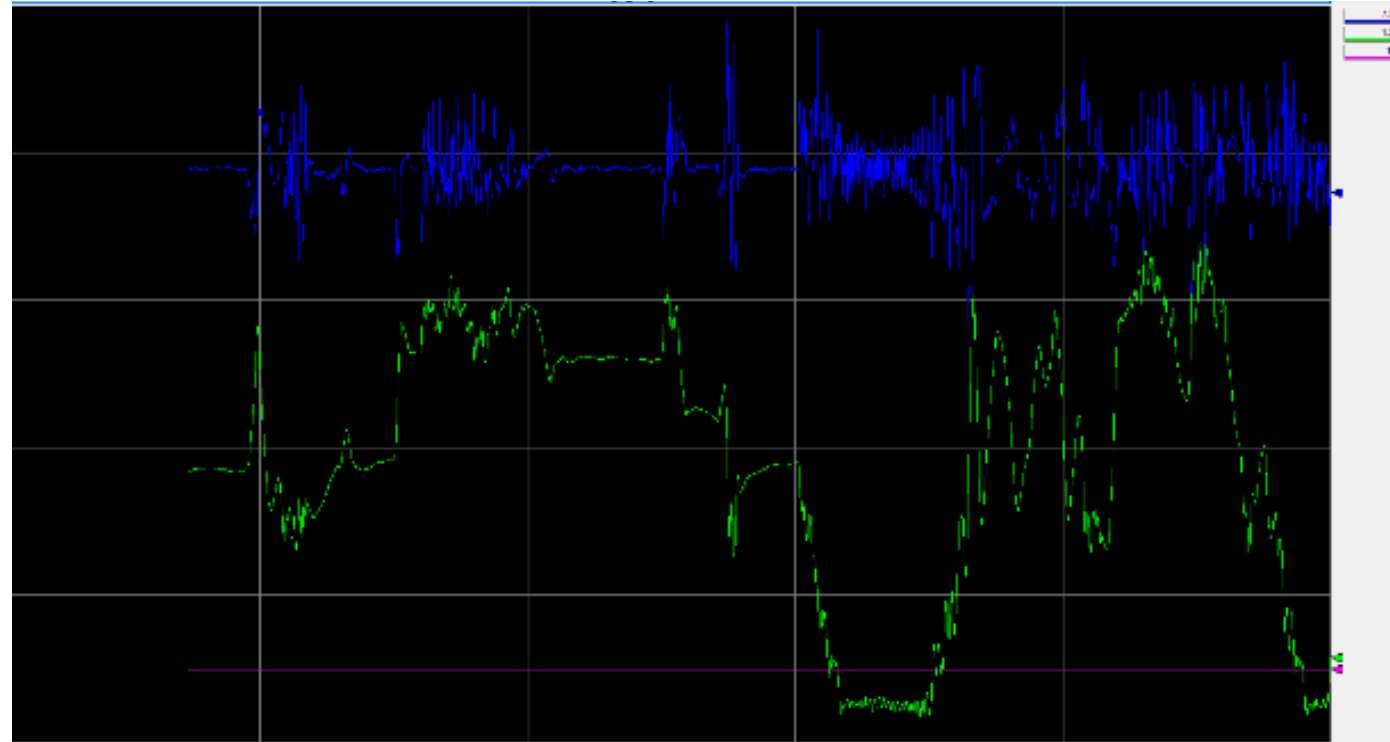
Tension monitoring in real time

- Blue line is actual wire tension.
 - Capped at 10 N due to limits of a spring and readout (will upgrade).
- Green is servo motor reaction to keep tension in limits.
- Measurements taken every 10 ms.
- Spikes at 10 N seen rather often.
- Raw data stored (last couple of weeks)
- Analyzing as we speak to count single and also double or more consecutive 10 N events.
- May assume that number of ticks at limit indicate higher actual tension in the event (think TOT).

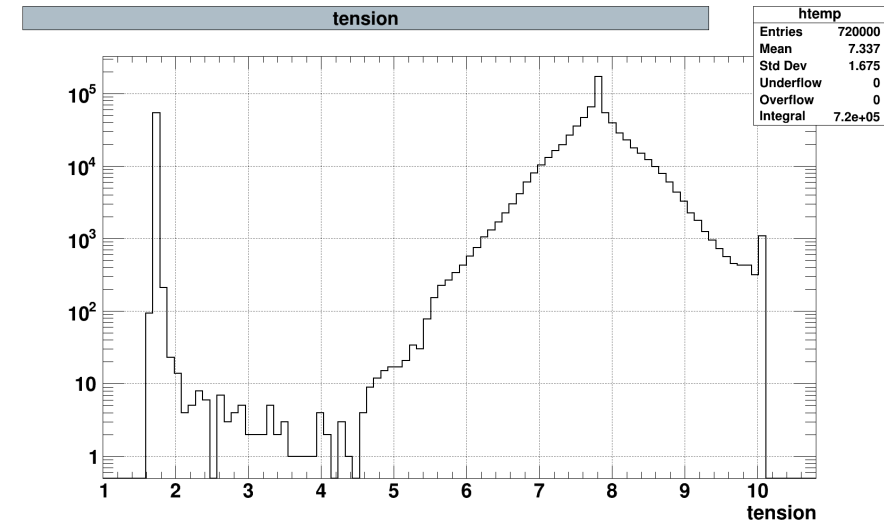
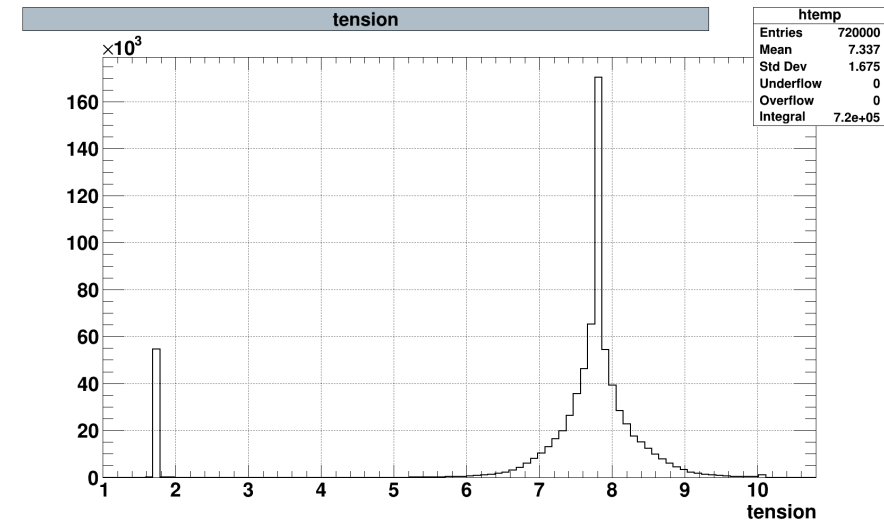
Frequency of high tension events

- Hot – just in
- From V layer of APA 7 on winder 4
- Tension measurements histogram
- Low value peak: winder idle
- Peak around 8: normal operation
- Peak at 10 (incl. overflows): high tension events

- Immediate priority actions:
 - Analyze winder tension data, count frequency of single, double or higher consecutive 10 ms ticks above 10 N.
 - Timestamp in real time all measurements at the 10 N limit and correlate with head position.
 - The aim is to identify particular parts of head movement (going around the frame, accelerating, other) and then modify recipe to reduce acceleration and speed to eliminate tension excursions.
- Mid-term actions: replace spring and modify readout so that actual tensions can be recorded up to at least 20 N.
 - Then record max tension per wire segment, aiming to identify a small number of wires per layer that experienced high tension (threshold TBD) and replace them.

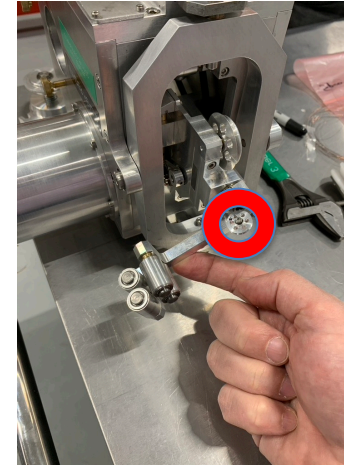
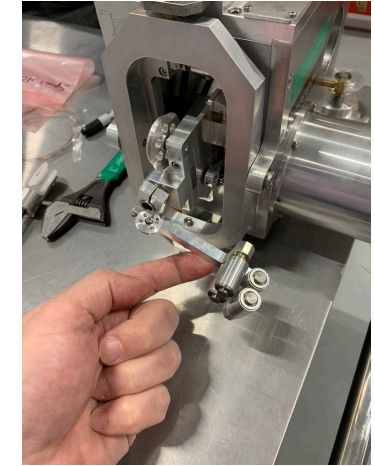
The damaged pulley and damaged wire on APA 6

- At the tip of the “dancer arm” of the winder head we have the last pulley that the wire runs through.
- This pulley gets stressed more than others due to the changes in direction.
- There is 200 micron clearance between the cross-drill holes to save mass and the bottom of the wire groove.
- On one pulley shortly after replacement the groove was worn through to the cross drill holes.
- That left marks on the wires laid on the U and G layer of APA 6.
- Winding has stopped.

- Winding of APA 6 has stopped.
- Samples were taken from the damaged wire, the same spool, another spool (all from *Alloy Wire*), and a sample from *Little Falls Alloy Inc* used in previous APAs.
- Samples being tested (measure break point for five pieces each sample) at our Liverpool University labs.
- U layer wires of APA 6 can't be replaced.
- We may have to restart APA 6.
- This is very recent (last Thursday).
- Tolerance of 200 microns in the pulley will be increased.
- The particular pulley is in metrology at Liverpool to check if it was a problem in manufacture or rapid wear due to large forces. For completeness of our understanding.

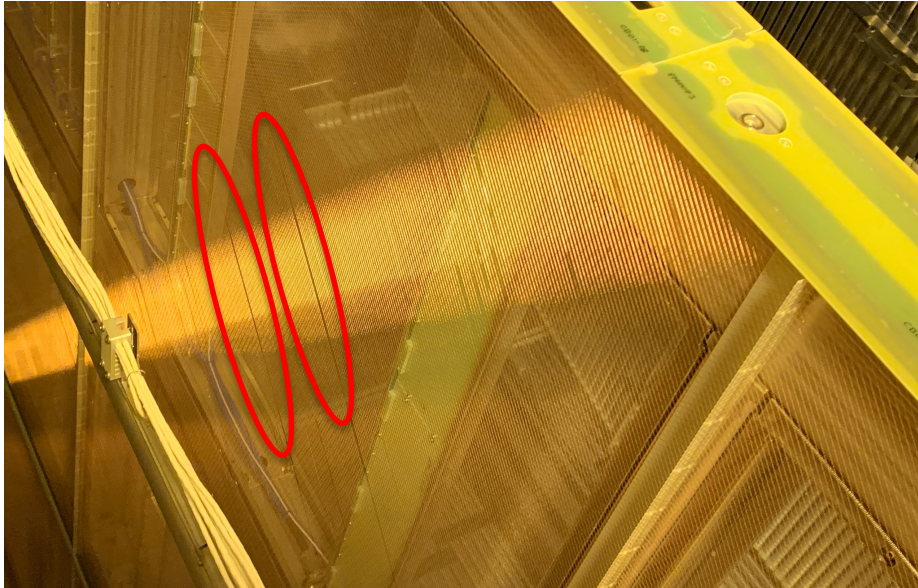
Old and new broken V wires, APA 3 at CERN

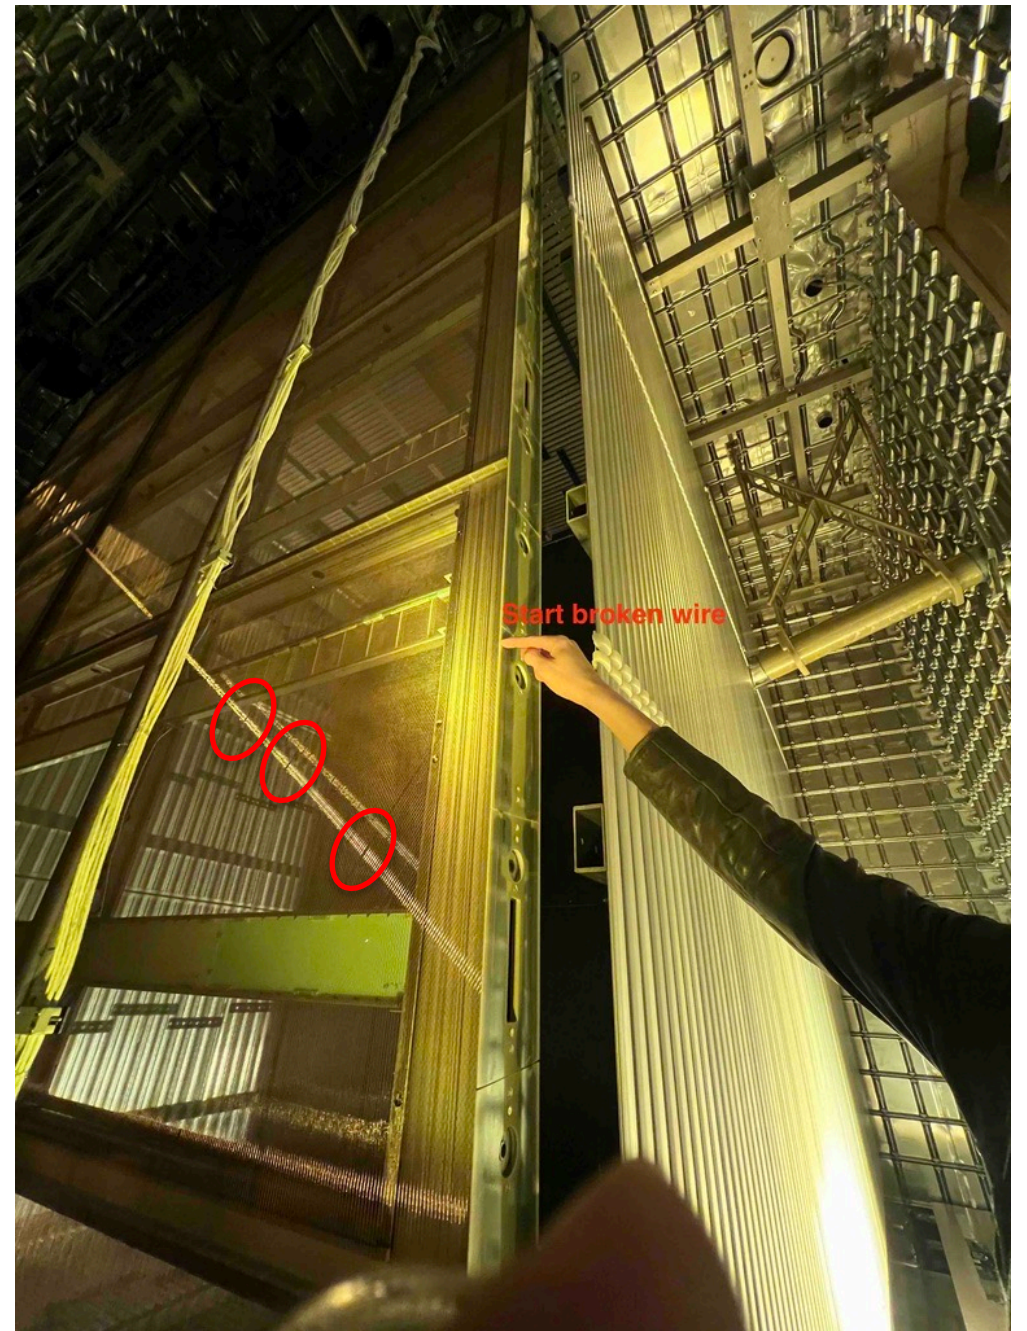
18 November, different angle, same APA 3 zone

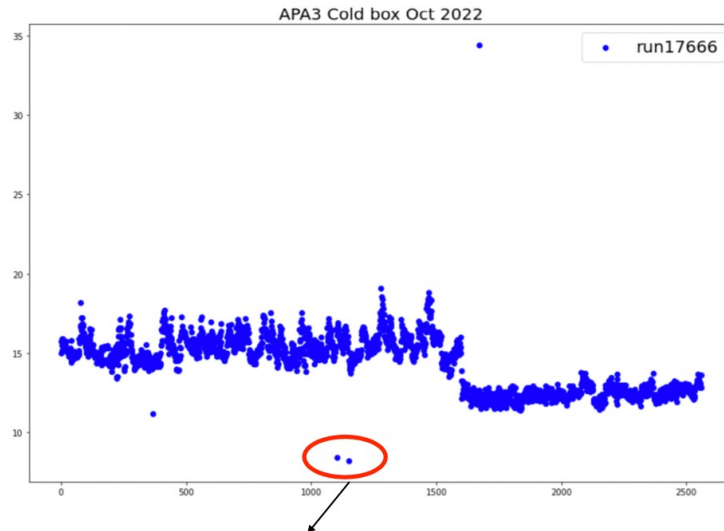
One of the last APA3 cold box on Oct 2022

Offline Channels		FEMBs
1102	→	FEMB 8, ch 72
1149	→	FEMB 9, ch 106

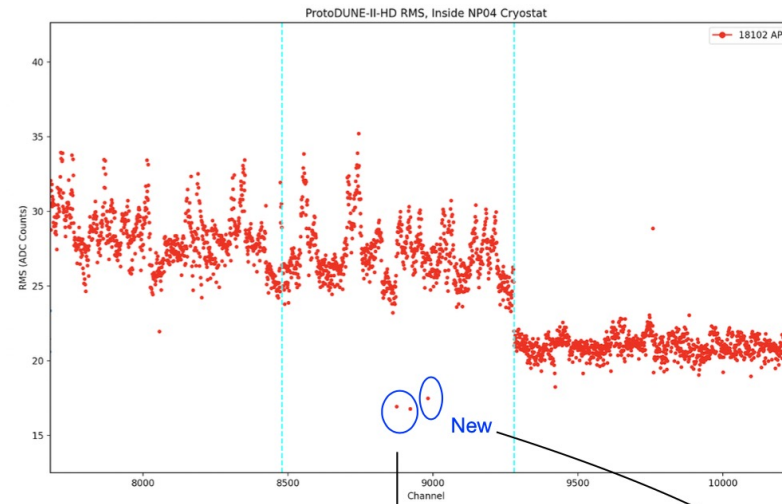
First cryostat run, Nov. 23 2022

Offline Channels		FEMBs
8922	→	FEMB 8, ch 72
8875	→	FEMB 9, ch 106
8983	→	FEMB 7, ch 54

Newly Broken wire location:
V2 wire on adapter board 7

Run taken on Nov. 23, before photo on Nov. 28 showing the wire still in its nominal place.
