# **Module 3 Run 2 Operation Summary: Charge Readout**

Stephen Greenberg, March 2, 2023

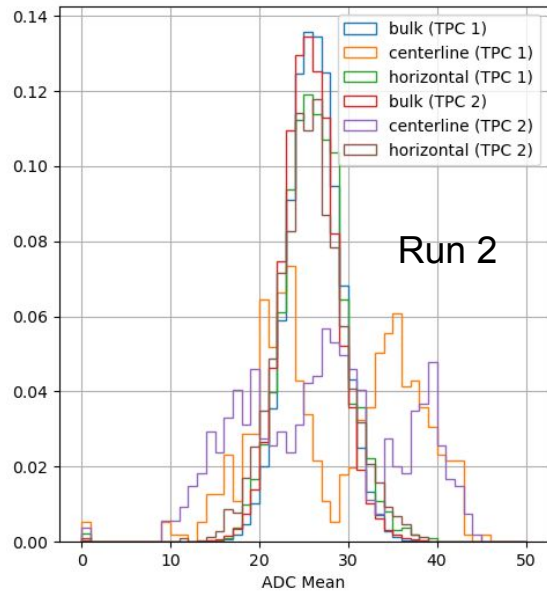
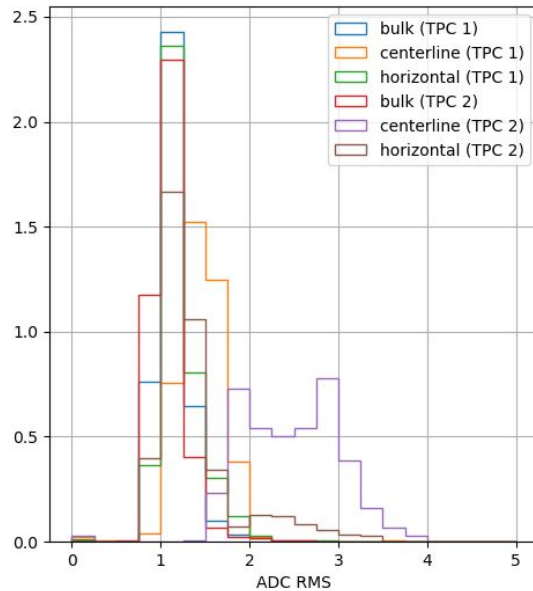
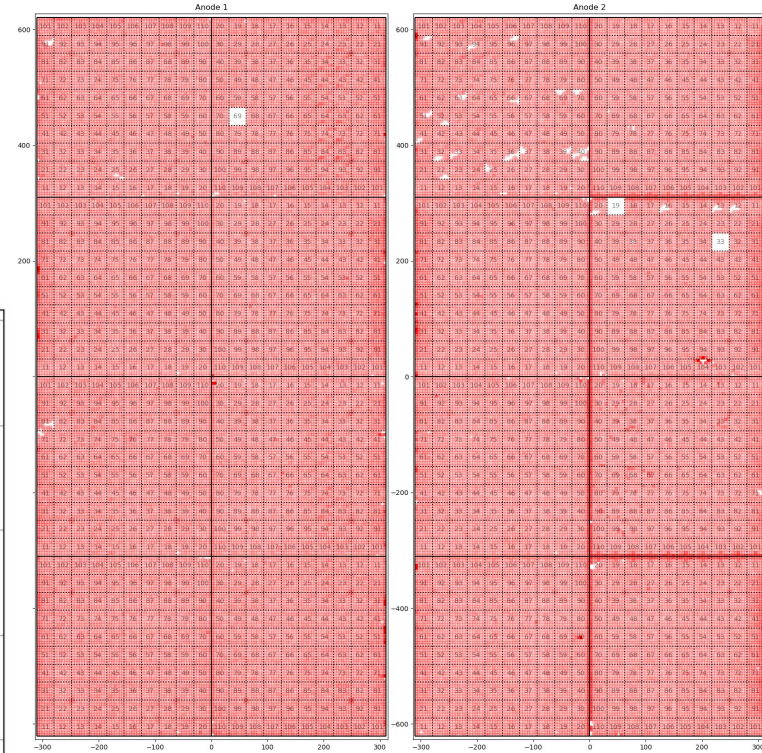
- DC Pedestal shift for centerline pixels on both TPCs
- Increased pedestal RMS on some TPC2 tile boundaries
- Observed warm/cold in both run 1 and run 2.
- Same grounding scheme for TPC1 and TPC2

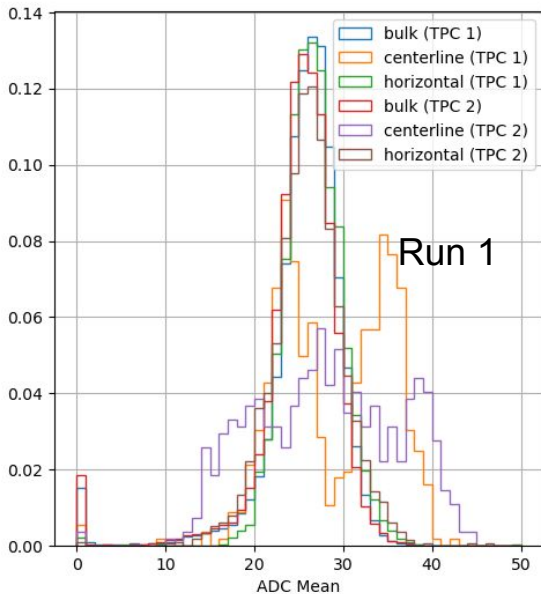
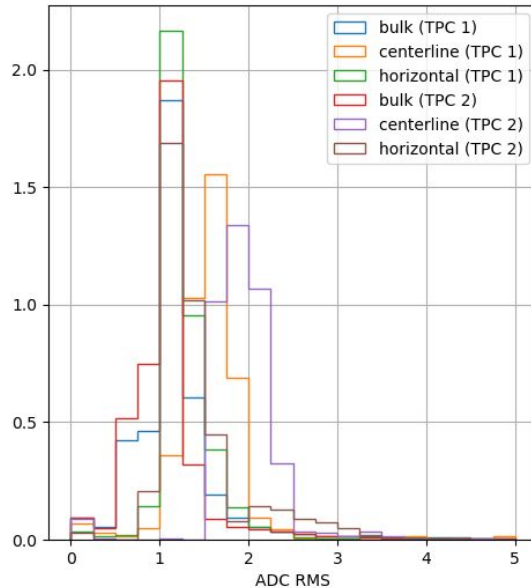
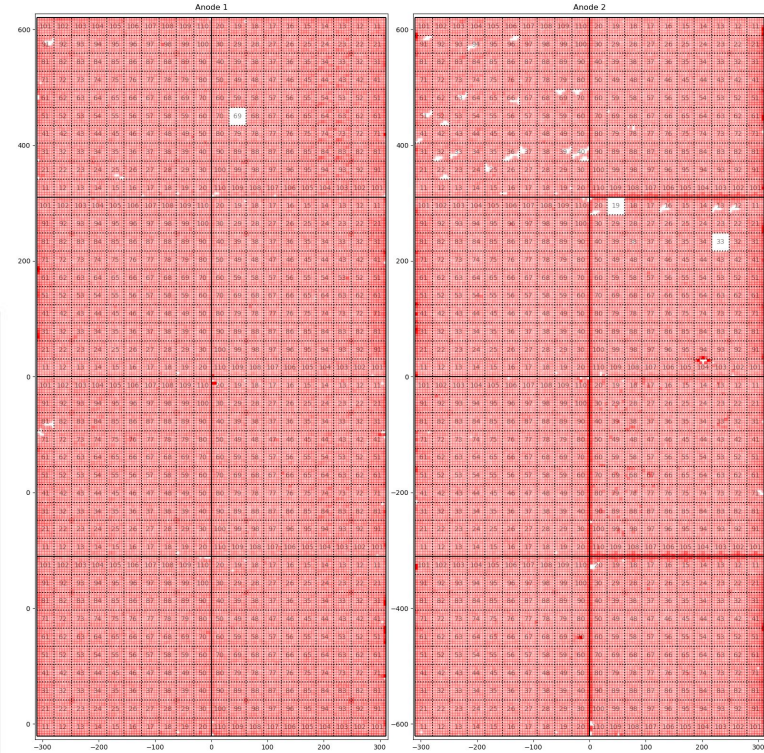
- DC Pedestal shift for centerline pixels on both TPCs
- Increased pedestal RMS on some TPC2 tile boundaries
- Observed warm/cold in both run 1 and run 2.
- Same grounding scheme for TPC1 and TPC2

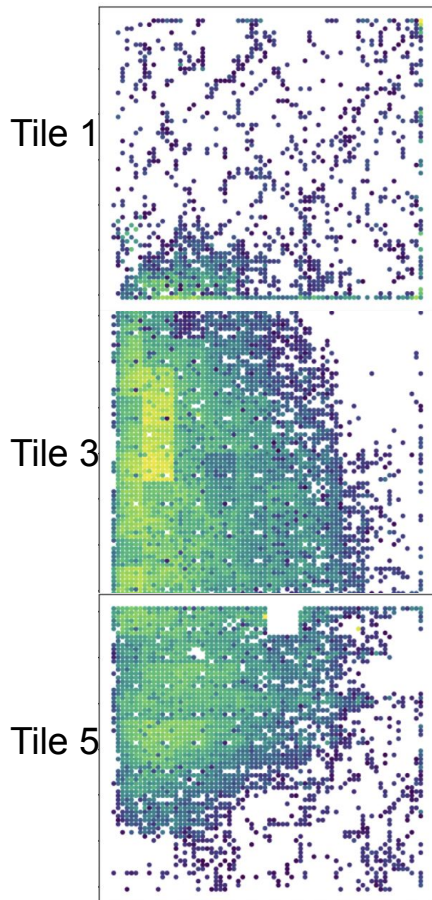
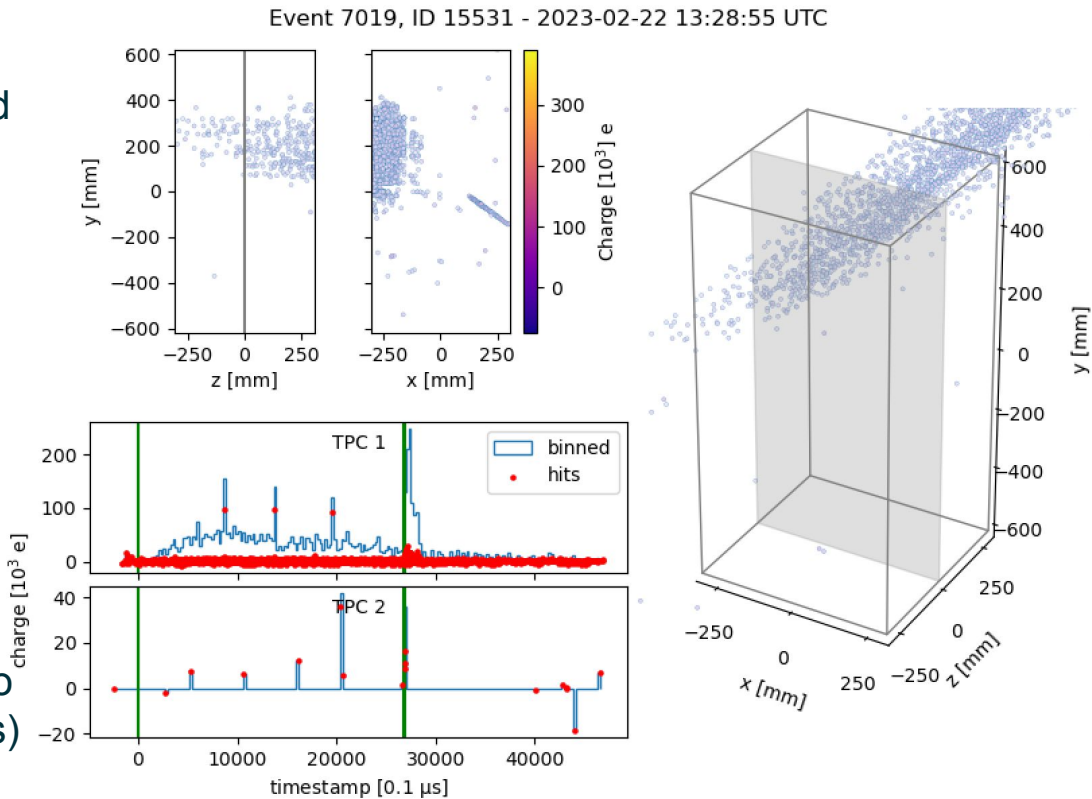
- Started with HV ramp up, stopped after ramp-down
- Visible only on TPC 1
- Spatially correlated with sparking on field cage panel and impacted ARCLight
- Not visible in run 1 (possibly due to higher thresholds)

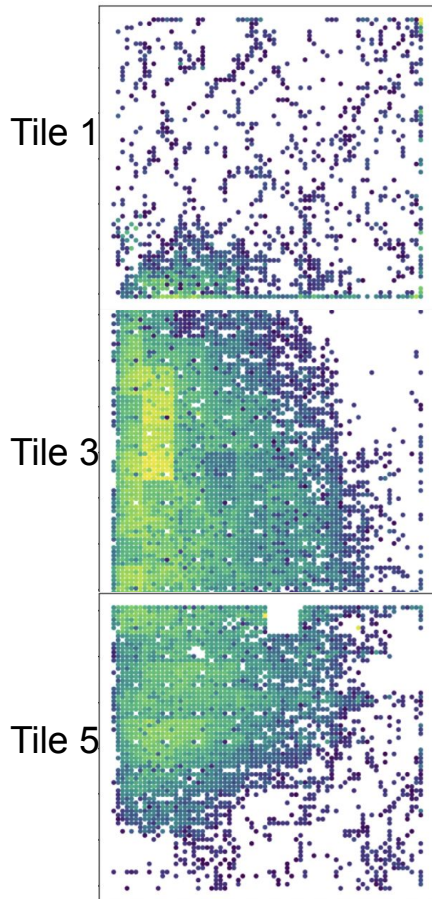
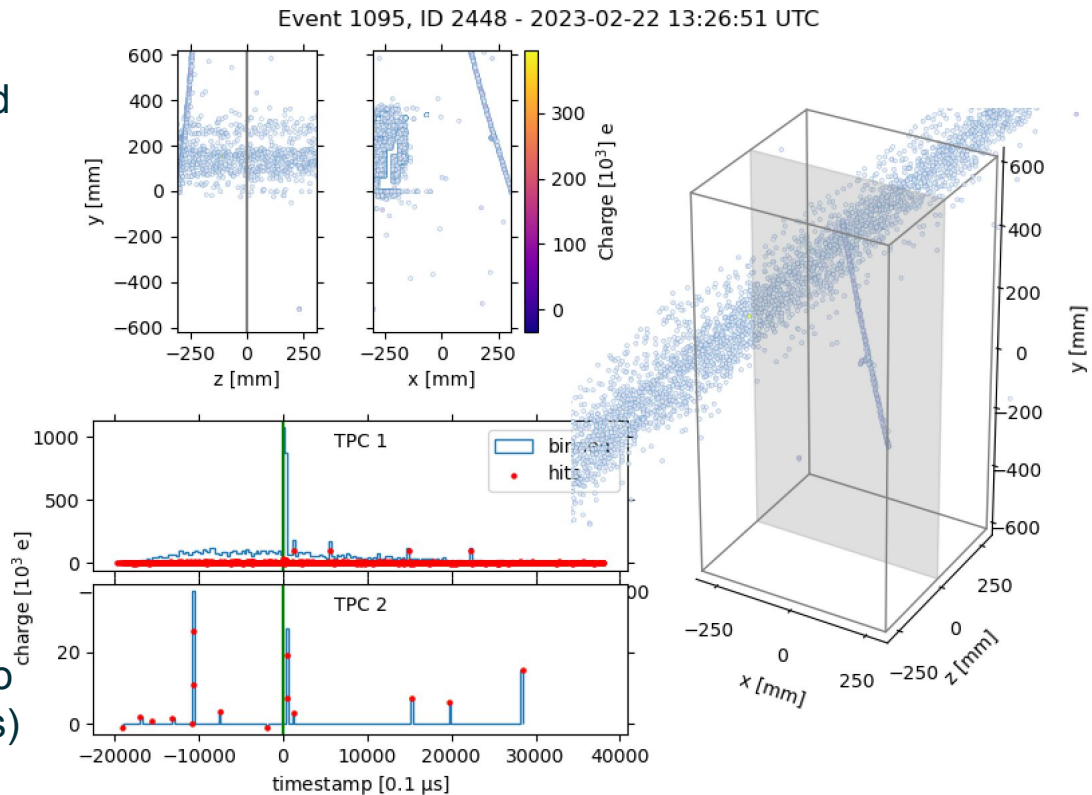
- Started with HV ramp up, stopped after ramp-down
- Visible only on TPC 1
- Spatially correlated with sparking on field cage panel and impacted ARCLight
- Not visible in run 1 (possibly due to higher thresholds)

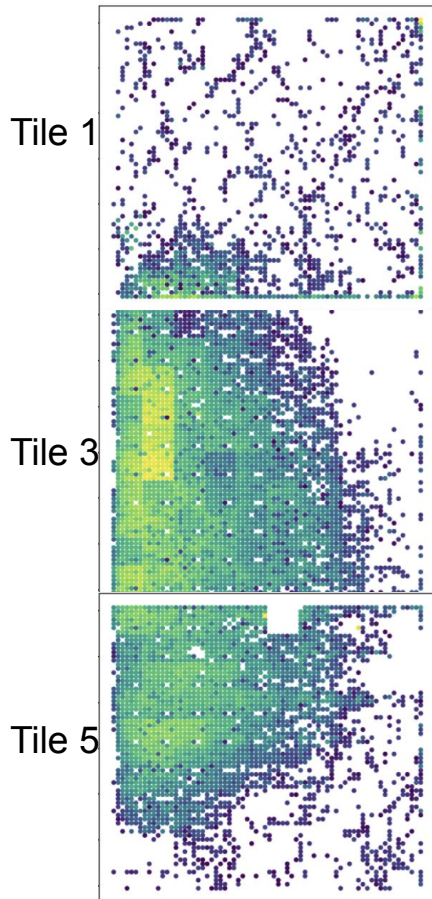
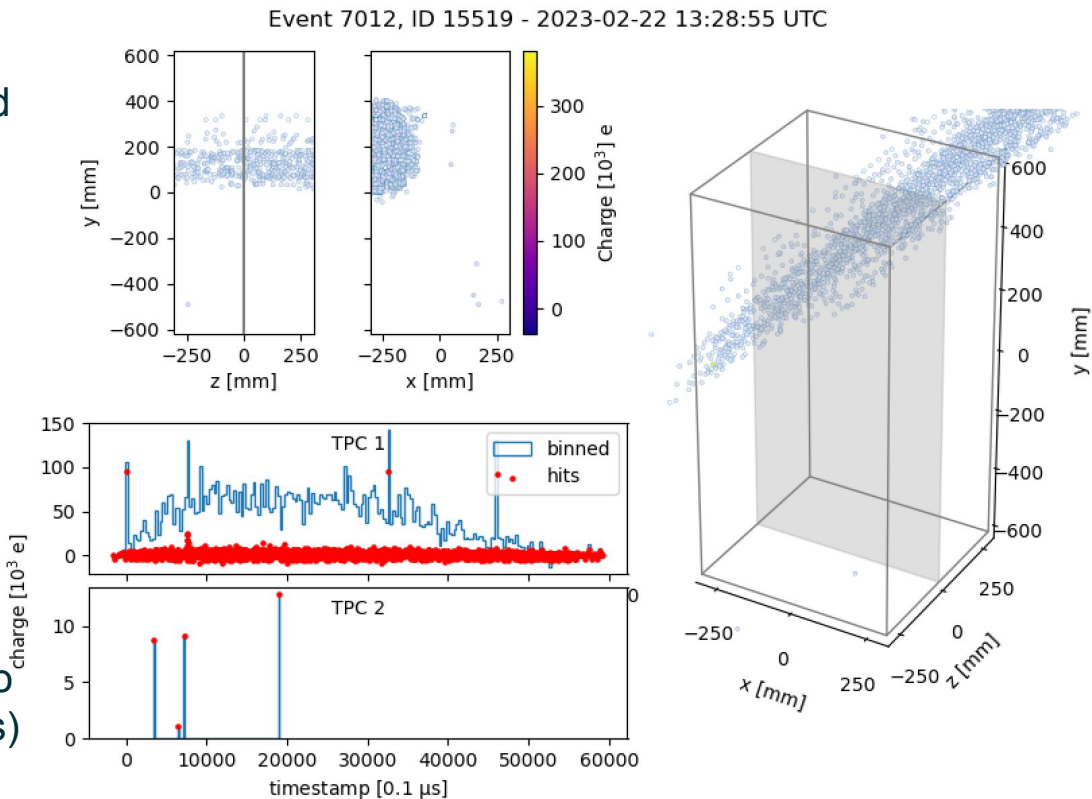
- Started with HV ramp up, stopped after ramp-down
- Visible only on TPC 1
- Spatially correlated with sparking on field cage panel and impacted ARCLight
- Not visible in run 1 (possibly due to higher thresholds)

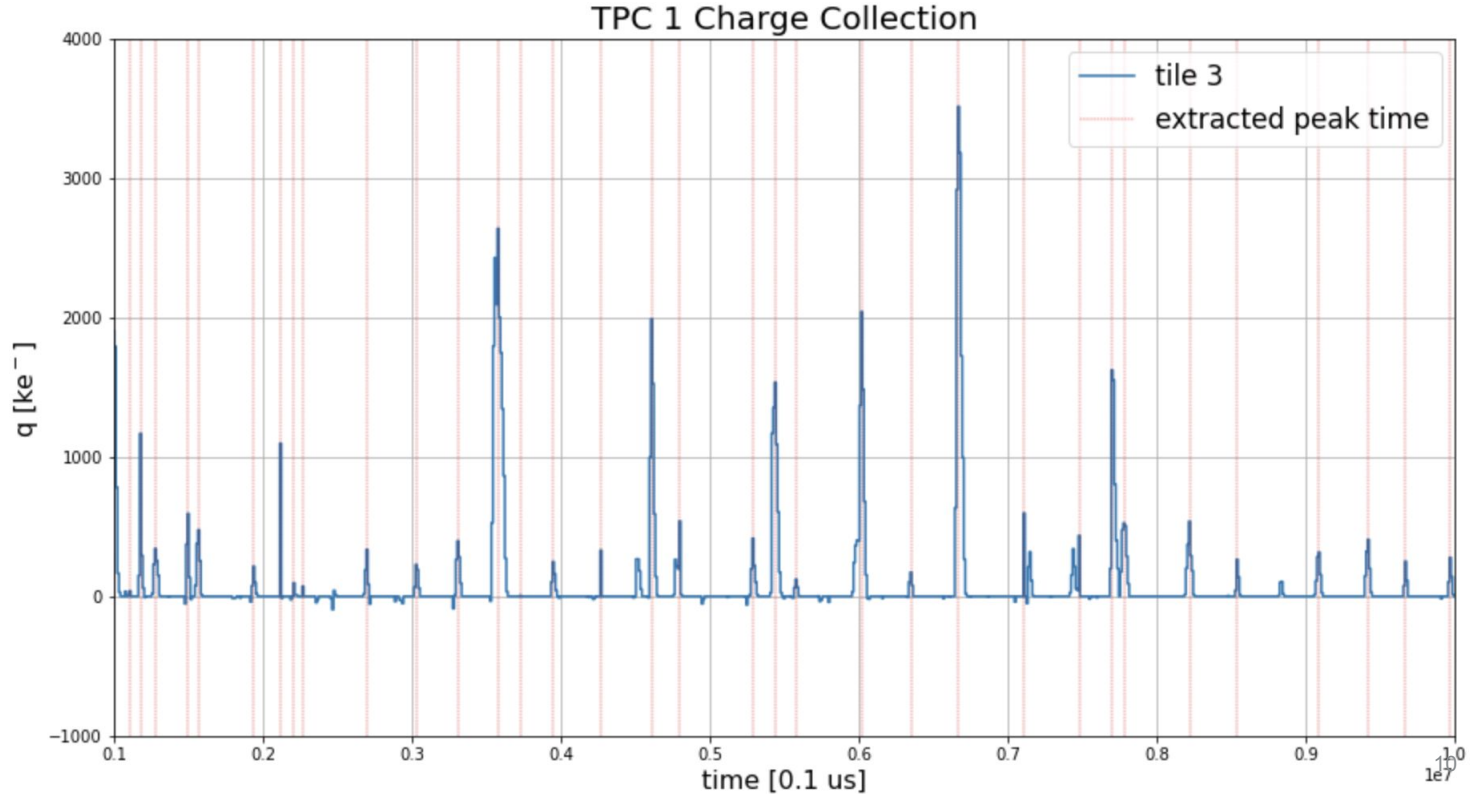
- Typical duration 3-8 ms
- (right) Charge collected vs. time on single tile

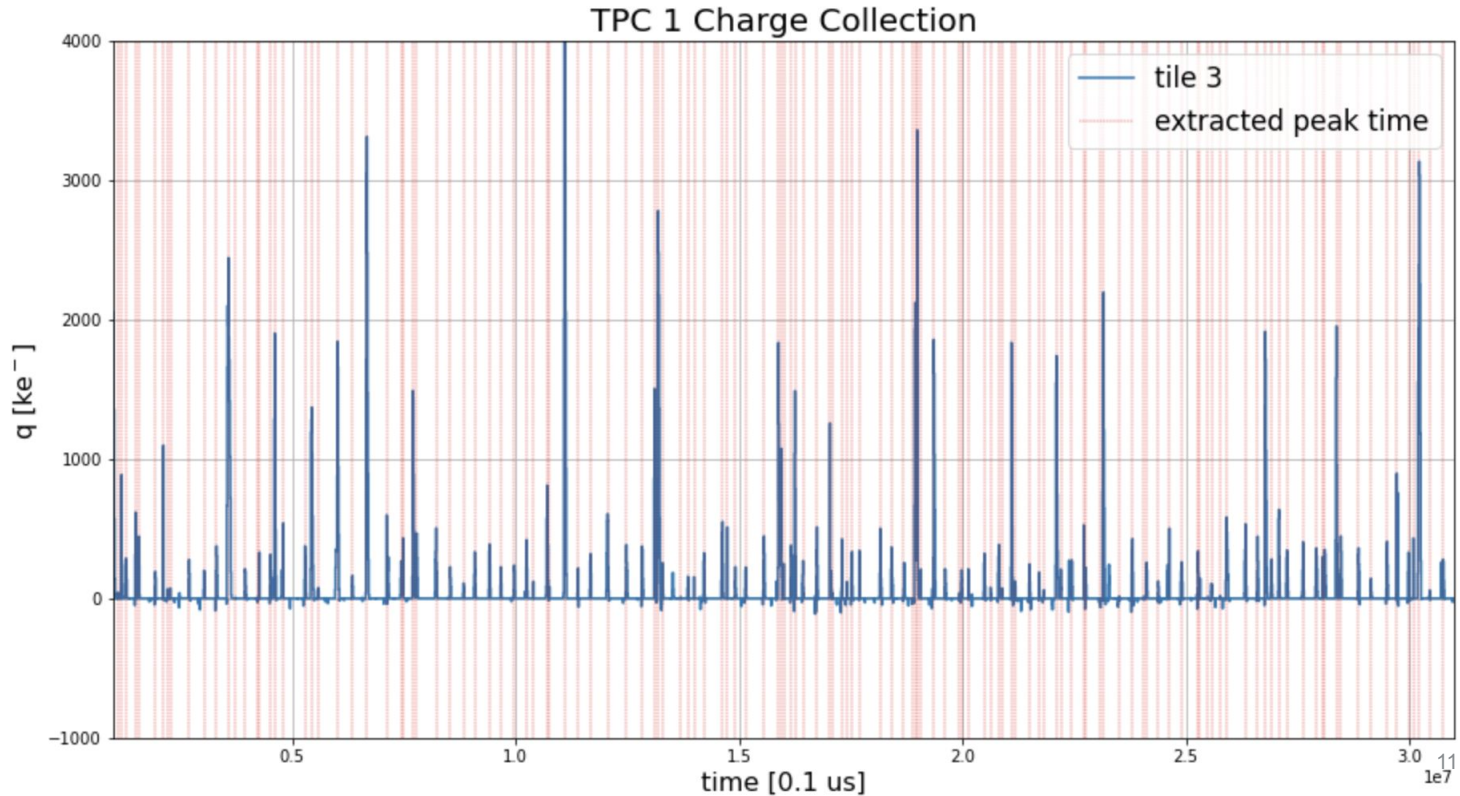
- Typical duration 3-8 ms
- (right) Charge collected vs. time on single tile

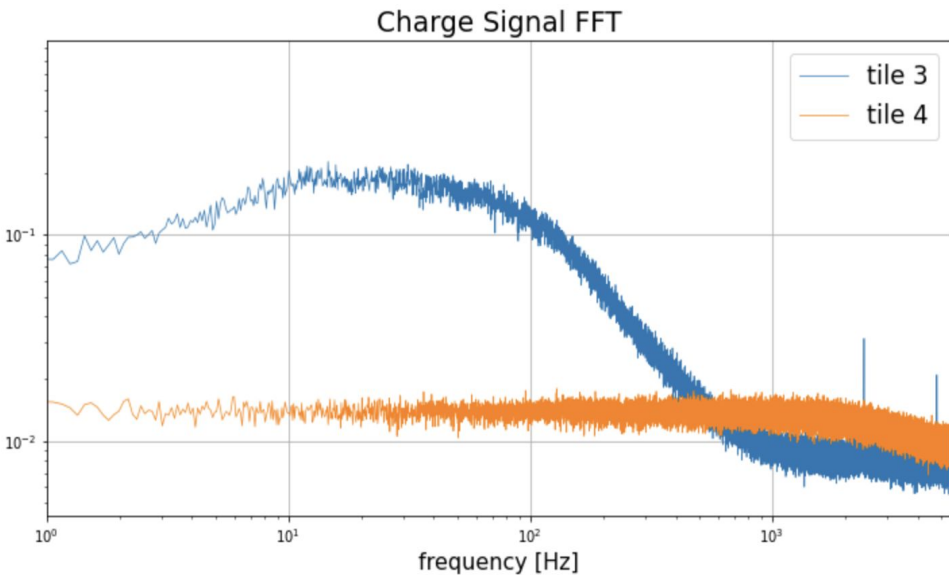
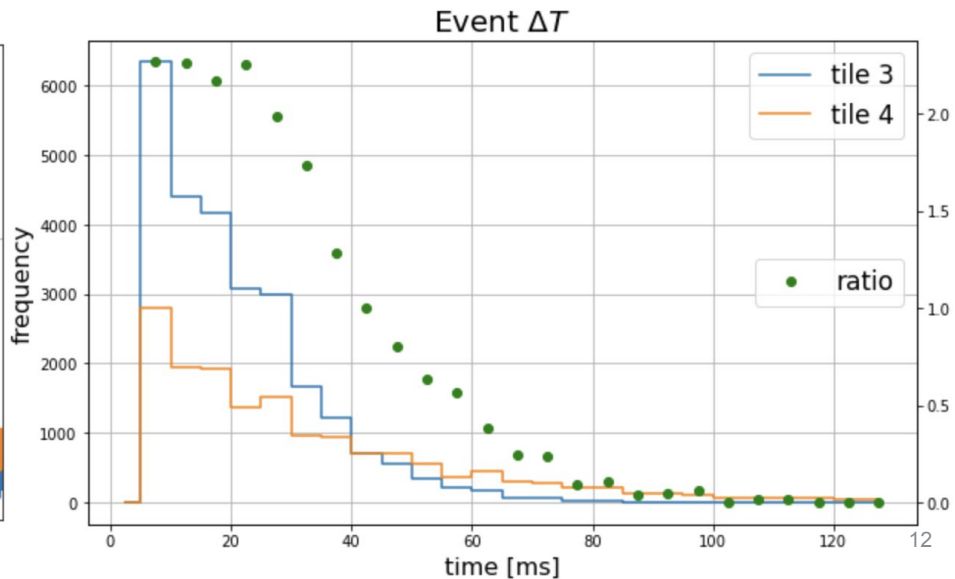
- (right) Time between extracted peaks,  $\sim 10\text{-}30$  ms
- (left) full charge collected vs. time signal FFT

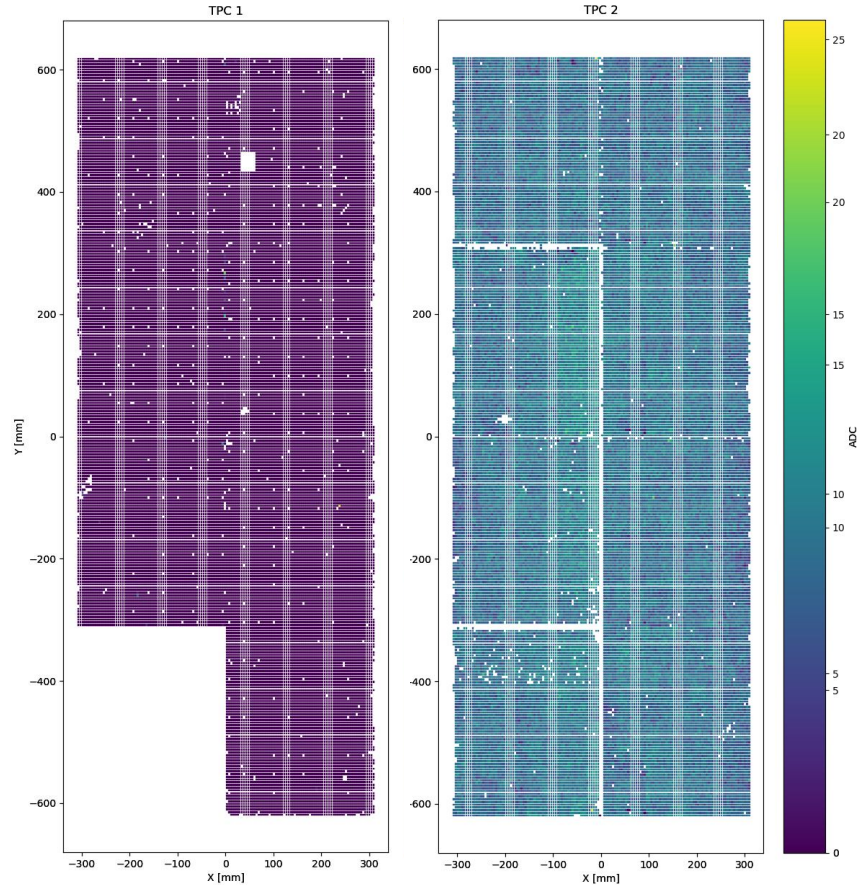
- 2.56% disabled total
  - Includes channels disabled on tile 7 prior to failure
- Edge effects result is significant disabling

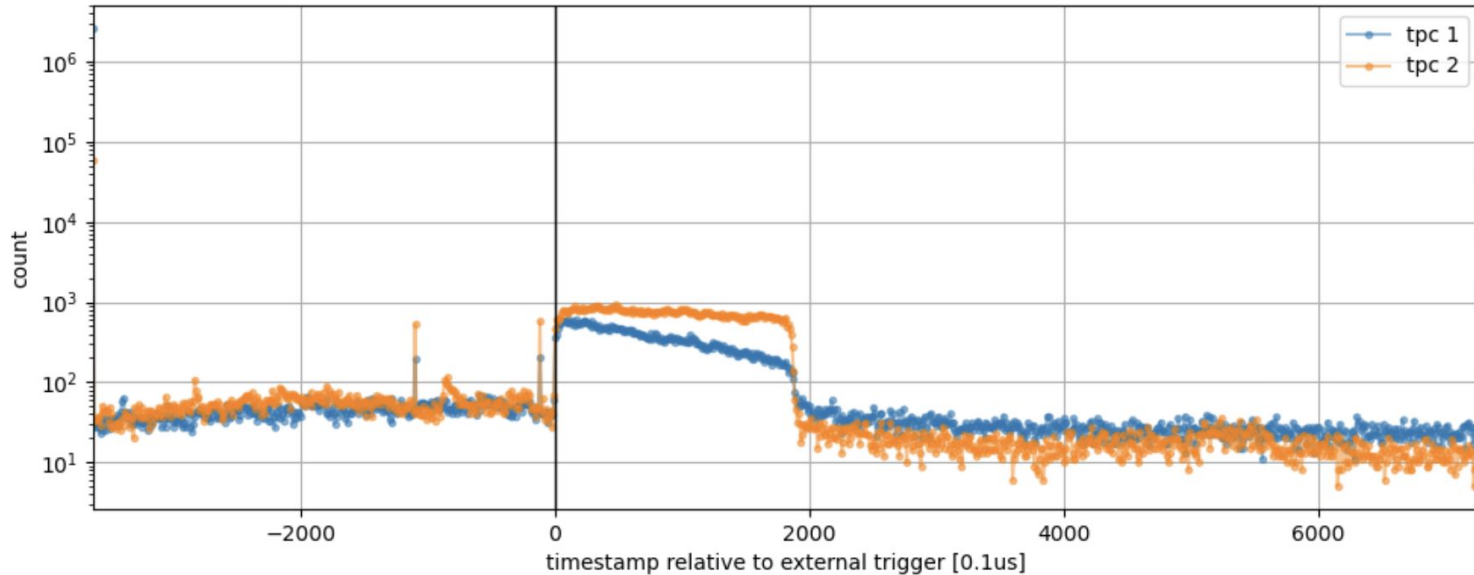
- Relatively poor purity seen in TPC1
  - Run started quickly after filling
- Plot from end of run around 02/22 17:00 CET
