CRP5 Summary of Issues from Coldbox Test

Roger Huang for the CE Consortium

Issues Observed during CRP5 Coldbox Test

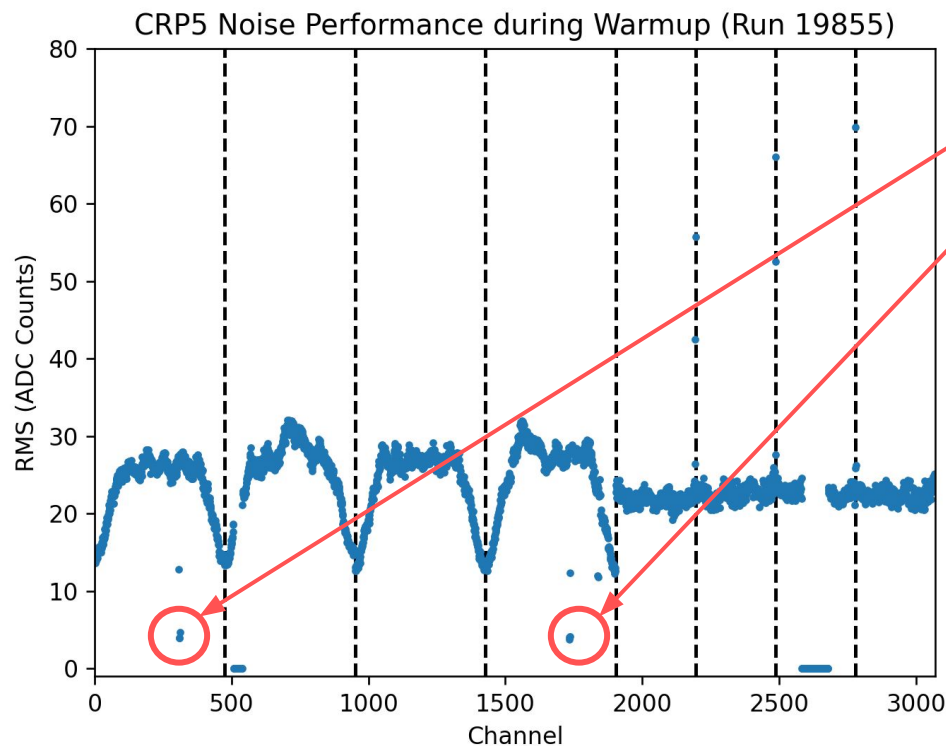
Dead Channels

- During warmup we lost 3 channels on each of FEMB-5 and FEMB-20
 - Channels no longer respond to pulsers
- Channels all had normal response in initial LAr data
- Channels died one at a time during warmup

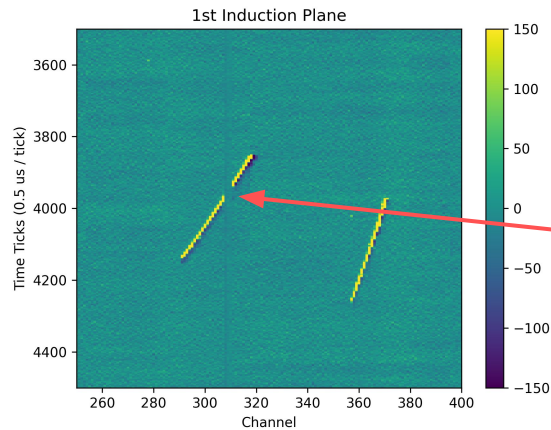
Dead channels before they died

- The channels that eventually died were part of channel clusters that had connectivity issues at cold
 - But were still responding normally to internal pulsers at the time

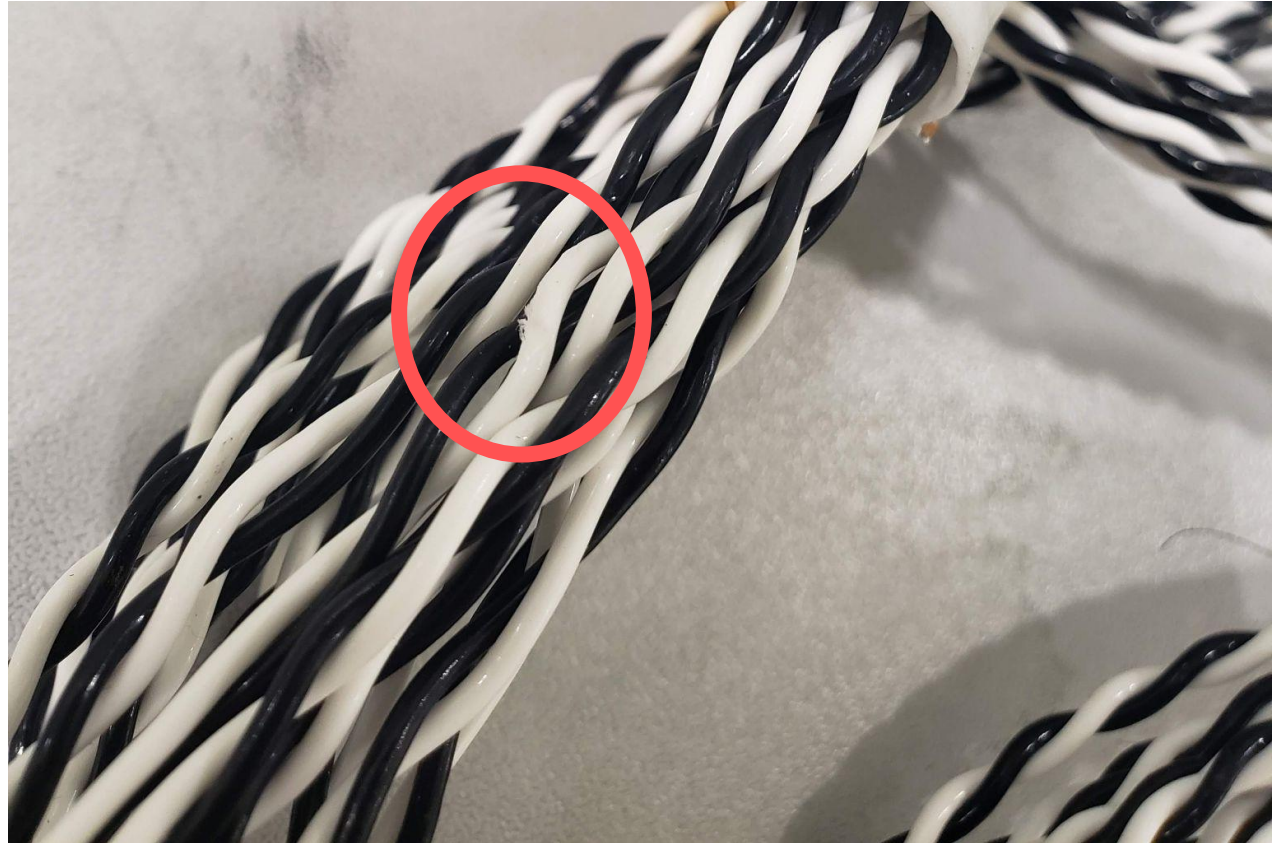
FEMB-5 Damaged Power Cable

- Short power cable was damaged by the patch panel clamp, causing an electrical connection between the clamp and the inner conductor
- This was found before the coldbox test and remedied with a teflon sleeve, but the **cable is now replaced**

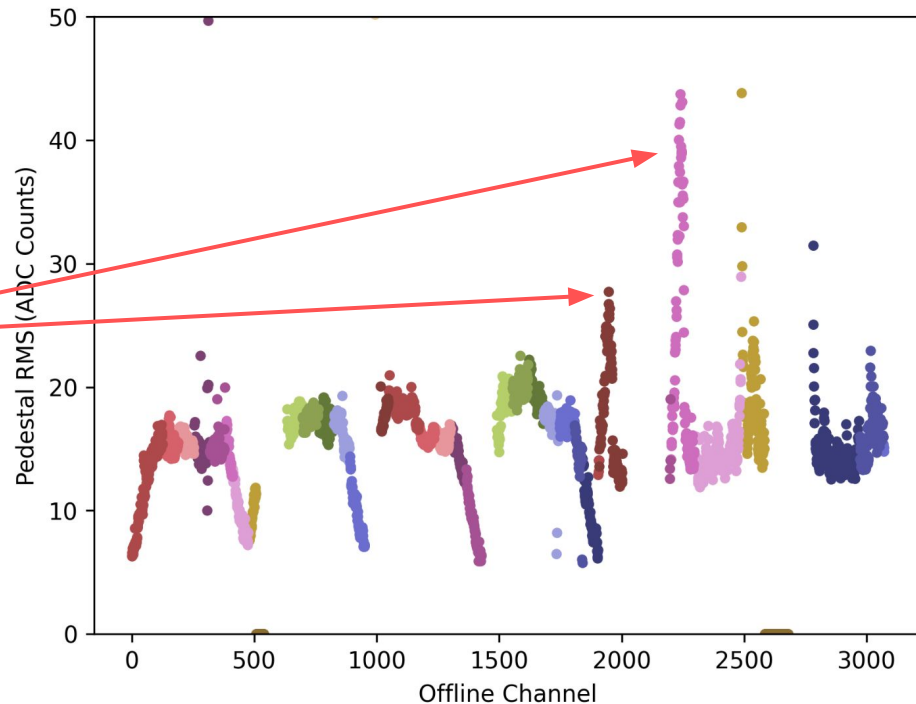
- Using very long readout windows (268 ms), we can see some strips experiencing large baseline oscillations

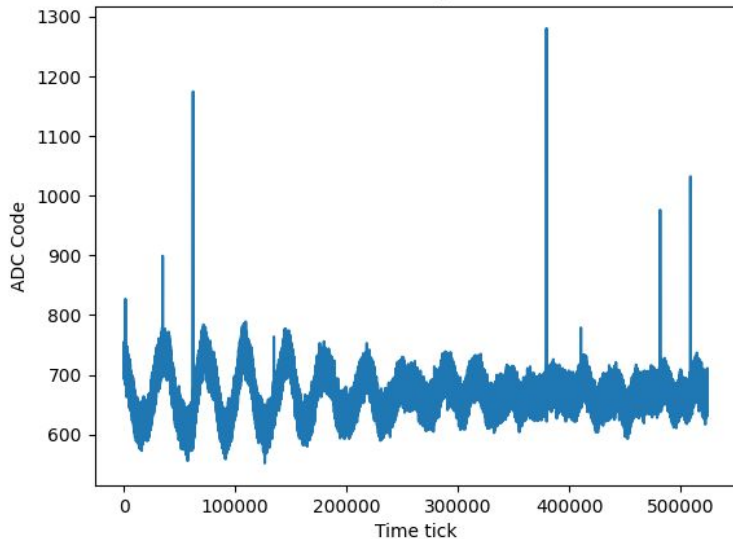
Offline ch 2234, RMS 32.2

- Very slow (<100 Hz) baseline oscillations, but with significant amplitude

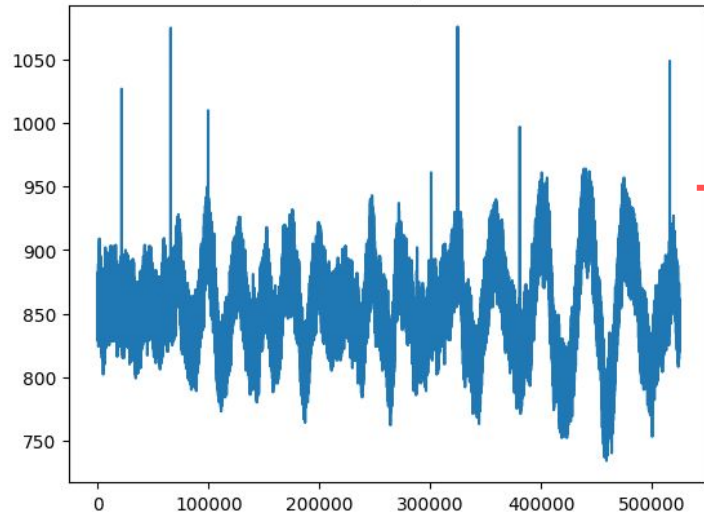
Offline ch 1946, RMS 32.6

- This very-low frequency effect only appears when anode bias is on
- Amplitude decreases as HV level is decreased
- Turning off collection bias but keeping induction bias results in visible oscillations on some induction strips but no collection strips

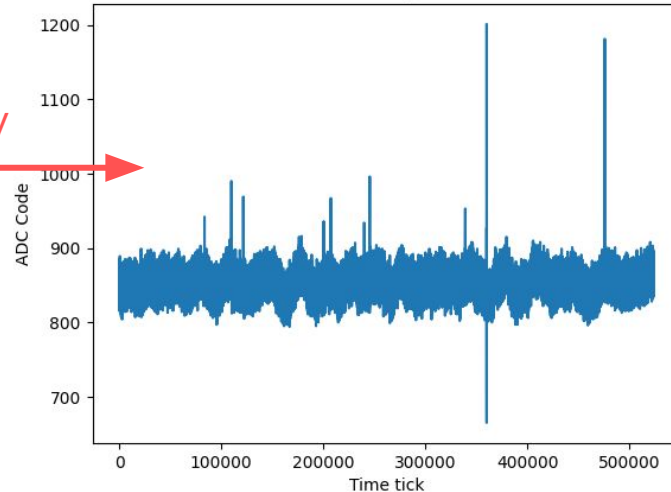
Offline ch 1946, RMS 13.9

50% HV

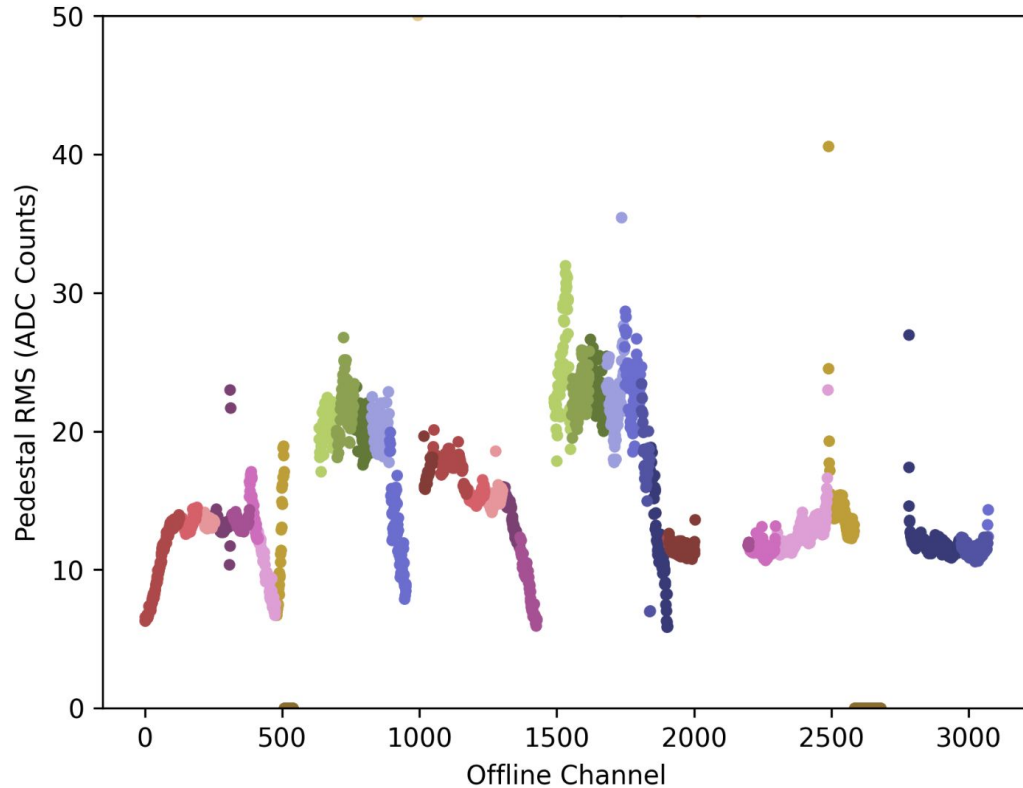
Without Collection Bias

- Removing collection bias but keeping induction bias causes oscillations to disappear from collection channels
