# QC Progress of FEMBs & WIBs for ProtoDUNE-VD at BNL

Lingyun Ke on behalf of the BNL CE Team

03/14/2023

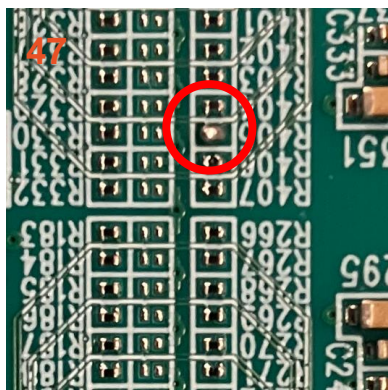
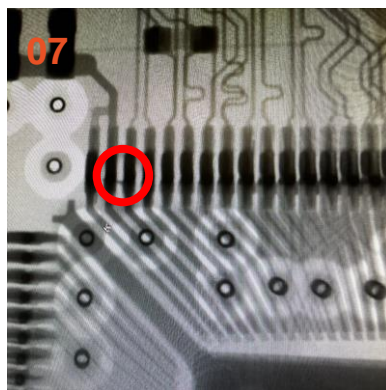
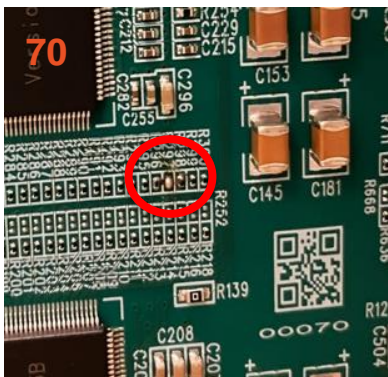
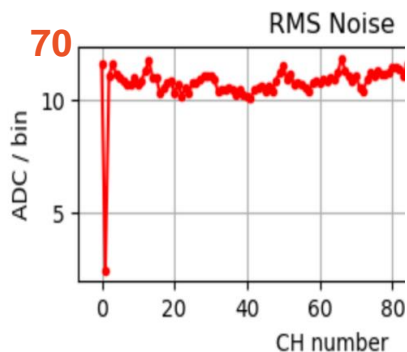
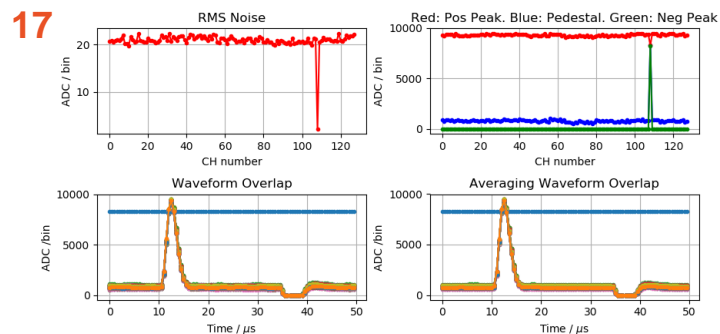
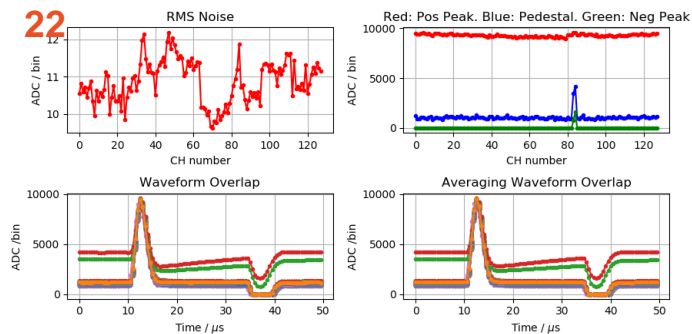
- #07: two pins shorted on U20 (ColdADC)
- #47 CH17: soldering issue of 0201 resistor
- #70 CH01: soldering issue of 0201 resistor
- #22 CH83 & 84: soldering issue of 0201 resistors
- #17 CH108: soldering issue of 0201 resistor

0201 resistors between FE and ADC are not needed, a FEMB revision is proposed to remove them to improve assembly quality

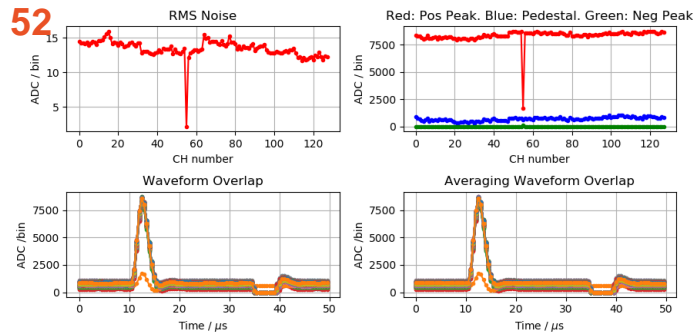
- #52: lower Pos Peak observed in the cold Leakage Current test, RT performance is normal
- #63: U23 (LArASIC) shows RMS noise and all performance slightly lower than other chips at both RT and LN2

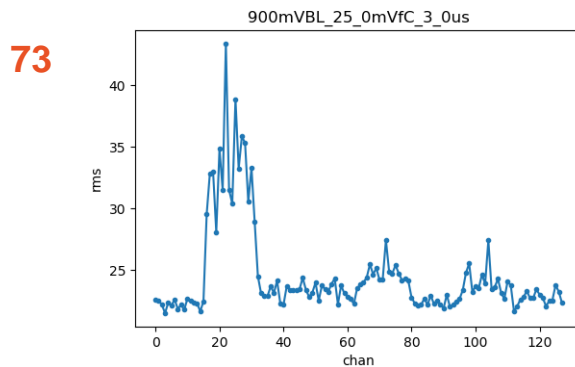
- #73: higher RMS noise observed in the cold test, RT measurement is normal

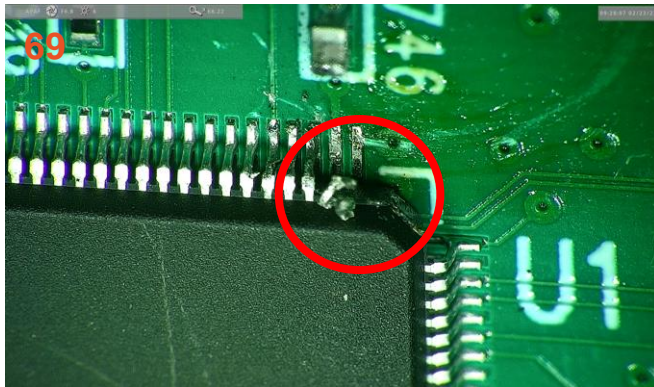
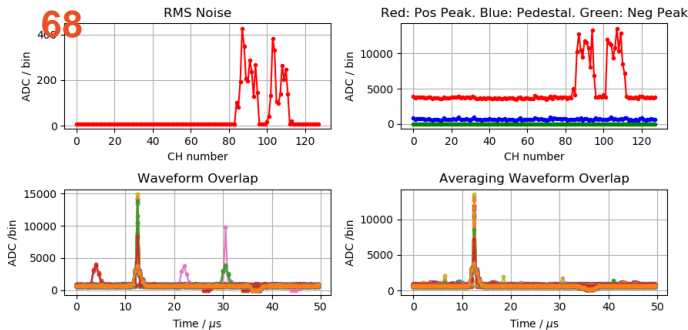
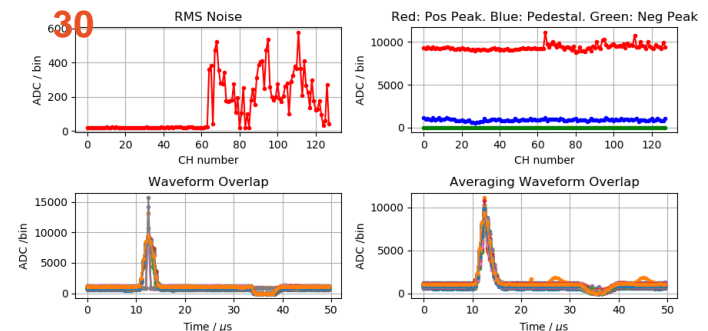
- #69: low impedance (< 7 Ohm) was observed on Pin 110 (VDD\_LArASIC) of U1 (COLDDATA)
- #80: pin VDDIO, VINT shorted, After we removed the chip from board, we figured out the short to ground, which also broken the fuse on WIB
- #68: U2 (secondary COLDDATA) is sensitive to temperature, can't output good data at warm.
- #30: COLDDATA (U2, address=0x02) (CONFIG\_PLL\_BAND. Register 65 (0x41) default value 0x20 can't work at RT. Set to 0x19 can work at RT occasionally.

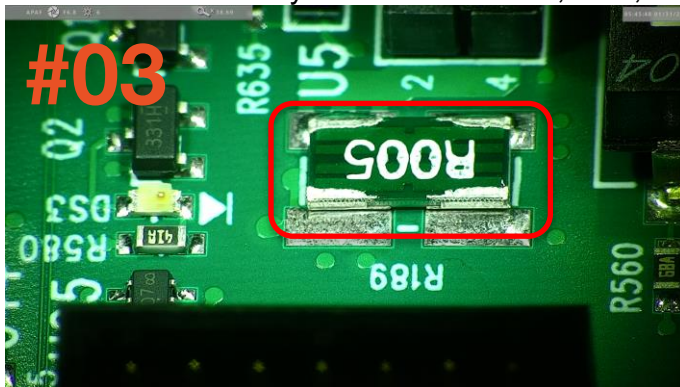
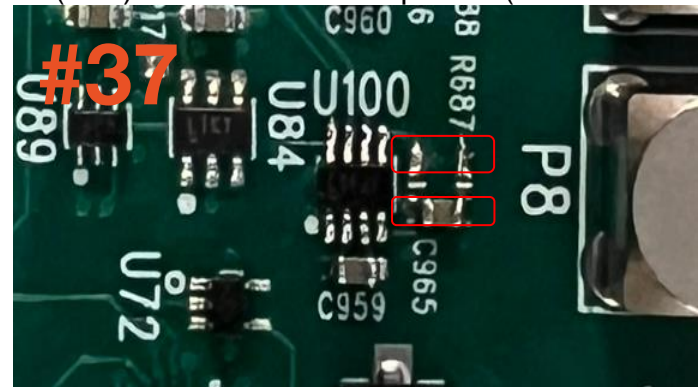
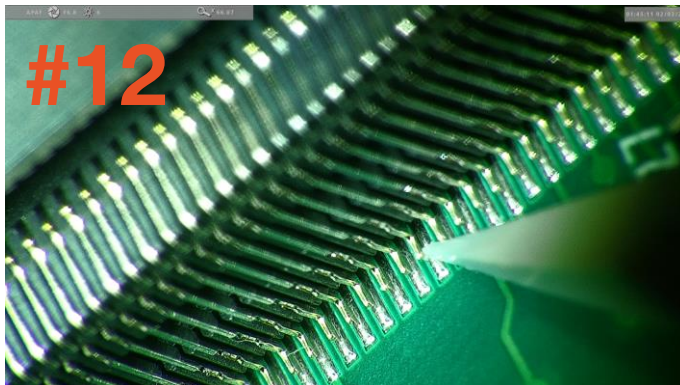
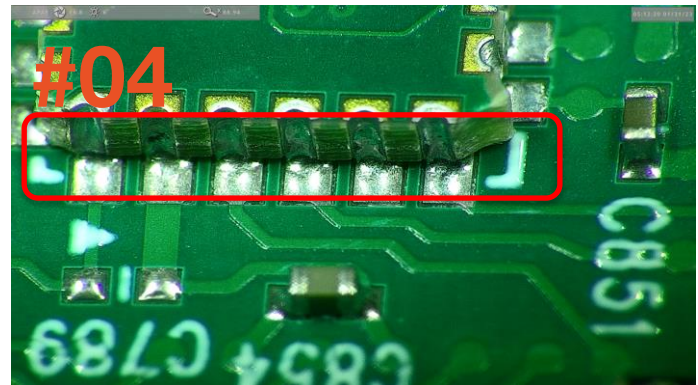
- SN 03: C372, U96 and R186 have soldering issues and Zynq+ PS can not boot
- SN 37: R687 and C965 are populated in wrong direction
- SN 12: Pins on DDR4 SODIMM socket are open & a LEMO connector is shorted
- SN 10: LTC2977 has assembly issue (not shown in picture)
- **SN 04**: Assembly issue on SD card, also, the chip LTC2991 (U36) is defective and replaced (not shown in picture)

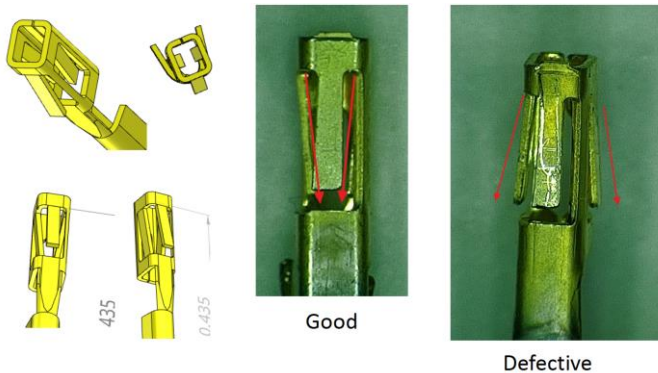
Batch#5 (SN0018, 25m): A loose connection was identified when we performed the daisy-chain test. It turns out there is a **defective crimp**

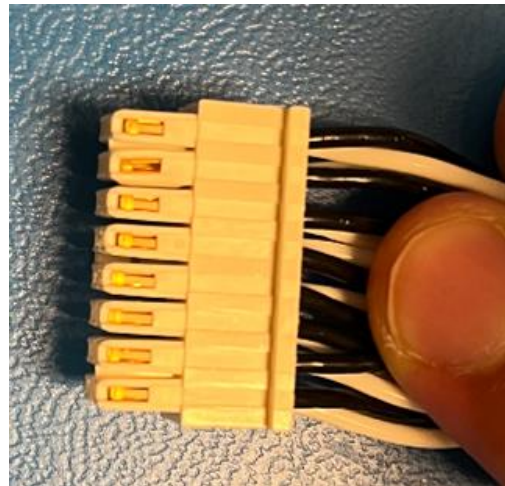
SN0020 had one crimp rotated 90 degrees
