# CRP4 Coldbox Results

CE Consortium Meeting 3/21/2023

Roger Huang, Herilala Razafinime

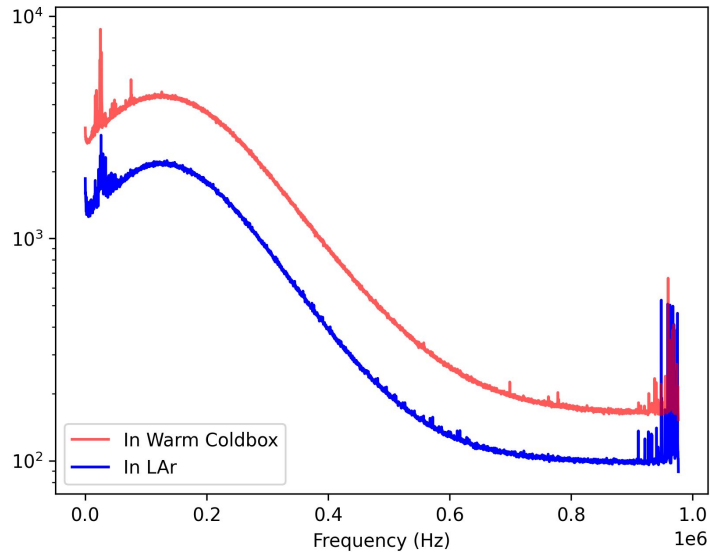
CRP4 Noise Power Spectrum  
All Channels Summed

- No big surprises going to cold
- Channels 1243 and 2172 show anomalous noise response at cold, but are alive

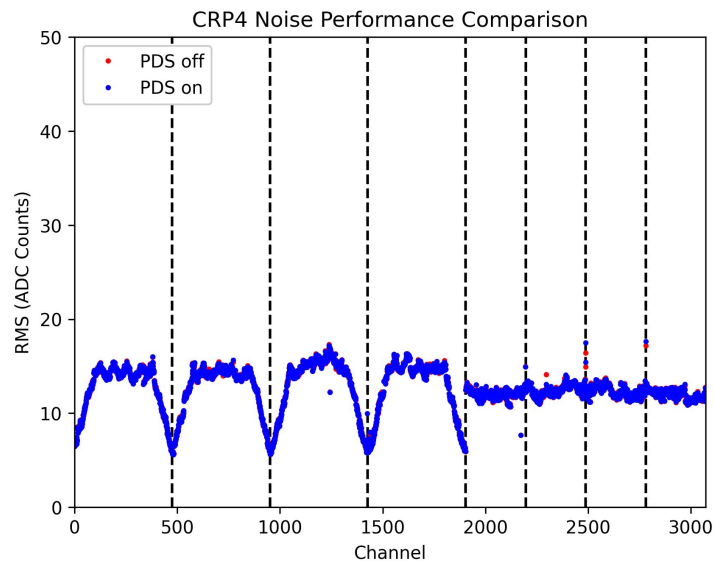
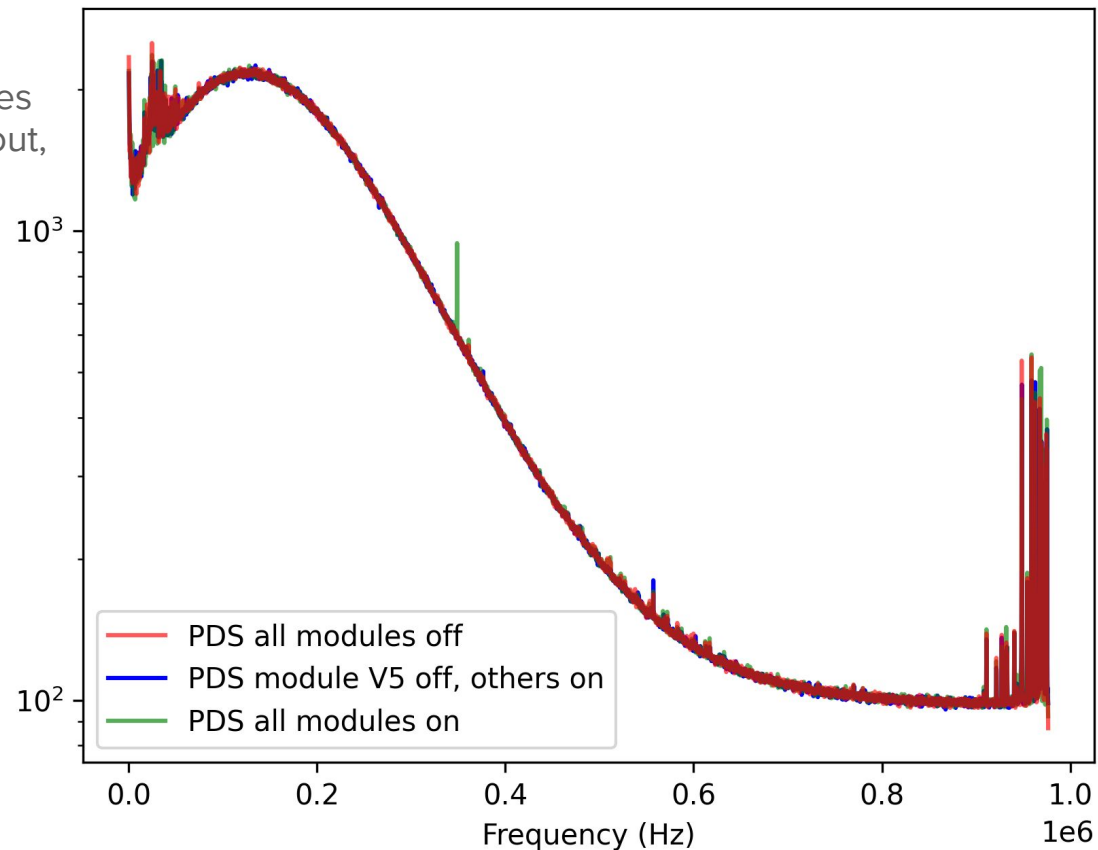
## CRP Noise Power Spectrum Comparison All Channels Summed

- One of the cathode PD modules induces a 350 kHz noise peak in CRP CE readout, though the effect on overall noise is negligible
  - This frequency is known to the PDS group

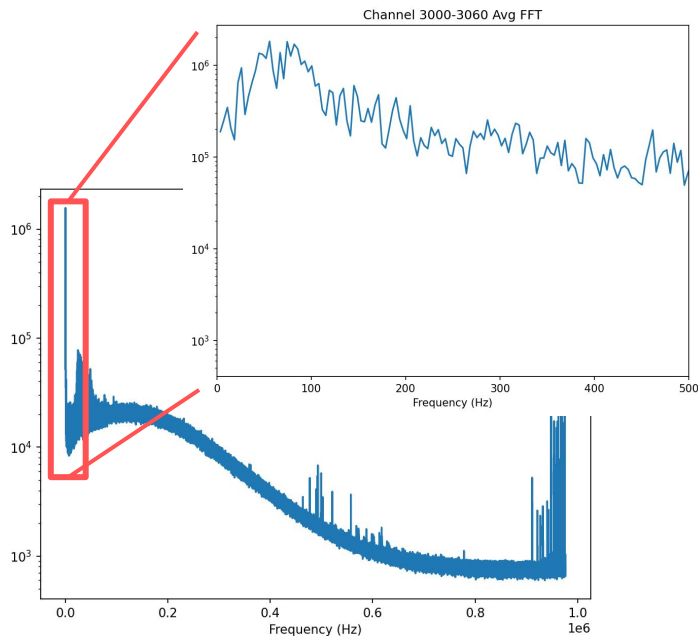
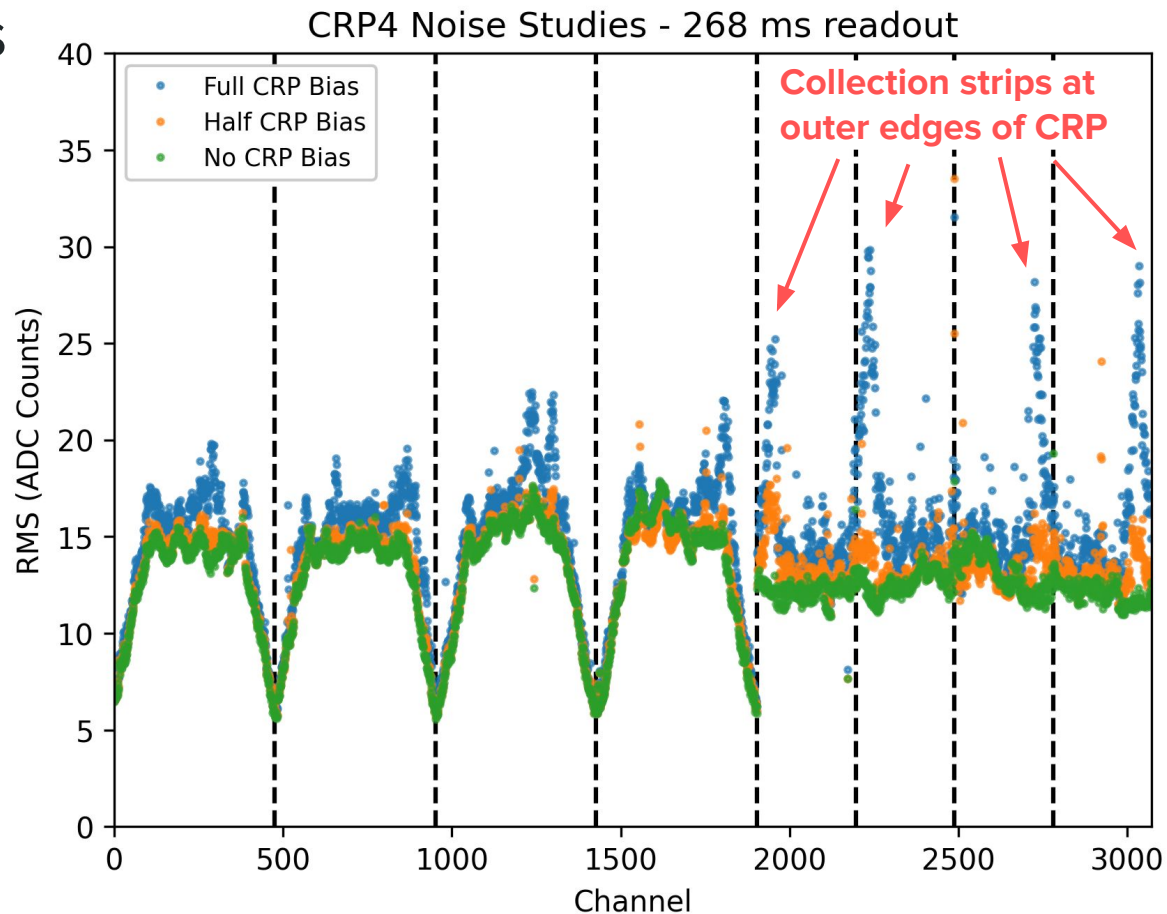
- Very low frequency (50-100 Hz) oscillations on some collection strips when CRP bias is on
  - Channels that run under the adapter boards?

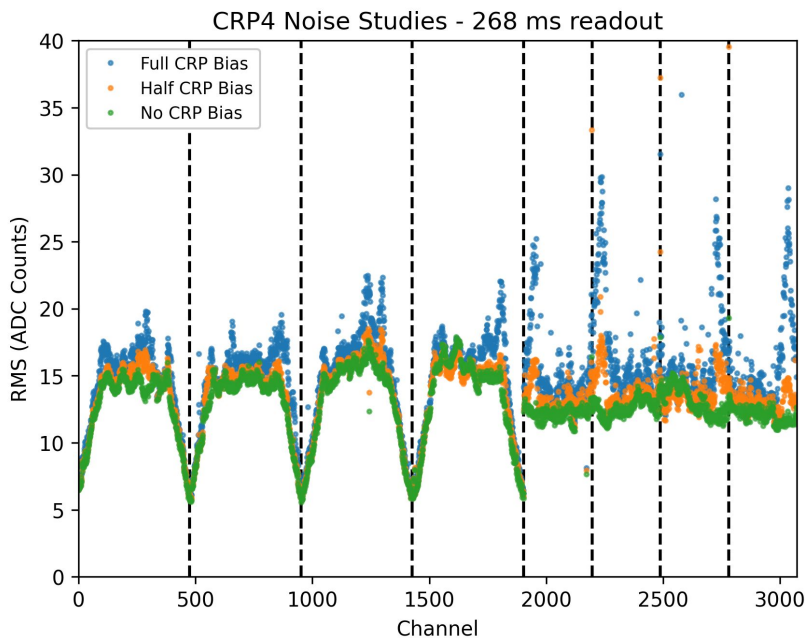
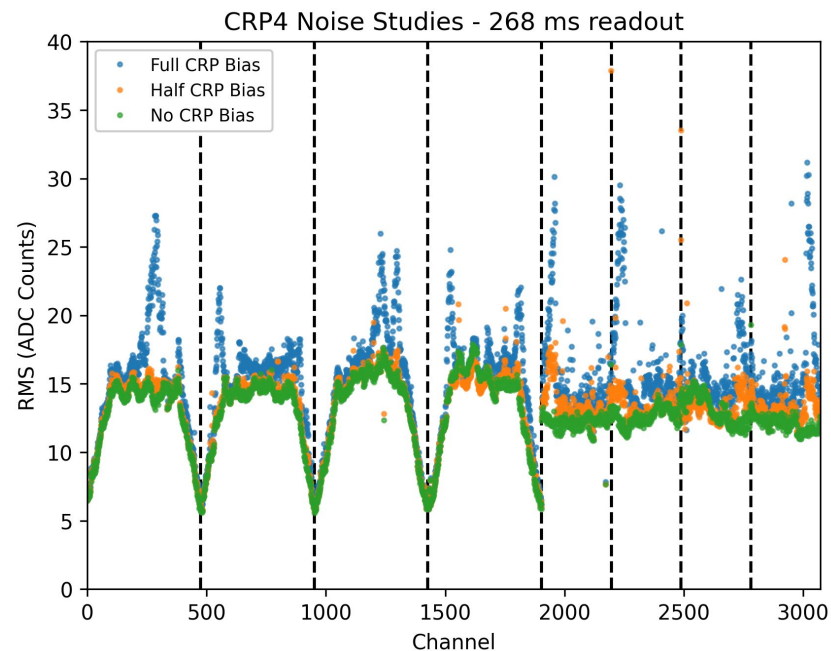
- Intensity of oscillations in different areas varies over time

Sampled  
at a  
different  
time with  
the same  
conditions

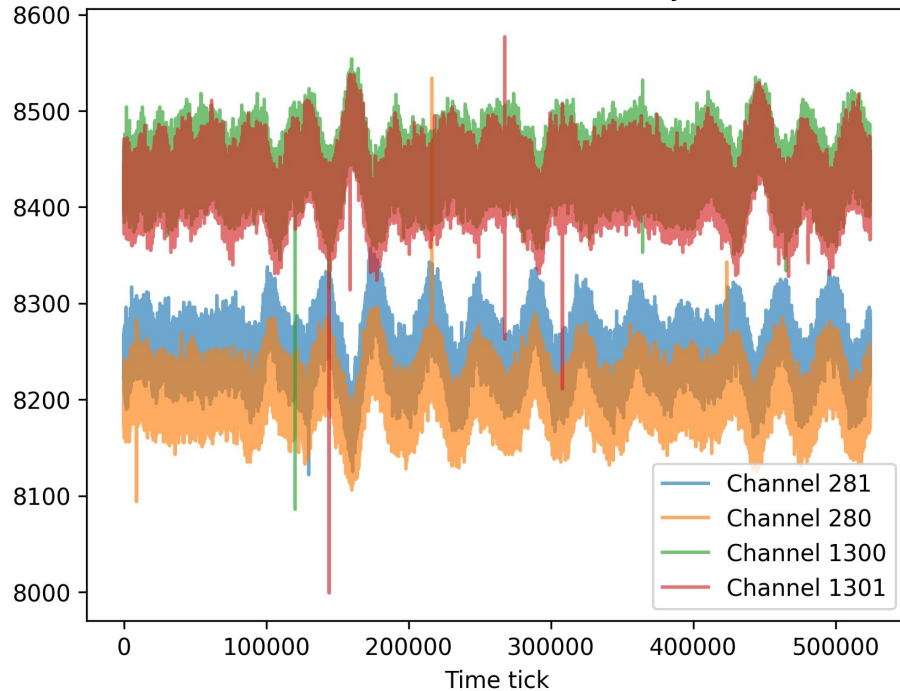
Channel Waveform Overlay

- Induction channel oscillations are coherent within the same area of the same plane
- Oscillations are coherent but flipped between U and V channels in the same area

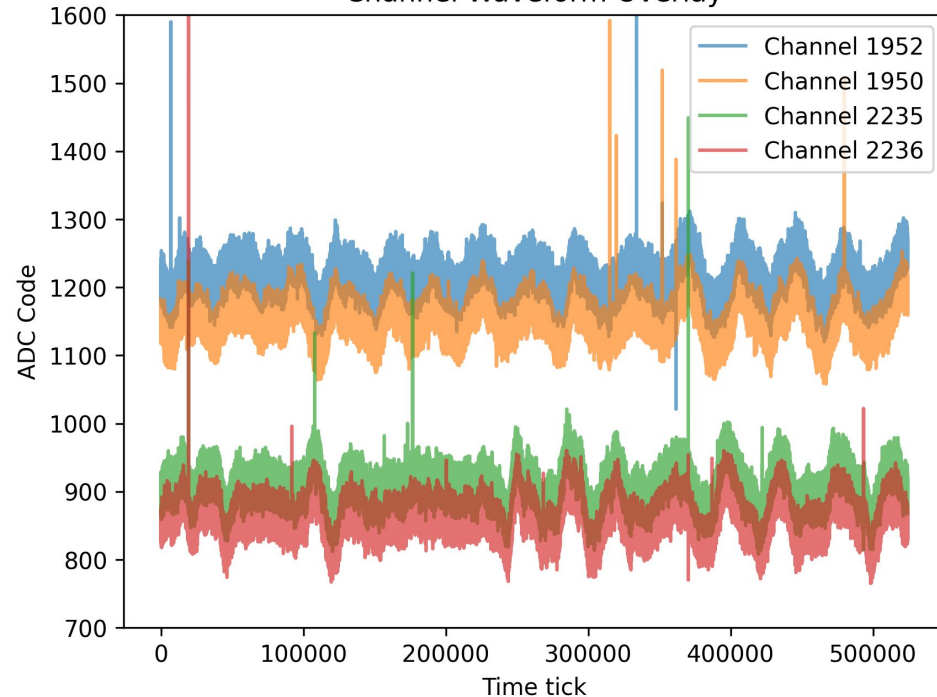
Channel Waveform Overlay

- Collection channel oscillations are coherent within the same quarter of the CRP, but not across different sections

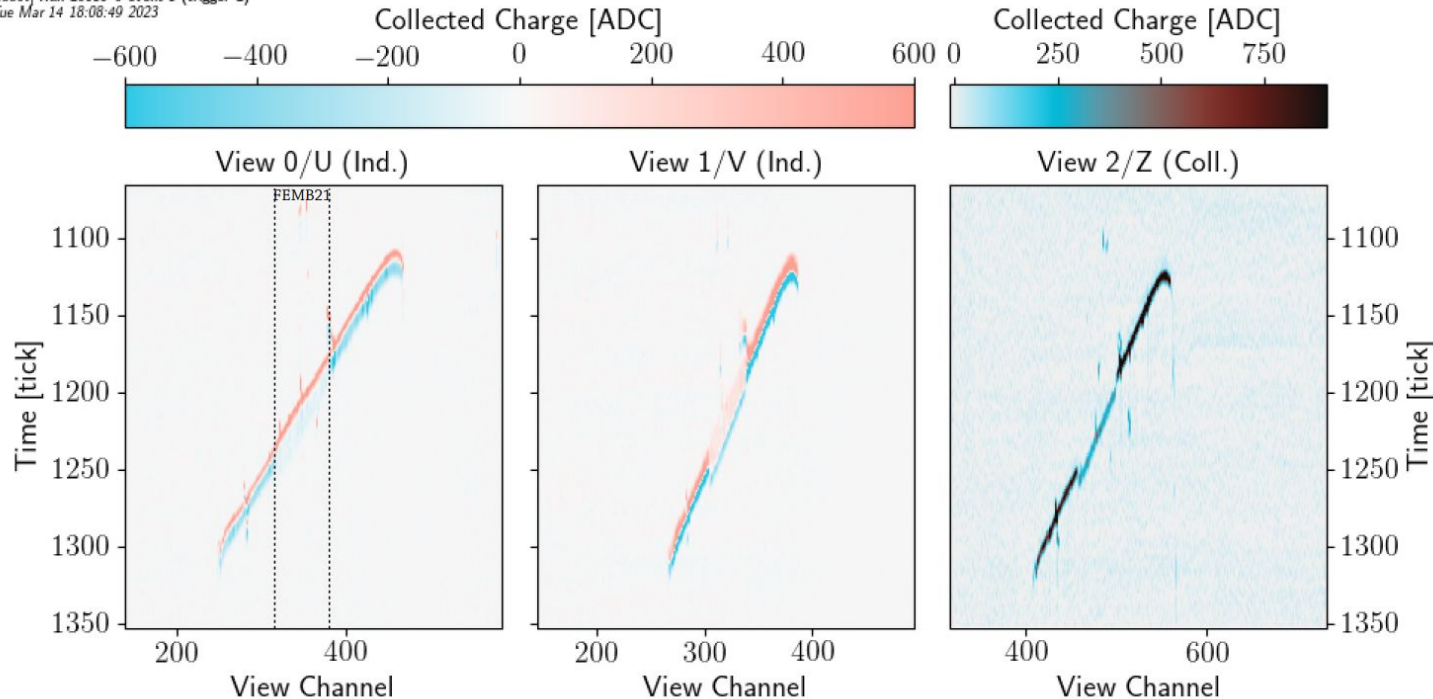
[cbbot] Run 20616-0 event 1 (trigger 2)  
Tue Mar 14 18:08:49 2023

- The boards of FEMBs 9 and 21 were missing their U layer bias due to missing jumper cables
- Confirmed after extraction from coldbox

- CRP4 went back to 185 for 2 FEMB replacements, installation of adapter plates, and fix of 2 boards missing U bias
  - New FEMBs respond as expected
- Modifications completed today, and CRP4 will return to EHN1 at the end of this week for installation in NP02
- CRP4 will not be cold tested again until PD2-VD operation

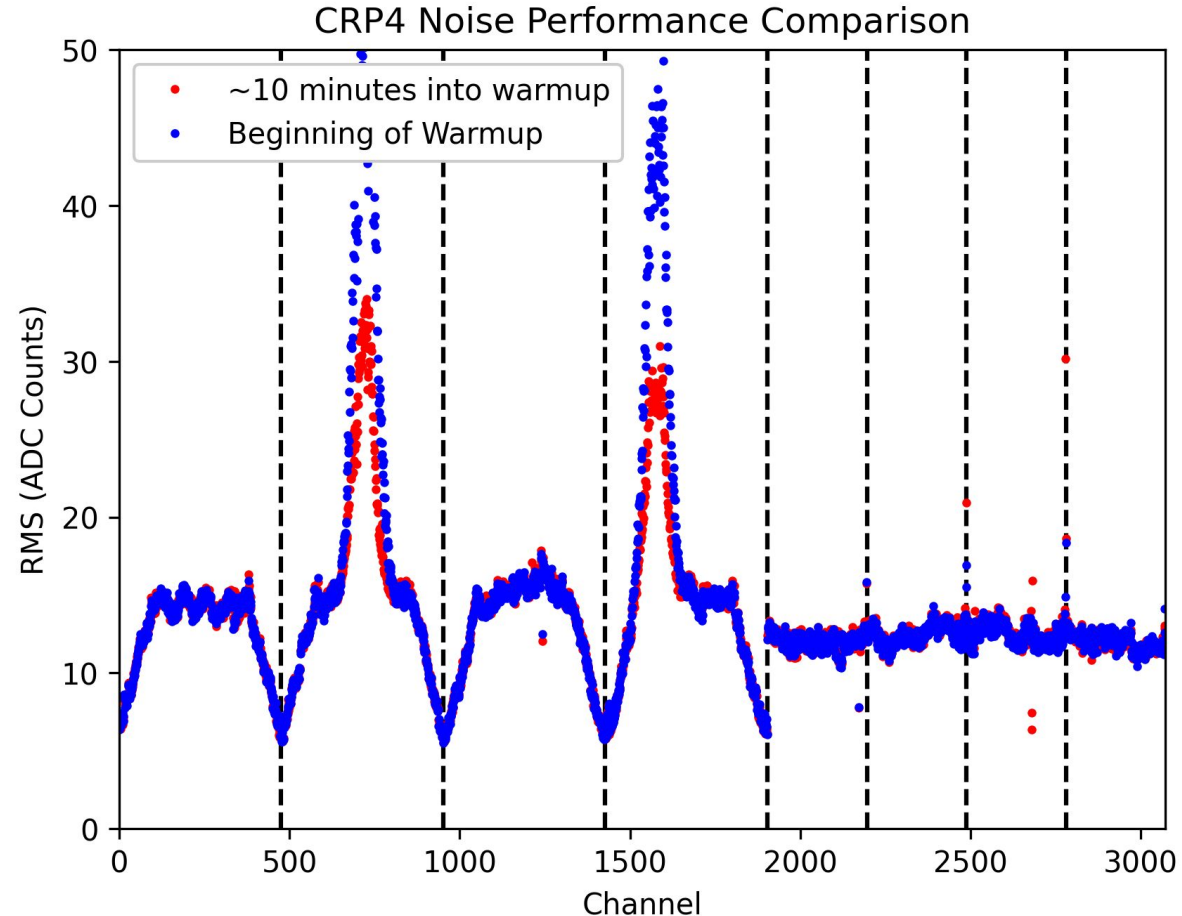
- Shortly after warmup began, we lost two channels to discharge-like damage
  - Channels 2679 and 2680 on the collection plane, on FEMBs 10 and 11
- Cathode and anode HV bias had been ramped down about 45 minutes prior to beginning of warmup

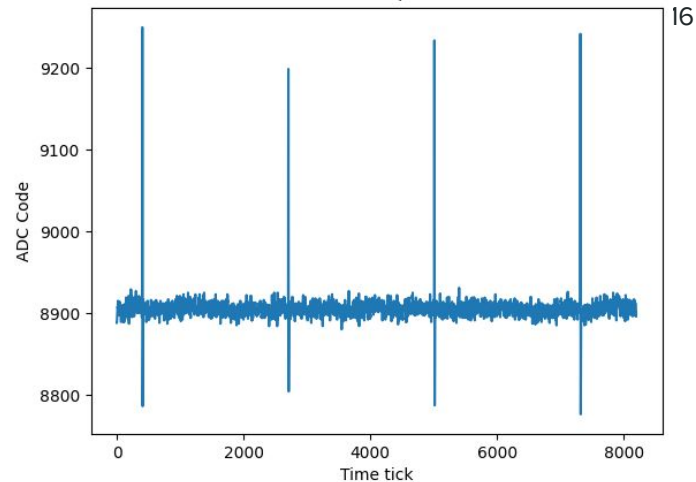
Offline ch 2679, RMS 13.8

**Pulsar DAC=20, low  
baseline setting  
(sees crosstalk but  
not the actual directly  
injected pulses)**

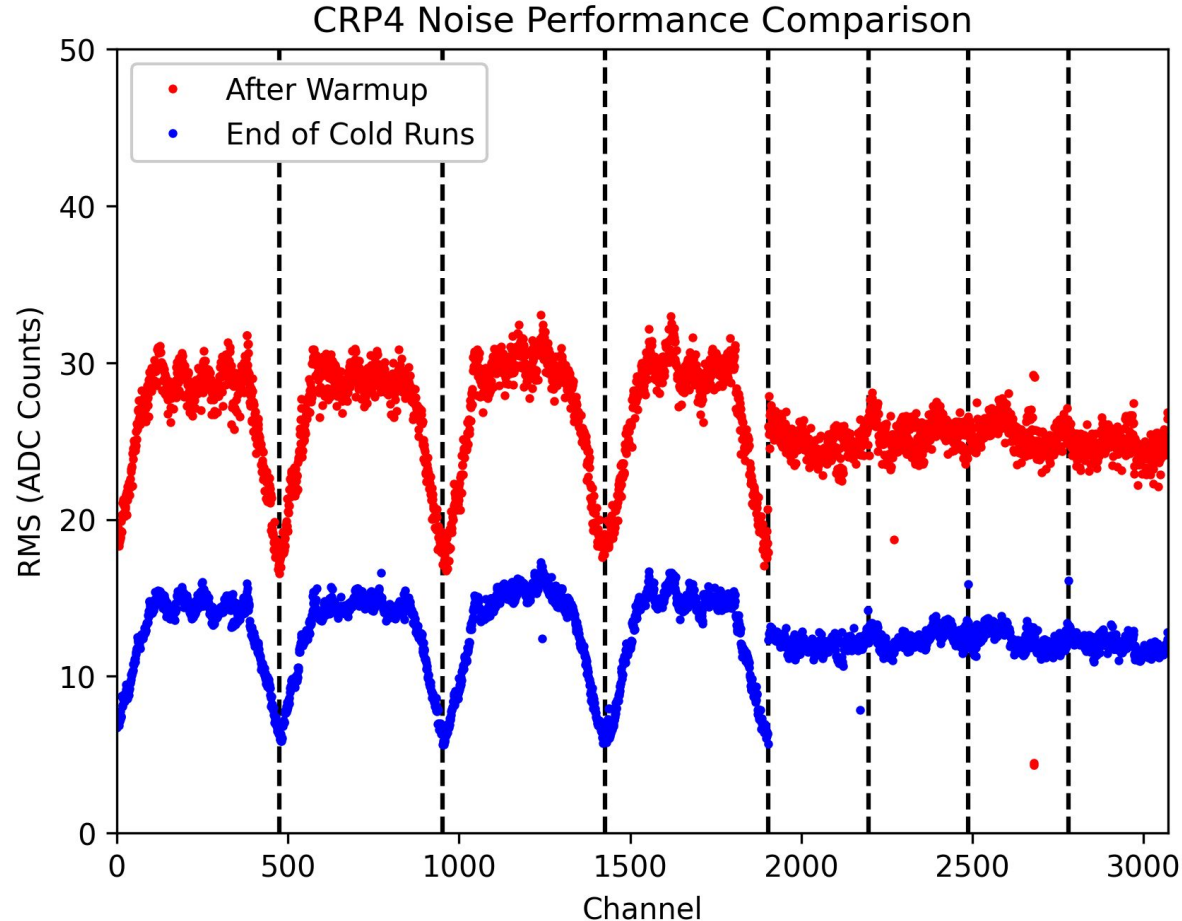
- Two channels lost - these two FEMBs have now been replaced on CRP4
- Channels 1243 and 2172 seem to be disconnected from part of their strips only at cold
- Channel 2272 seems to have dome connectivity issue only at warm
