# CRP4 Coldbox Results

US CRP/BDE Meeting 3/22/2023

Roger Huang, Herilala Razafinime

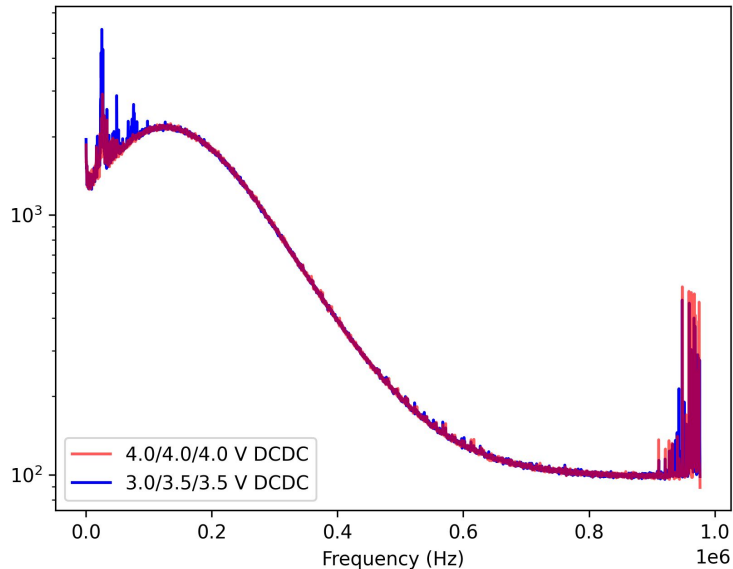
CRP4 Noise Power Spectrum  
All Channels Summed

- 25 kHz coherent noise and effect of DC/DC settings persists

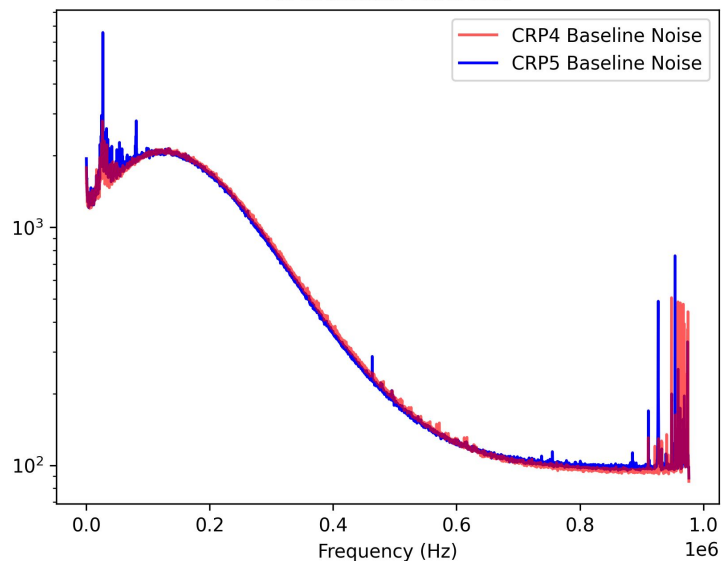
CRP Noise Power Spectrum Comparison  
All Channels Summed

- Overall noise levels mostly comparable, but corrected grounding on CRP4 has mitigated the extra noise on collection strips at the CRU border

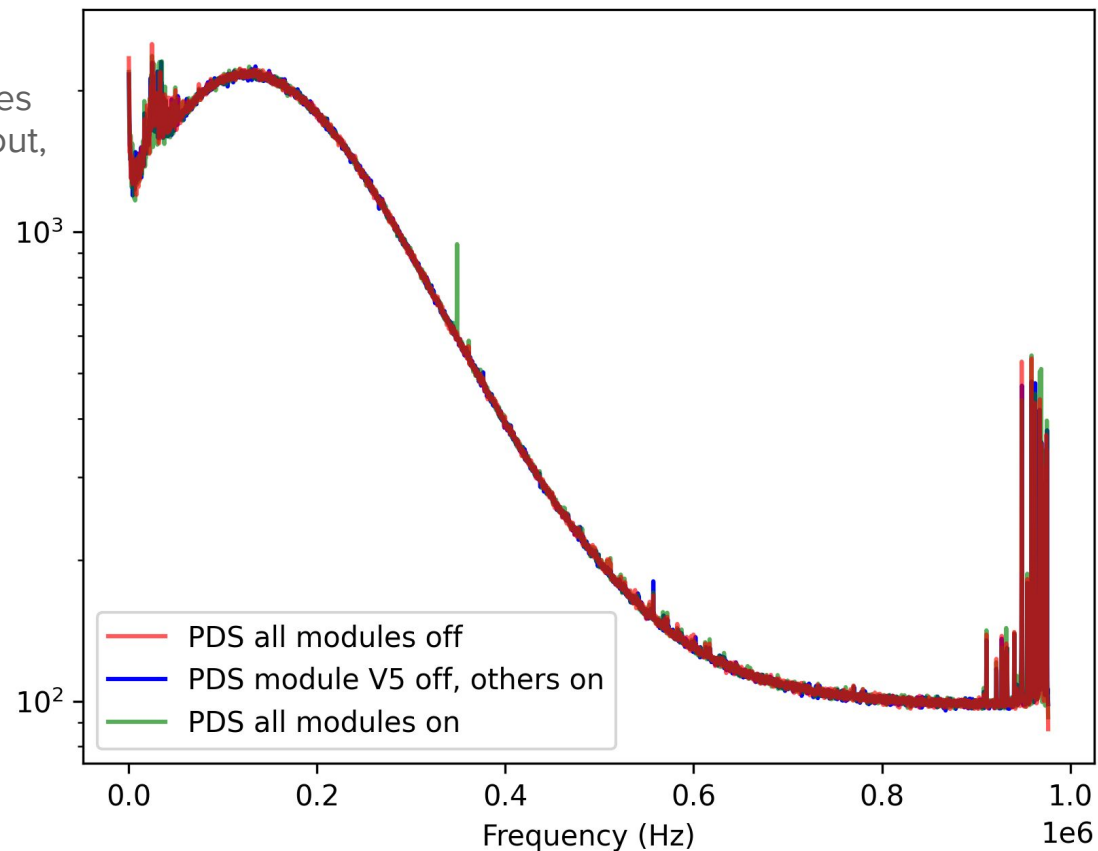
## CRP Noise Power Spectrum Comparison All Channels Summed

- One of the cathode PD modules induces a 350 kHz noise peak in CRP CE readout, though the effect on overall noise is negligible
  - This frequency is known to the PDS group

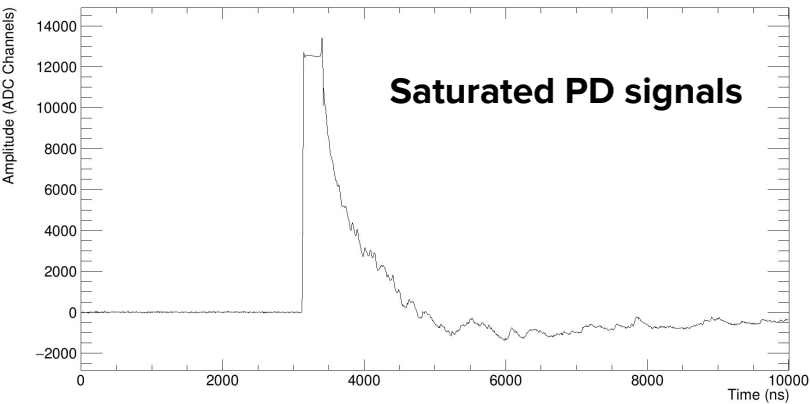
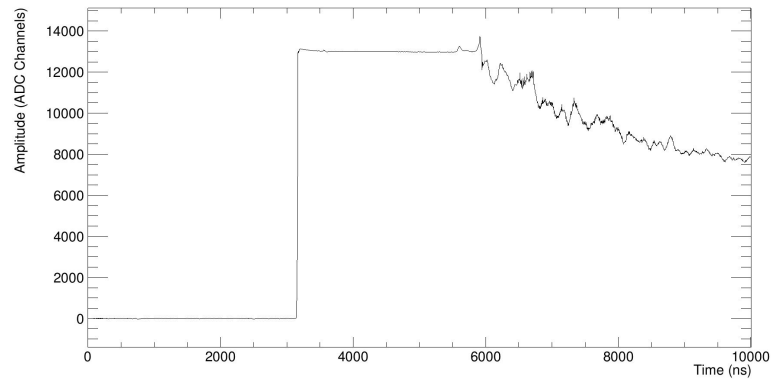
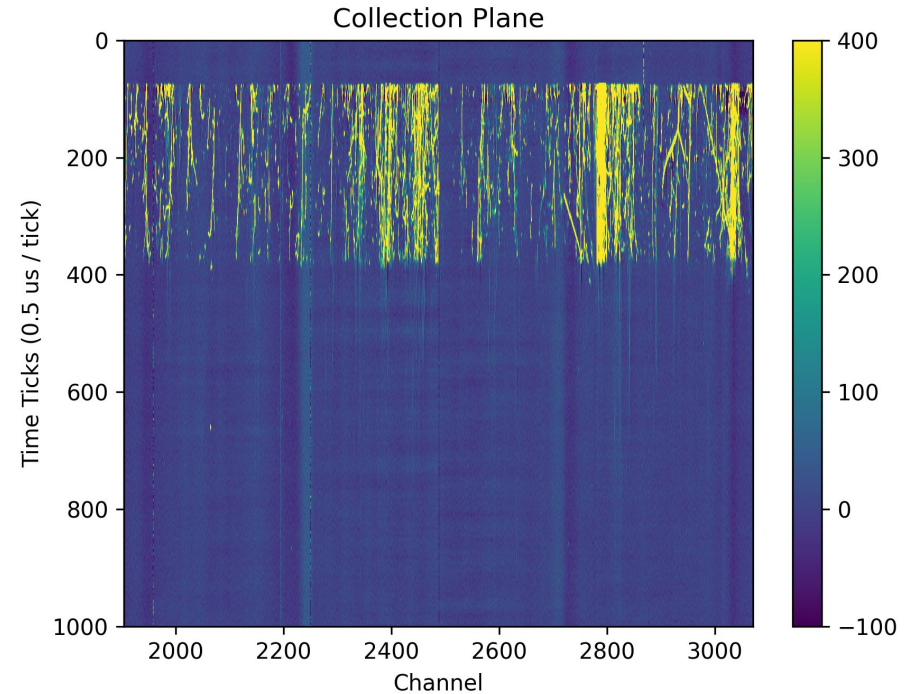
- Data using external trigger from CRT signal, sent to both PDS and CE DAQ
- Timestamps and signals look like they match

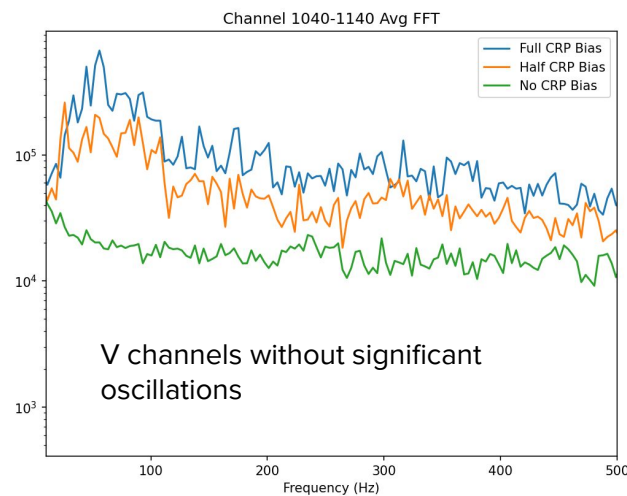
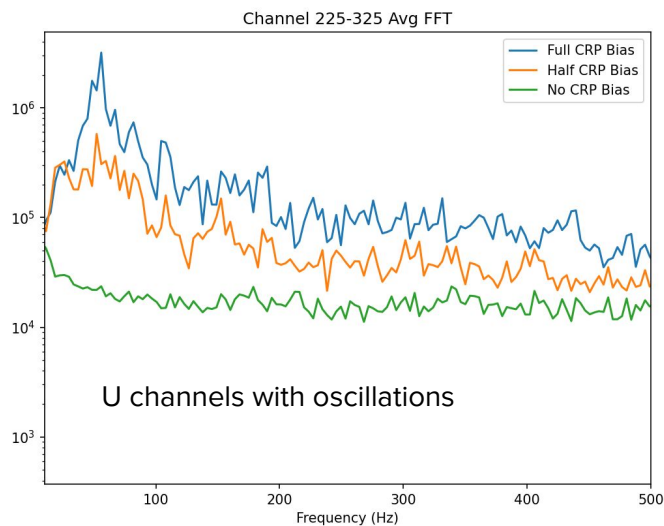
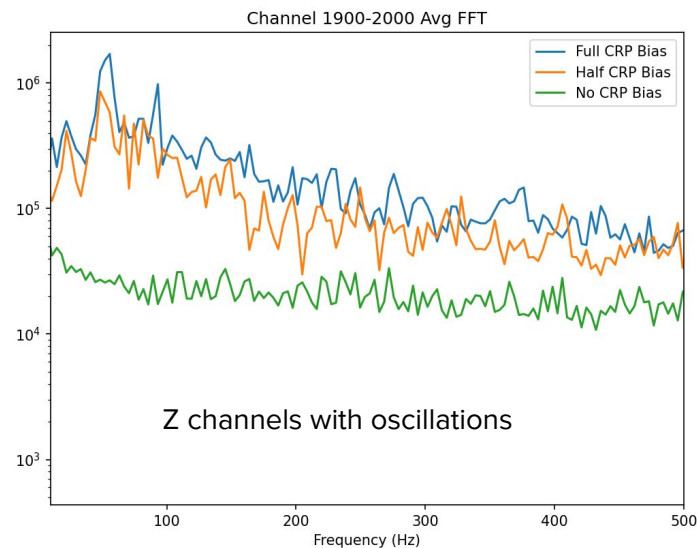
- Effect is consistently in the 50-100 Hz region (maybe most peaked around 50 Hz?) on channels where it appears

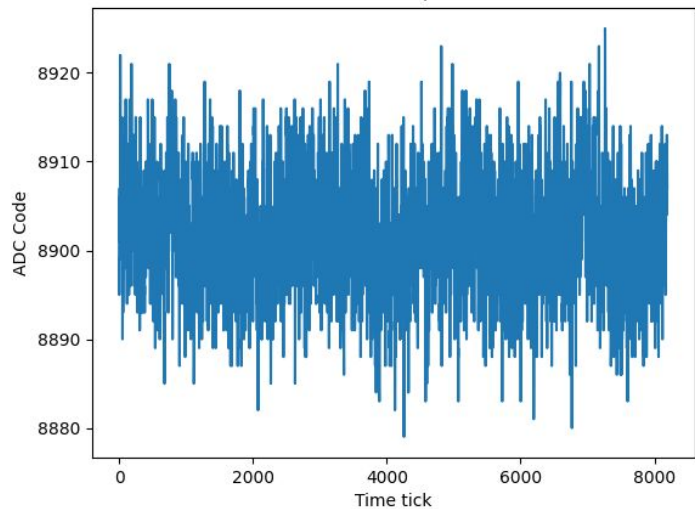
Offline ch 2679, RMS 6.4

**Low baseline setting**

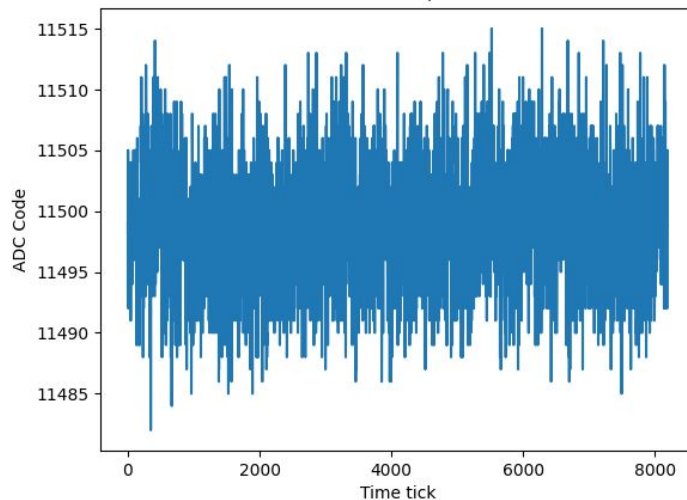
Offline ch 2679, RMS 4.7

**High baseline  
setting**
