Preacc/Linac Weekly Performance

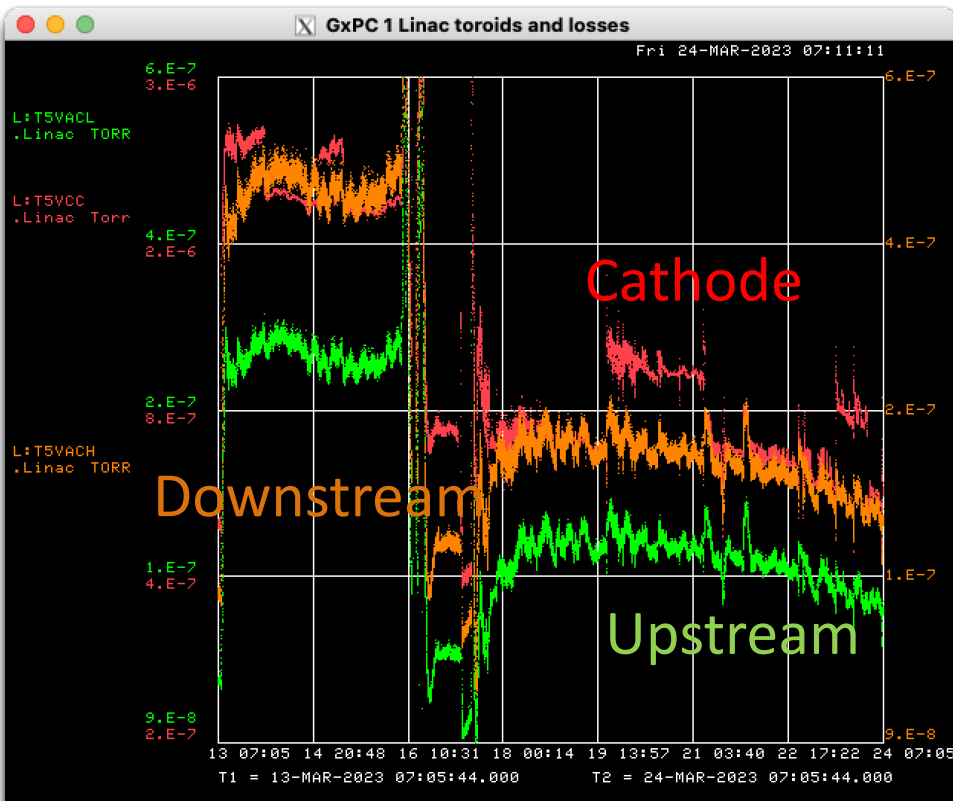
T5 vacuum

LE Tank 5 Vacuum

- Installed dedicated skid for T5 bulk tuner (thanks MSD & Kent T. and Jeff L.)
- Vacuum and temps holding mostly steady since
 - Flow meter reading unsteady because of low flow rate & pressure

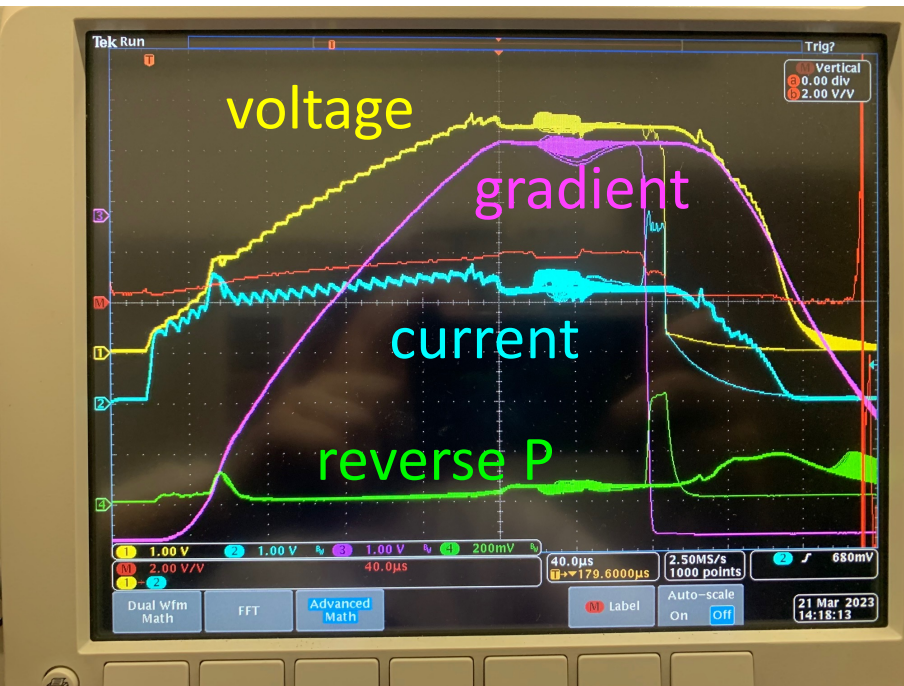
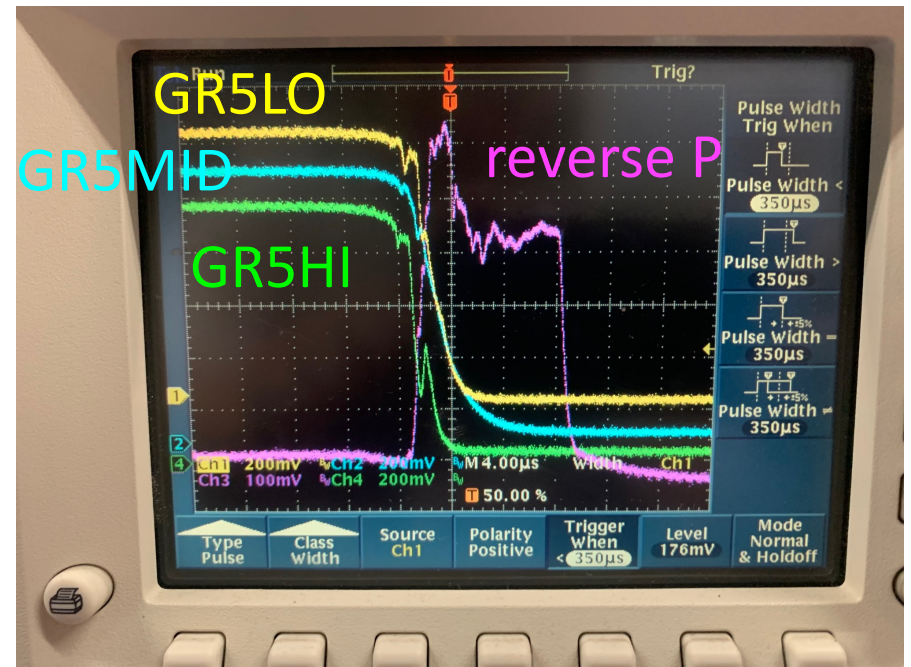
LRF5 OI Trips

- Bouts of up to 10 OI trips one after the other
- From diagnostics appears to be cavity sparking
- Seems correlated with T5 vacuum / temperature
 - Most frequent after cavity off, until temperature equilibrium
- Thanks Ops for helping diagnose & resetting

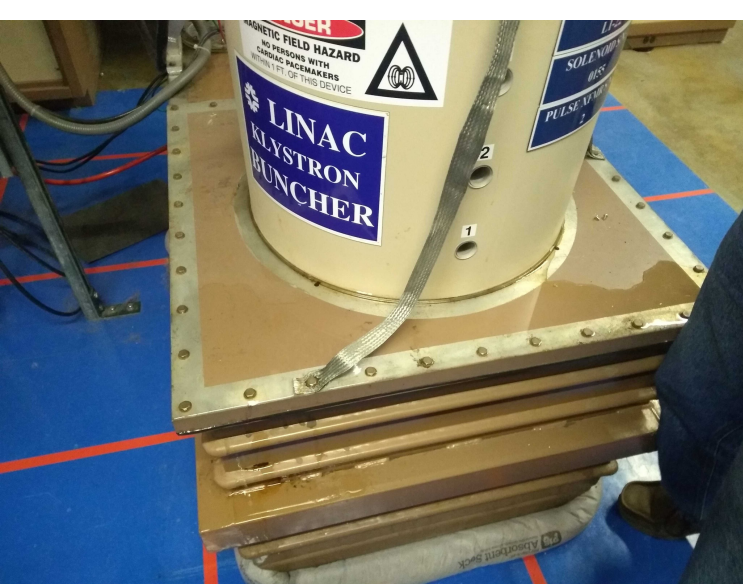
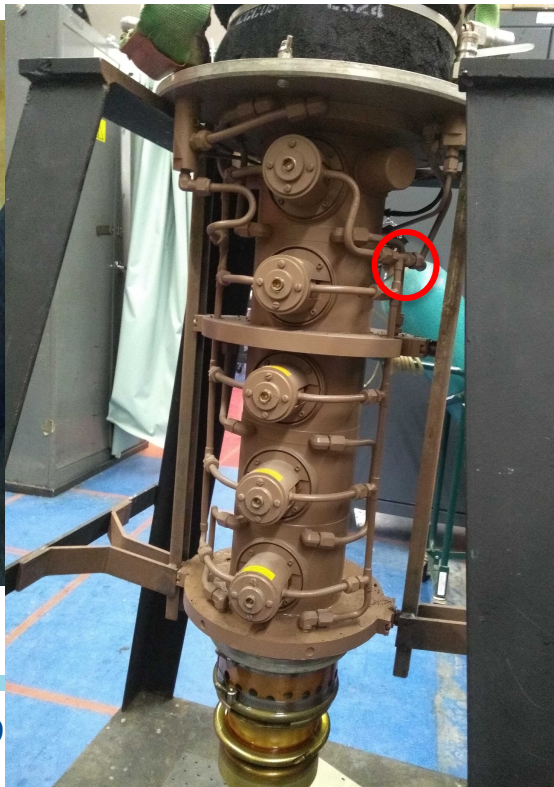
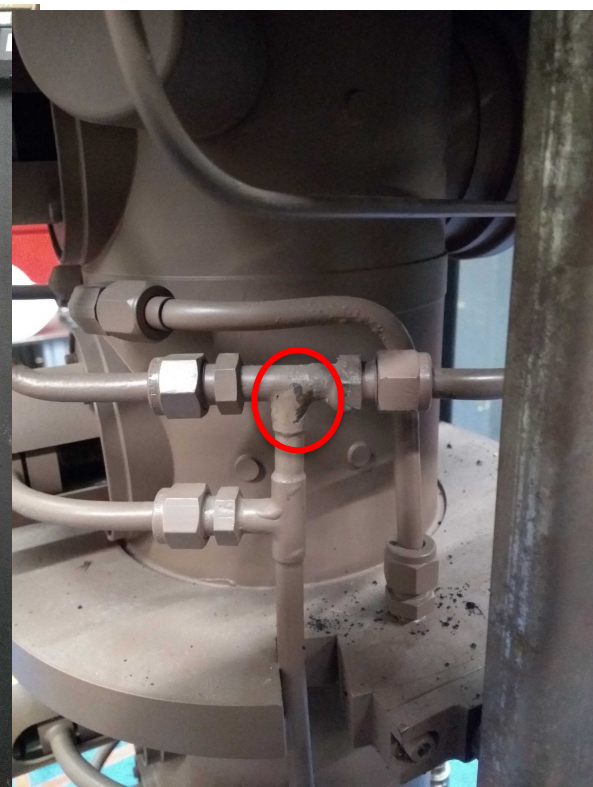
Buncher Klystron & Transformer Replacement

- 5AM Thursday Buncher tripped on coil comparator & ground fault
- Water leak discovered on Klystron/top of transformer
 - Given place of the leak and observed liquid level in transformer, likely oil was contaminated: decided to replace full assembly
 - Had one spare assembly
- After turning on had to do a lot of phase/gradient regulation tuning
 - Beam to BNB reestablished ~9PM
