Coupler exchange under local cleanroom conditions with the subsequent successful teststand operation of a cryomodule

Karol Kasprzak on behalf of SRF team

TTC Meeting, 5.12.2023

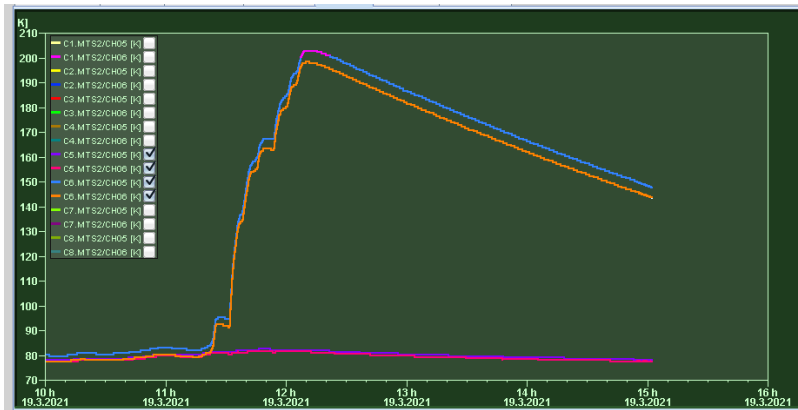
- During first power rise at 2K, an increase at T70K shield was noticed.
- Due to this cavity was set to high gradient for few hours in order to check coupler overheating. The temperature limit at 70K shield was set to 200K.

Overheating off-resonance !

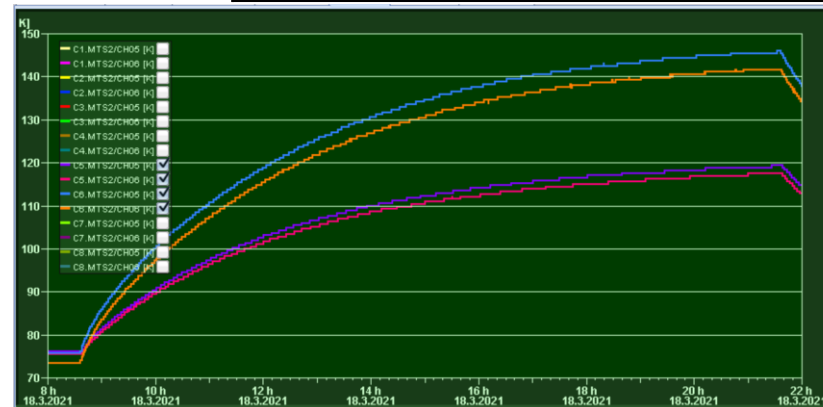
Overheating on-resonance !

Max acc. gradient
33.2 MV/m

Overheating of coupler 6 noticed at 70K shield! No problems with other couplers noticed.

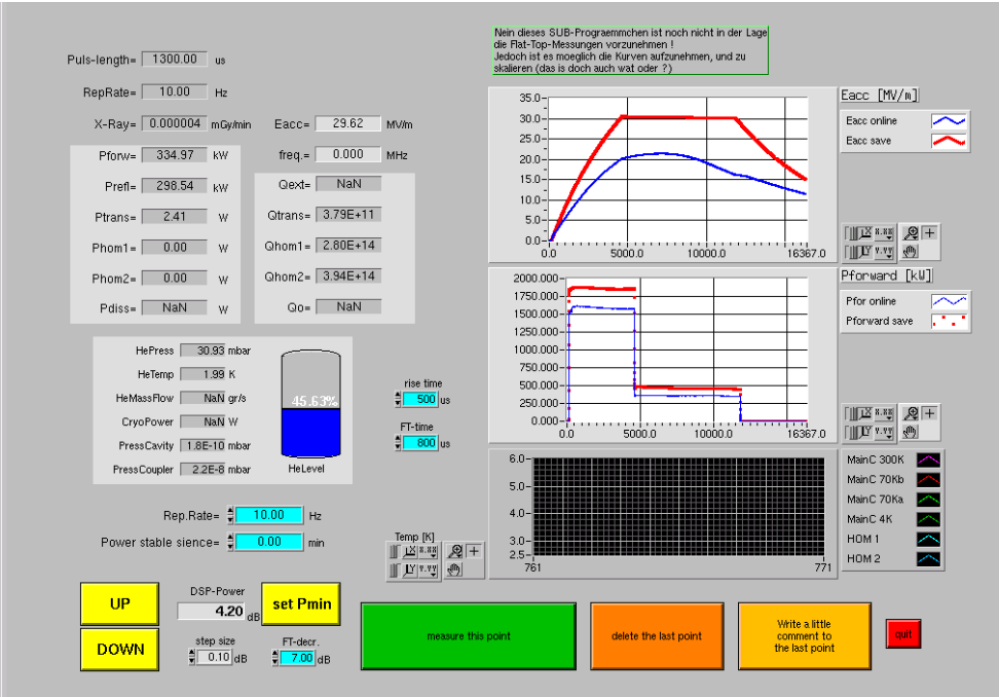
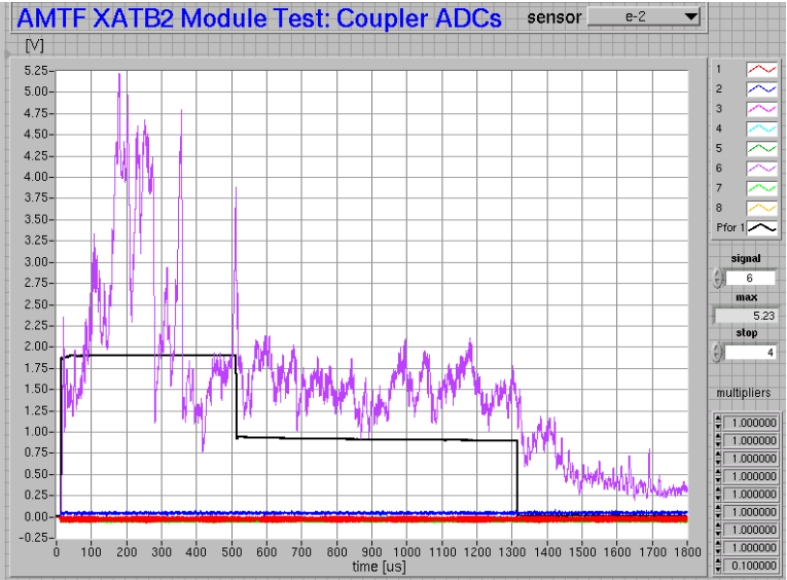
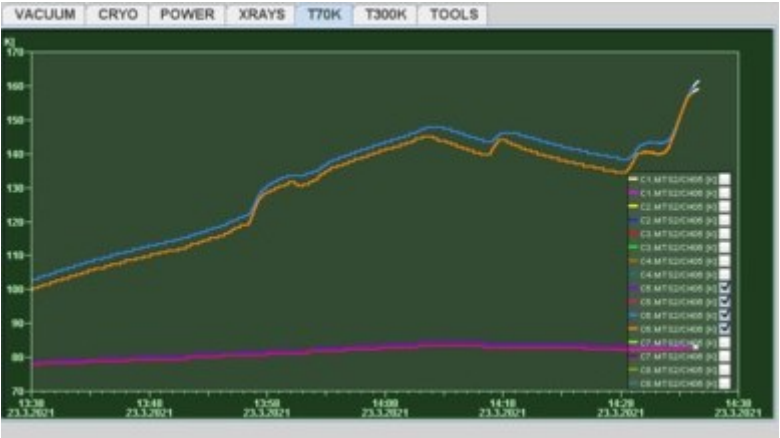
Second power rise – coupler 6 overheating

- Second electron sensor (e-2) disabled and then masked in the technical interlock
- Constant huge discharge in the coupler observed

Decision : WARM PART of coupler 6 had to be exchanged under local cleanroom conditions in the teststand.

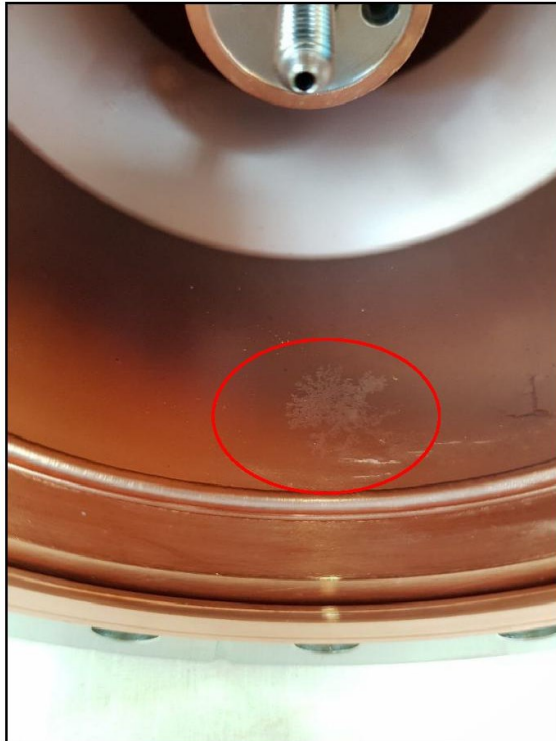
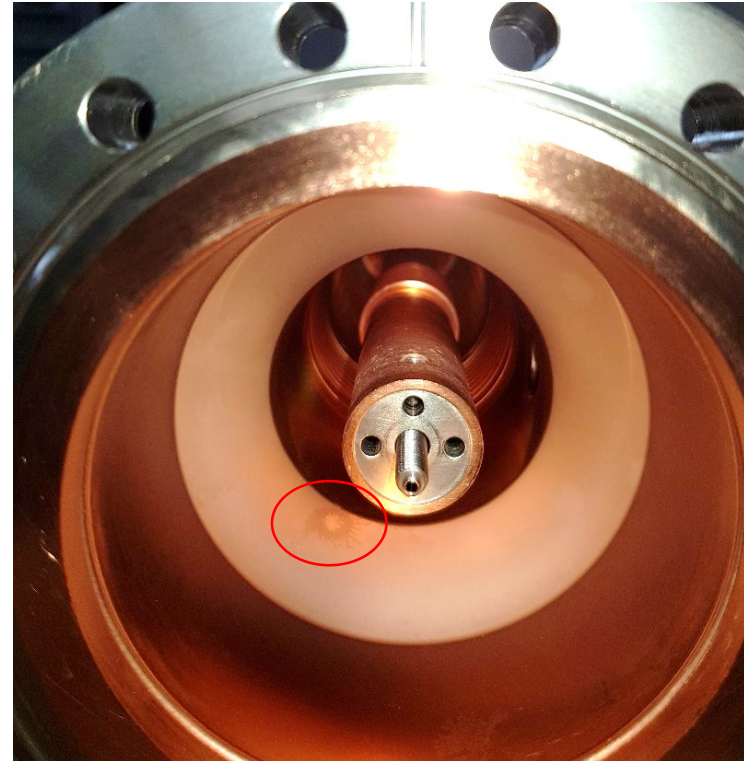
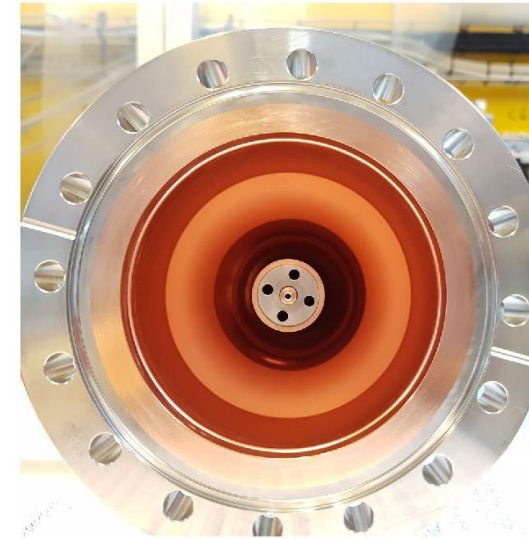
Visual surface irregularities on warm part after first dismounting of the warm part

- Heating spots on the outer and inner conductor as expected after dismounting the warm part

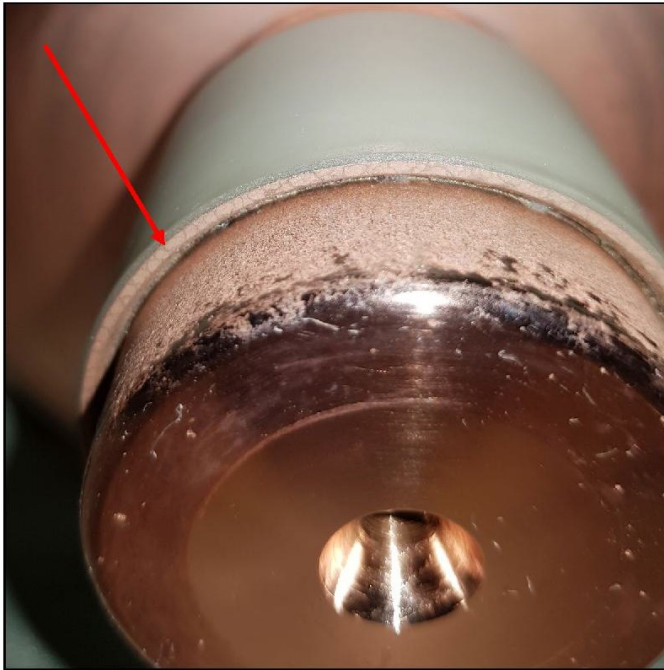
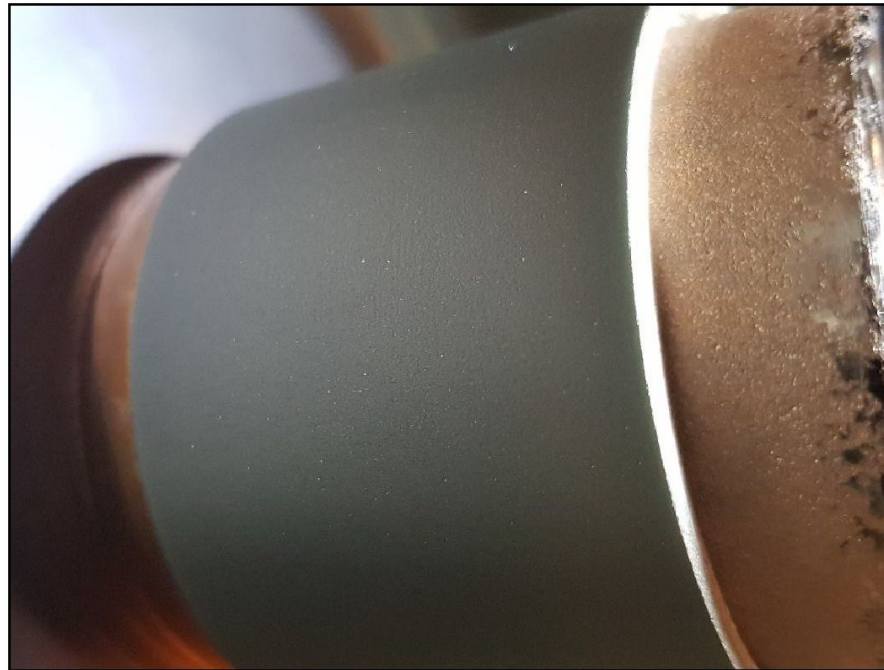
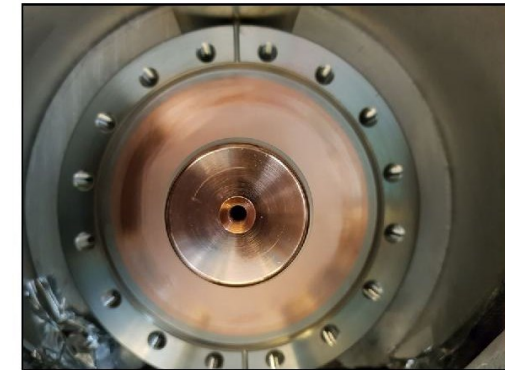
Visual surface irregularities on cold part

- Metalized copper layer detected on the frontal area (nearby the brazed seam)
- The copper surface and the superficial surface of the ceramic is heavily discolored and tarnished

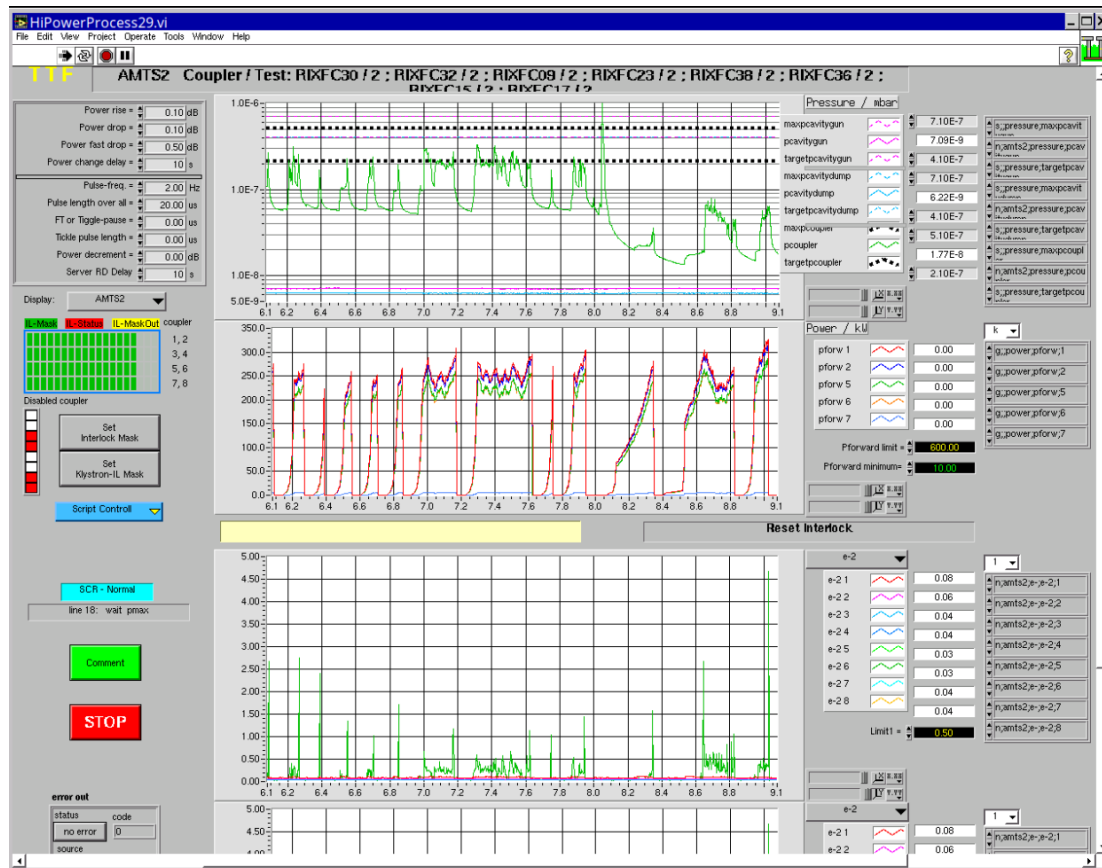
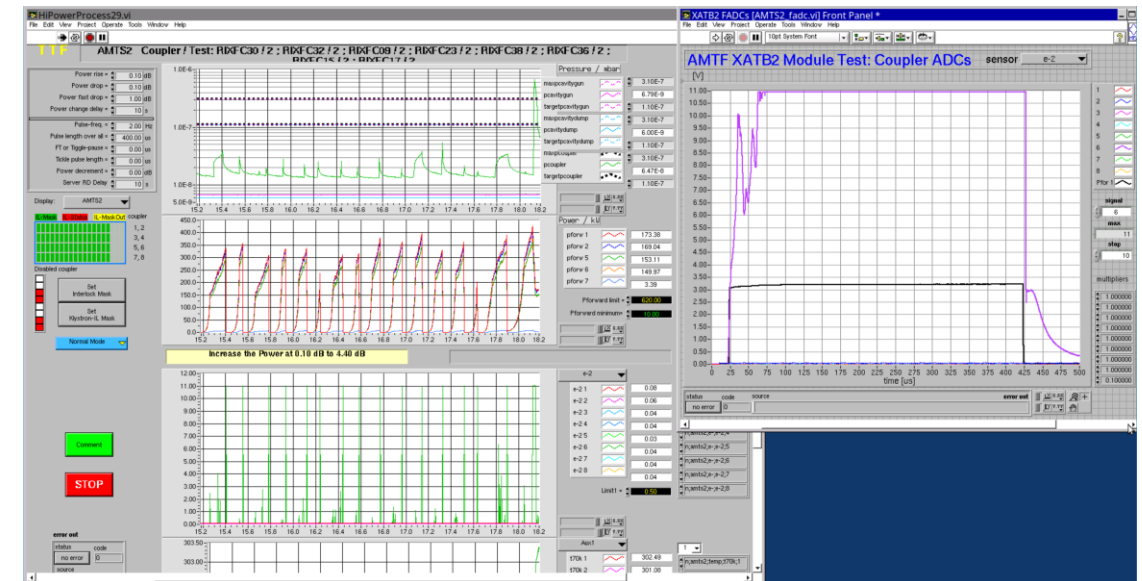
Second conditioning of coupler 6

- Second electron sensor (e-2) disabled and then masked in the technical interlock
- It just influenced increasing the coupler vacuum pressure and temperature at T70K shield
- Spontaneous discharge observed
- Coupler not conditionable

Decision : Exchange of cold and warm part of coupler 6 while coupler and beam vacuum is vented and then repeat the module test

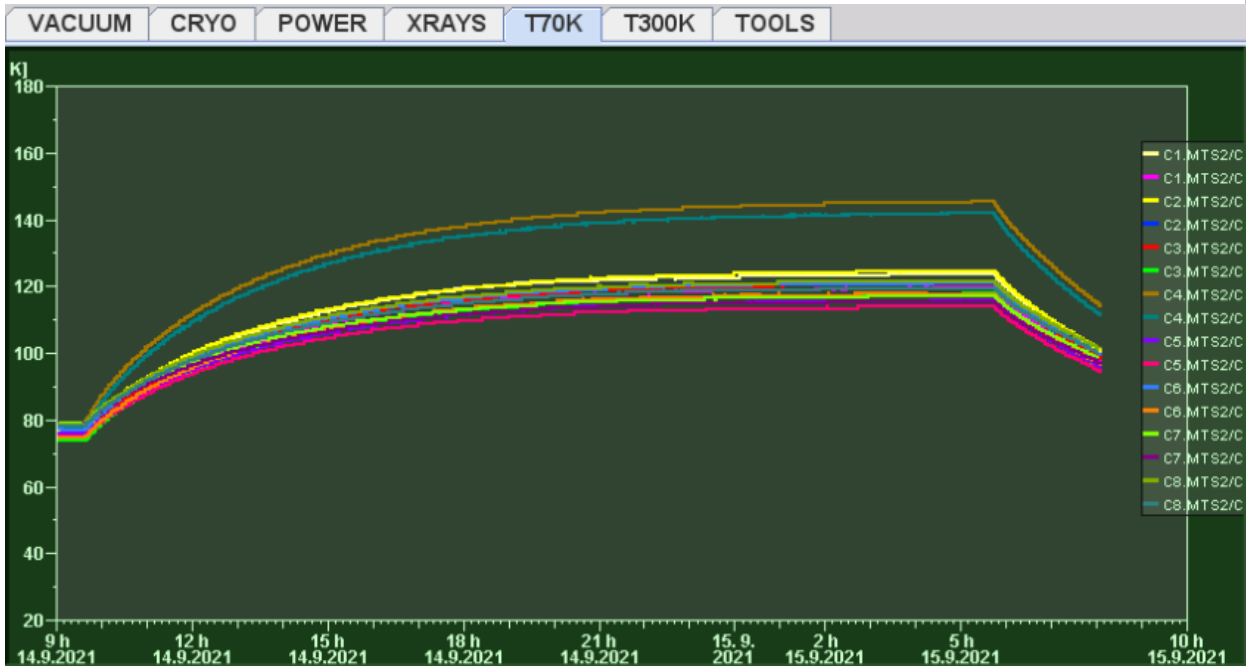
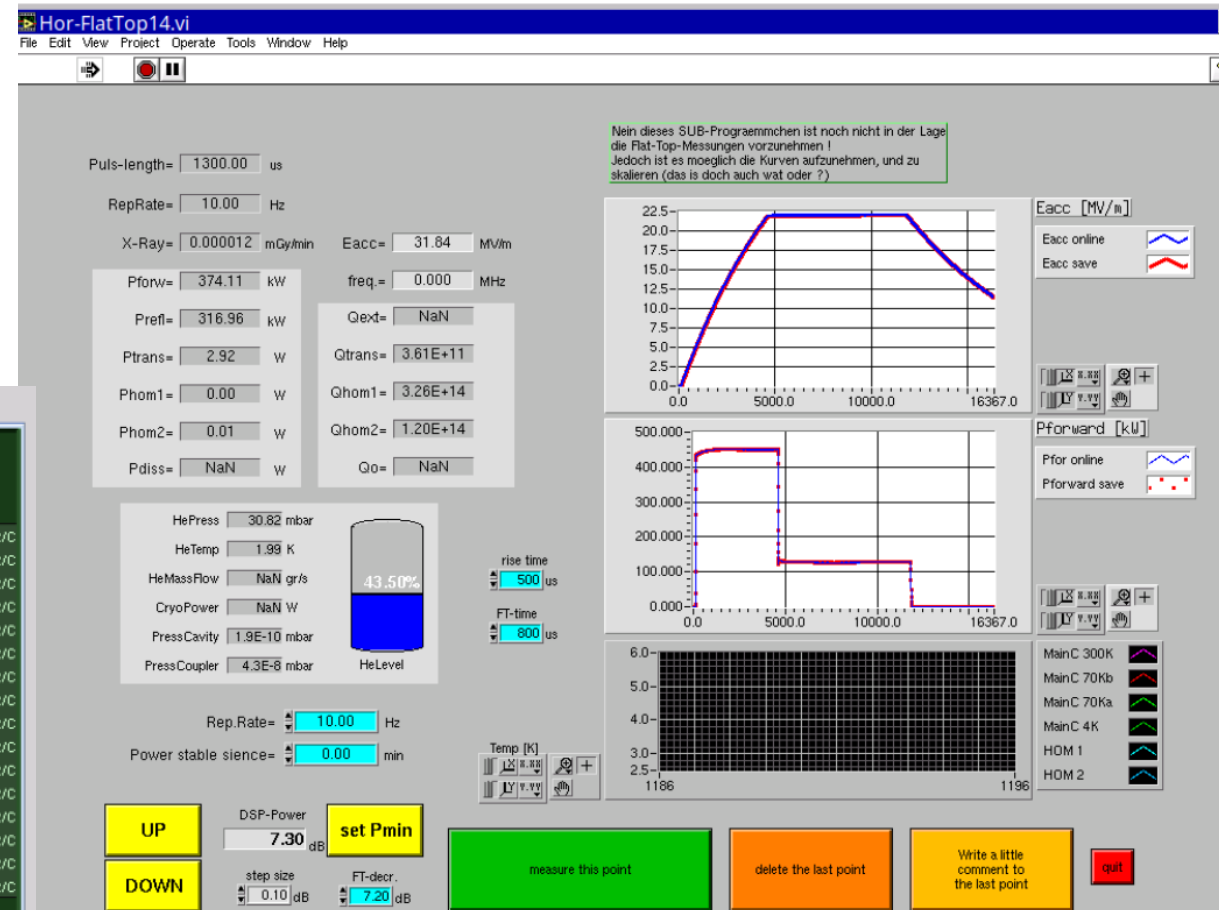
Power rise and off resonance temperature check

Max acc. gradient 32.3 MV/m (before 33.2 MV/m)

No radiation after the cavity processing!

- Thermal equilibrium at all couplers during the operation off resonance. Temperature reached max. 150K at T70K.
- No overheating OFF resonance!
- No overheating during long test (24h) ON resonance.
