HL-LHC Nonconformity Report LQXFA/B01 Leak Check

Work Package	WP3	Equipment <u>HCQQXF_SC002-FL000001</u>			
Collaboration	S. Feher, R. Rabehl, T. Vouris,	Process	Leak Check		
Contract Team	J. Blowers	Inspector	J. Blowers

The combination leak check/pressure test of the CM01 after being cryostated, did not meet the leak rate specification of lower than 1E-9 Torr-liter/sec (1.32E-9 atm-cc/sec). This is requirement #9 in "Requirements Specification for the Assembly of LQXFA/B/E/F", EDMS <u>1828585</u>.

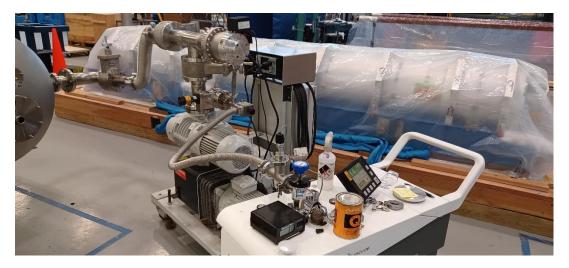
- At 15:41, 16 minutes after the CM reached full pressure (10 minutes after the HX reached full pressure), the MSLD backing the turbo started to show a slow rise in signal. This signal increase is attributed to Helium permeating through the O-rings used internally to the cryoassembly A flexible hose assembly is used to complete the pressurization circuit between the cold mass and the non-IP end can. A metal seal was used at the connection between this flexible hose assembly and the Cold Mass. However, an elastomer seal was used at the connection between the flexible hose assembly and the end can.

Figure 1 – Pumping cart being backed by Adixen MSLD

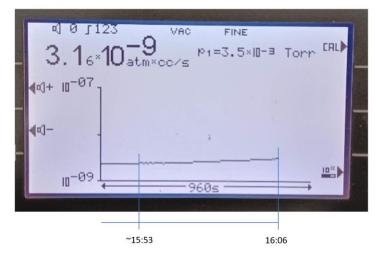
- At ~15:53, 28 minutes after the CM reached full pressure (22 minutes after the HX reached full pressure), the MSLD in the middle of the CA started to show a slow rise in signal.

Figures 3 – signal taken at 16:06 from MSLD connected to middle of CA – slow rise started ~15:53
