NP04 TCO Closure Checks TPC Electronics

Roger Huang
FD1 Technical Board Meeting 11/8

NP04 TCO Closure TPC Electronics Checklist

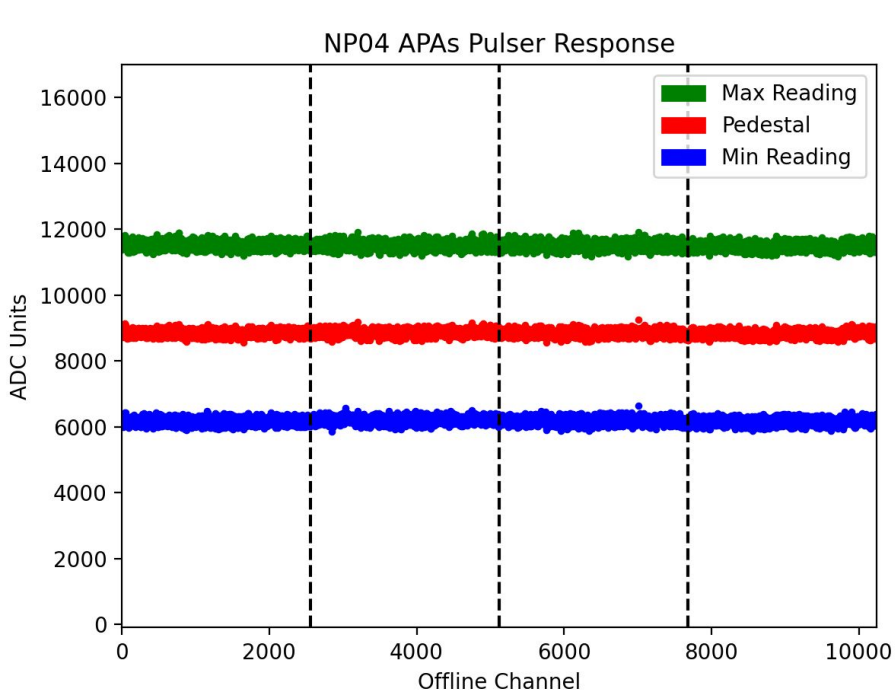
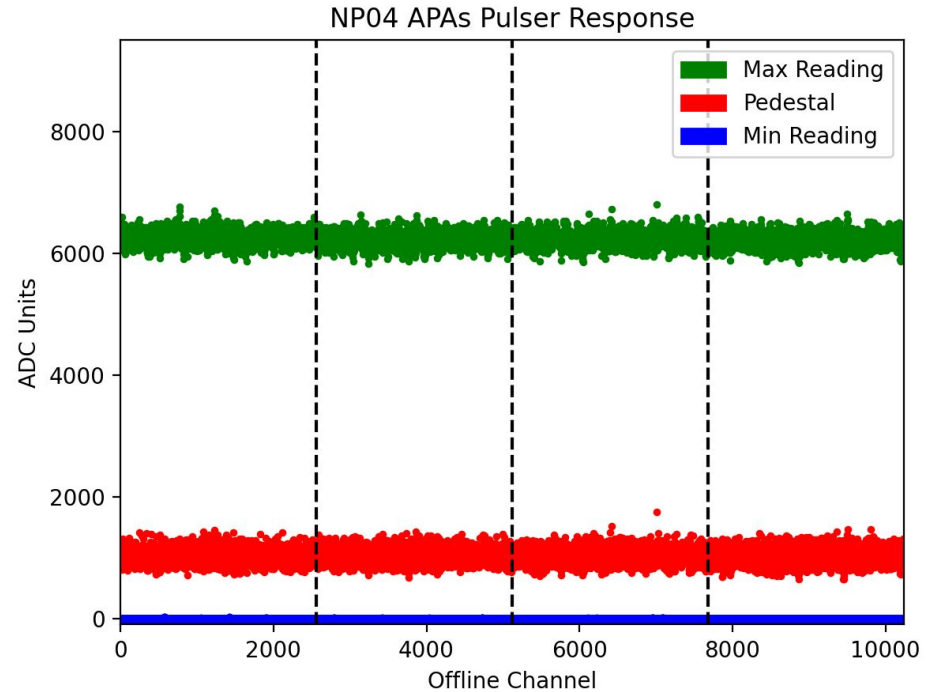
Pulser Checks

- Pulser data at high and low baselines looks as expected for all channels

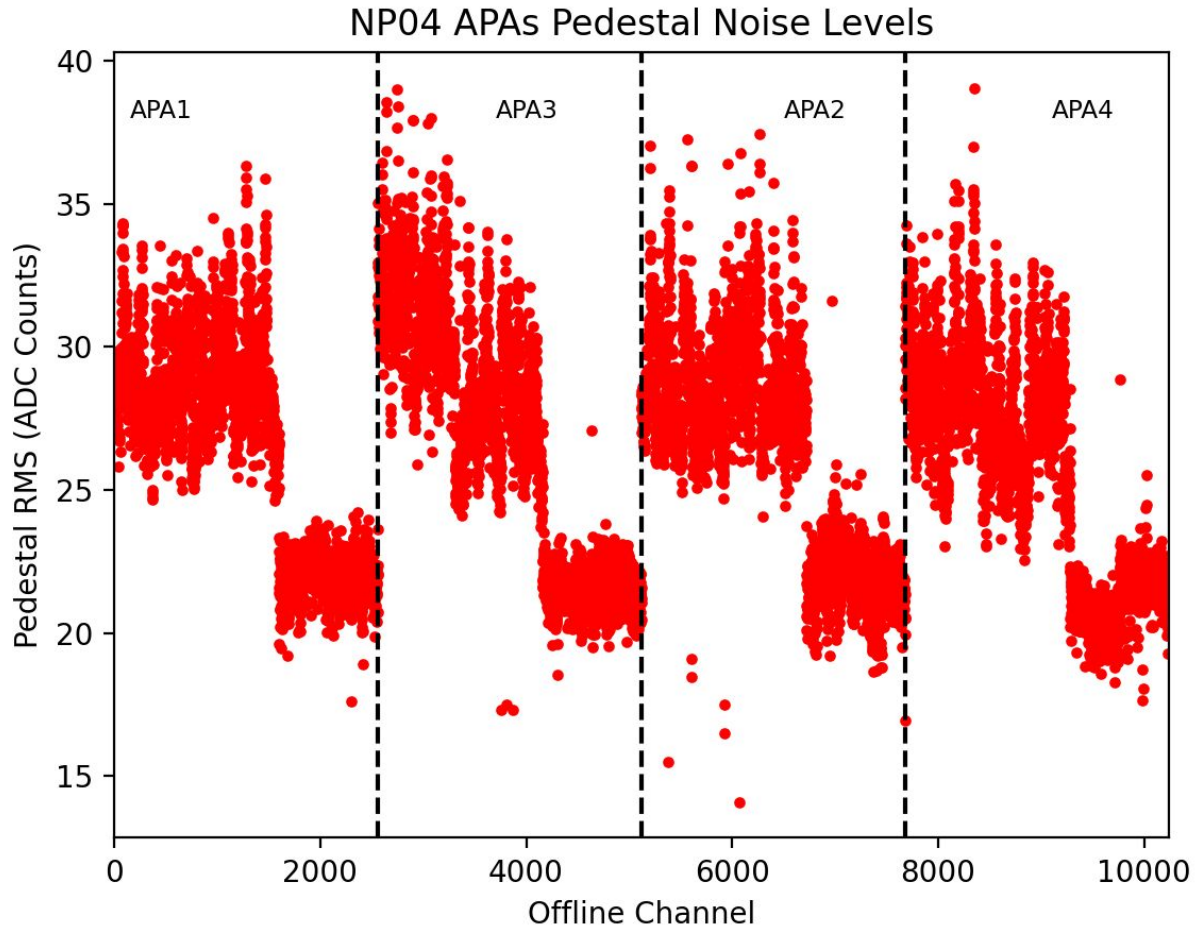
Noise Checks

- Pedestal noise levels are all about as expected for warm conditions
- Low-noise channels match the missing wires seen from the coldbox tests
- Note: APA3 is closest to TCO

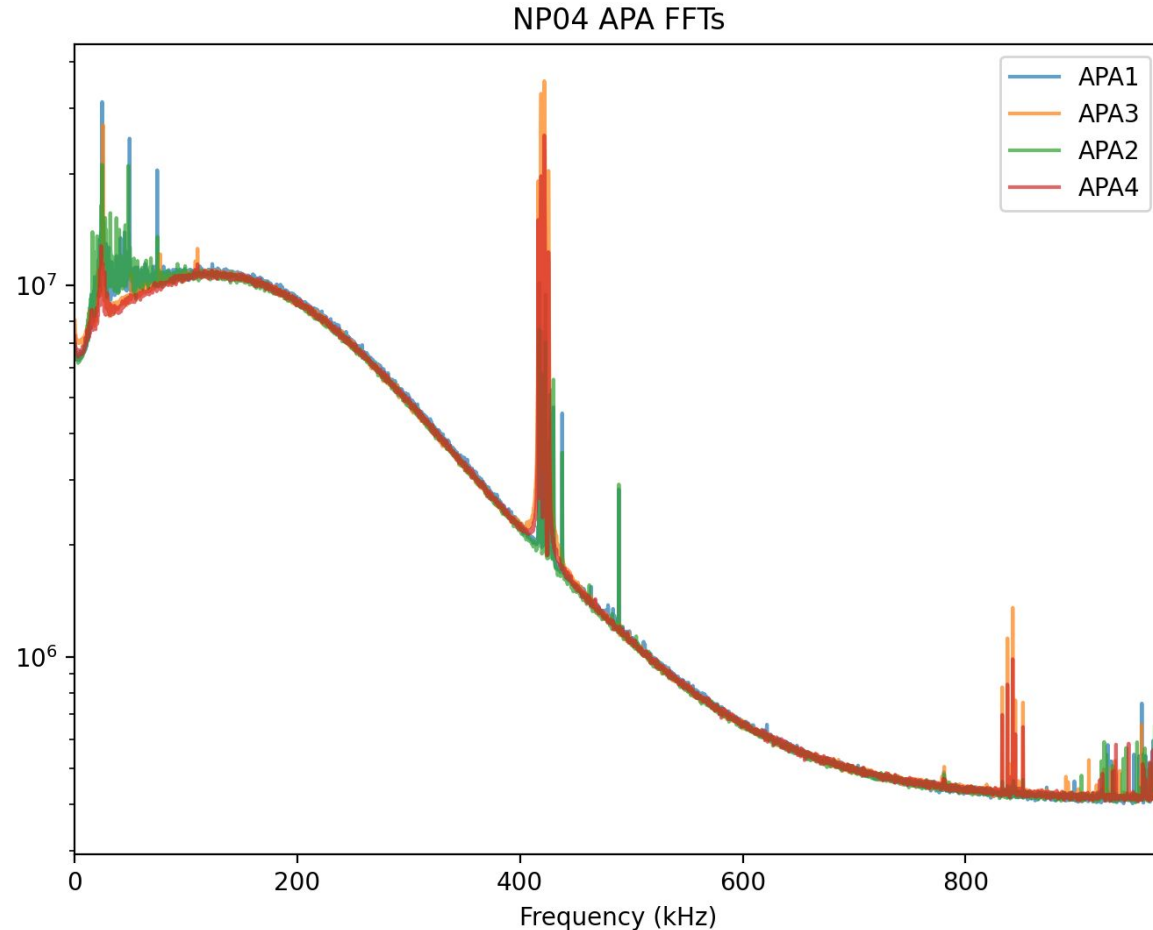
Noise Checks

- Typical coherent pickup around 25 kHz still seen in all APAs
- Large peak around 400 kHz is believed to be environmental pickup, and has been generally present in NP04

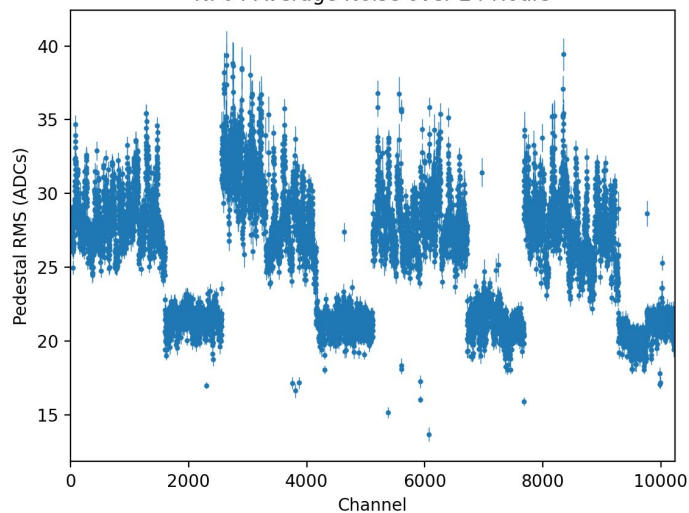
NP04 Average Noise over 24 Hours

- 24-hour run showed stable response
- Rare instances of dropped frames were seen, but believed to be DAQ-side issue

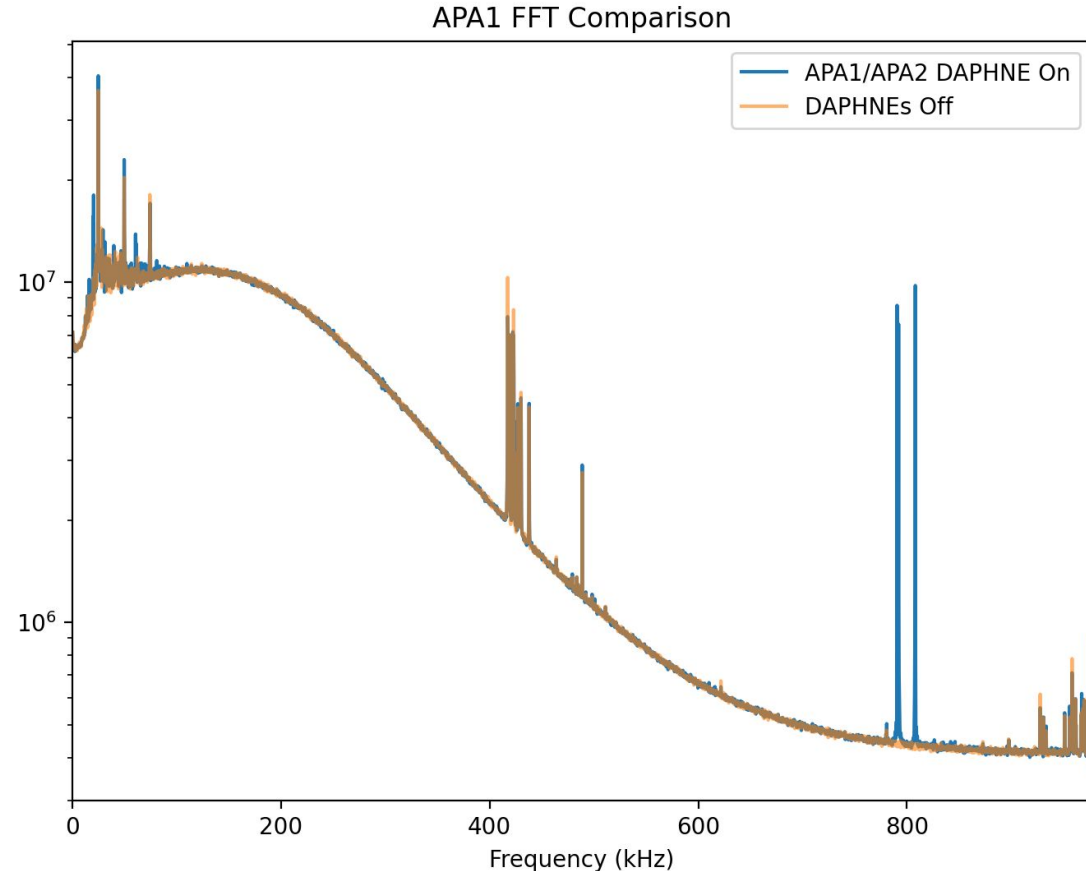
Noise Checks with PDS

- Powering on PDS DAPHNEs induces noise peaks around 800 kHz in the APAs sharing the same penetration
- Powering on only APA1 DAPHNEs will still cause noise in both APA1 and APA2 TPC electronics
 - Suggests noise is coming in at the warm/WIB level
- PD group has an understanding of how this comes from their DC/DC switching and grounding scheme and is investigating

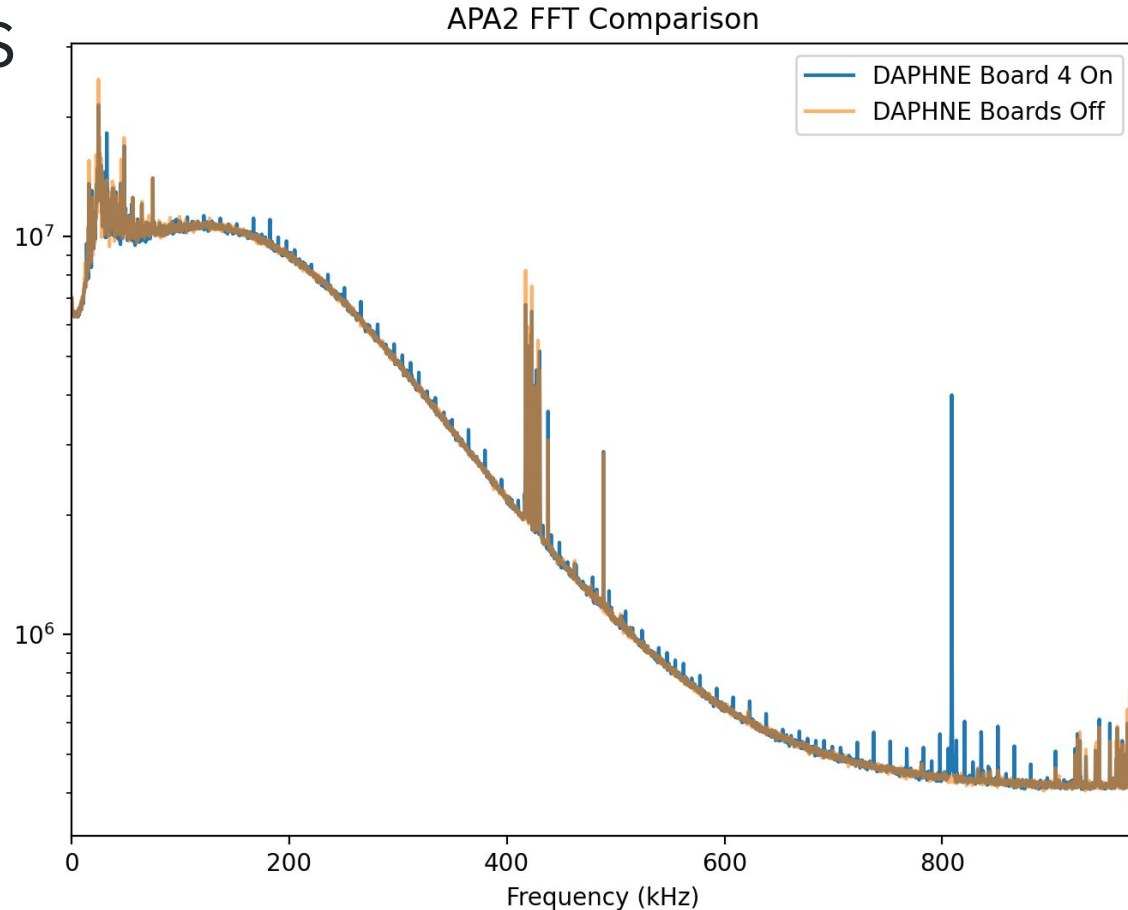
Noise Checks with PDS

- PD group has also identified a bad cable on APA2
- When that cable is plugged in and the corresponding DAPHNE powered on, APA2 sees a bunch of extra noise peaks

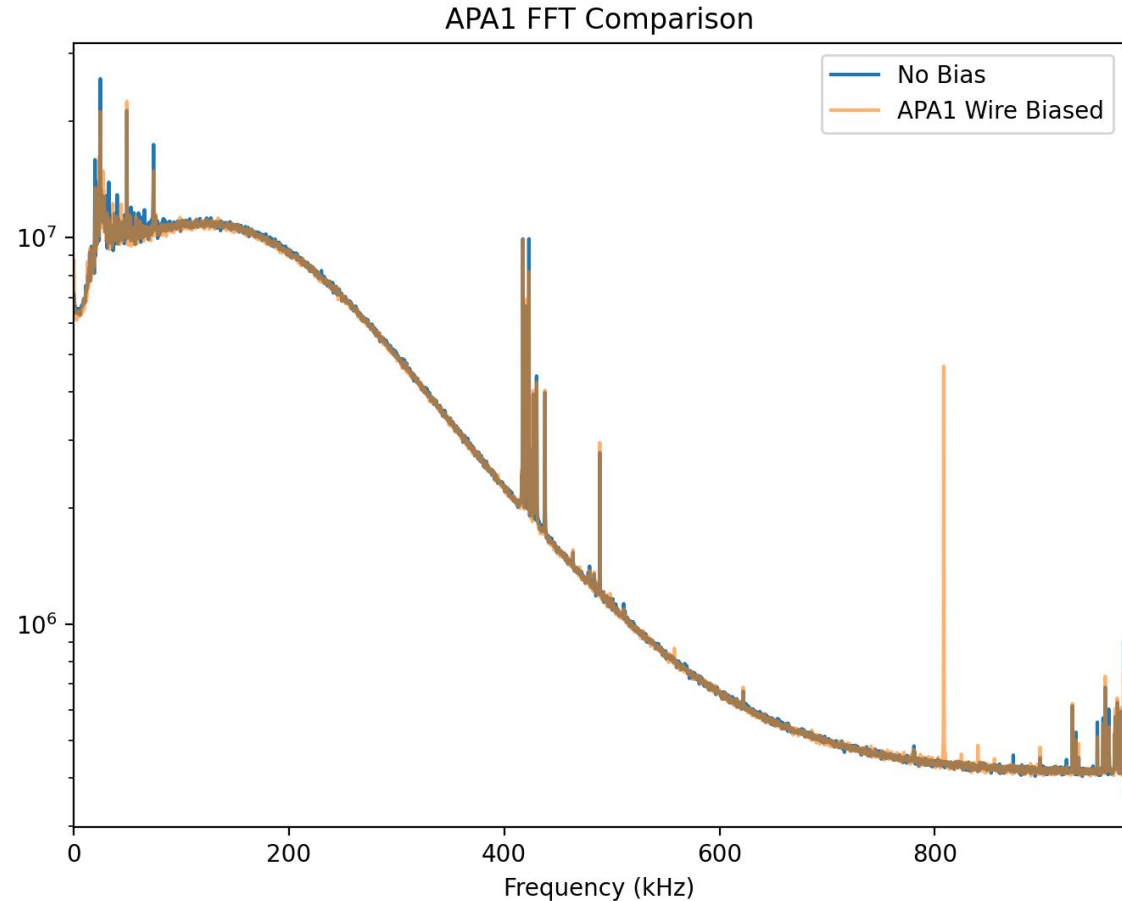
Wire Bias Tests

- Leakage currents remained low throughout the bias tests
 - ~ 1 μA during ramp-up
 - < 10 - 100 nA at 100 V
- No notable effects on TPC electronics response
 - Wire bias levels were too low to attempt to replicate the effects seen during coldbox tests though

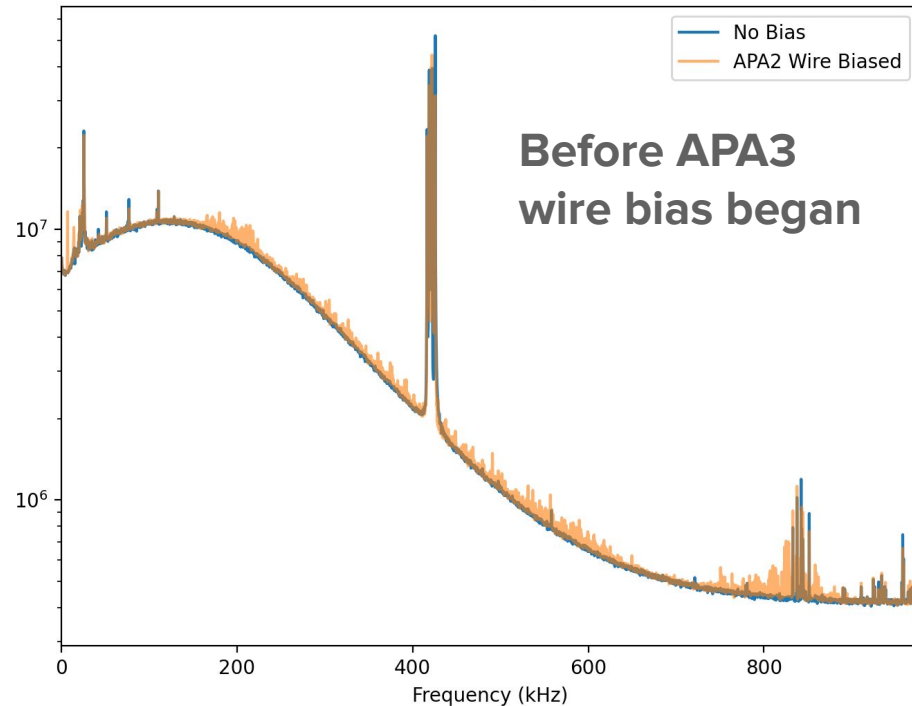
APA3 FFT Comparison

- APA3 saw some unusual noise during its wire bias tests, but it's possible this was an unrelated environmental factor
 - Begun even before APA3 wire bias was applied
