3 November 2023

## Technical Support Finding: Crosstalk Issue Due to Shorted PD Cables in NP04

### Summary

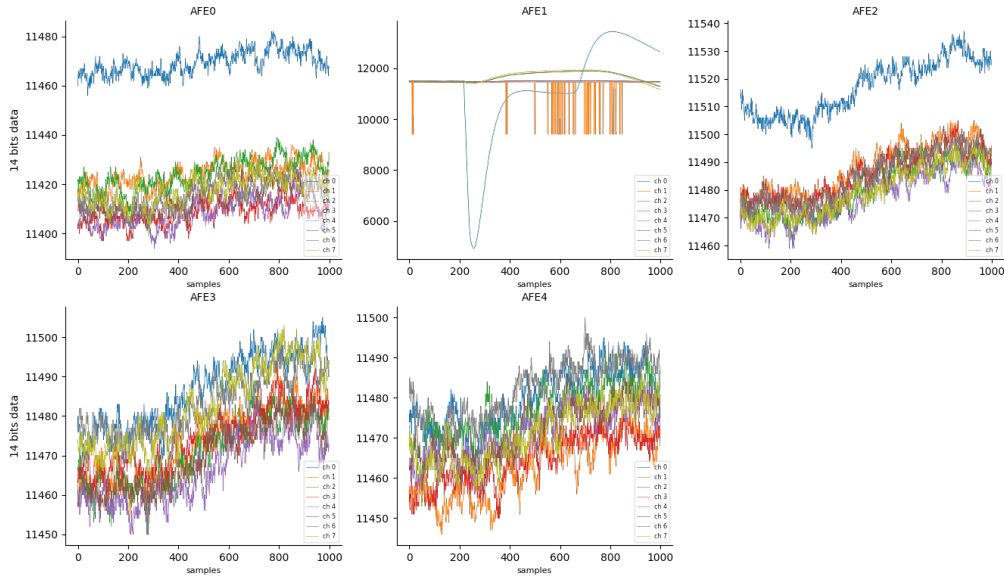
Figure 1: One waveform from each channel of APA 2. PD modules M7 and M8 are connected to AFE 1. Noticeable crosstalk in all channels of the APA 2

Detailed data acquisition was done with DAPHNE V2 in coordination with the DAQ. By the second week of October 2023, PD modules had been seamlessly integrated. Yet, during the early stages of data collection, irregularities were observed in modules 7 and 8. Importantly, these discrepancies were only apparent when analyzing the data and couldn't be identified using standard multimeter measurements. The problem is apparent when taking data in all 40 modules from APA2, Figure 1.

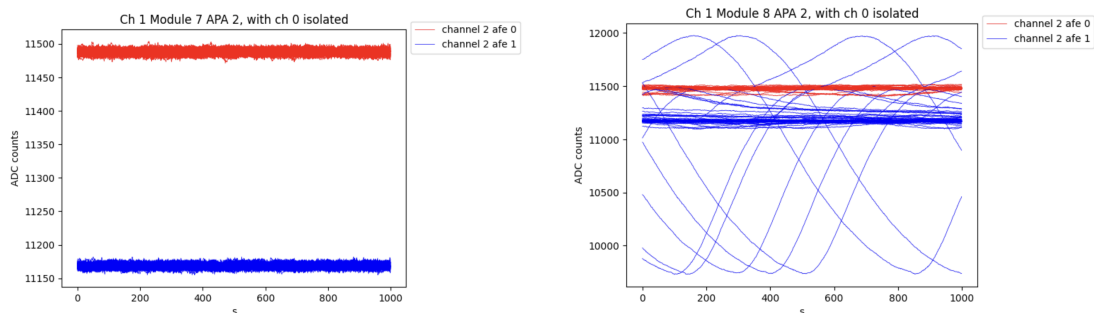
Figure 2: Comparison between M7 and M8 when isolating problematic channels

- When focusing on the most concerning channels, we discovered that quality data from three channels of M7 was achievable upon disconnecting the differential pairs related to the first channel of this module, specifically the orange wires. Under such conditions, no evident cross-talk was observed in other AFEs, and the RMS values remained consistent with PD modules found in other APAs. See figures 2a, 4a, and 3a

- Challenges with M8 persisted even after isolating the more problematic channels.
- Alarmingly, with only a single differential pair linked to the FEB, the RMS of the other 32 channels in APA2 saw a substantial rise. See figures 2b, 4b, and 3b

(a) 100 waveforms from a functioning channel (red) and 100 waveforms from Module 7's second channel (blue) after disconnecting the orange differential pairs on the DB15 connector (DAPHNE side). Both channels are connected to a PD, with no bias applied.

(b) 100 waveforms from a functioning channel (red) and 100 waveforms from Module 8's second channel (blue) after disconnecting the orange differential pairs on the DB15 connector (DAPHNE side). Both channels are connected to a PD, with no bias applied.

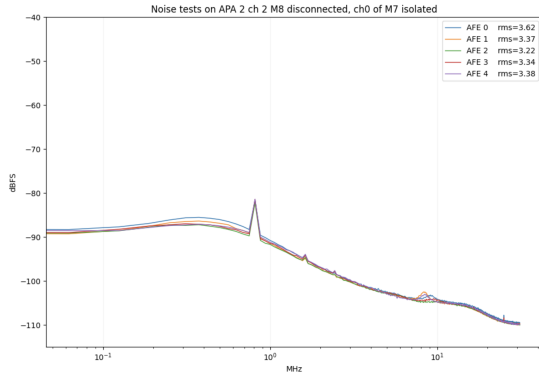
(a) FFT from one channel of each AFE in the DAPHNE FEB. M8 disconnected. The first channel of M7, orange differential pairs, was disconnected and isolated on the warm cable, DAPHNE side. Notice RMS values are similar to other PD modules installed in the system.

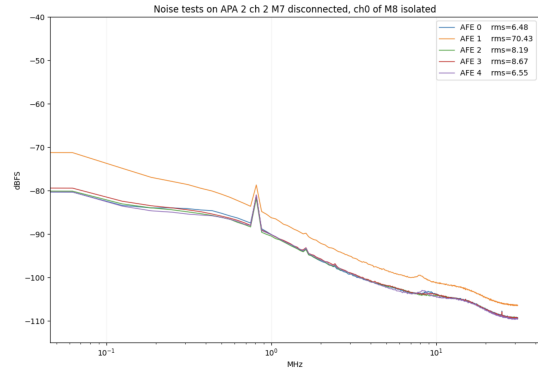
(b) FFT from one channel of each AFE in the DAPHNE FEB. M7 disconnected. The first channel of M8, orange differential pairs, was disconnected and isolated on the warm cable, DAPHNE side. Notice RMS values are similar to other PD modules installed in the system.

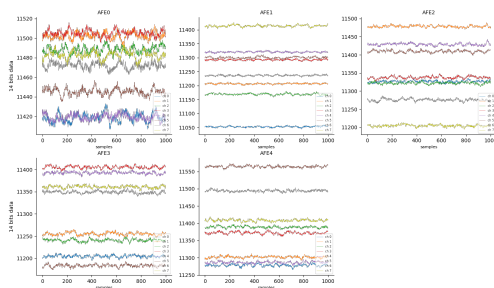
(a) One waveform from each channel of APA2. M8 disconnected. The first channel of M7, orange differential pairs, was disconnected and isolated on the warm cable, DAPHNE side.

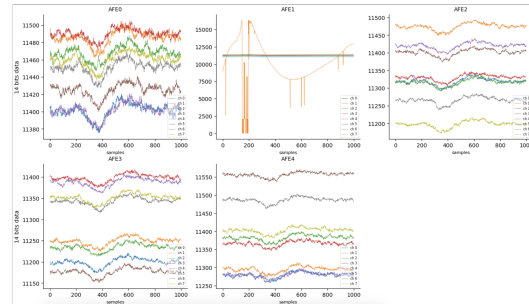
(b) One waveform from each channel of APA2. M7 disconnected. The first channel of M8, orange differential pairs, was disconnected and isolated on the warm cable, DAPHNE side.

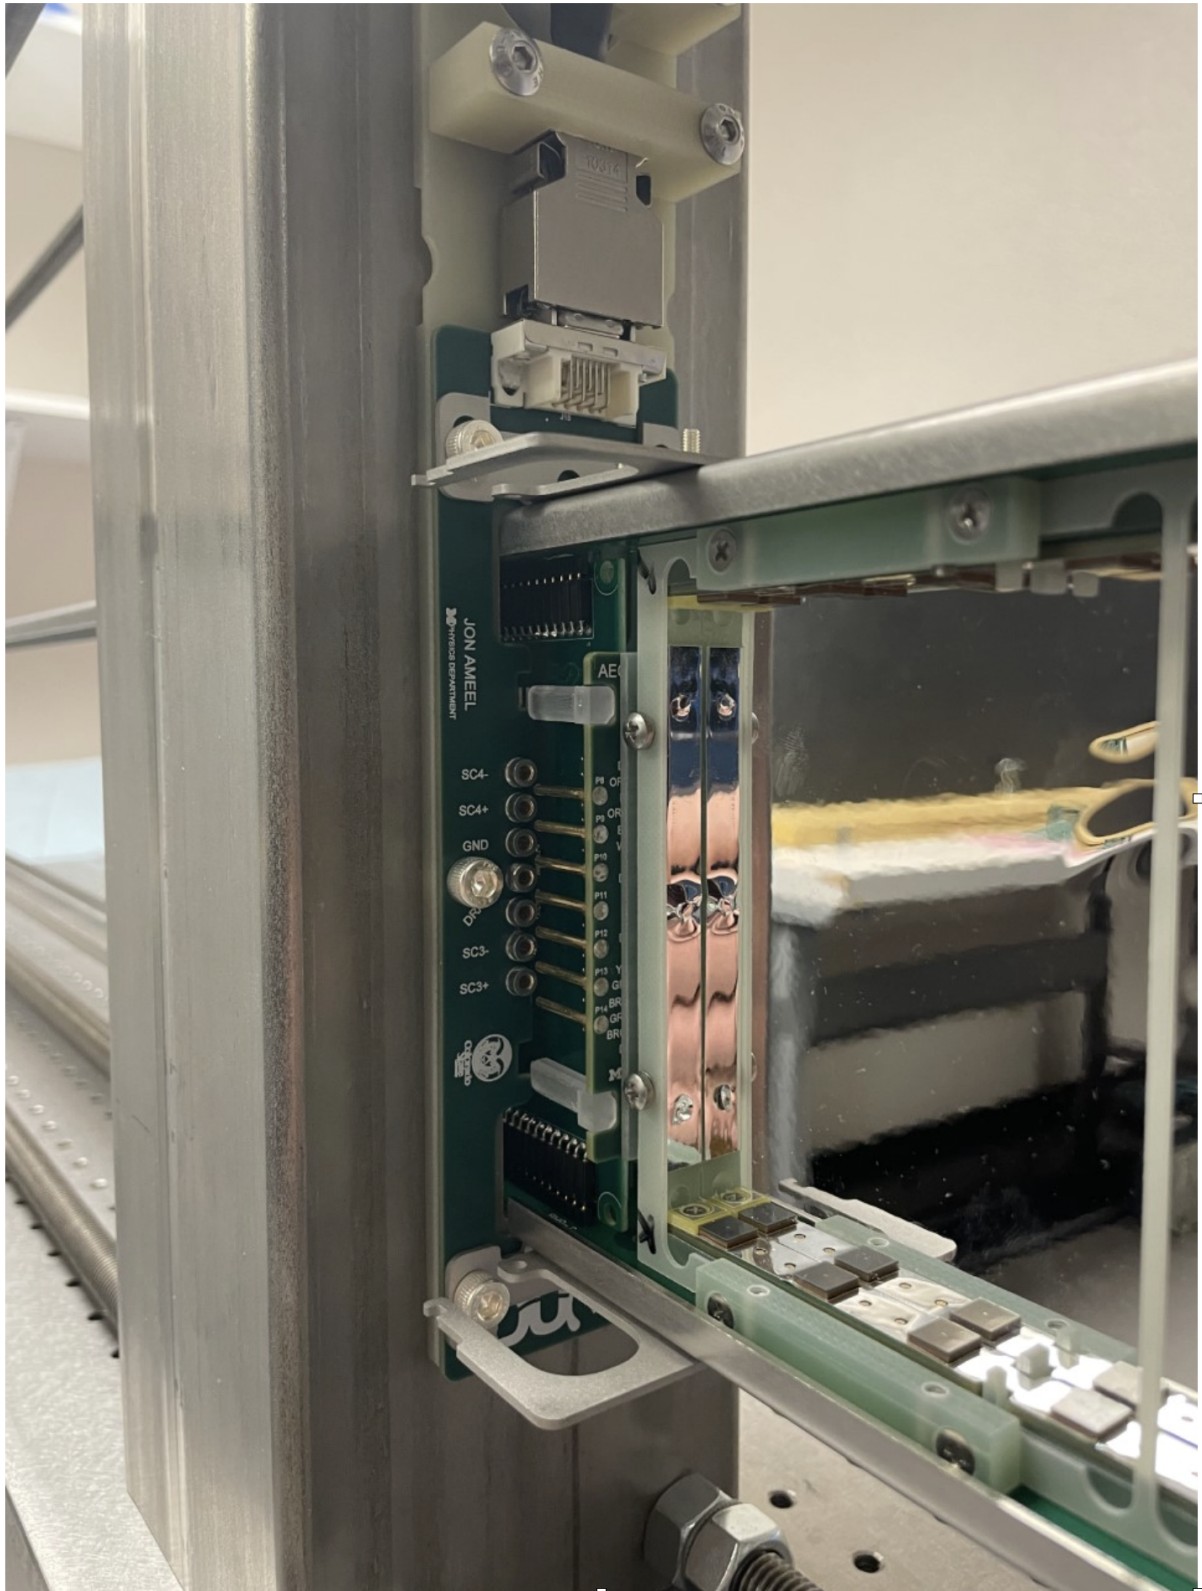
Figure 6: Sasebo connection

A mockup module was designed to test the connection. After removing and installing the modules again, a voltage different from zero was measured between the differential pairs of all the channels of M7. On the other hand, one channel from M8 was missing (orange cables). **The lost connections were reported between the Sasebo board and the APA frame.** The Sasebo connection can be found in figure 6

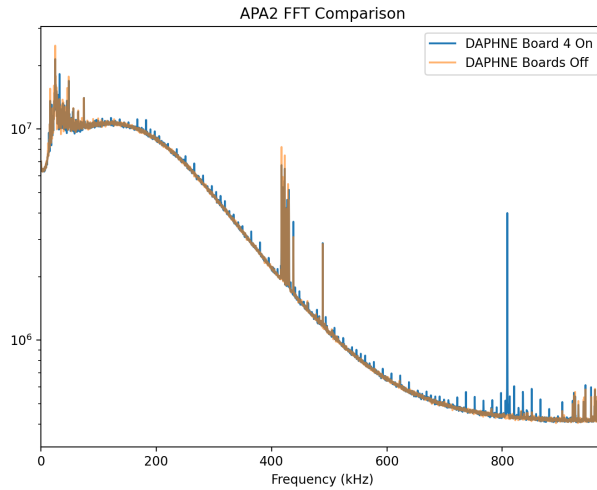
The impact on the charge readout was studied using data before and after connecting module 8 to DAPHNE. Unplugging the module from the end board solves the noise induction in the charge readout system. The FFTs are in figure 7a and 7b

(a) nominal FFT from the charge readout with M7 and M8 connected.

- Module 8 from APA2 cannot be connected to the FEB to prevent any noise in the PDS or the charge readout.
- Channel 0 from module 7 has to be disconnected from the warm cable on the DAPHNE side.

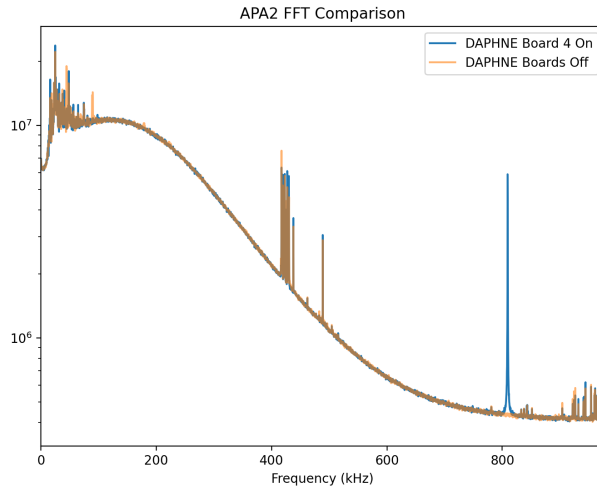
(b) nominal FFT from the charge readout with M7 connected, problematic channel disconnected from the warm cable, and M8 NOT connected to the DAPHNE FEB.

Figure 7: The forest of peaks disappears when removing the M8 connection from the FEB (DAPHNE) side.
