ProtoDUNE 2 PDS Connector Issues

Manuel Arroyave, [David Warner](#), Francesco Terranova
FD1 Technical Board Meeting
8 November 2023

FD1 Photon Detector (PDS) TCO Closure Status: SUMMARY

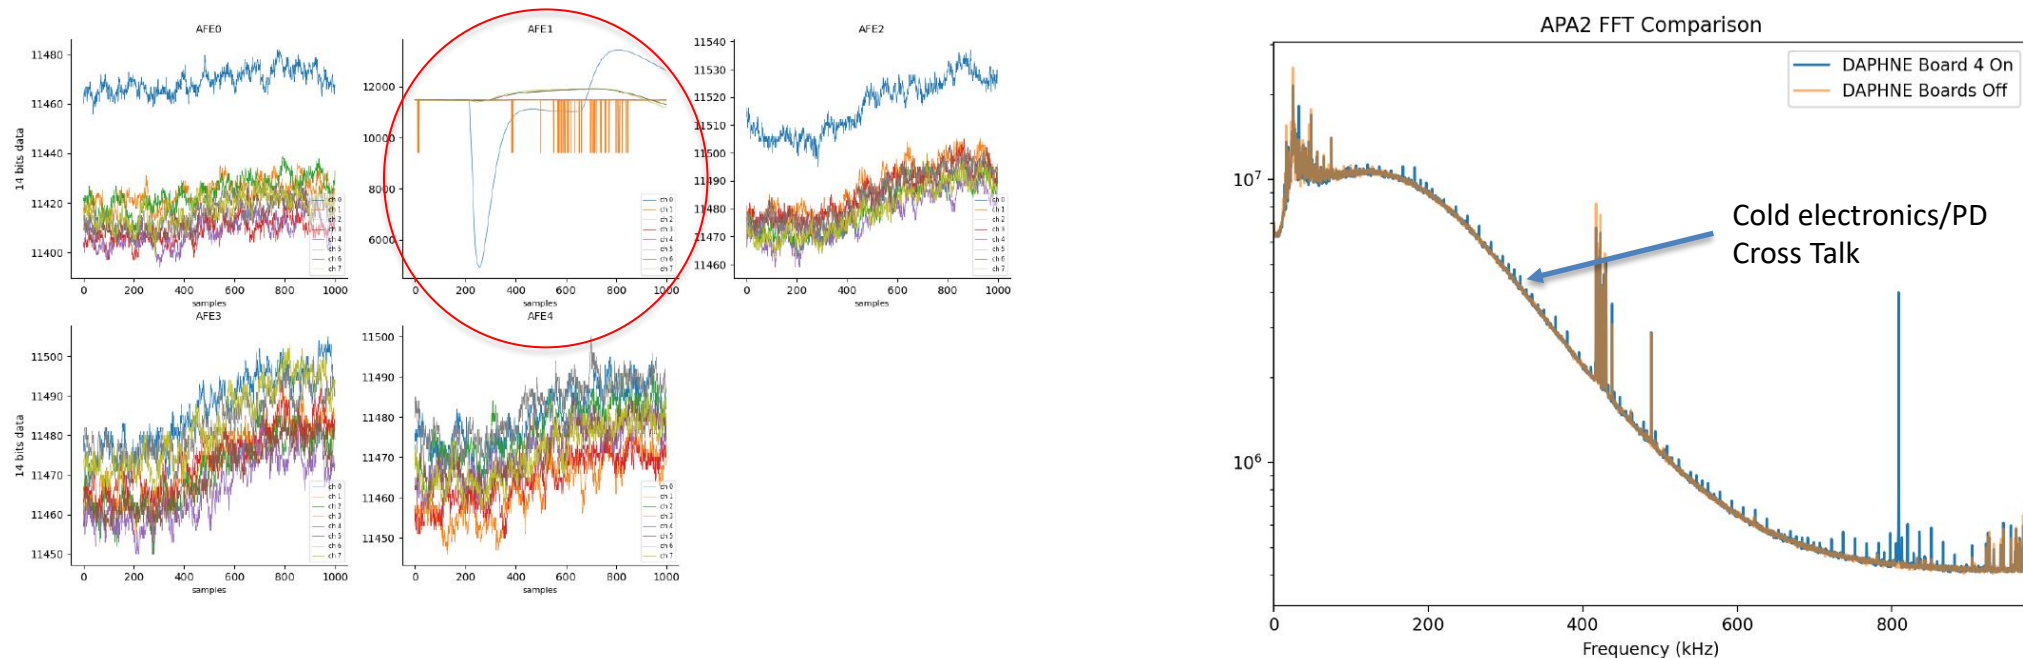
The noise issue was traced back to two channels that were **already flagged** as troublesome during the installation: One channel in Module 7 and one in Module 8. In the 2022 cold box tests, we identified these faulty channels and we traced back the origin of the problem.

Figure 1: One waveform from each channel of APA 2. PD modules M7 and M8 are connected to AFE 1. Noticeable crosstalk in all channels of the APA 2

(a) nominal FFT from the charge readout with M7 and M8 connected.

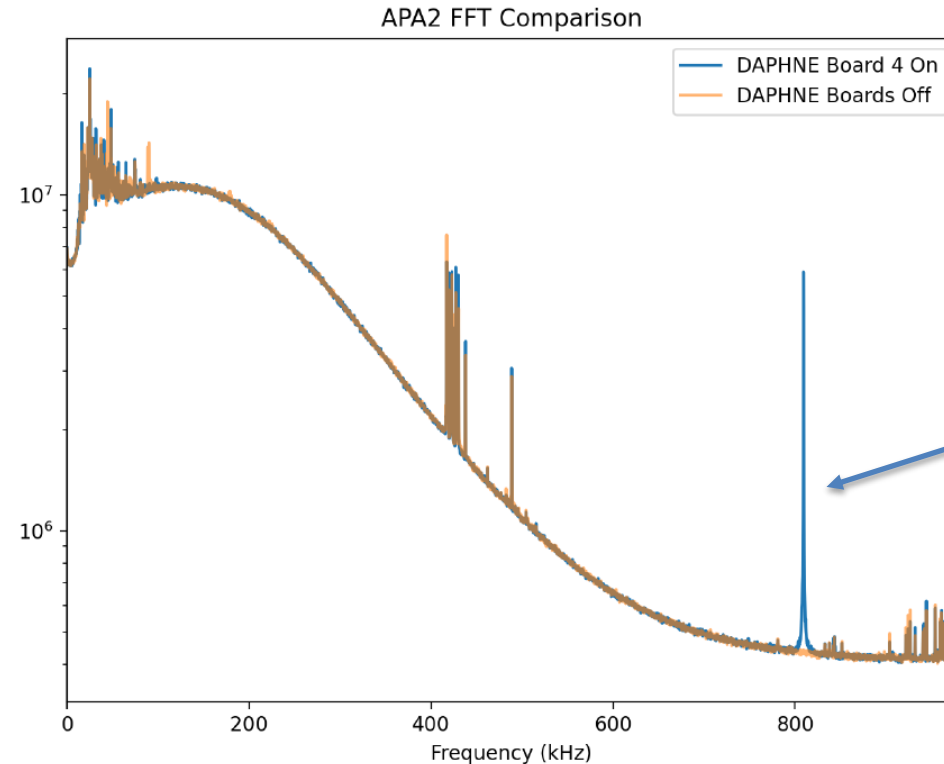
We were able to remove the cable-induced cross talk with the TPC electronics and DAPHNE readout problems by disconnecting the module 8 connector at the DAPHNE input, while keeping the Module 7 cable connected (but disconnecting the faulty channel). In APA2, we will thus run with 4+1=5 dead channels.

Remaining 800 kHz noise pickup likely due to internal DAPHNE grounding issue.
Under investigation now.

(b) nominal FFT from the charge readout with M7 connected, problematic channel disconnected from the warm cable, and M8 NOT connected to the DAPHNE FEB.

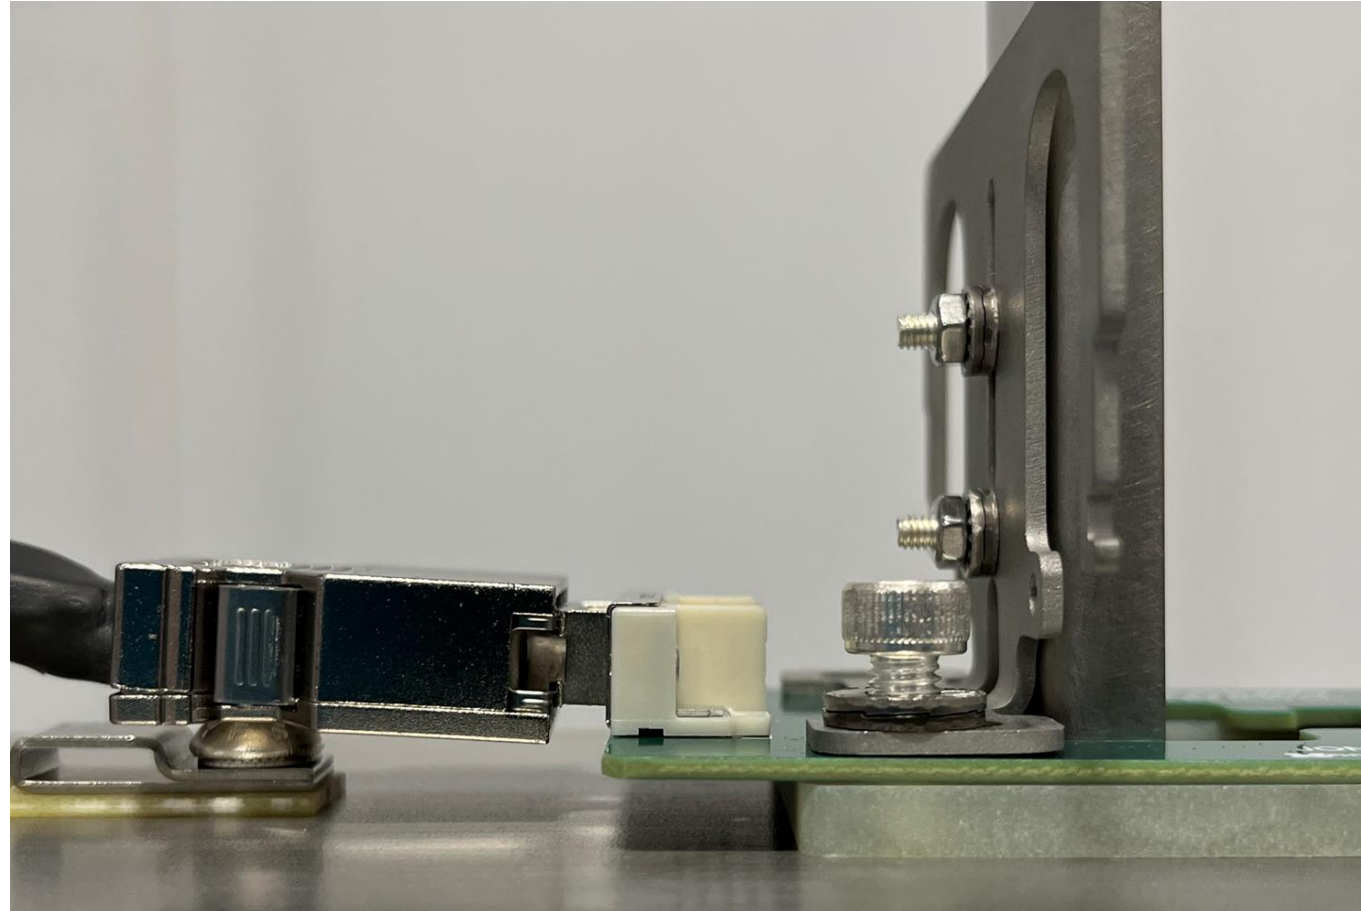
ProtoDUNE 2 Design: Significant (~2mm) PD cable interference with temperature sensor and cable tie clip (Upper APA only)
