# Temperature sensors on APAs

A. Cervera

IFIC-Valencia

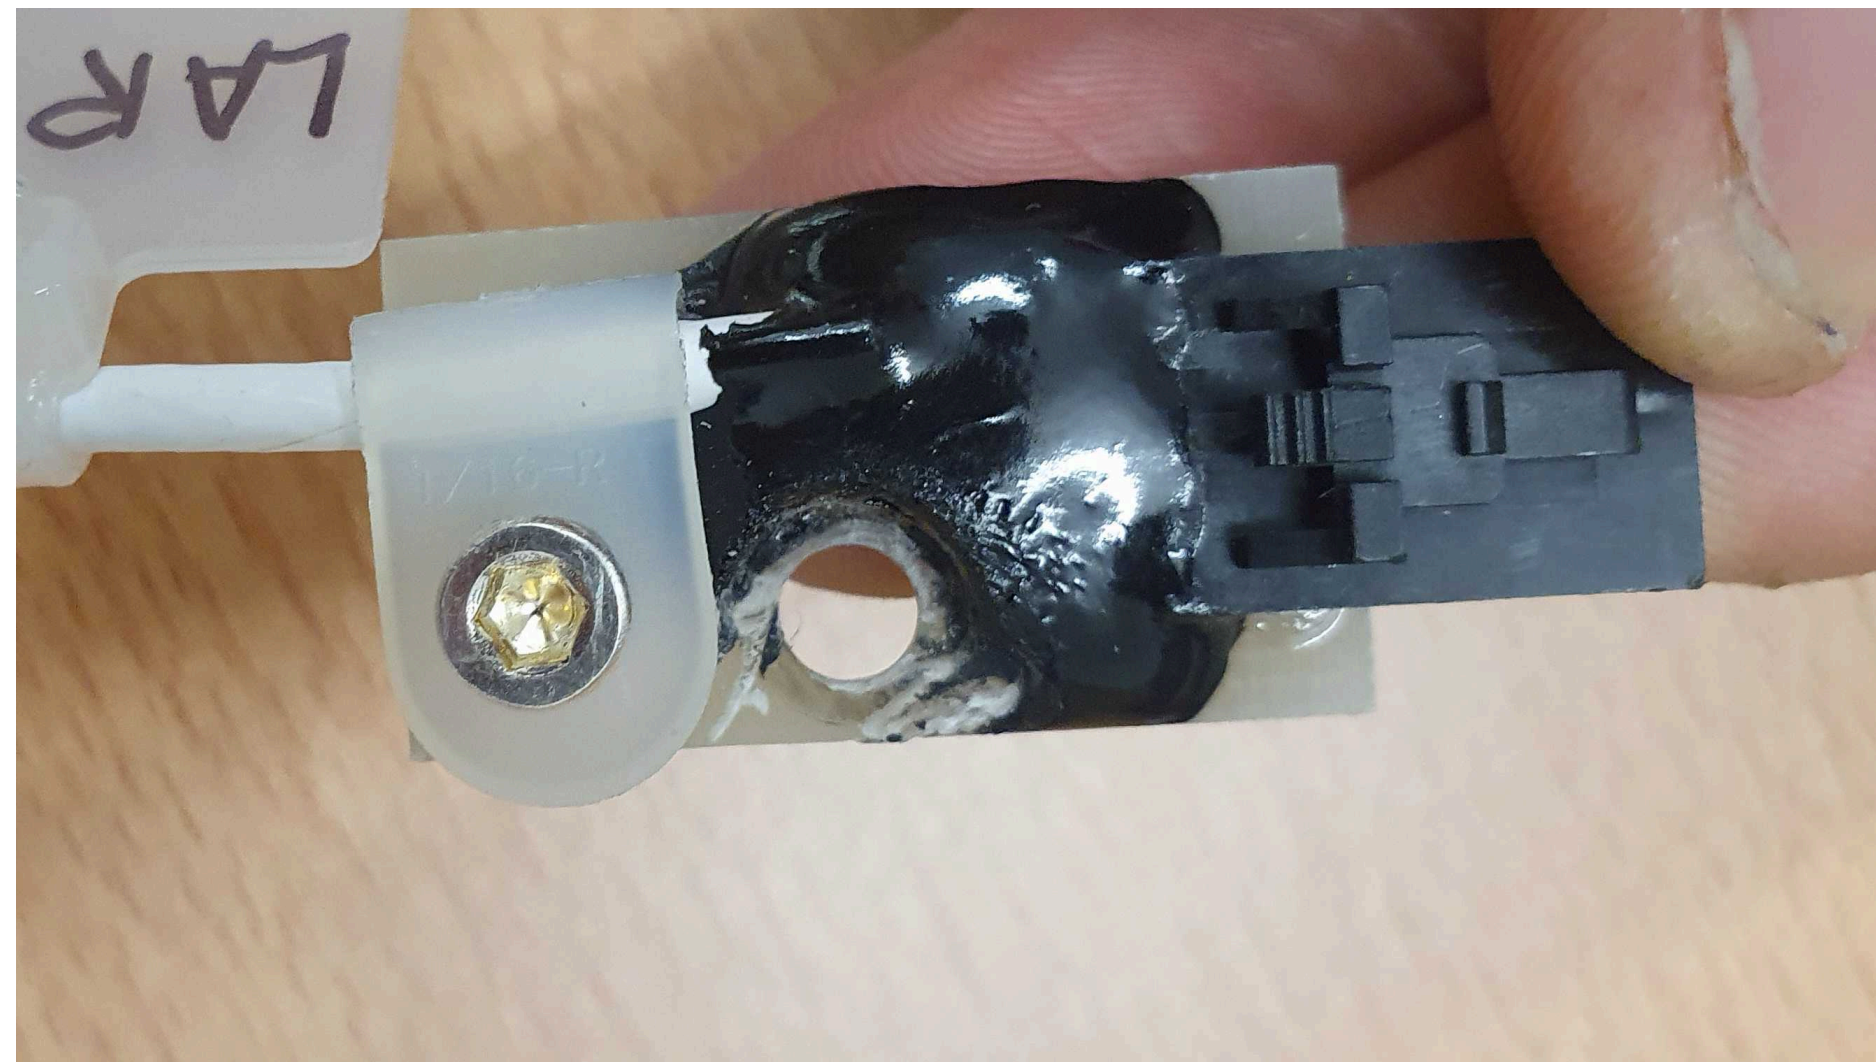
## Cable clamp for upper APAs

# Problem 2: cable tie/clamp not present

- After APA 13 we decided to remove the cable tie/clamp in order to simplify the manufacturing process
- However we have noticed that the assembly is more robust with it
- In consequence, these elements will be restored

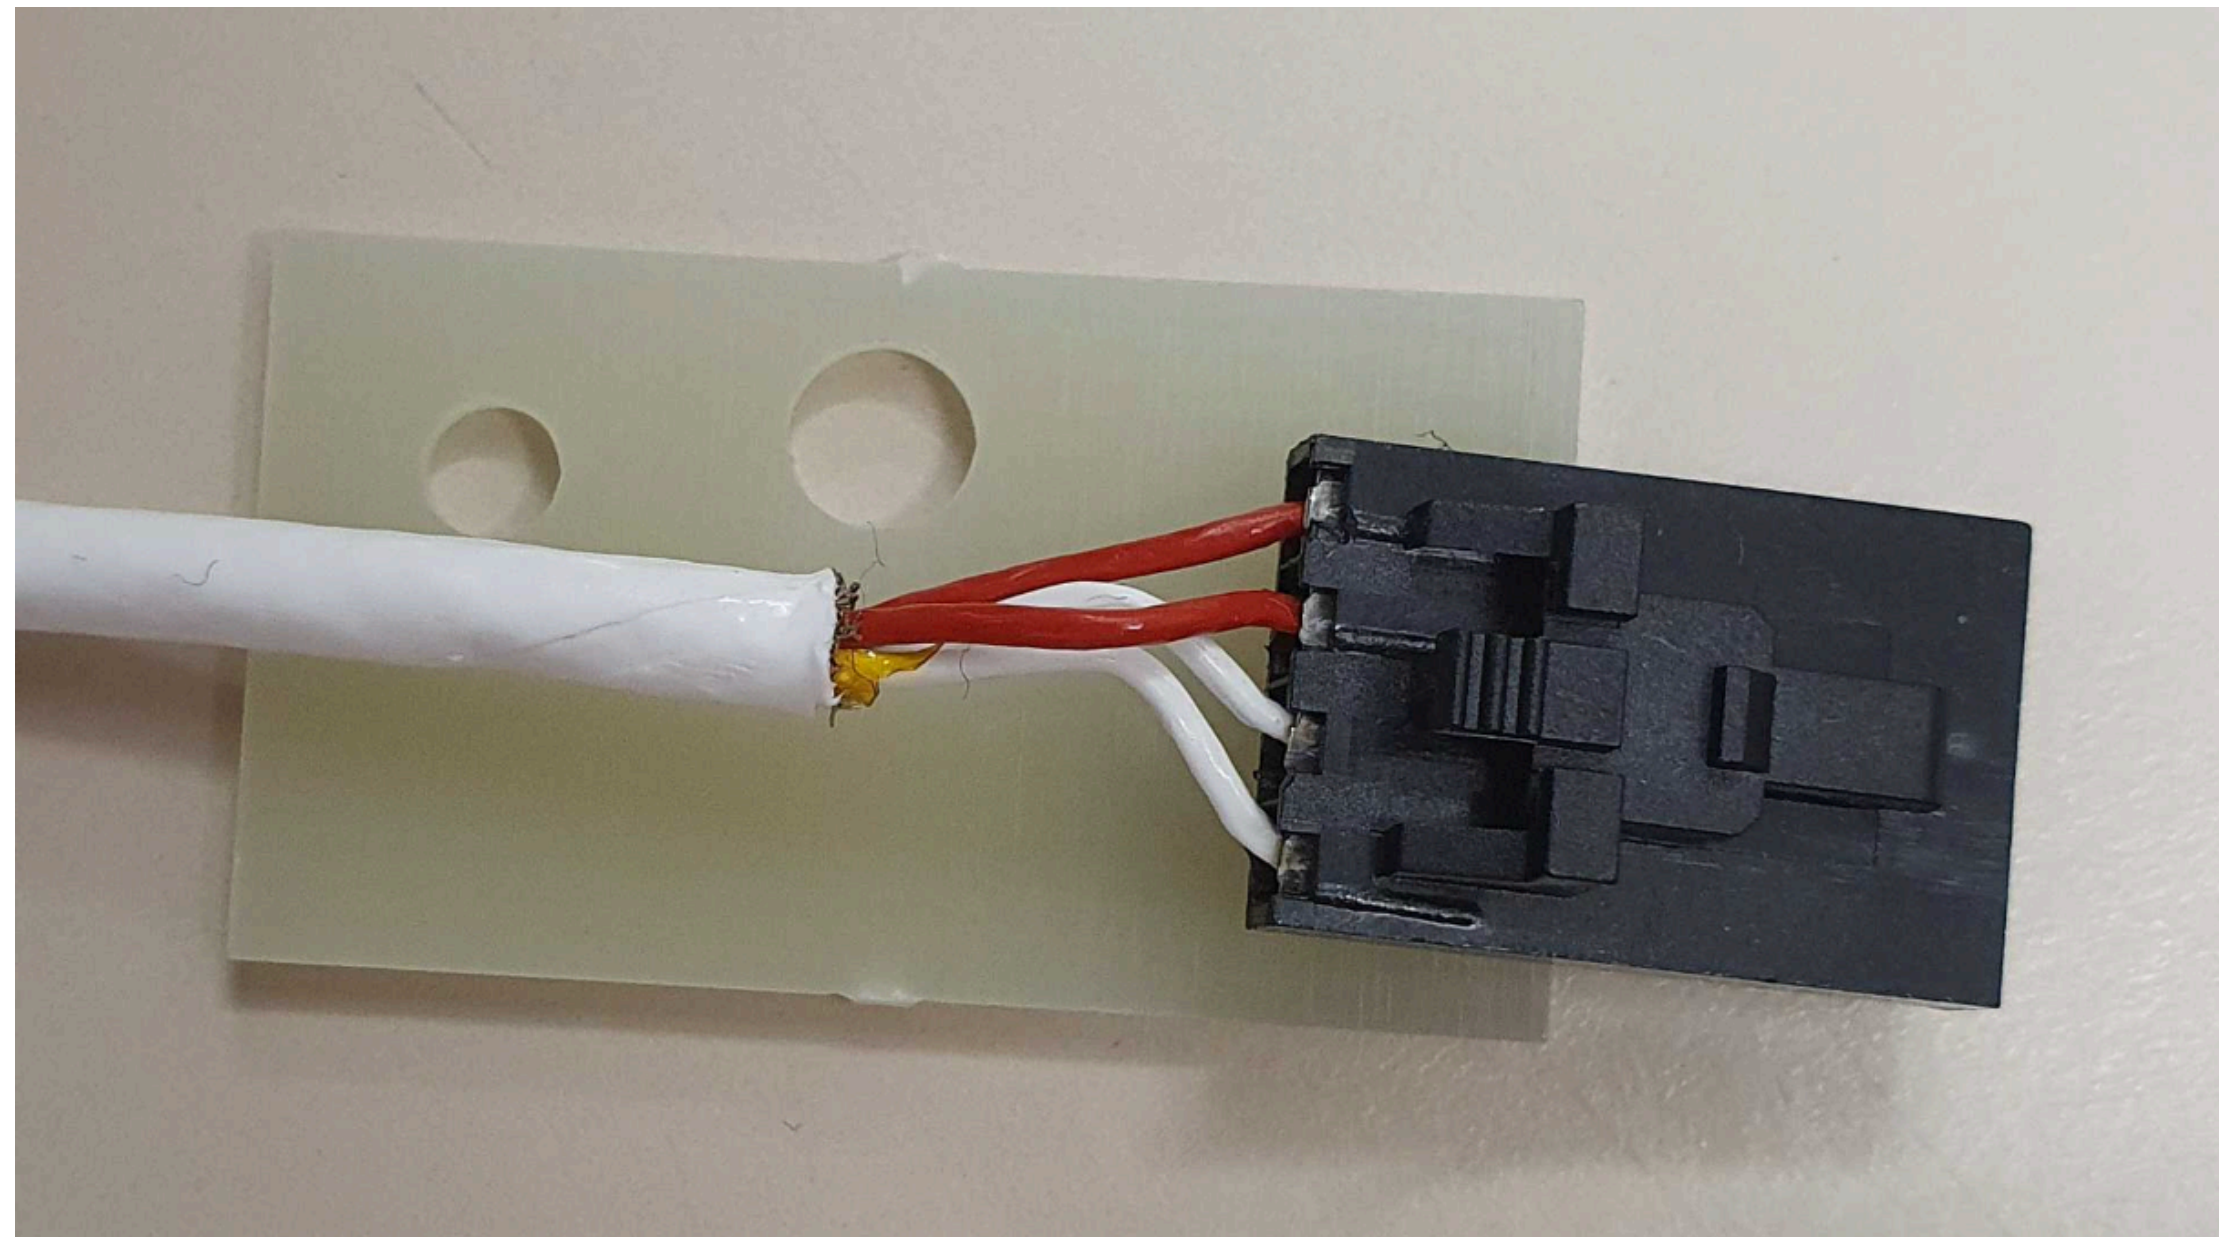
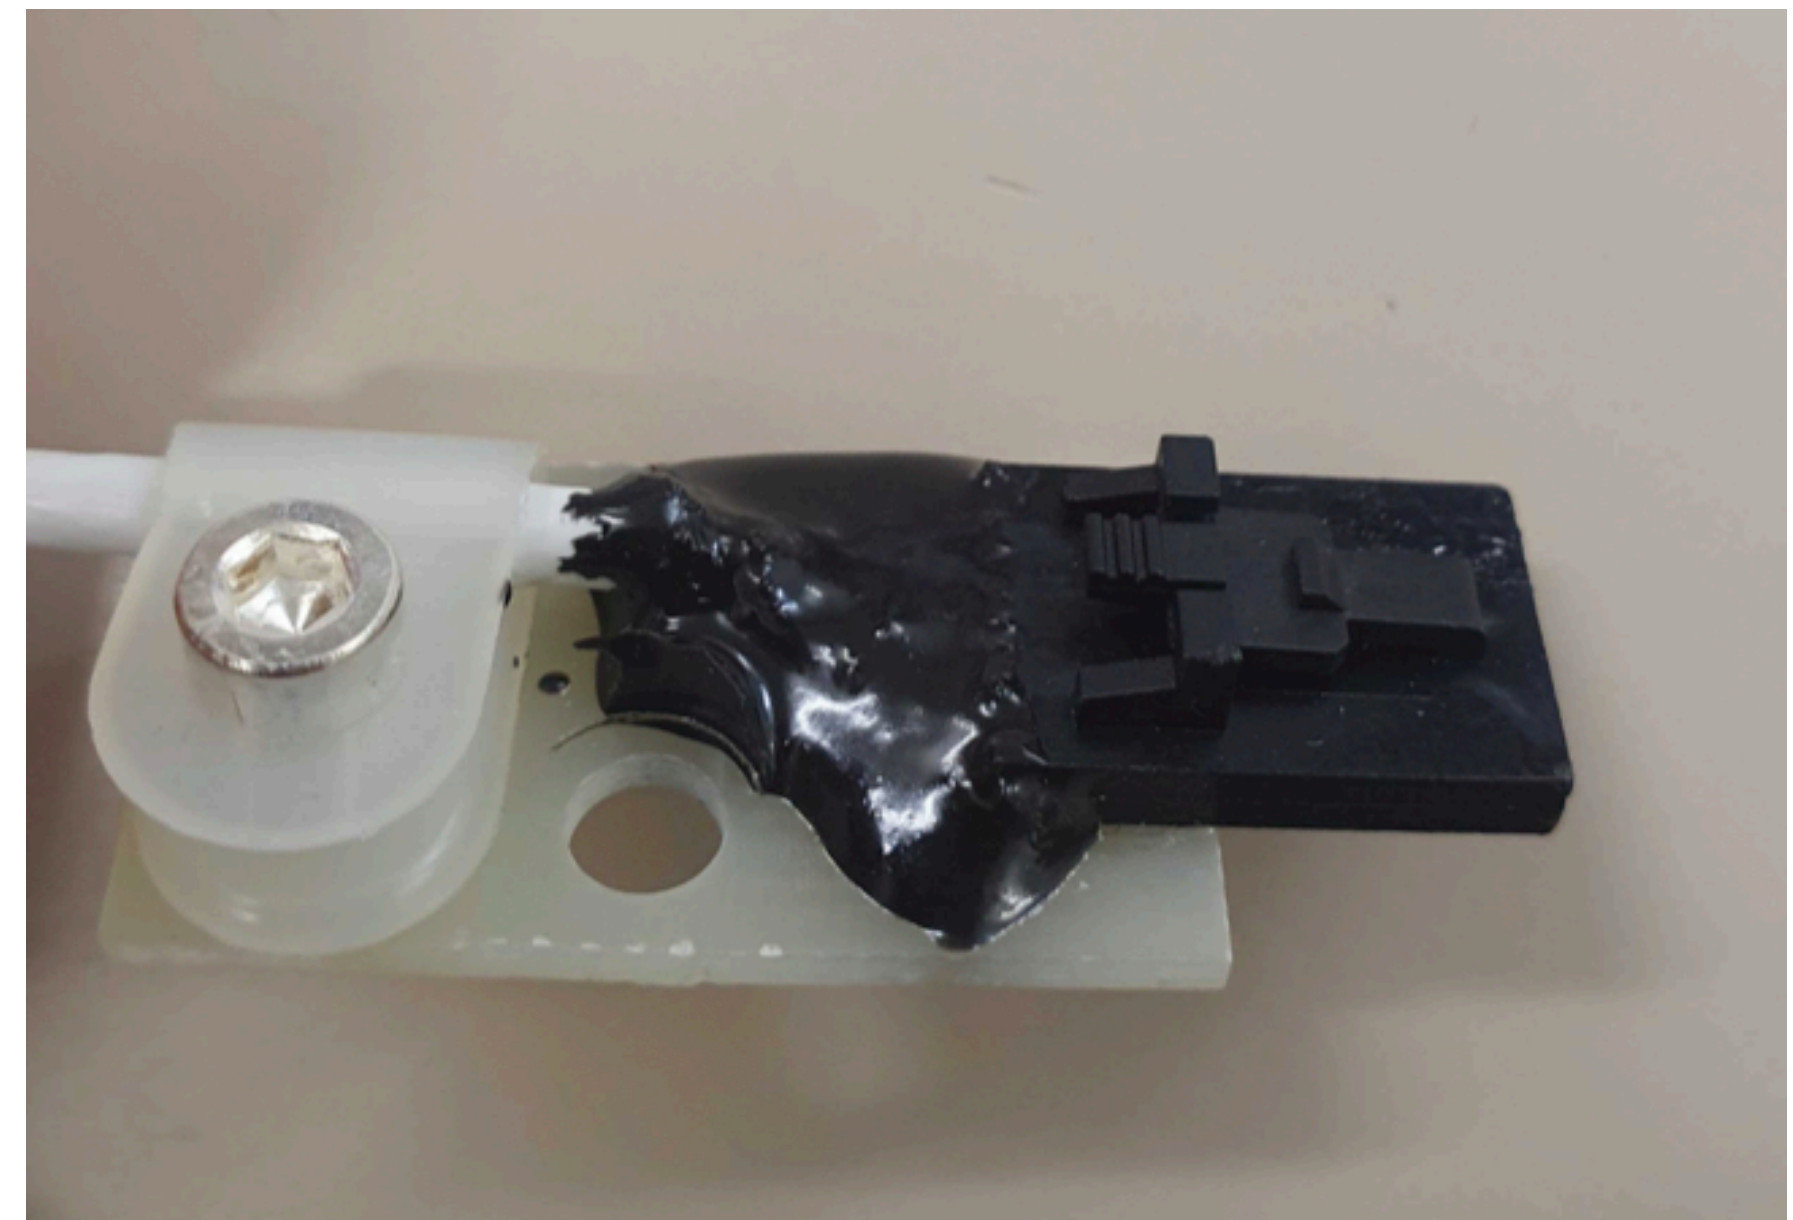
# Problem 3: Epoxy quality

- Loctite Stycast 2850 FT epoxy is used to protect the four little cables in each sensor cable
- Several problems have been identified

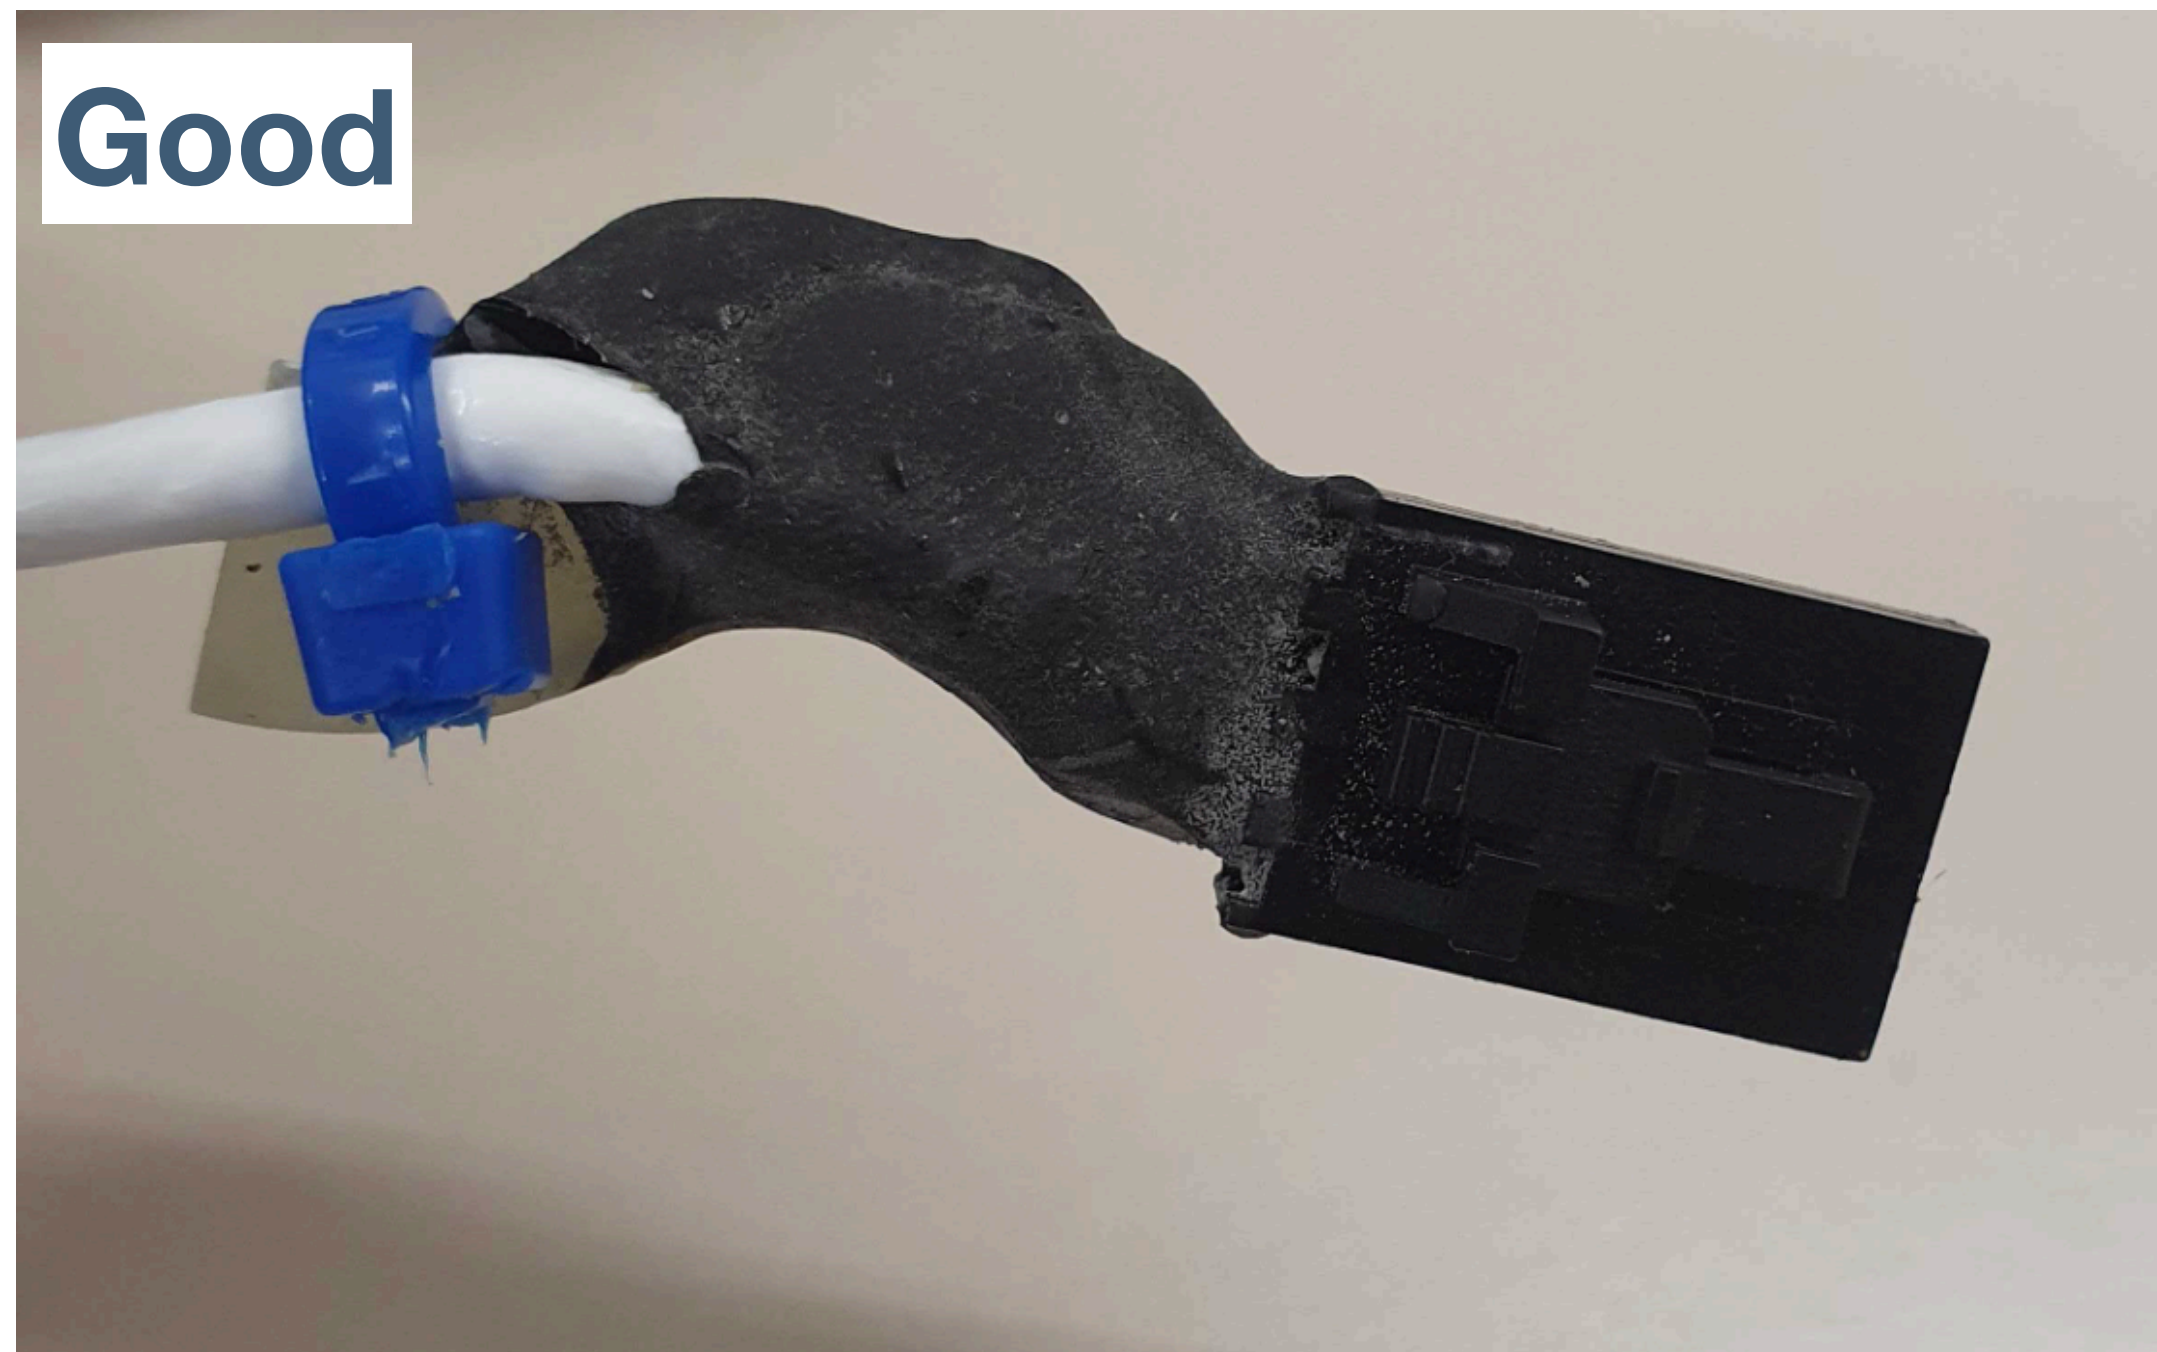
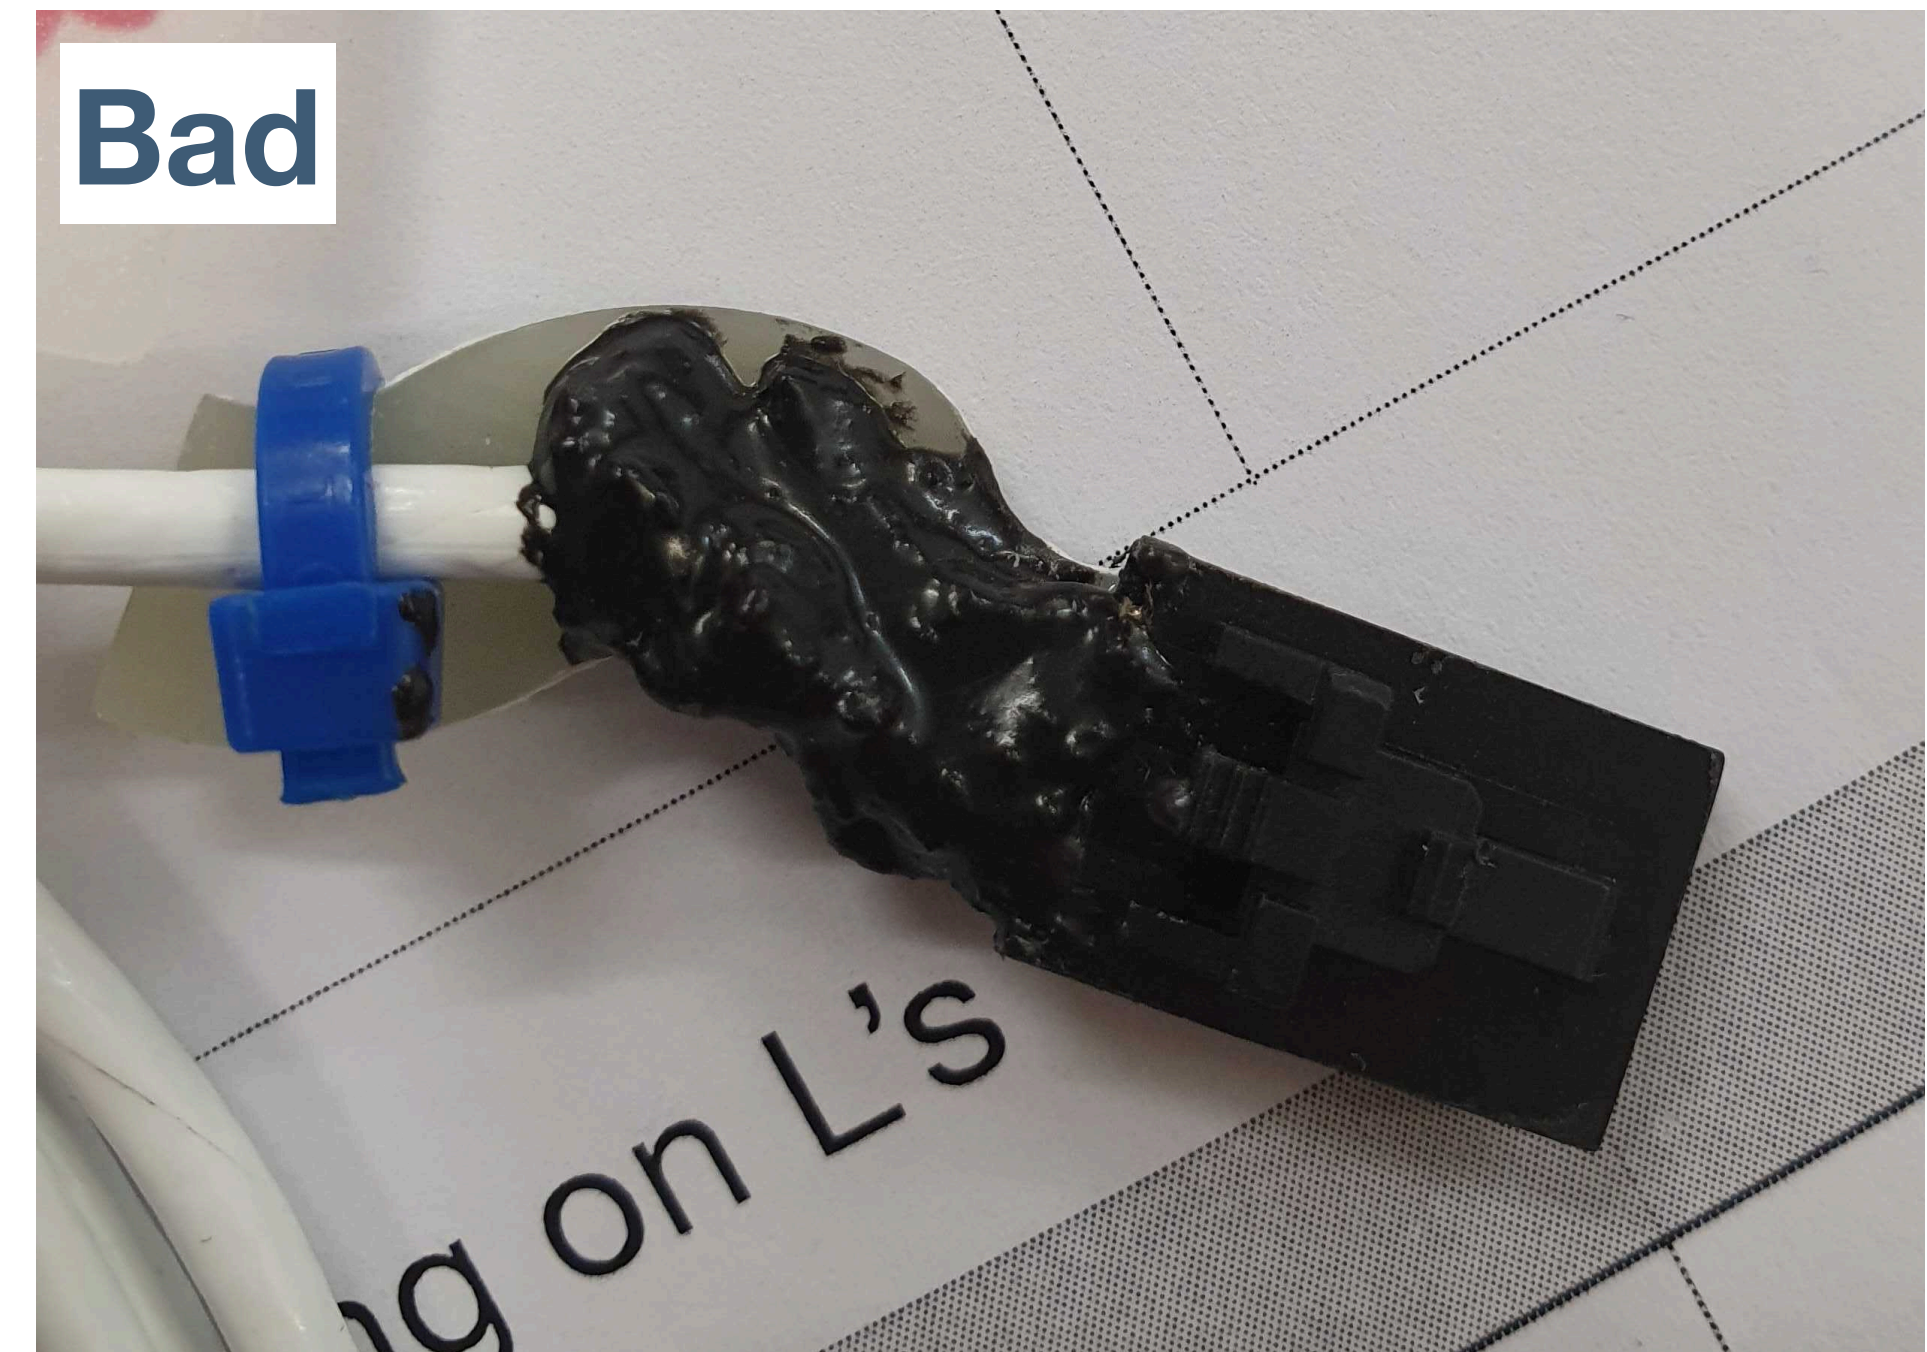
# Problem 3.a: Epoxy quality

- Sometime it is only aesthetics
- **Repair:** add more epoxy with proper distribution
- **Changes in production:** remove bubbles before applying epoxy
- **Changes in QA/QC:** look at aesthetics

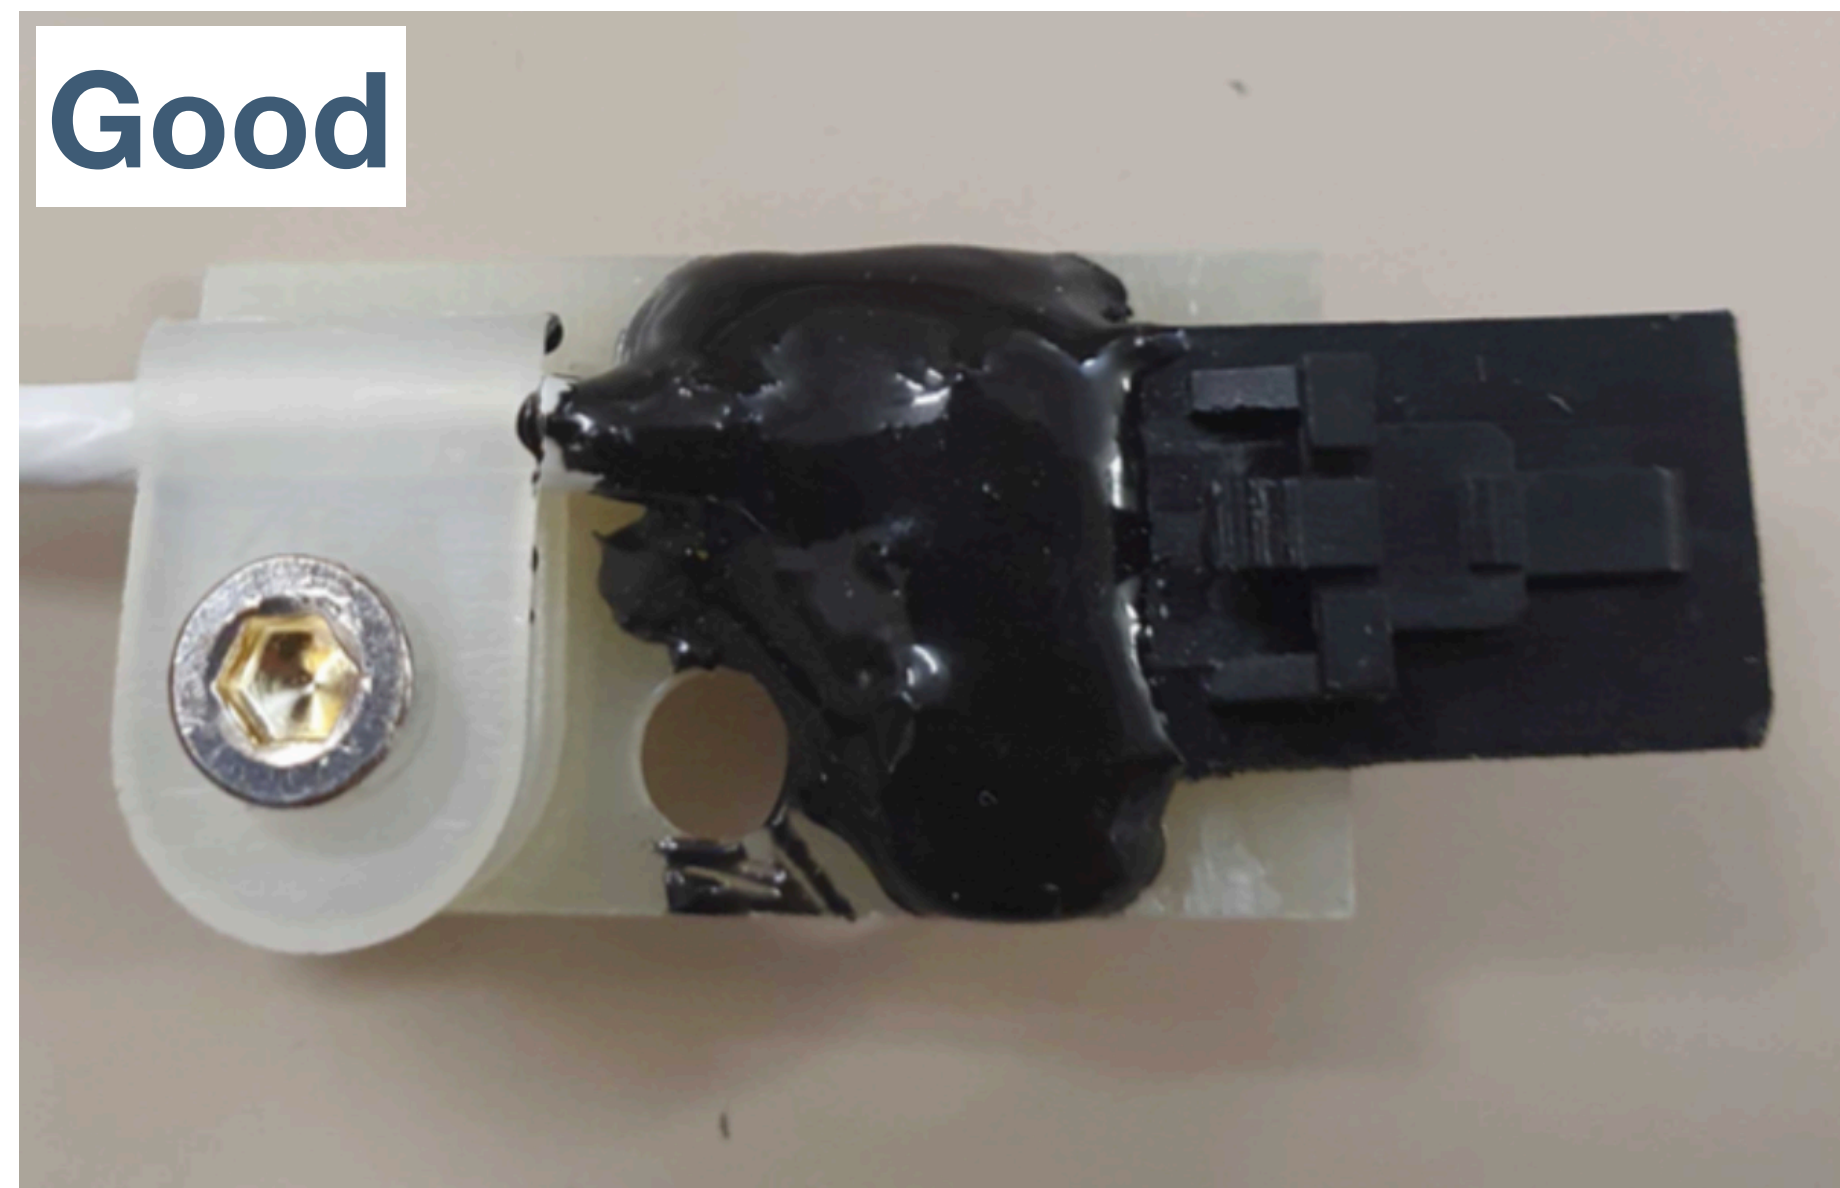
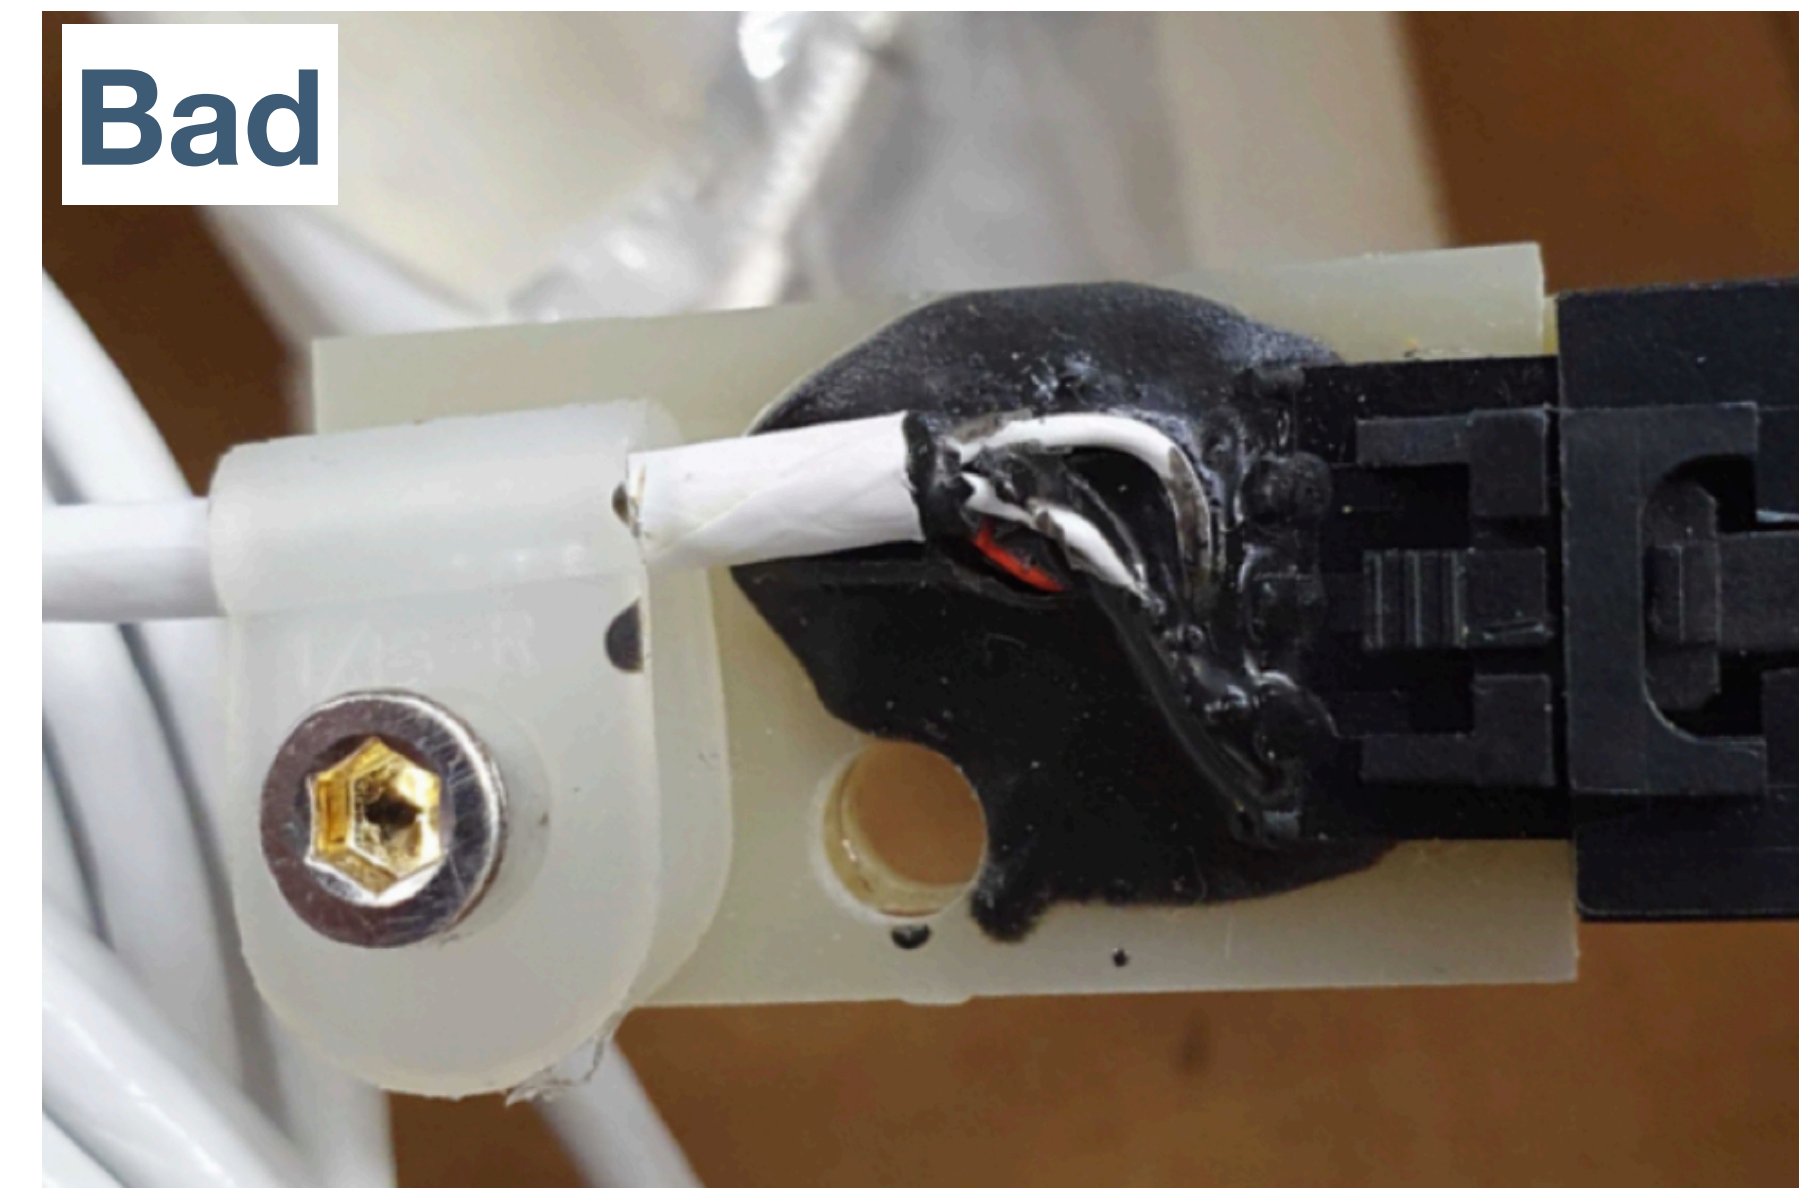
# Problem 3.b: Epoxy quality

- The four little cables not completely covered by epoxy
- **Repair:** add more epoxy
- **Changes in production:** when applying epoxy make sure it covers cables
- **Changes in QA/QC:** make sure epoxy covers cables

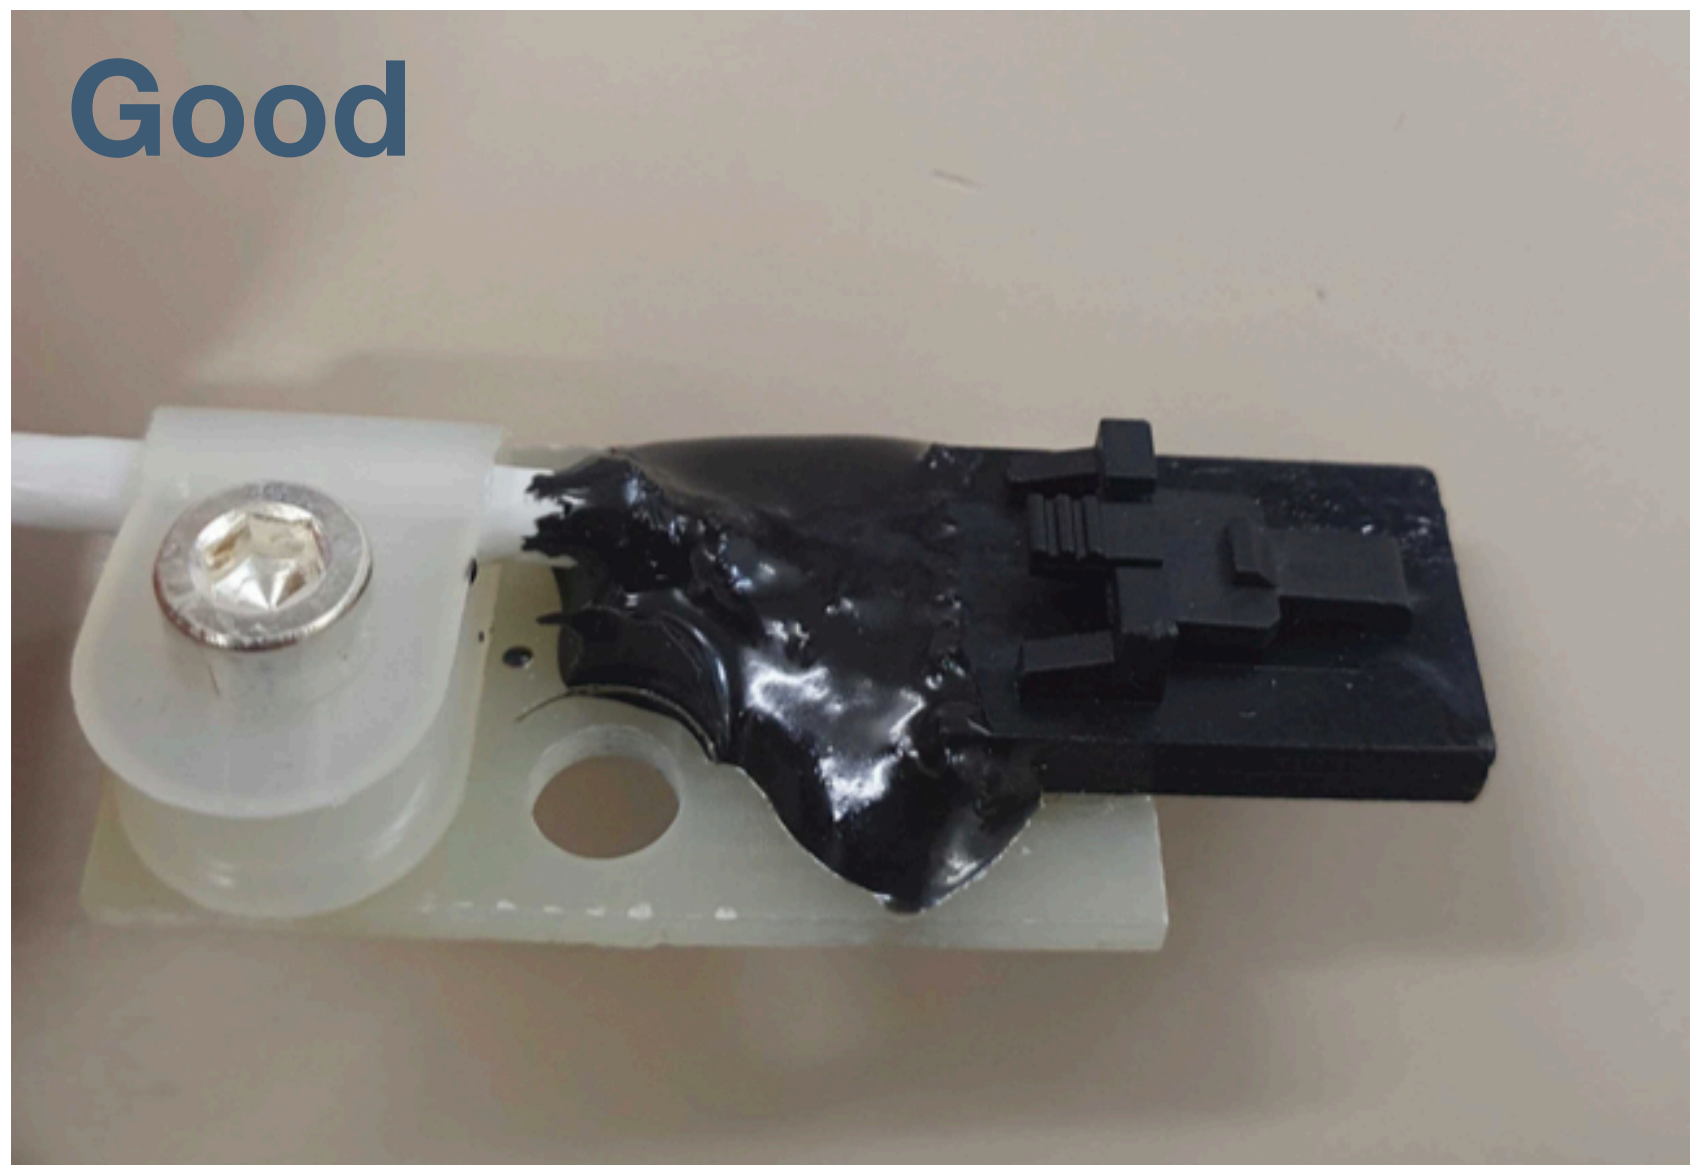
Good

- Epoxy prevents housing the M4 screw head
- **Repair:** remove extra epoxy with a drilling machine
- **Changes in production:** none, a temporary bolt is used when adding epoxy
- **Changes in QA/QC:** mount entire kit

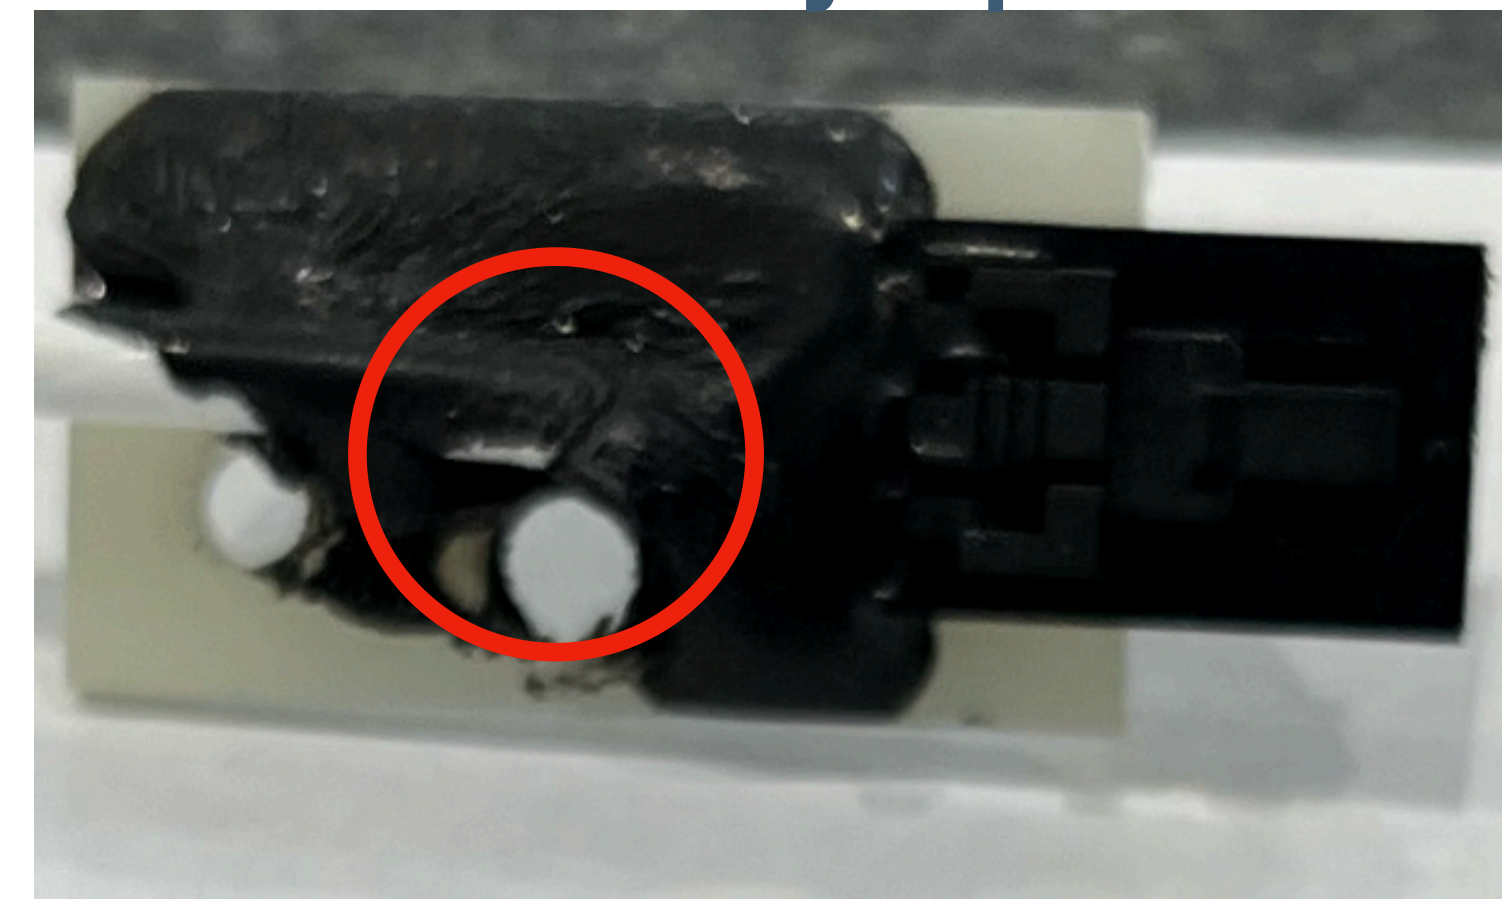
Cable is too close, cannot be easily repaired
