# Temperature sensors on APAs

A. Cervera

IFIC-Valencia

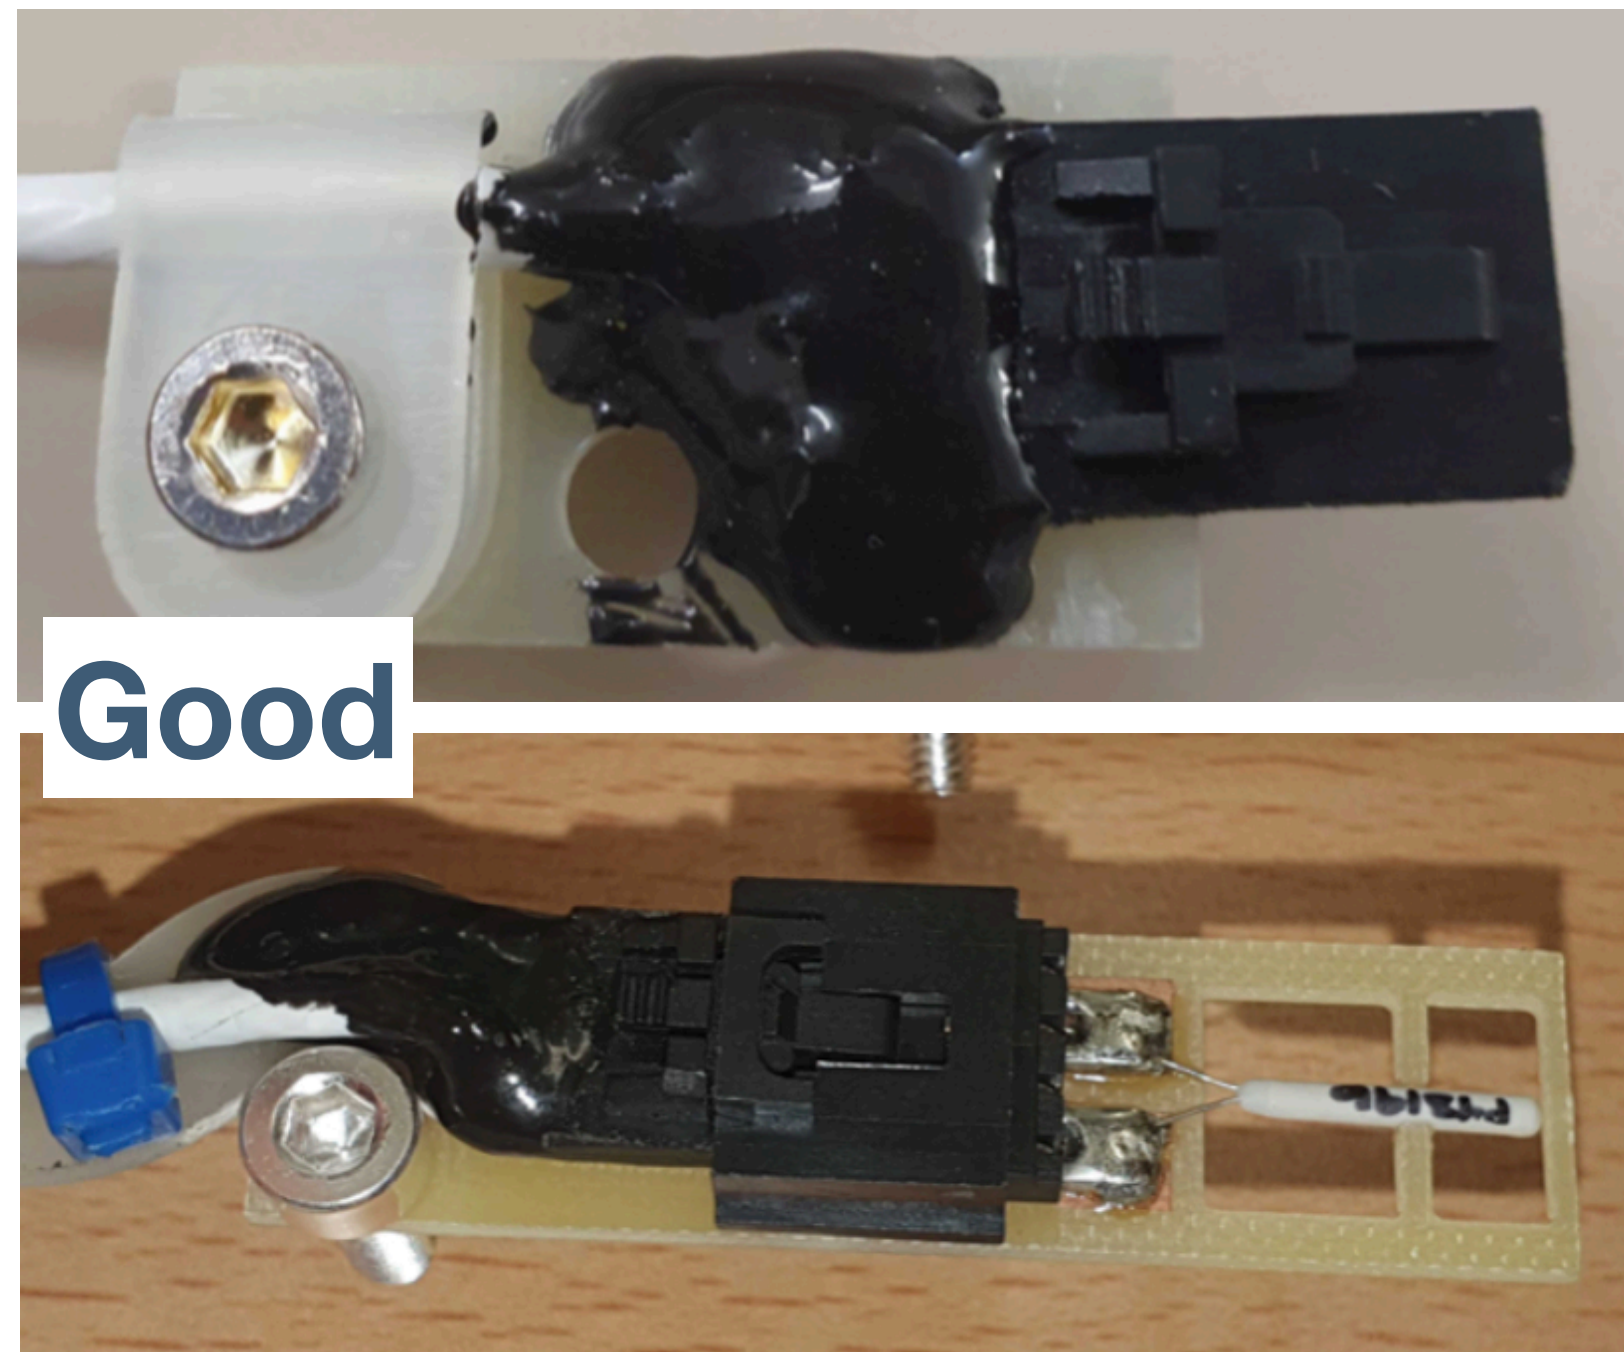
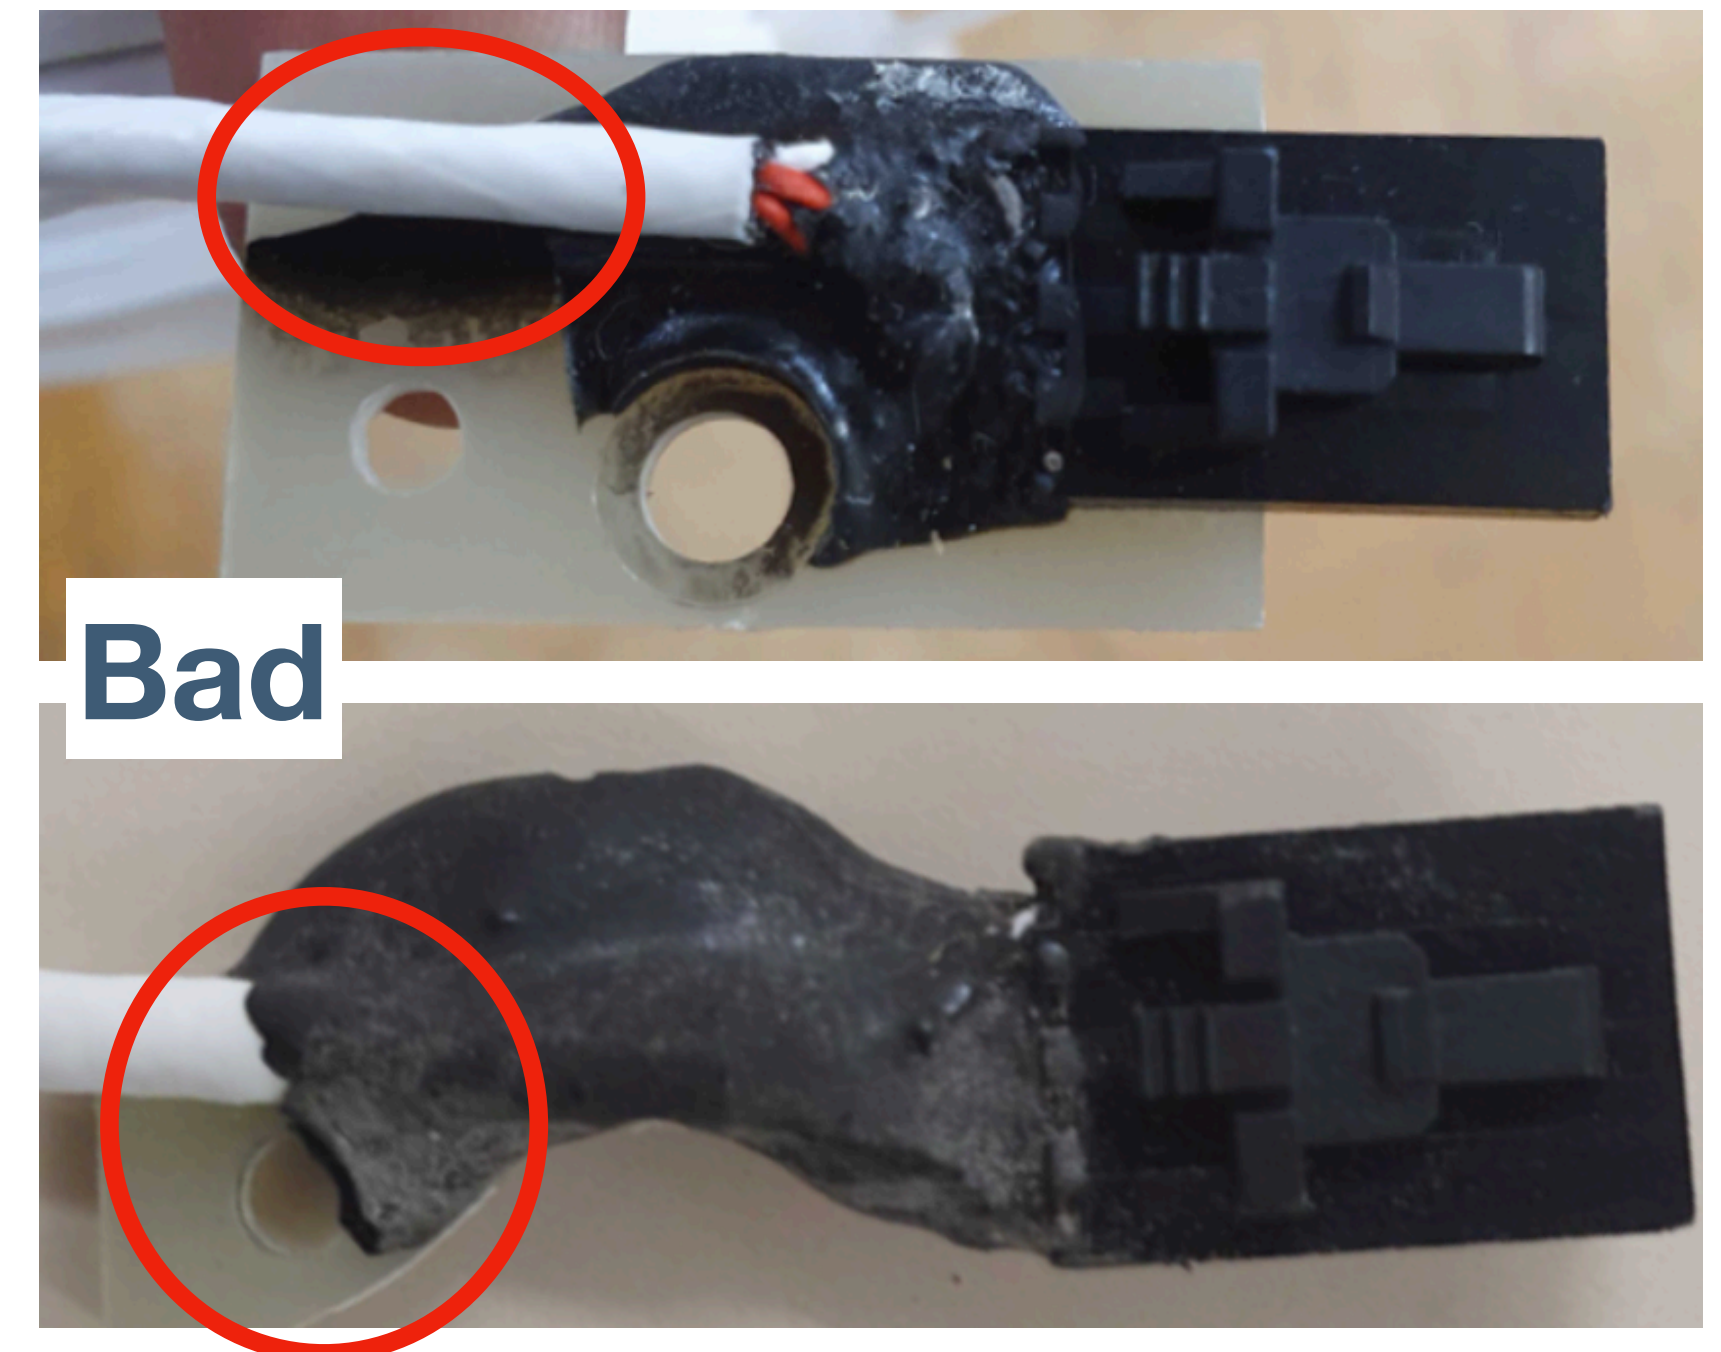
# Problem 3.d: Epoxy quality

- Epoxy prevents adding the cable clamp/tie
- **Repair:** remove extra epoxy when possible
- **Changes in production:** add cable tie/clamp before epoxying
- **Changes in QA/QC:** make sure cable tie/clamp is present before

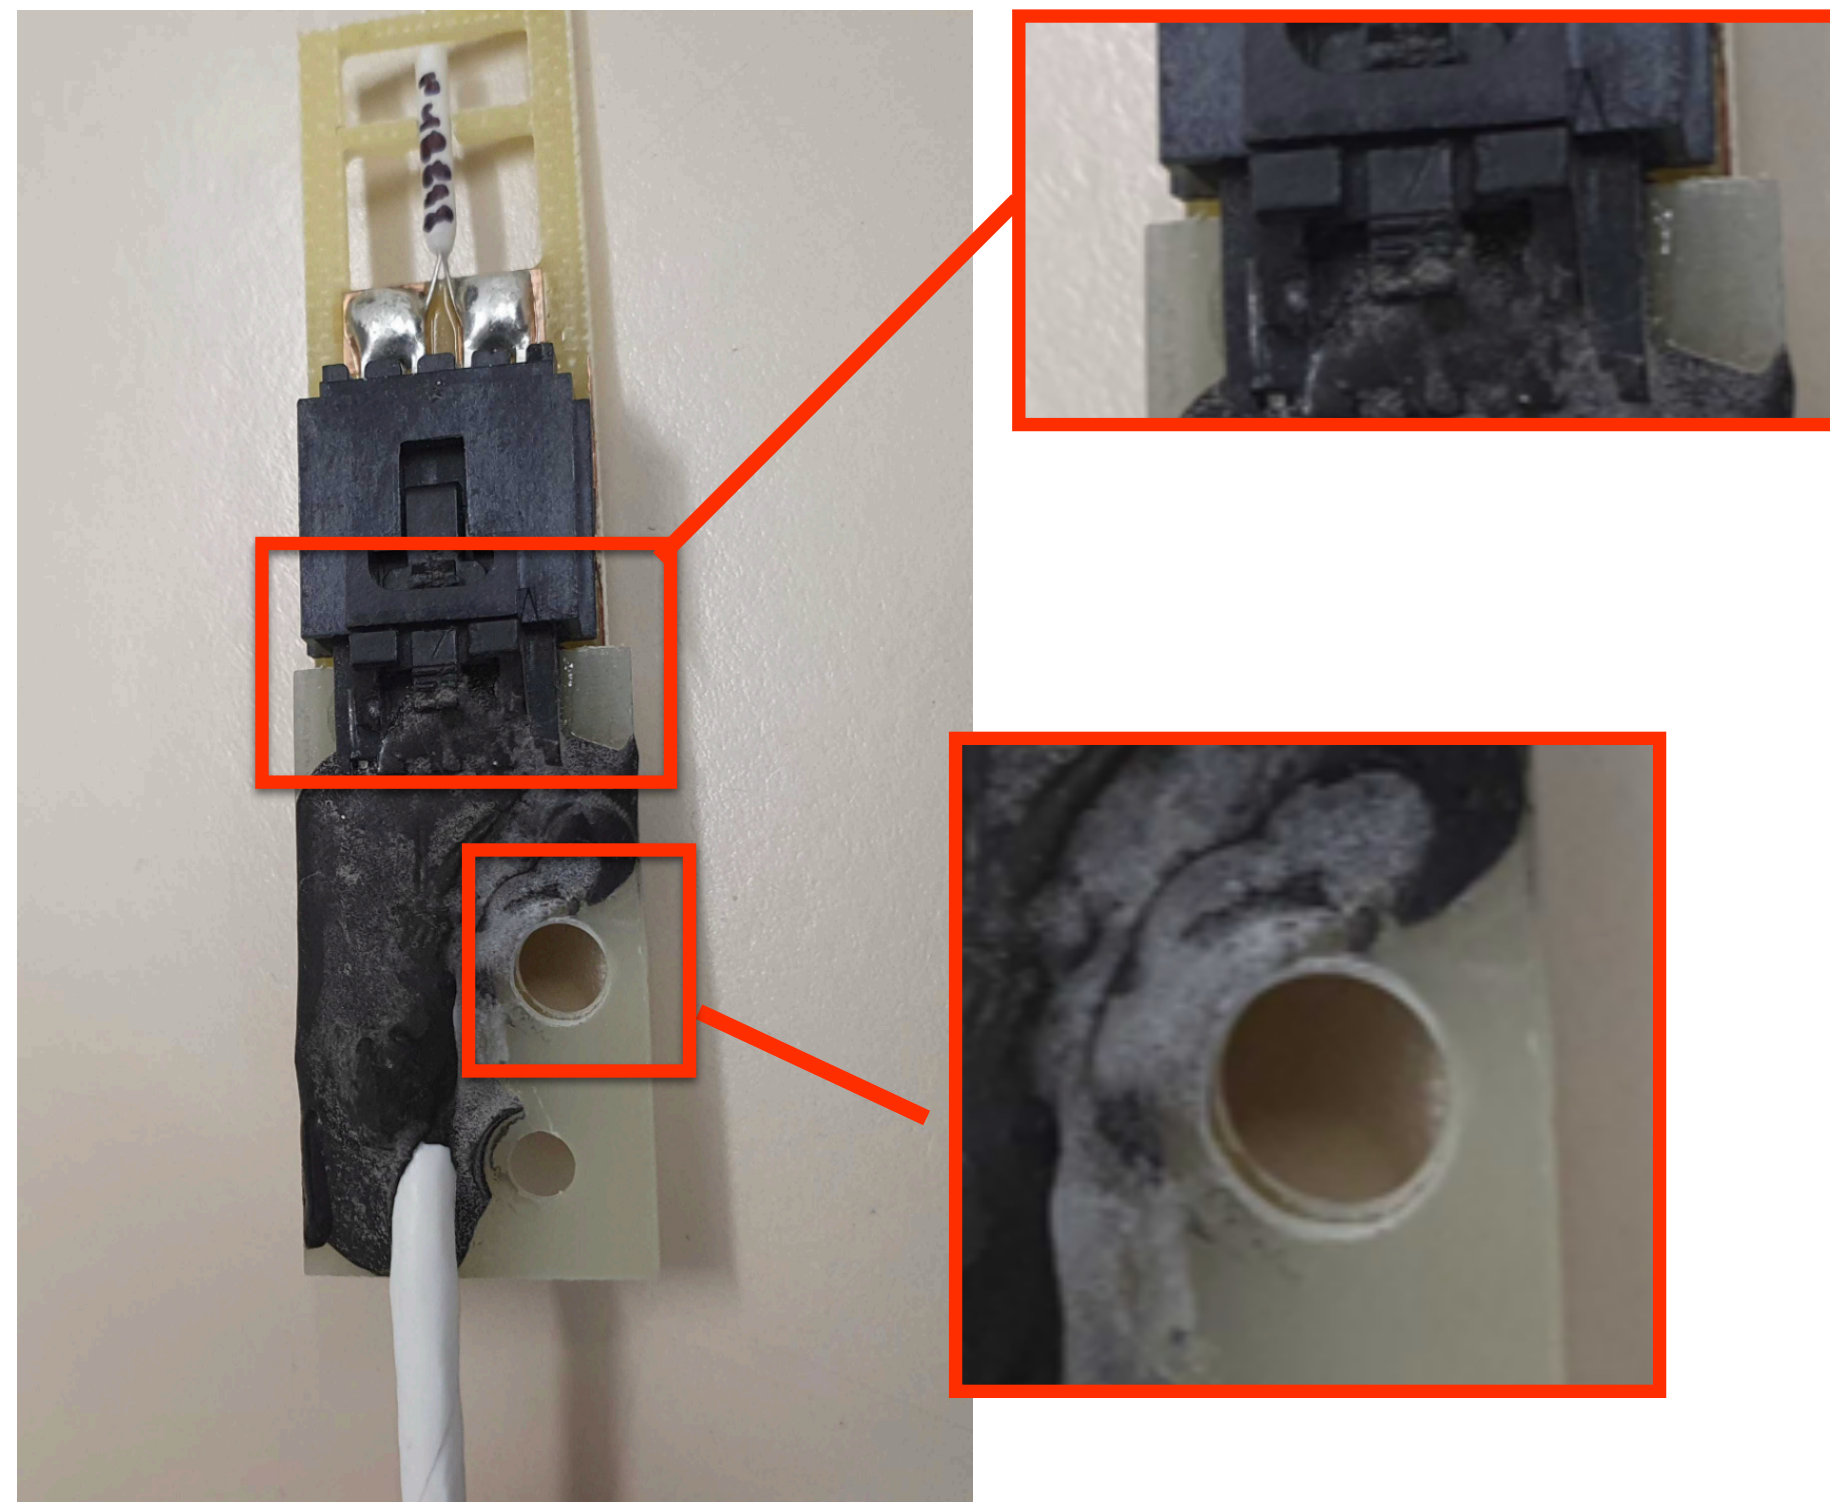
Good

- In some cases the alignment is not correct and once the sensor is plugged in the holes of the two PCBs doesn't match each other

- **Repair:** Use a cylindrical lime to increase the size of hole in lower PCB
- **Changes in production:** A special tool where the cable PCB and the IDC-4 female connector are placed before gluing is been fabricated
- **Changes in QA/QC:** Mount the entire kit

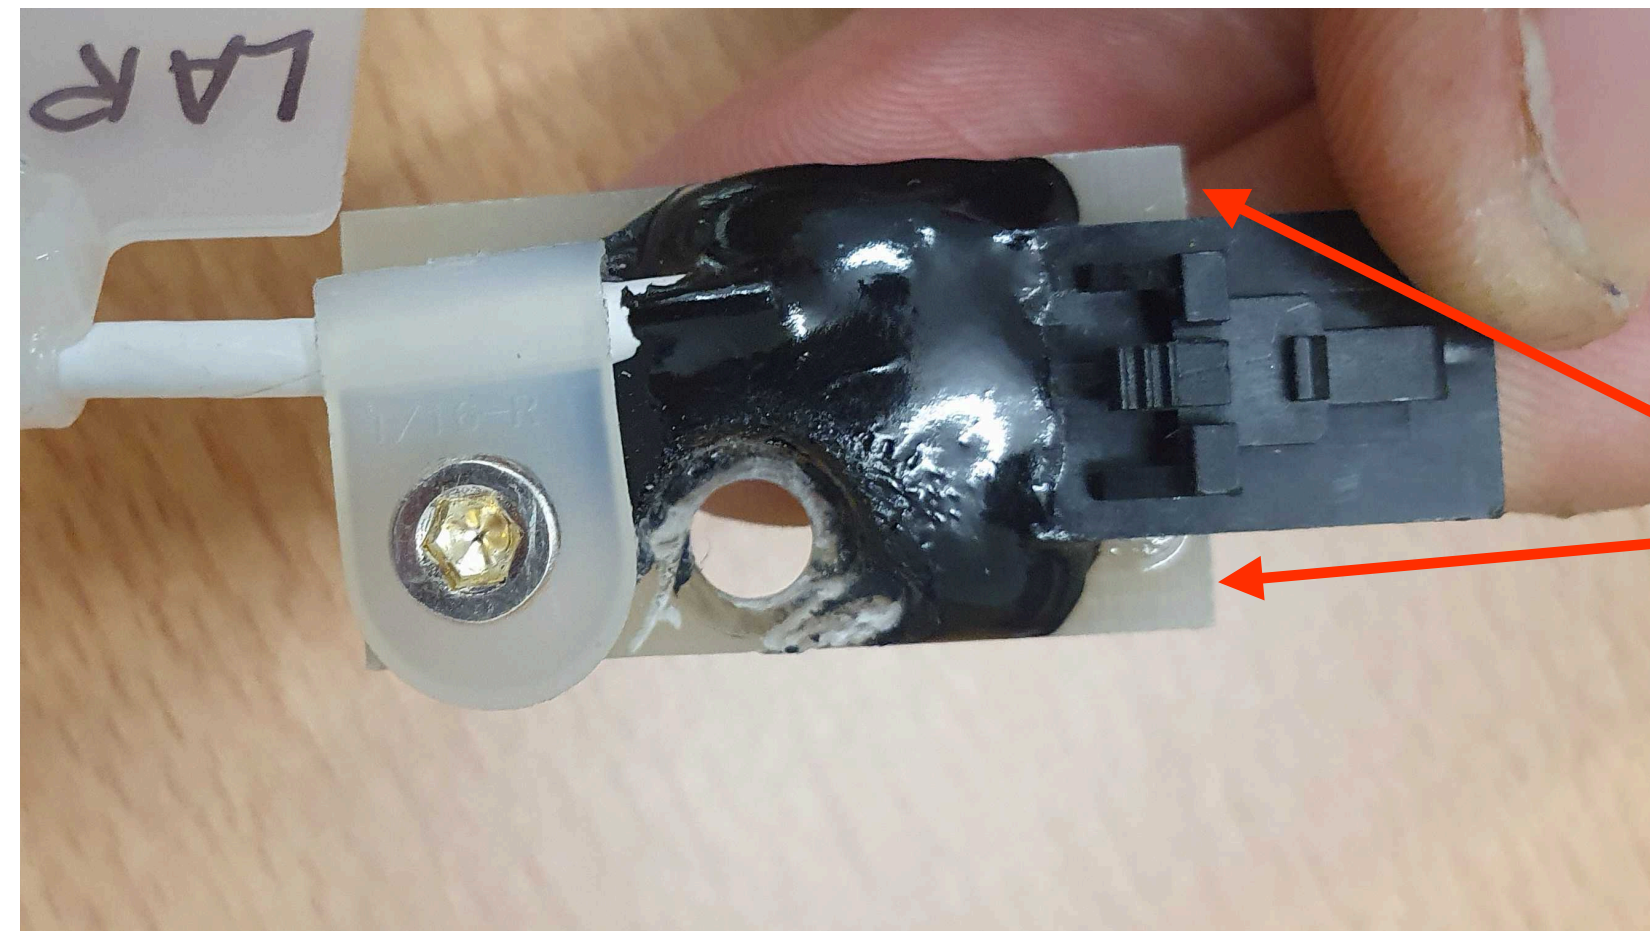
- In some cases the IDC-4 female connector is not correctly placed on the cable PCB (too much inside the PCB) and the sensor cannot be plugged in
- **Repair:** remove FR4 material with flat lime
- **Changes in production:** use new tool to correctly place the IDC-4 connector
- **Changes in QA/QC:** make sure RTD can be plugged in

Remove a bit of material in these two points

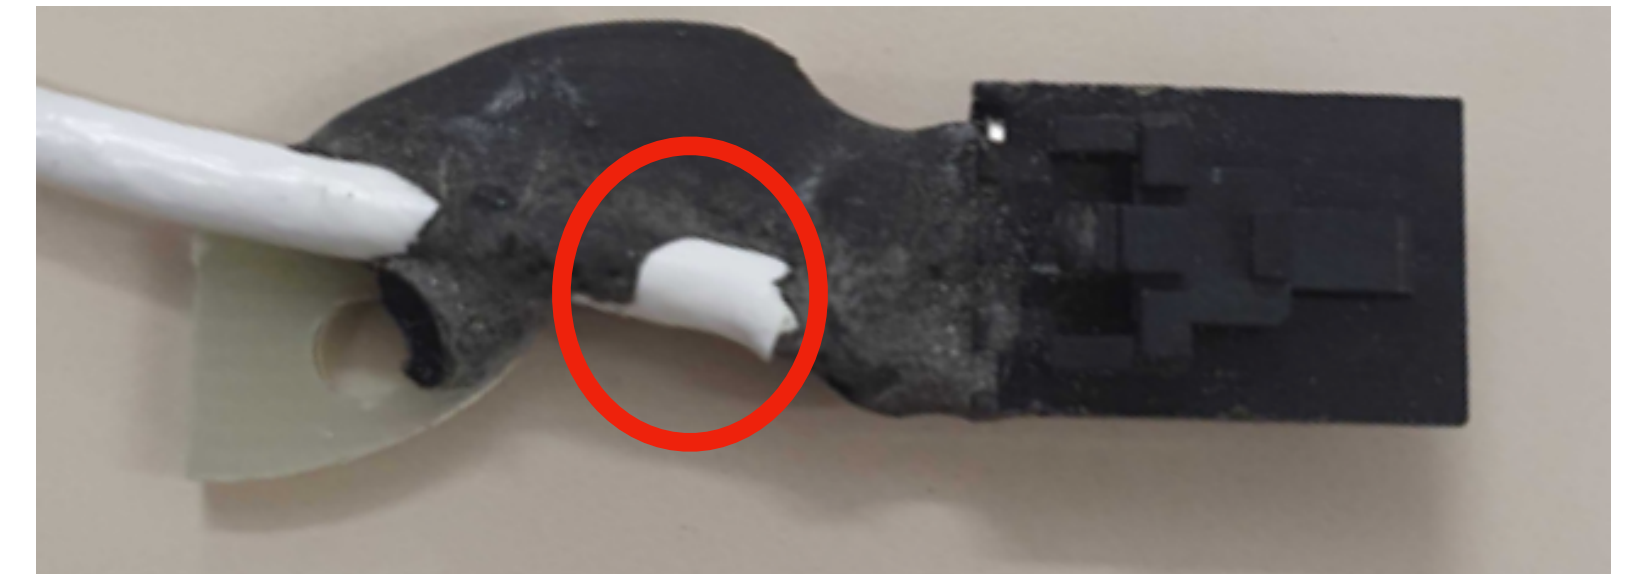
**Bad**

- For lower APAs there is no hole in the PCB. Instead a narrower PCB with the appropriate curve is used. Sometimes the cable prevents adding the M4 bolt
- **Repair:** There is no quick solution for this. The cable must be cut as close as possible to the edge and a new PCB and connector should be installed
- **Changes in production:** Correctly position the cable before epoxying. Add a bit of loctite super glue to fix the cable
- **Changes in QA/QC:** Mount entire kit with M4 bolt

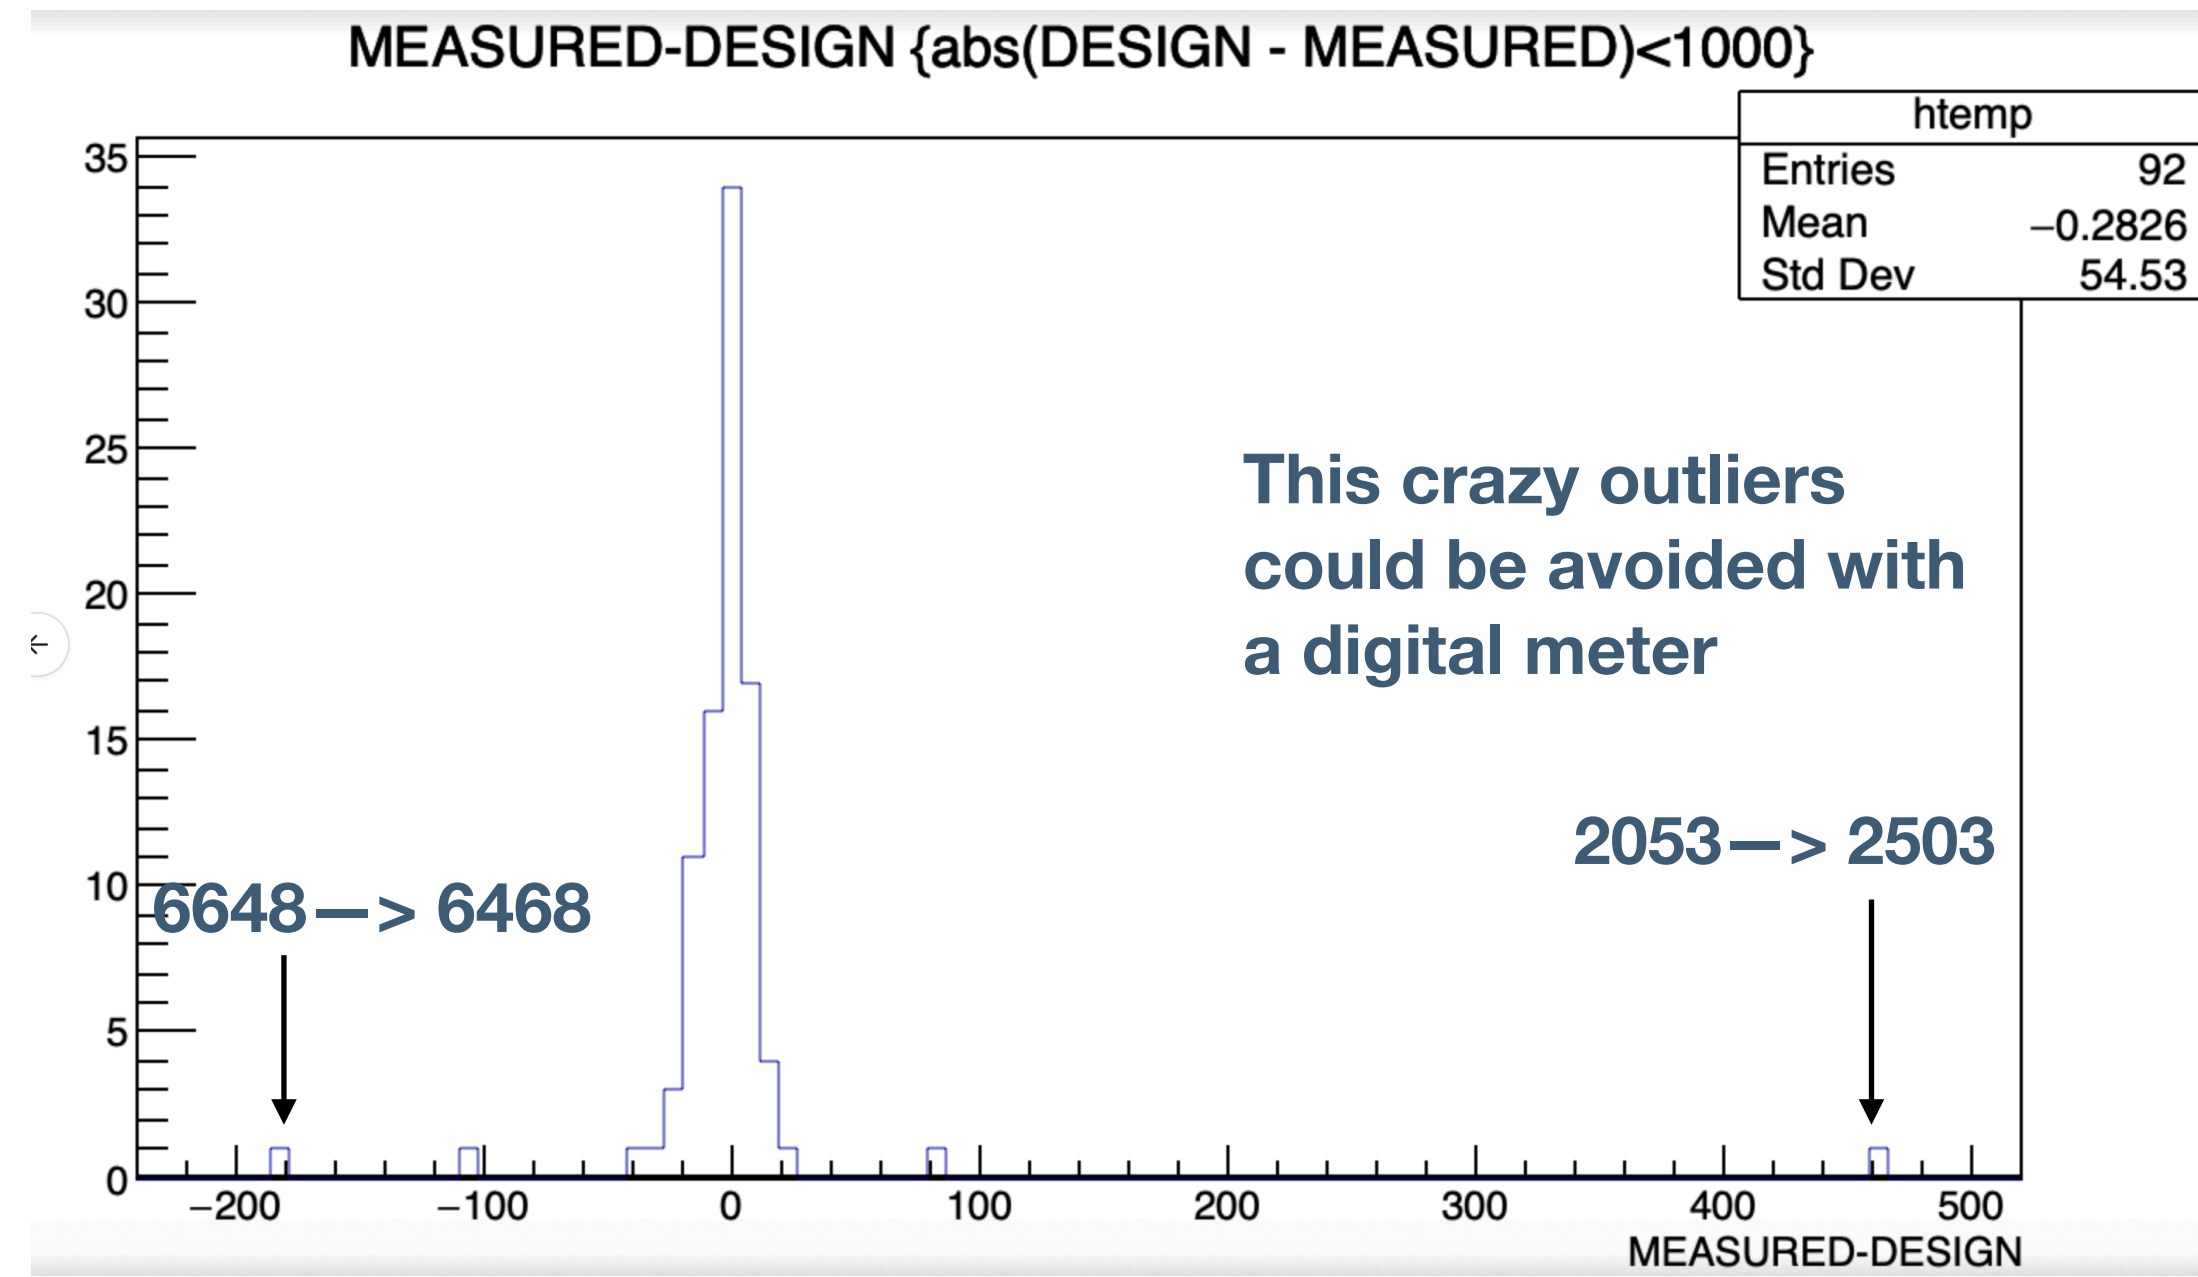
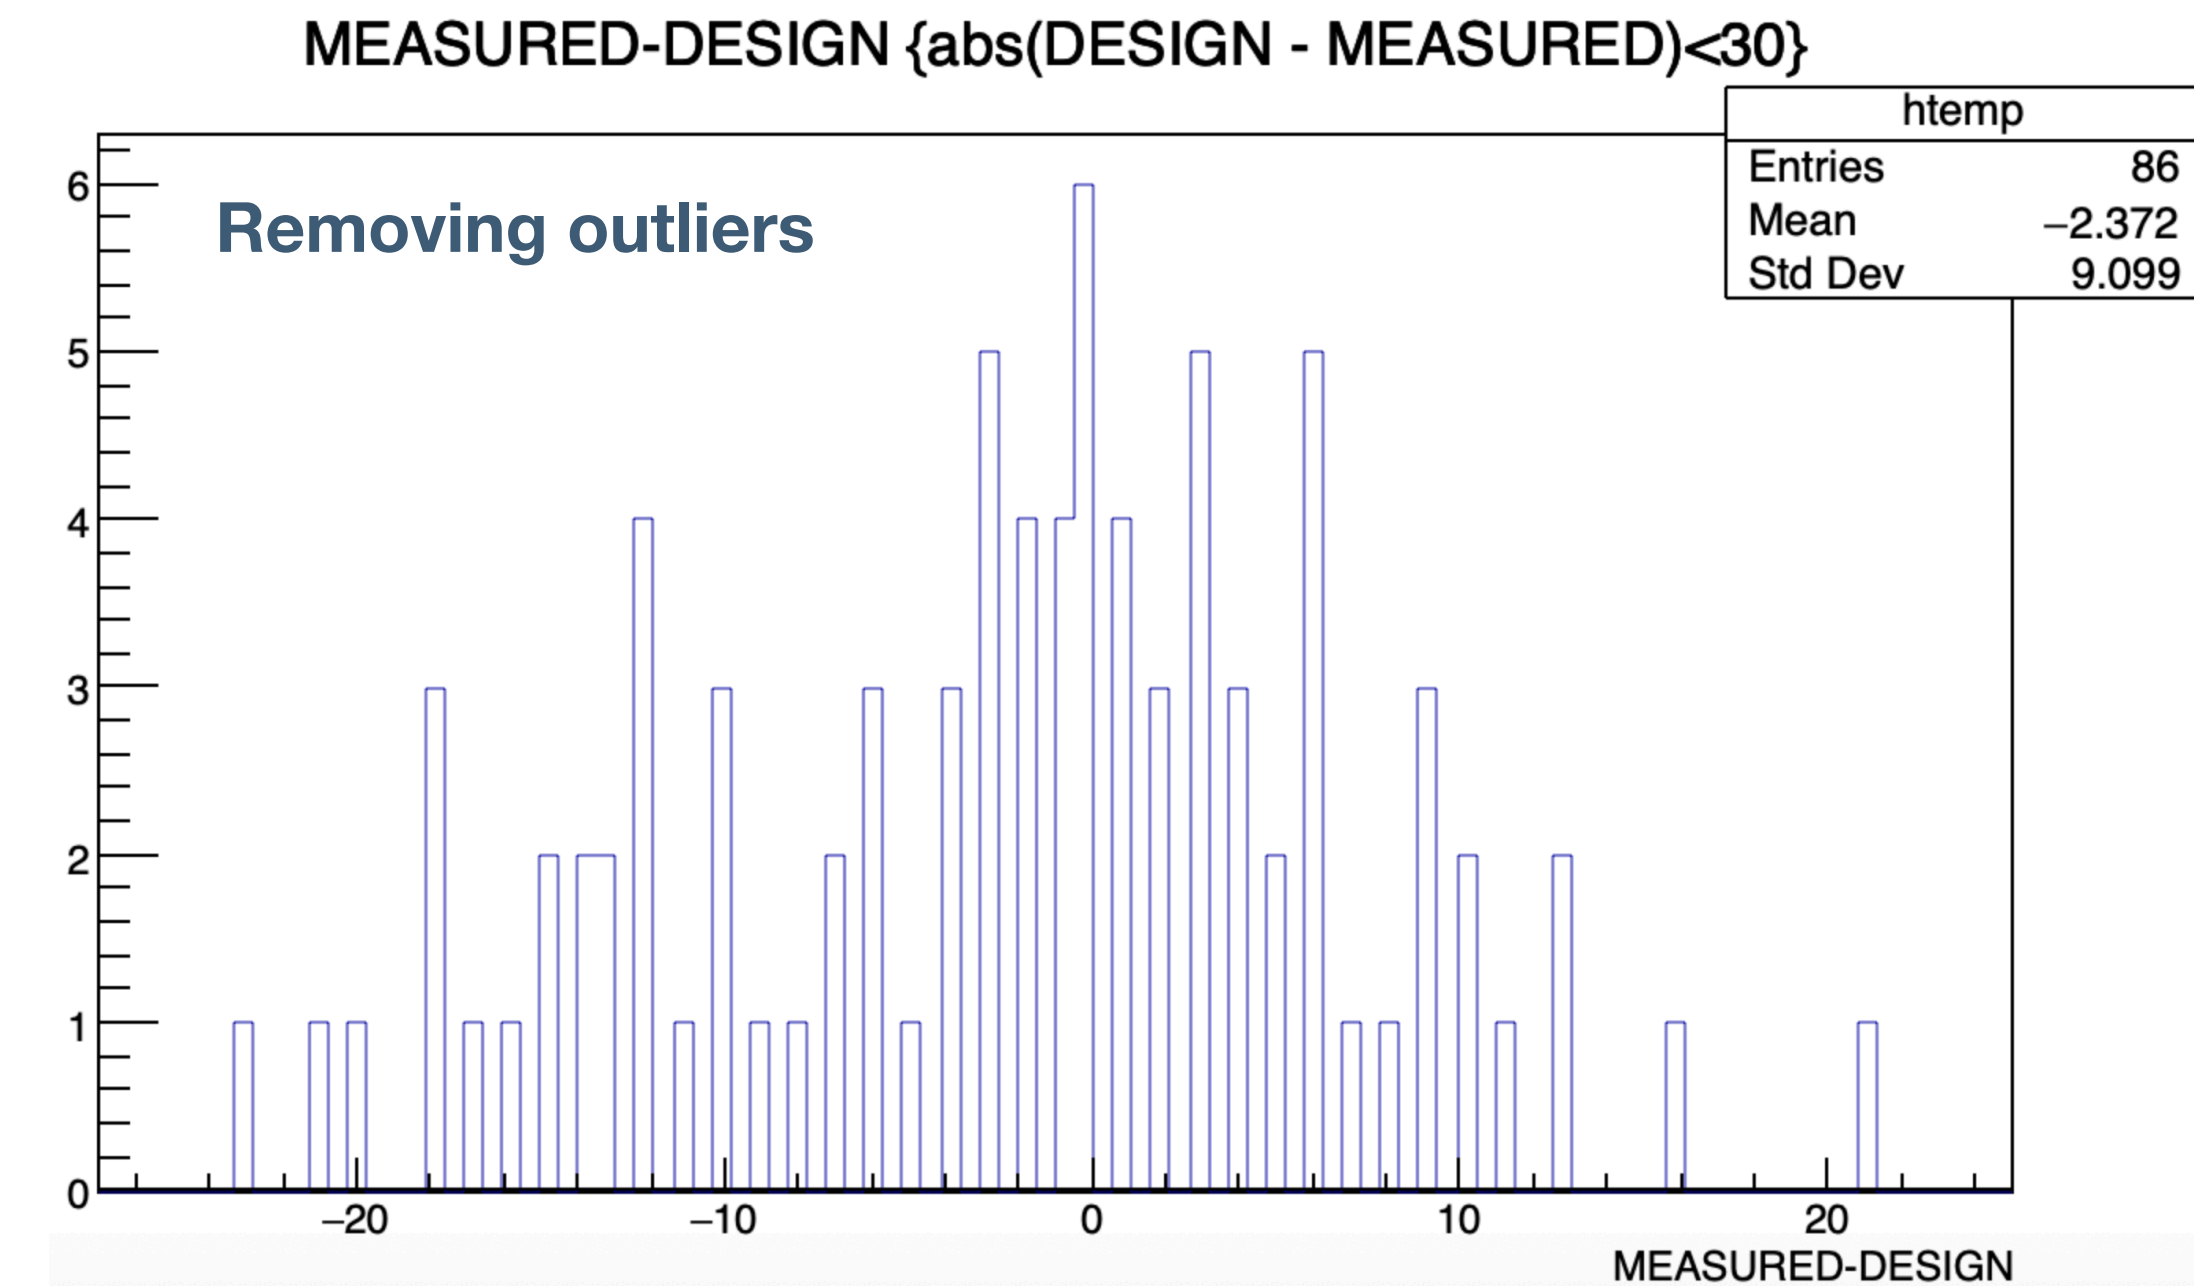
- 9 mm standard deviation on absolute length (removing outliers)
- This can be easily improved with a laser distance meter and better fixing tools

- Insufficient QC for cable lengths
- **Repair:** redo cables with lengths outside allowed range
- **Changes in production:** use a laser distance meter and proper fixing tools
- **Changes in QA/QC:** measure cables at several stages during production
  - When cutting them
  - After connectorising
  - Before packaging for shipment
