Temperature sensors on APAs

IFIC-Valencia

Introduction

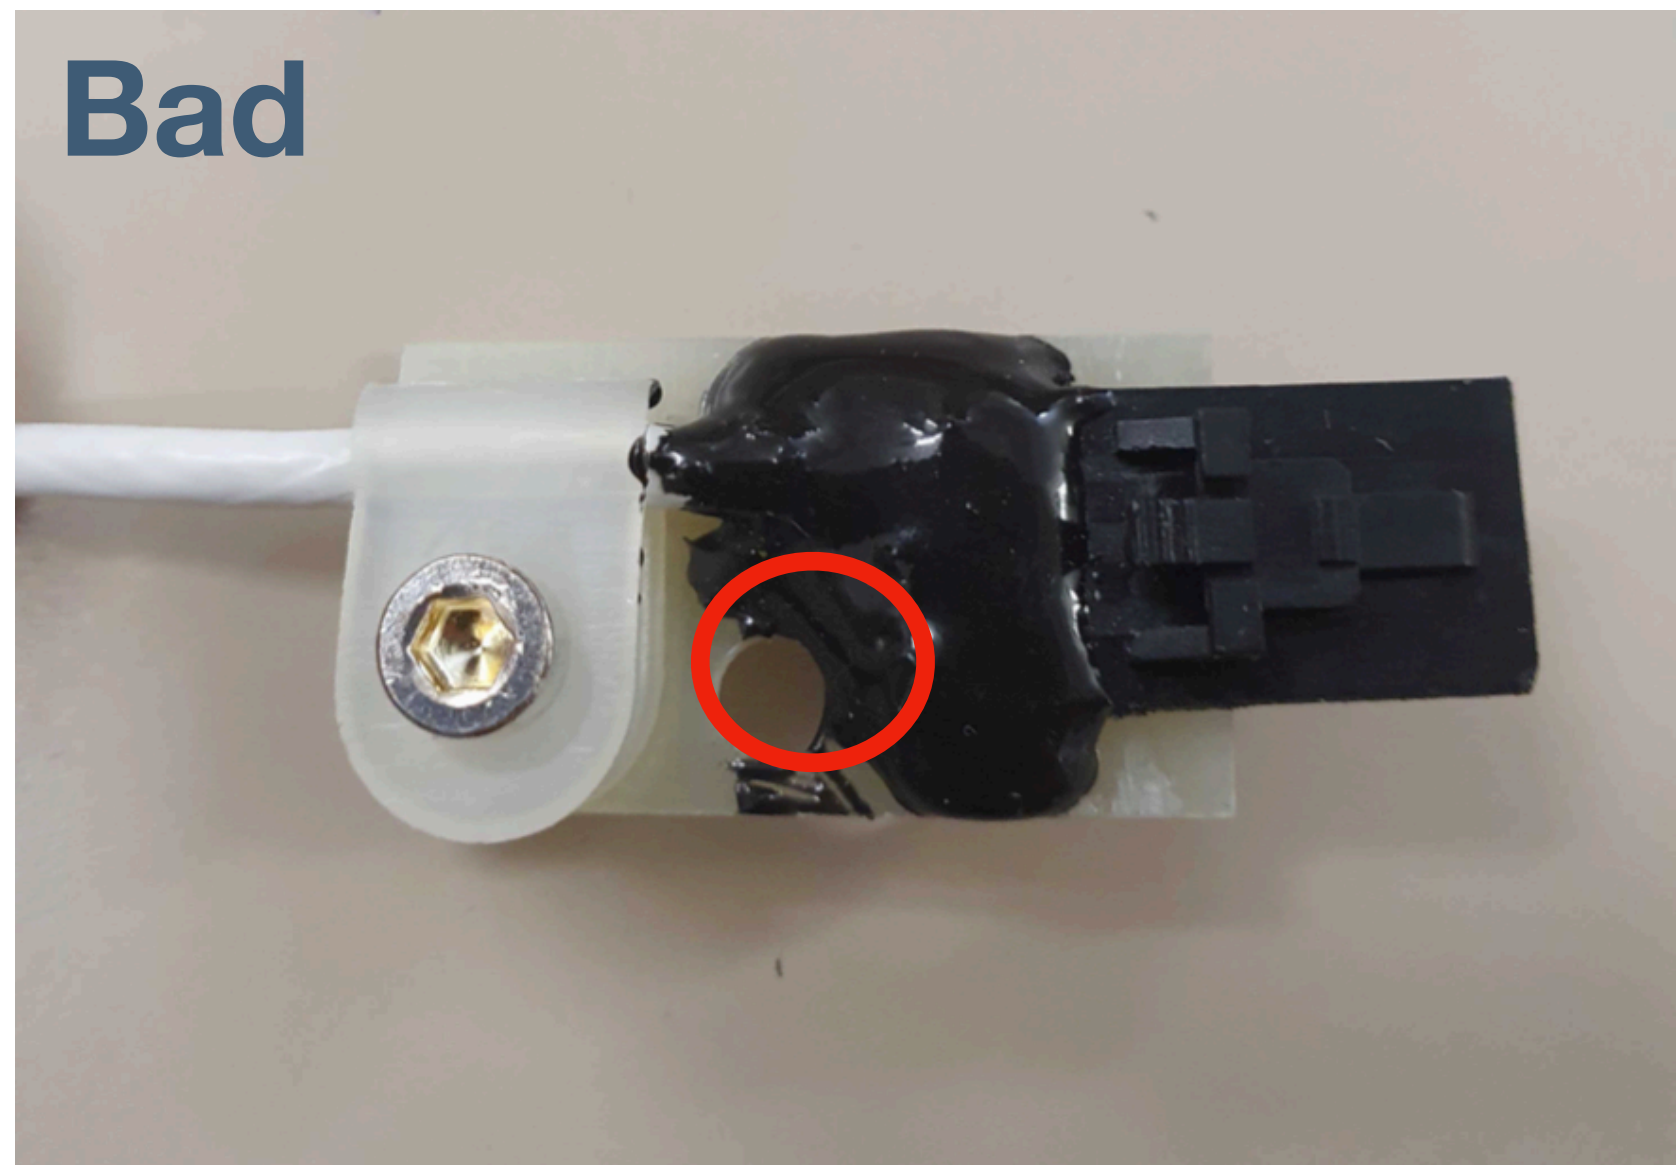
Bad

- Epoxy prevents housing the M4 screw head
- **Repair:** remove extra epoxy with a drilling machine
- **Changes in production:** none, a temporary bolt is used when adding epoxy
- **Changes in QA/QC:** mount entire kit

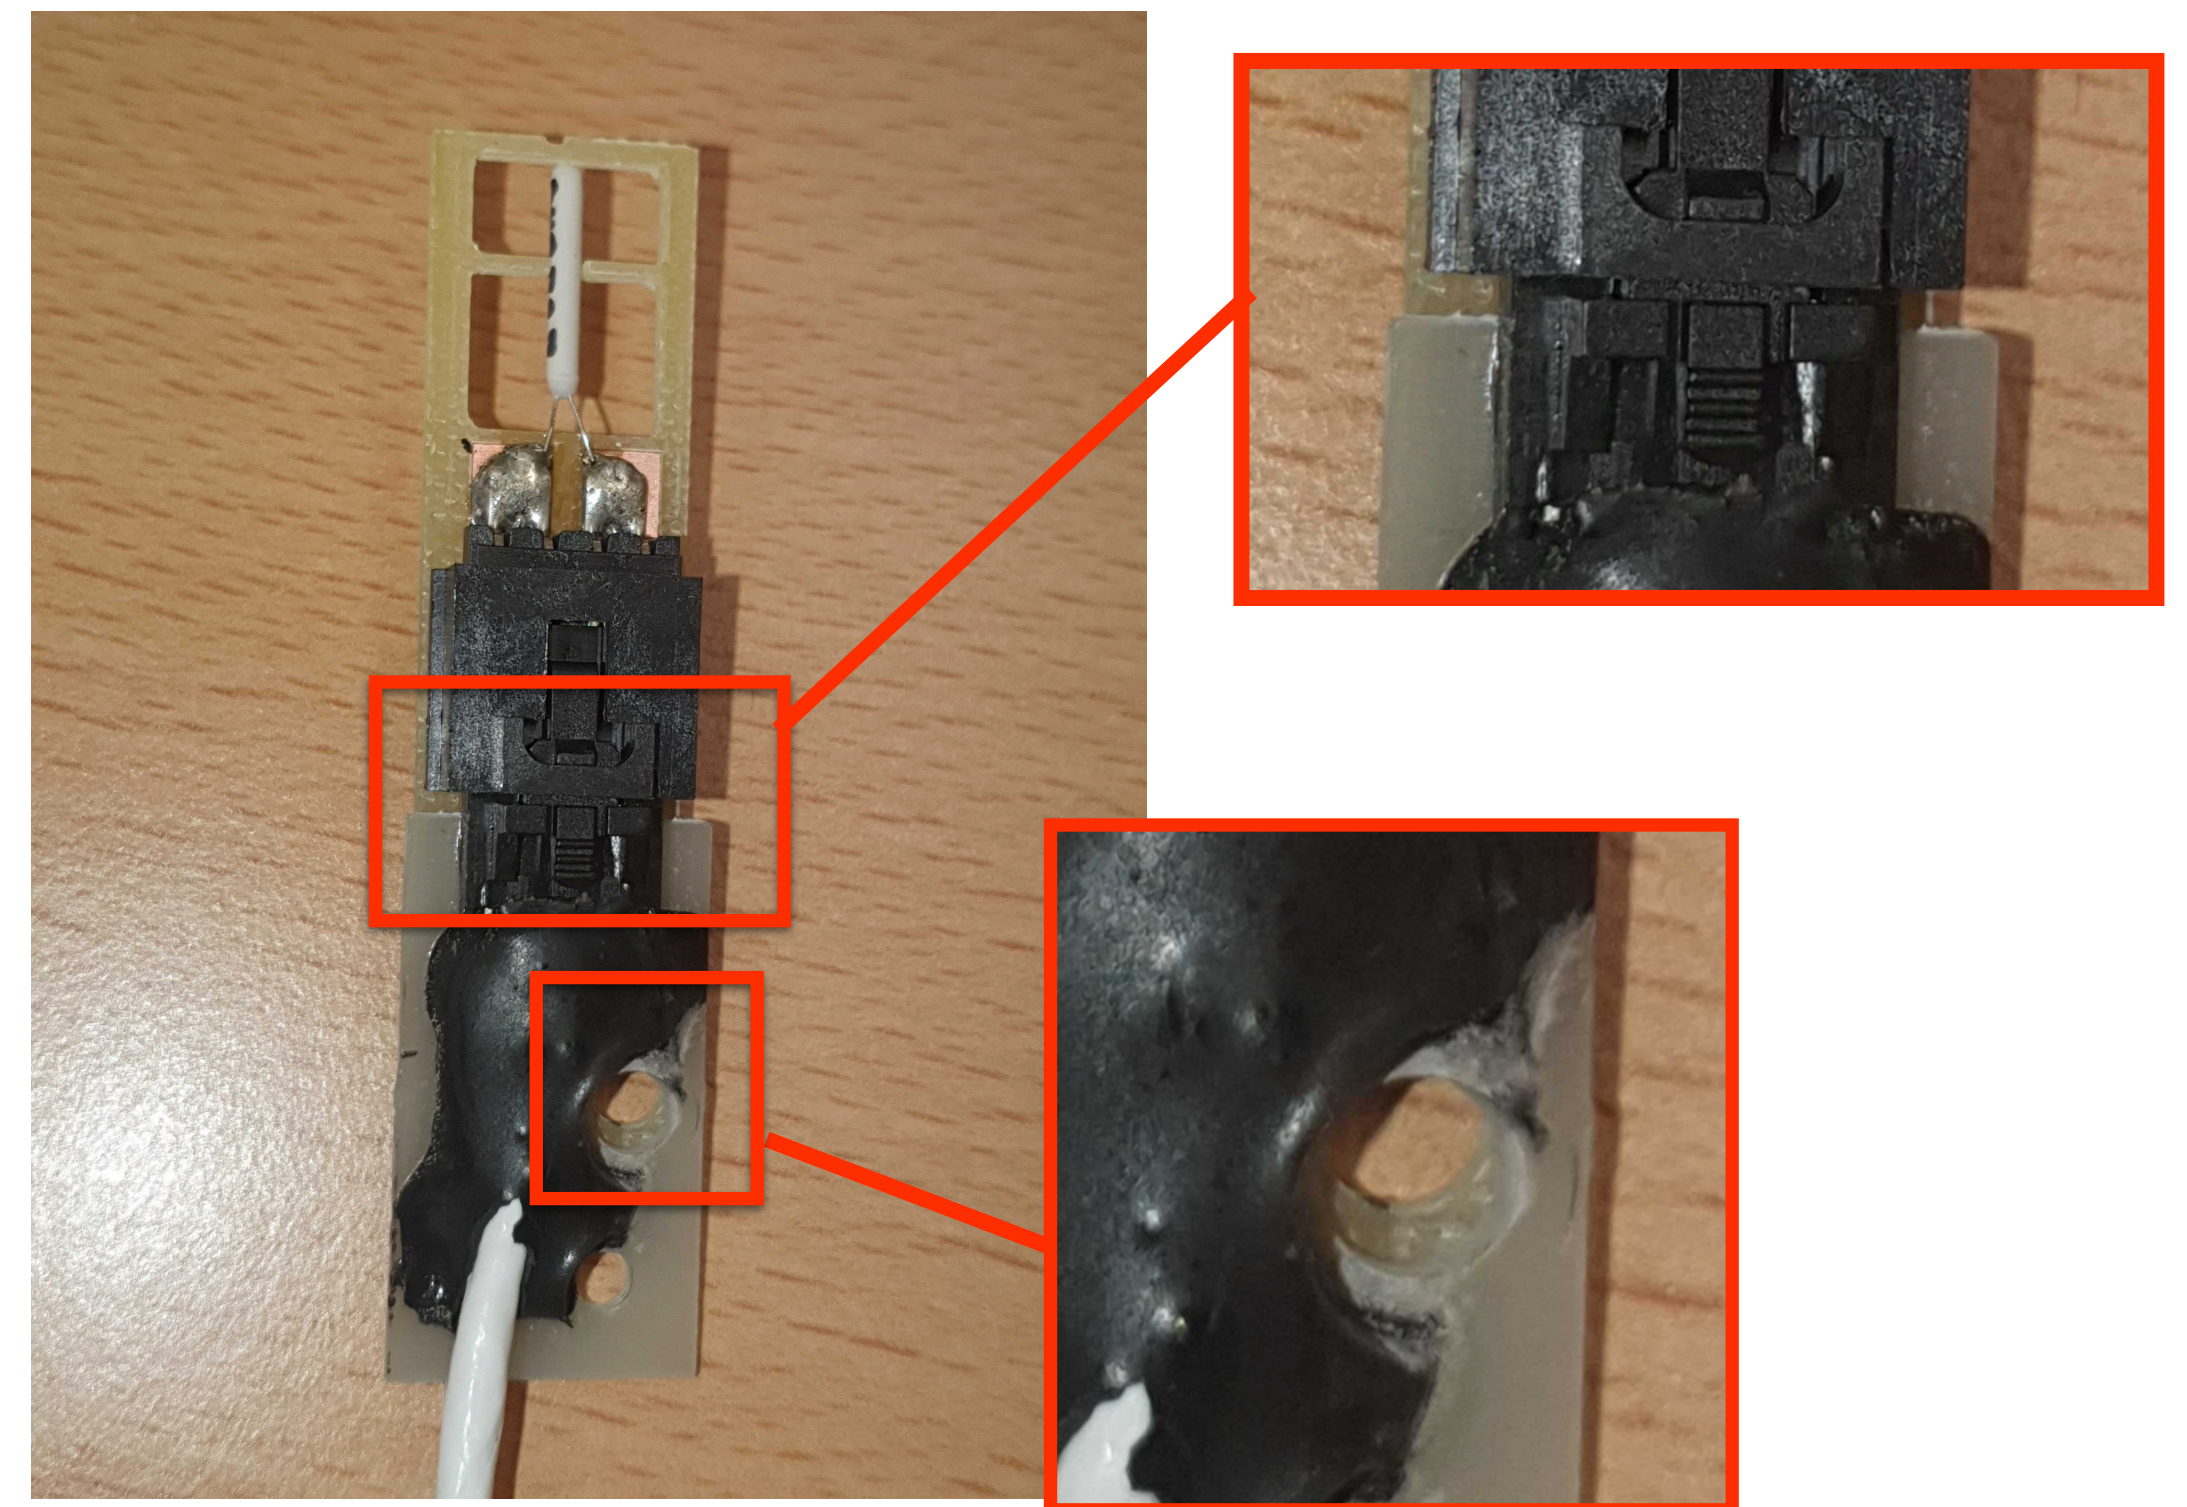
Bad

- In some cases the alignment is not correct and once the sensor is plugged in the holes of the two PCBs doesn't match each other

- **Repair:** Use a cylindrical lime to increase the size of hole in lower PCB
- **Changes in production:** A special tool where the cable PCB and the IDC-4 female connector are placed before gluing is been fabricated
- **Changes in QA/QC:** Mount the entire kit
