CRP6 ColdBox testing update

11/28/2023

Roger, Cheng-Ju, Volodya

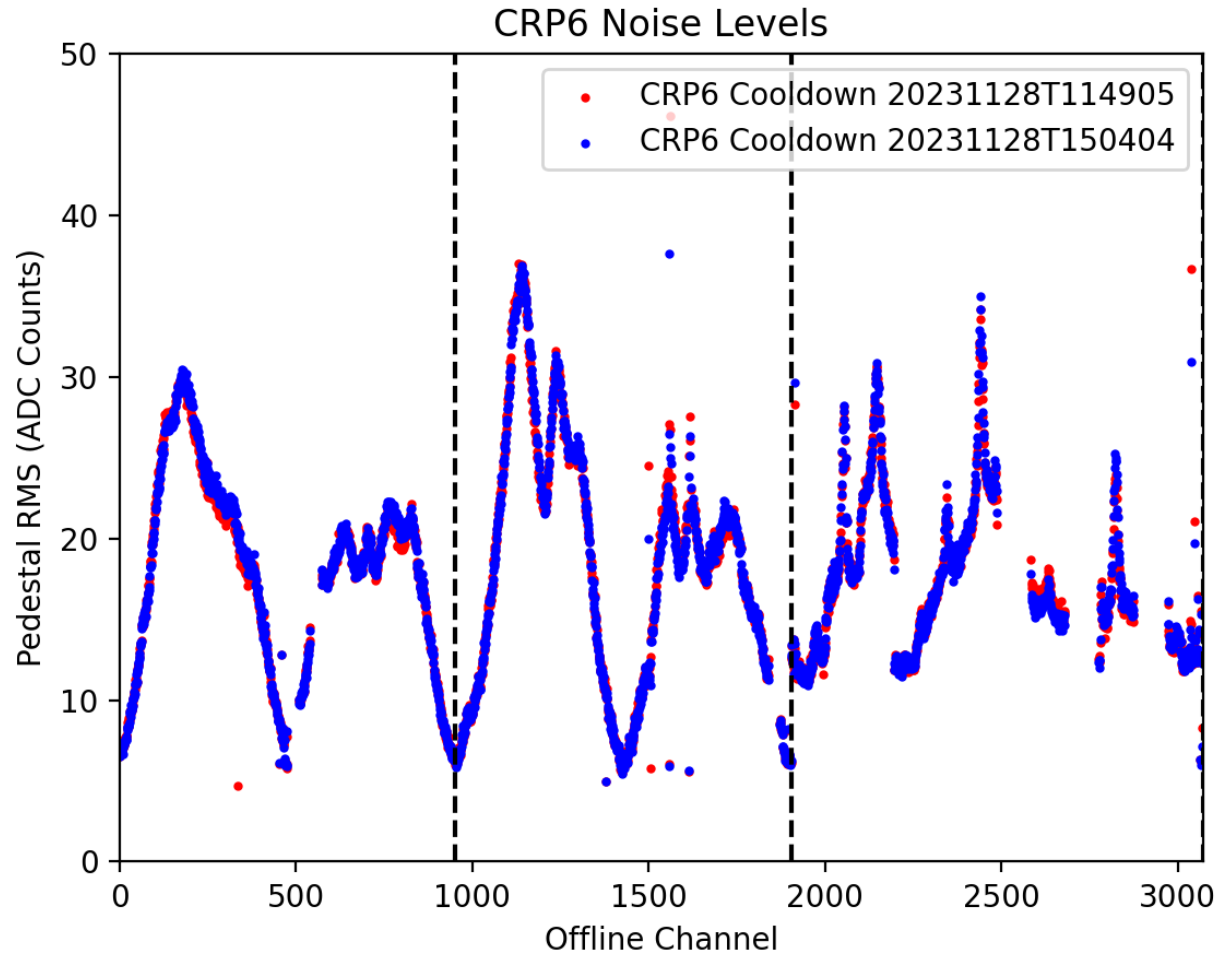
CRP6 noise before and after several tweaks of grounding on top of ColdBox (see next slide)

... not much difference

- 1) Heaters disconnected and related PTs; flange covered.
- 2) Disconnected CRP metallic frame temperature probes at the flange and terminated
- 3) Connected Cathode HV cable at the Power Supply
- 4) Sealed remaining gaps around the lid with Al foil
- 5) Tightened ground plugs on camera flange.

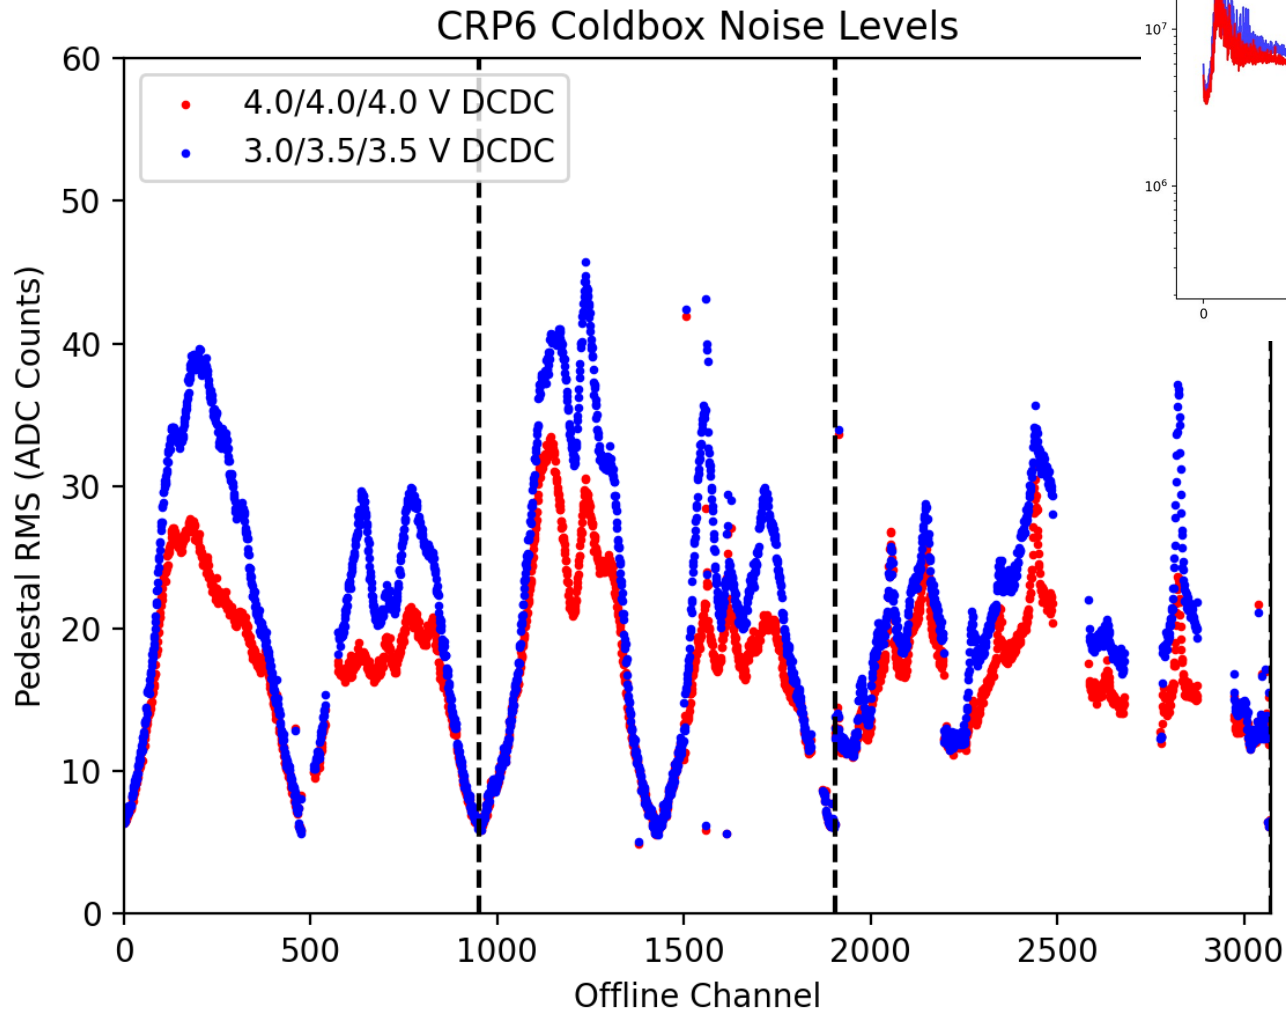
Lower DCDC power settings – noise gets worse

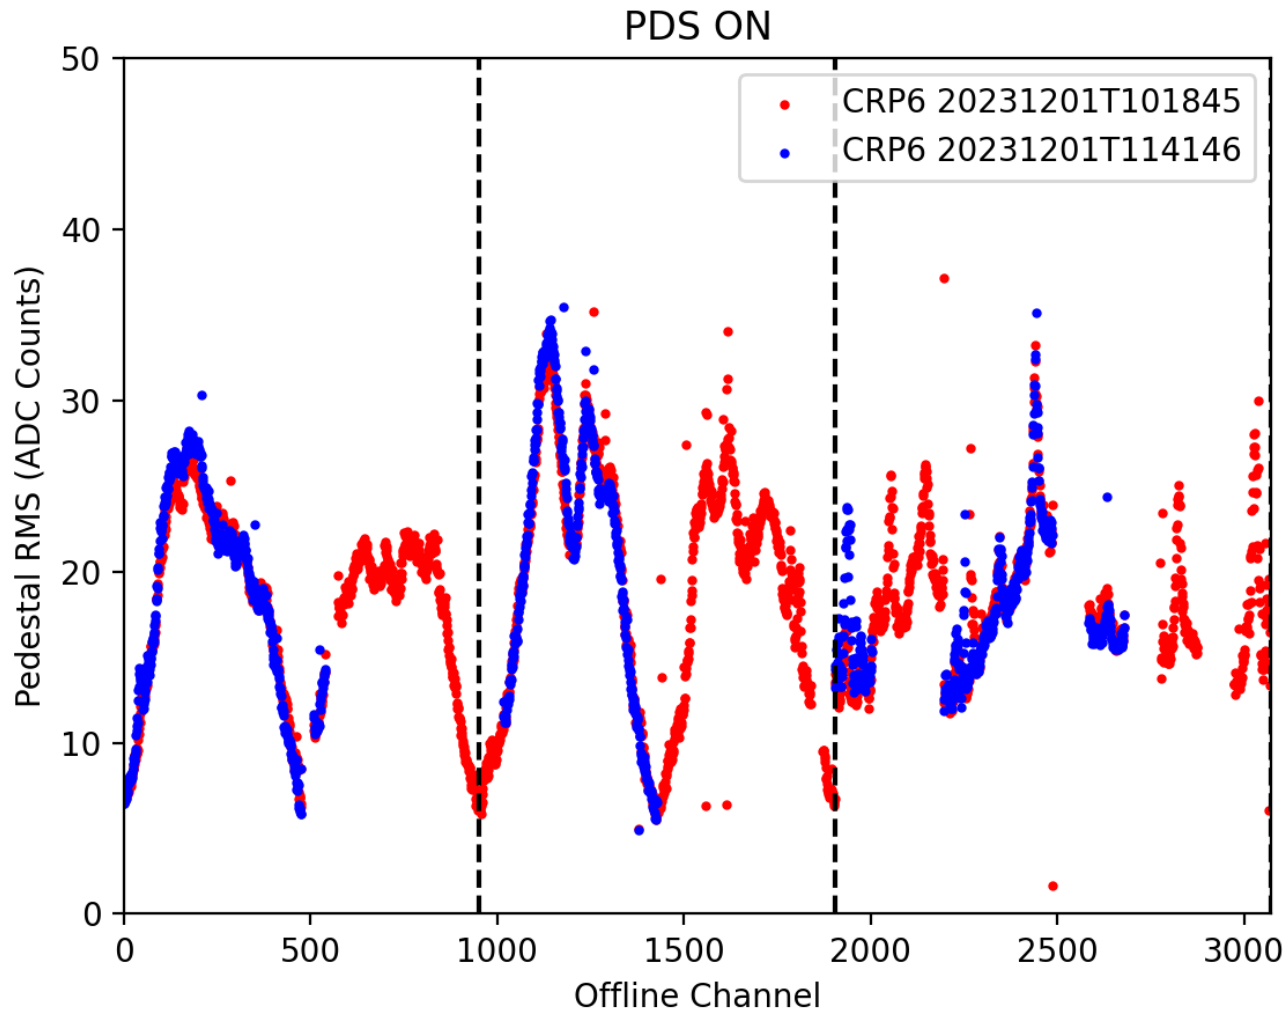
PDS ON (blue) vs OFF (red)

We don't know why some FEMBs are missing – the DAQ said there were no error messages during the run.

No noticeable effect due to PDS.

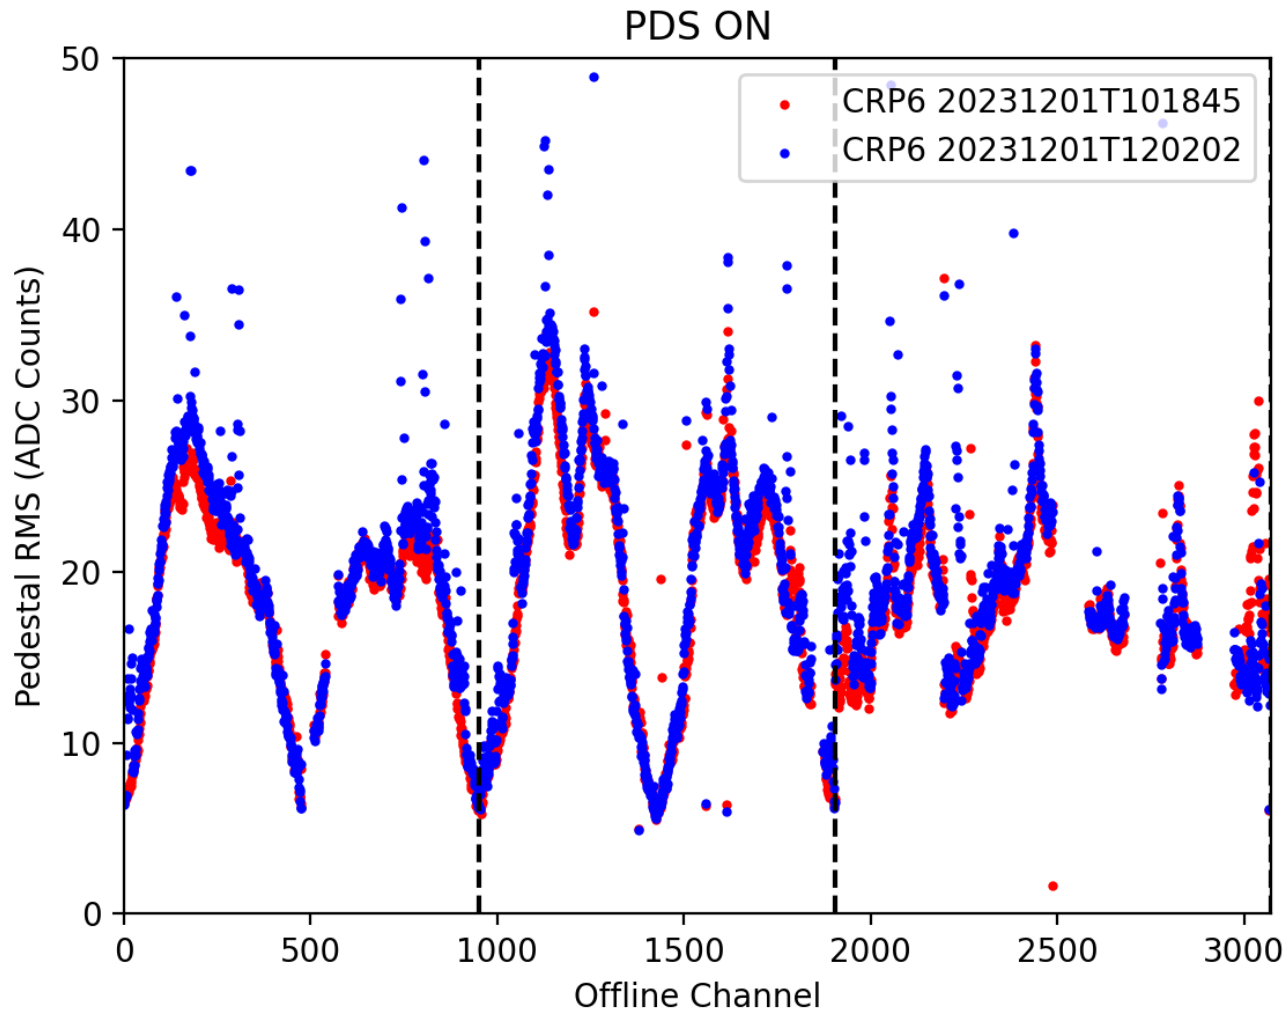
PDS ON Cathode ON (blue) vs PDS OFF Cathode OFF (red)

The extra “noise” is due to charge collection (HV is on).

No noticeable effect due to PDS.

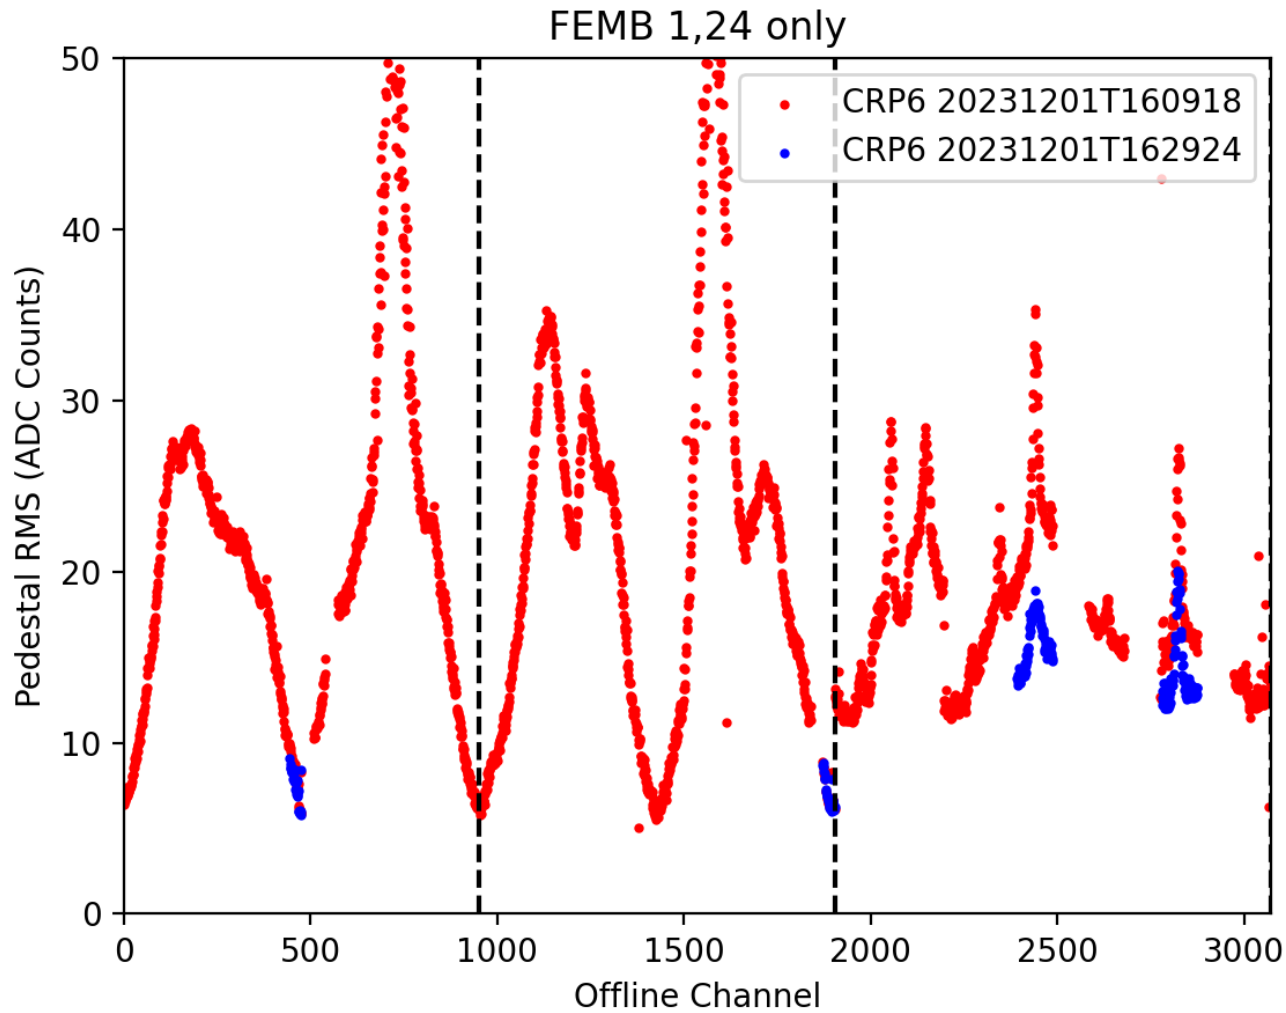
With FEMB 24 powered ON alone the noise is lower, but the peak structure persists.

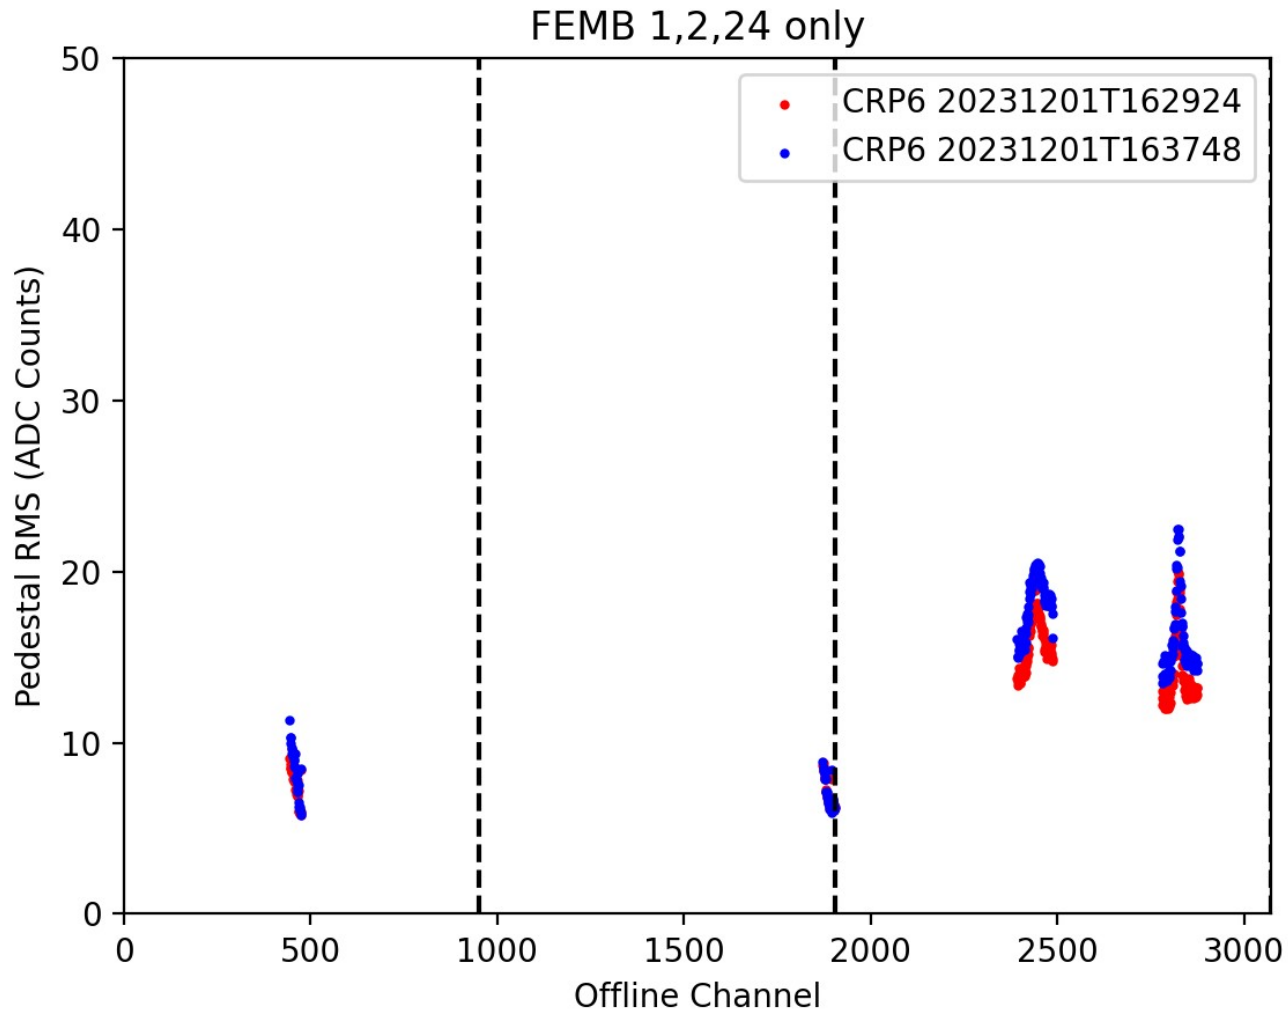
The noise on FEMB 24 went down. Is this due to interference between FEMBs 1 and 24, or the noise conditions in the ColdBox are changing?

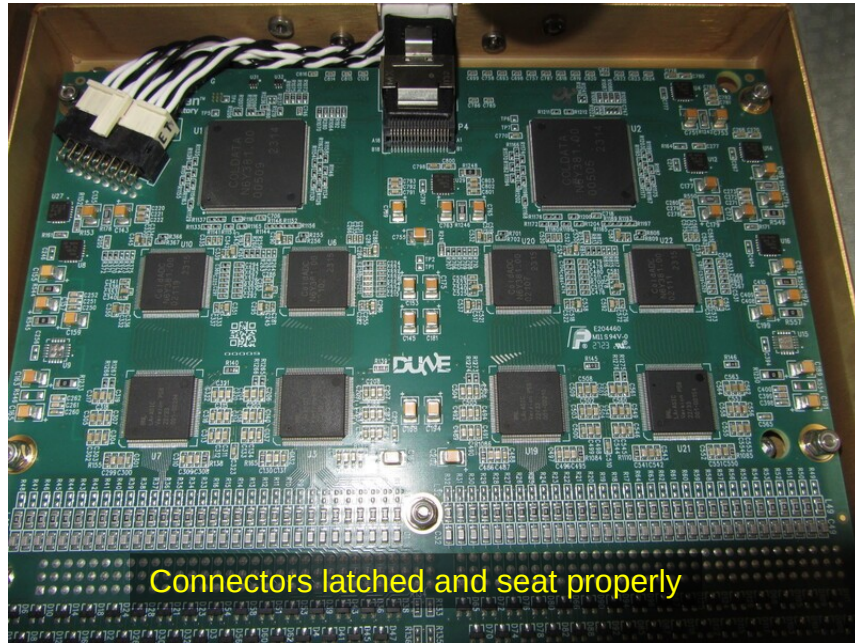
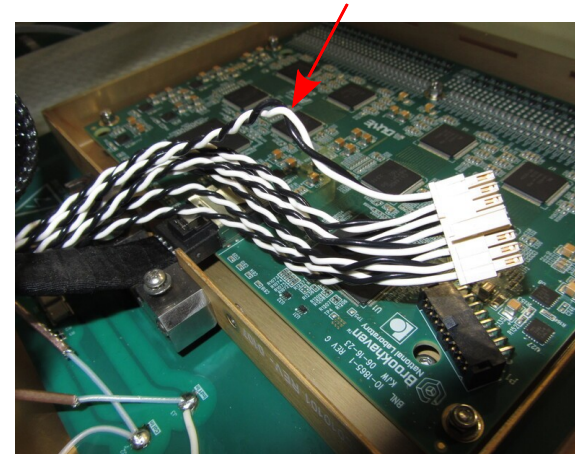
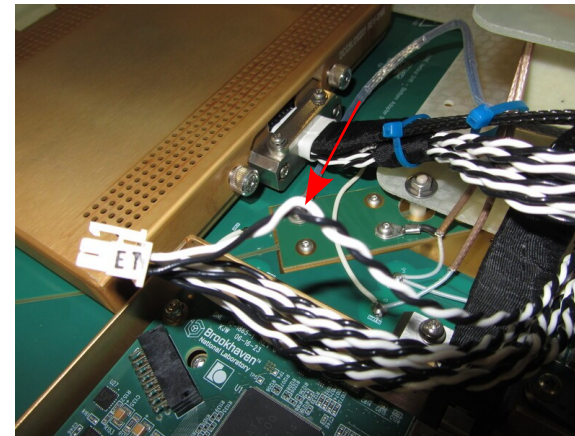
12/06/2023 FEMB-10 investigations

- Activities:
1. Dominique and Serhan lowered CRP6
 2. Confirmed low current in FEMB10 (expected ~2.4 A, measured 2.09 A at PS)
 3. Opened FEMB 10 for visual inspection. No obvious problems observed.

4. Unplugged power and signal cables from FEMB 10 and plugged into a spare FEMB. Observed 2.39 A at PS with the spare FEMB – good.
Conclusion: Problem with FEMB-10?

5. Plugged power and signal cables back to FEMB 10. Observed 2.44 A at PS – back to normal.
 6. Conclusion: The problem must be with cable of connector at FEMB side, or with FEMB 10 itself. We did not disturb cables at the patch panel nor at the CE flange. The good news is that those connections most likely are Ok. The only potential problem we see is a suspicious kink and “week when wiggle at the kink” on the one white cable as indicated by red arrows.

7. We tried to wiggle the cables, but could not reproduce the low current situation anymore.
- Recommendation:
- * Replace both FEMB10 and short cables for FEMB10 / (only the power cable?).

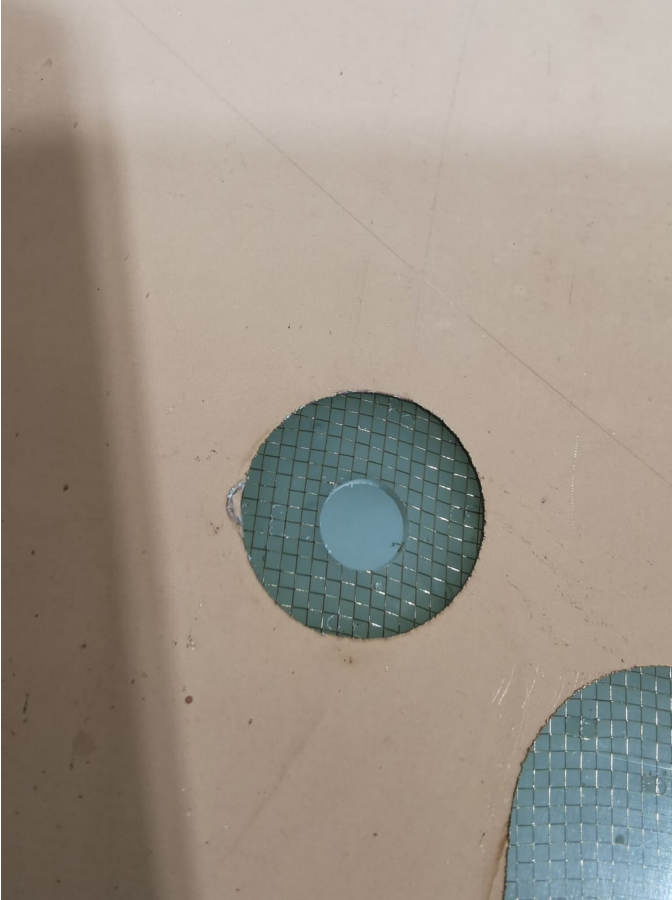
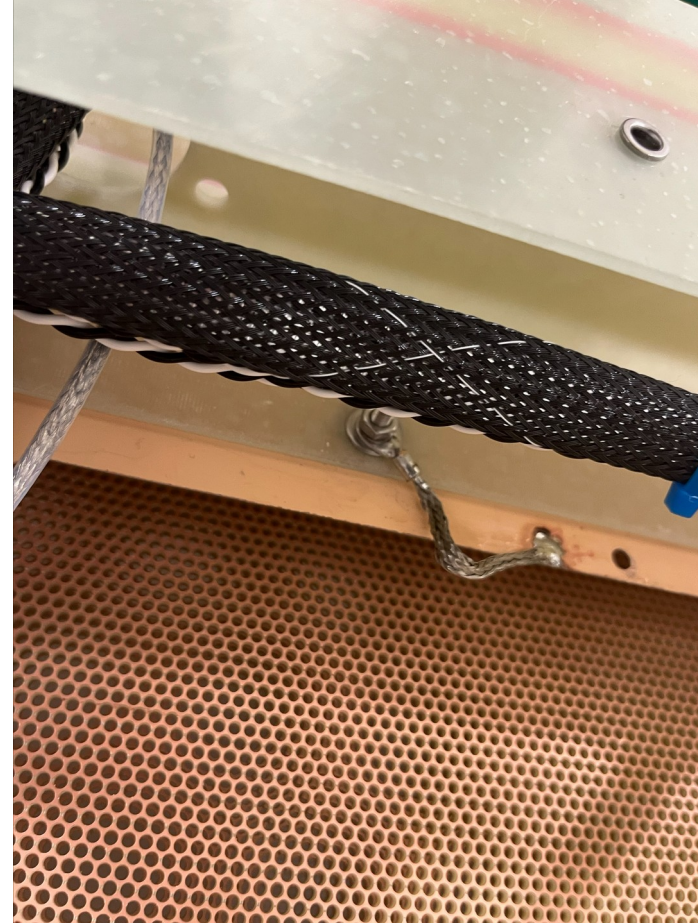
December 13, 2023: Ground mesh is grounded to Copper Plane for the 2nd CB test – from Chris.
