# **CRP6 Coldbox Results**

Roger Huang, Cheng-Ju Lin, Volodya Tishchenko CE Consortium Meeting 12/5

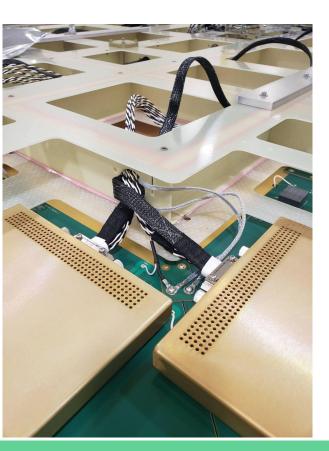
#### **Ground Mesh**

- CRP6 tests a design with a bronze mesh built into the composite frame, with grounding braids screwed into it and going to the FEMBs
- Multimeter measurements showed resistances of >= 0.8 ohms between the FEMBs and the ground mesh

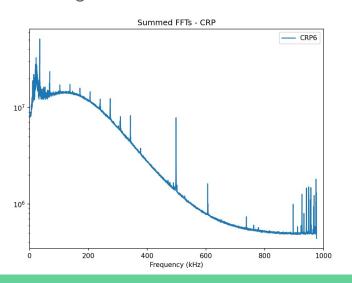
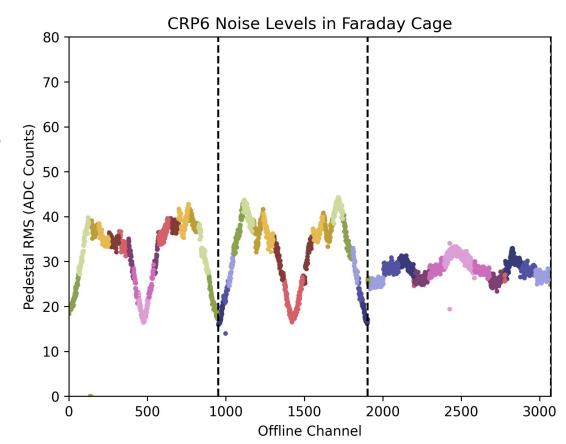
# Faraday Cage Tests

- CRP6 tested in Faraday cage in EHN1 first
- Unexpected noise patterns already visible, and baseline noise higher than seen in CRP4/5

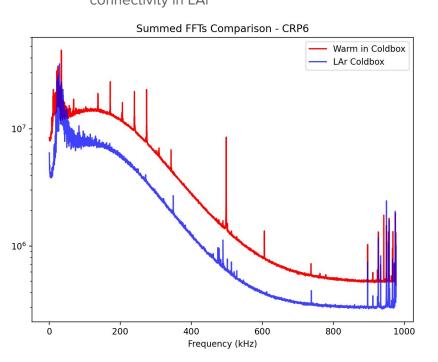
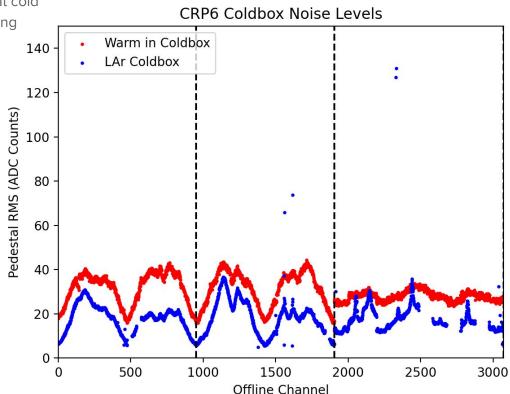
#### **CRP6 Coldbox Noise Performance**

• Noise levels didn't worsen, but remained suboptimal at cold

We observe the same old problems with channels losing connectivity in LAr

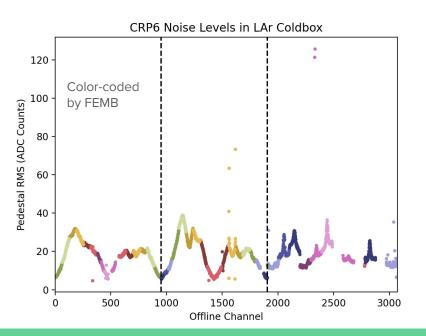
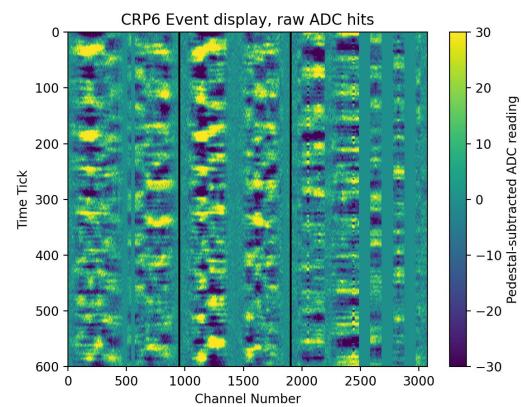
#### CRP6 Noise Performance in LAr

Noise is coherent within sections, but not across the whole detector

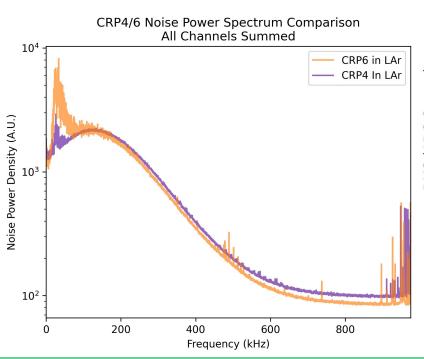
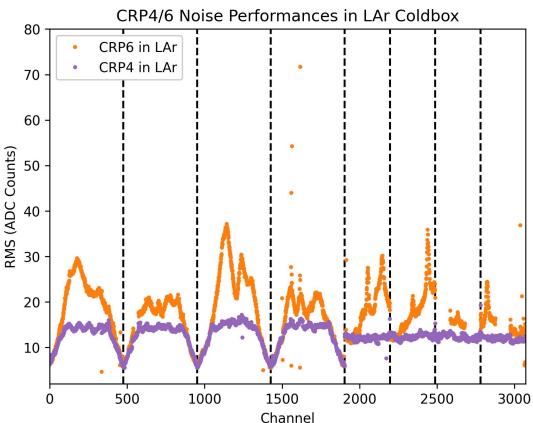
# CRP6 / CRP4 Comparison

Worsened performance in CRP6 largely comes from increased magnitude and width of peak around 25 kHz

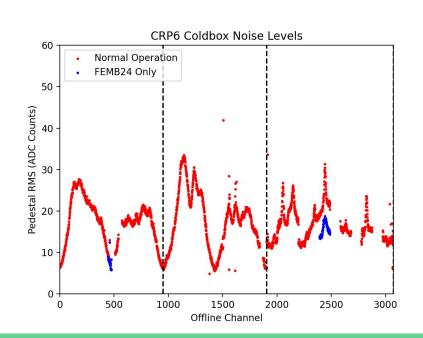
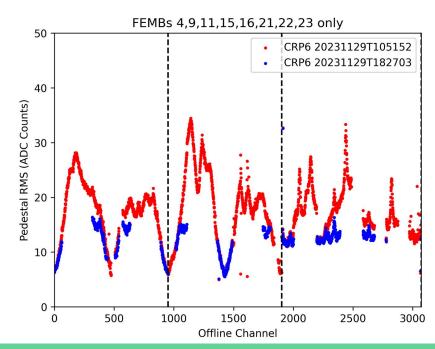
#### **CRP6 Noise Studies**

- Noise levels are better when only some subset of the FEMBs are powered
  - Consistent with power/grounding issues as the cause of excess noise

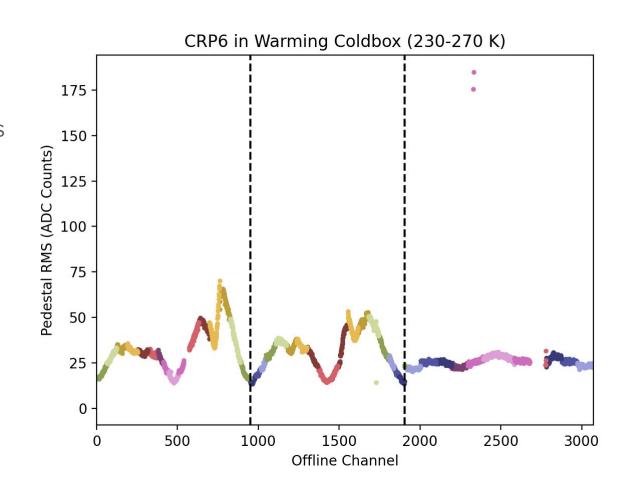
# Channel Connectivity

Most of the channels
with broken
connectivity
recovered
themselves during
warmup
