# IERC Facility Update

Dave Pushka

IERC Managers Meeting

25 January 2024

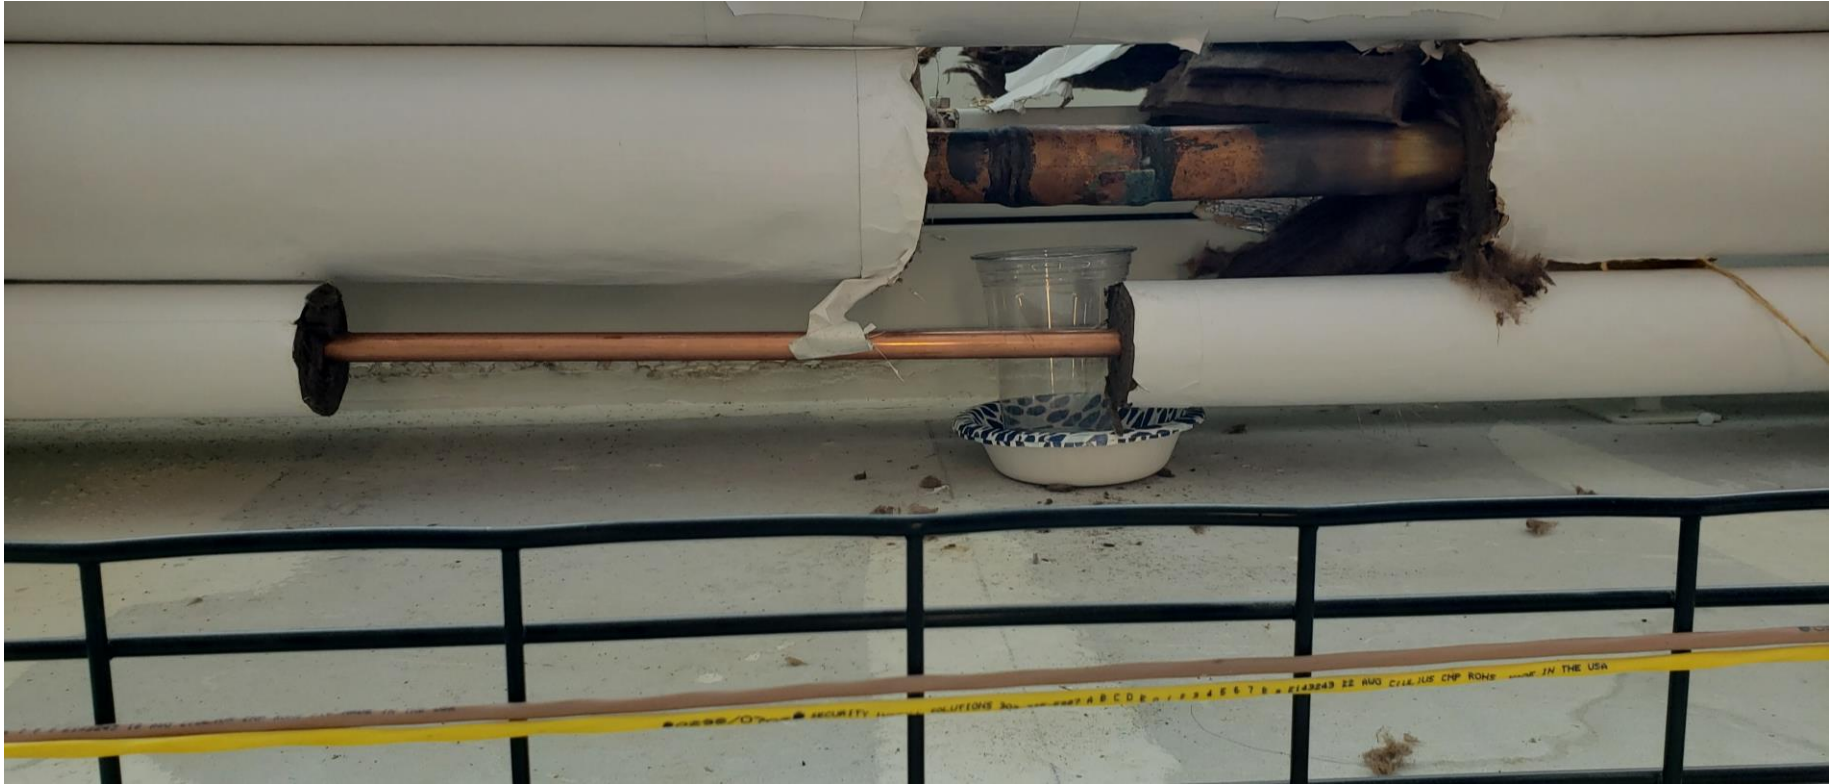
**1.5 Inch Brazed Copper Pipe for heating located above office 1770 (IERC West Side, Upper Level). Appears to be very poor quality braze joint with perhaps a patch (see next slide). This should not have been accepted by the construction management people.**

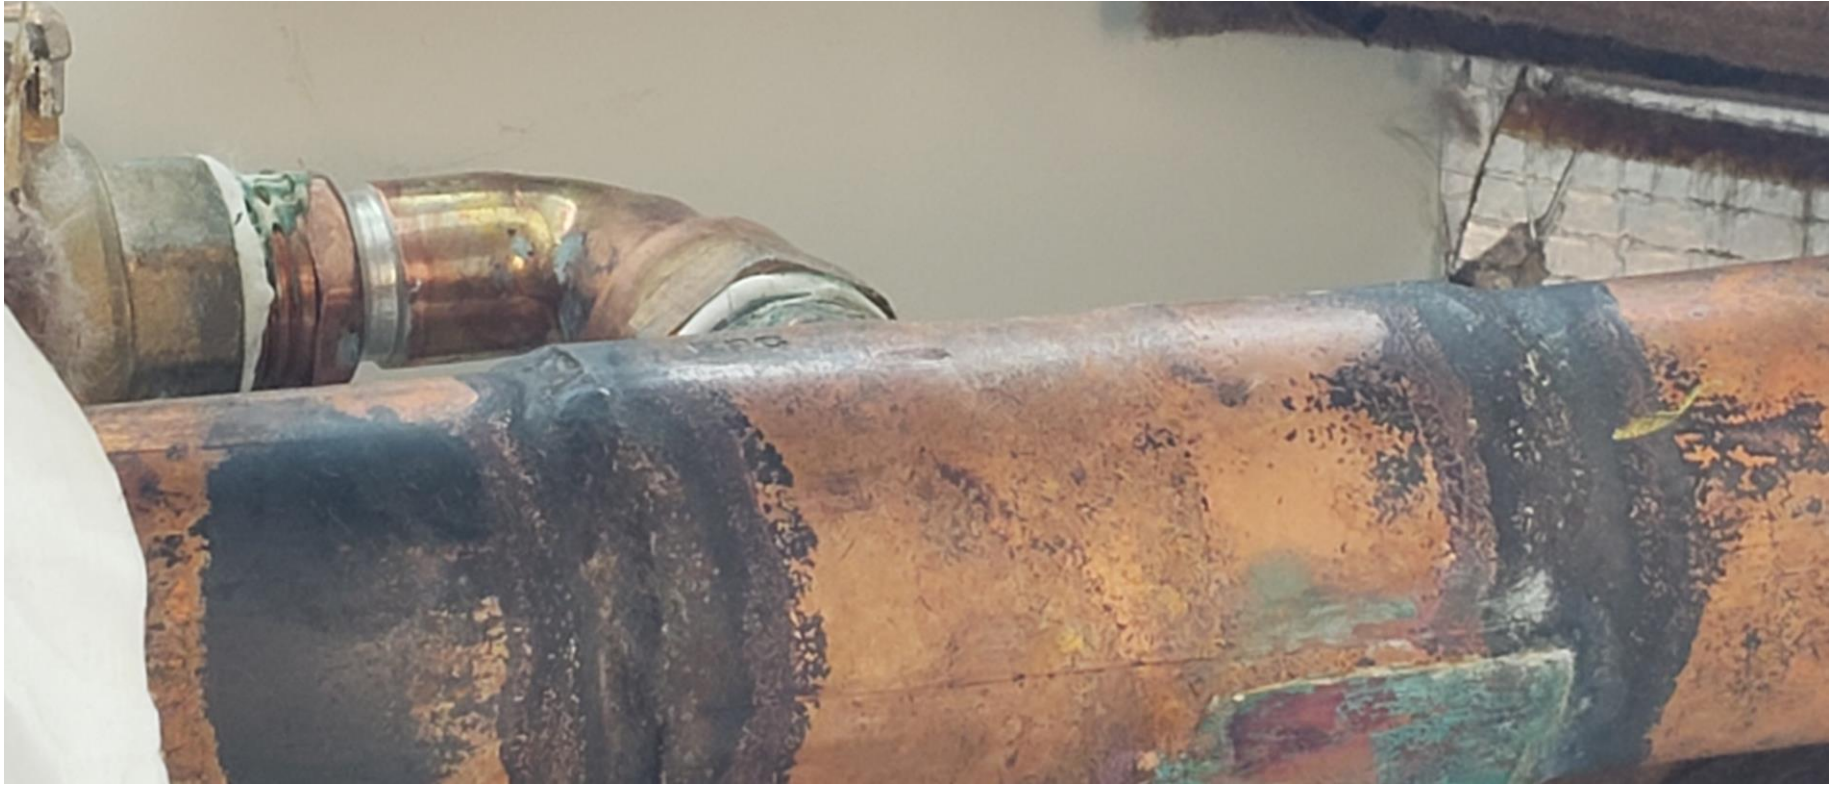
**Behind the 1.5 Inch Brazed Copper Pipe is an elbow with a threaded connection. It may be that the threaded connection is where the leak occurred as a plastic cup is placed below the threaded connection.**

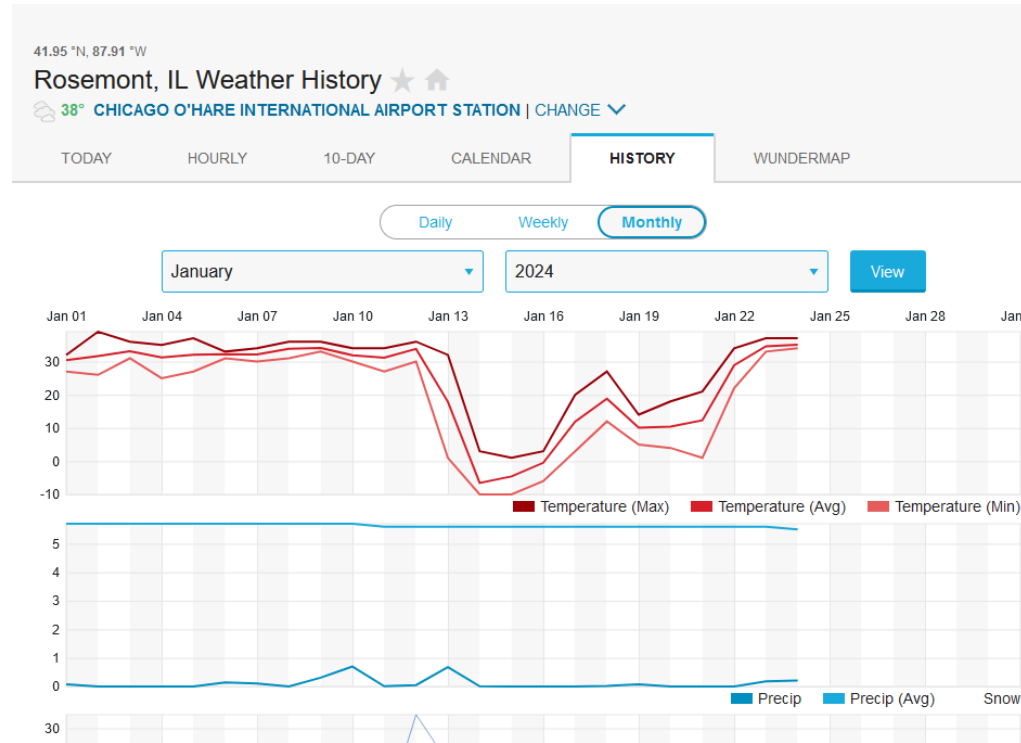
- Never received feed back from ISD on the low temperatures during the week of 1-15 to 1-20-2024
- A plausible explanation is that the building heating system cannot maintain temperature during cold snaps.
