Linac Status (1)

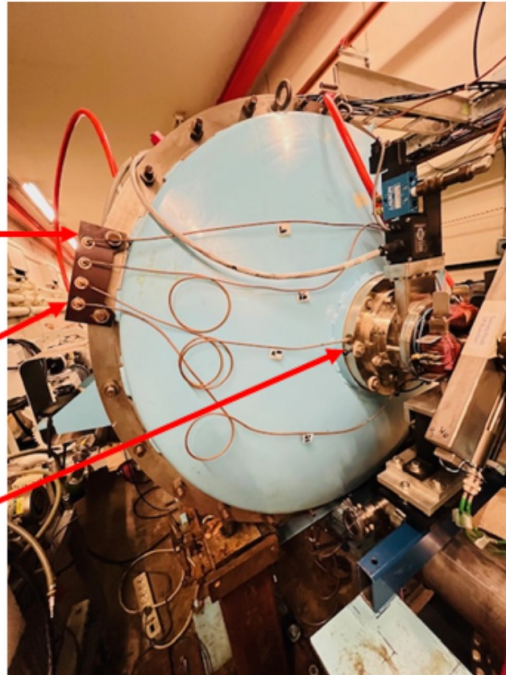
- Linac is in stand-by & supporting studies until beam to users
- Fri Feb 16 controlled access for instrumentation inspection
 - Found damage on BPM5OT connector & BSM HV connector
 - Not critical for beam monitoring – will hold off repairs until opportunistic downtime

Heavy damage to connector on the BPM
Presently the cable/connector goes in at
an angle (maybe 20deg off)
Repair: TBD

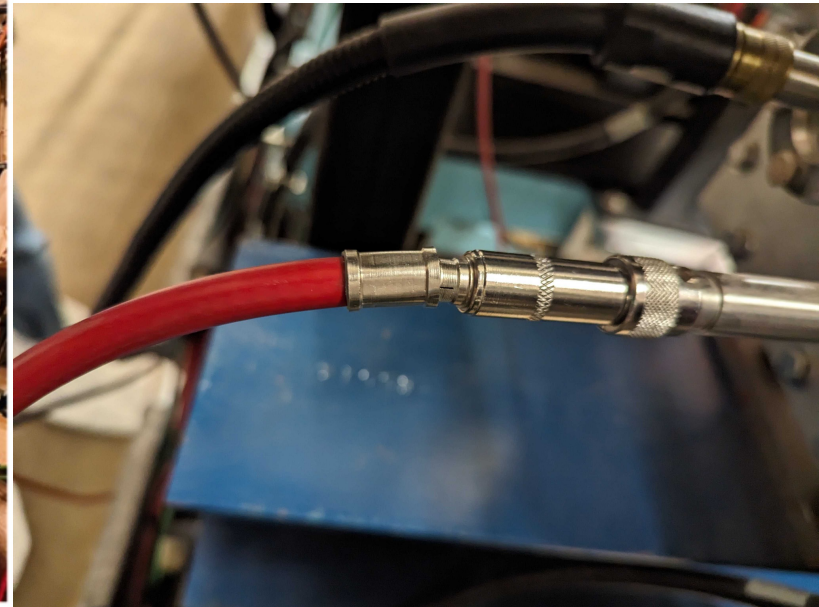
Loose connector
& solder joint at connector cracked
Repair completed: re-soldered and
connector tightened

solder joint at connector cracked
Repair completed: re-soldered

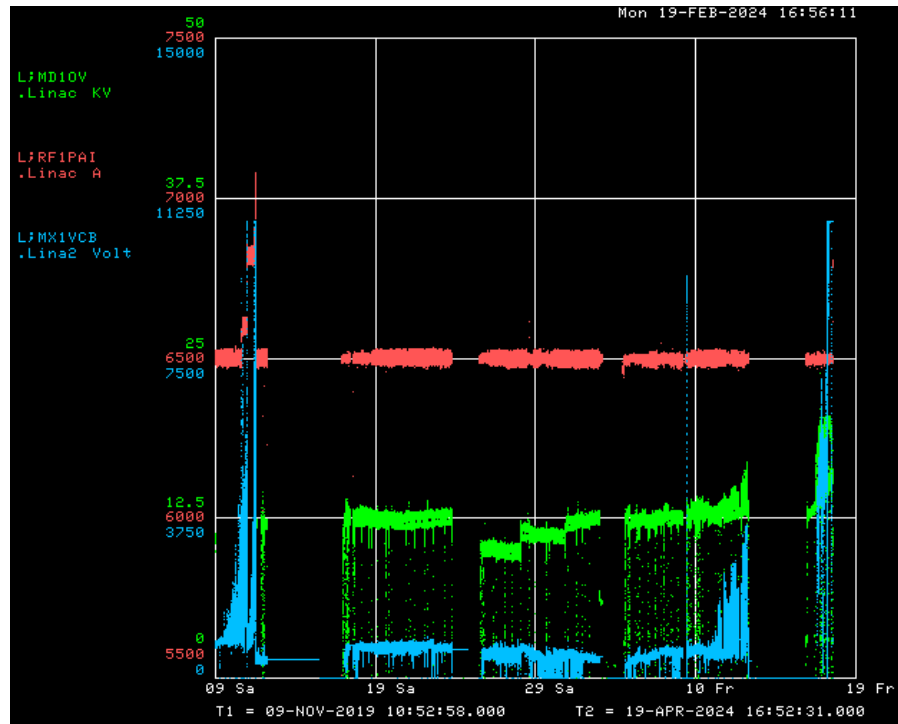
- Over the weekend & into Monday LRF1 OV frequent trips
 - Found indications of tube starving, increased filament current & issue was resolved

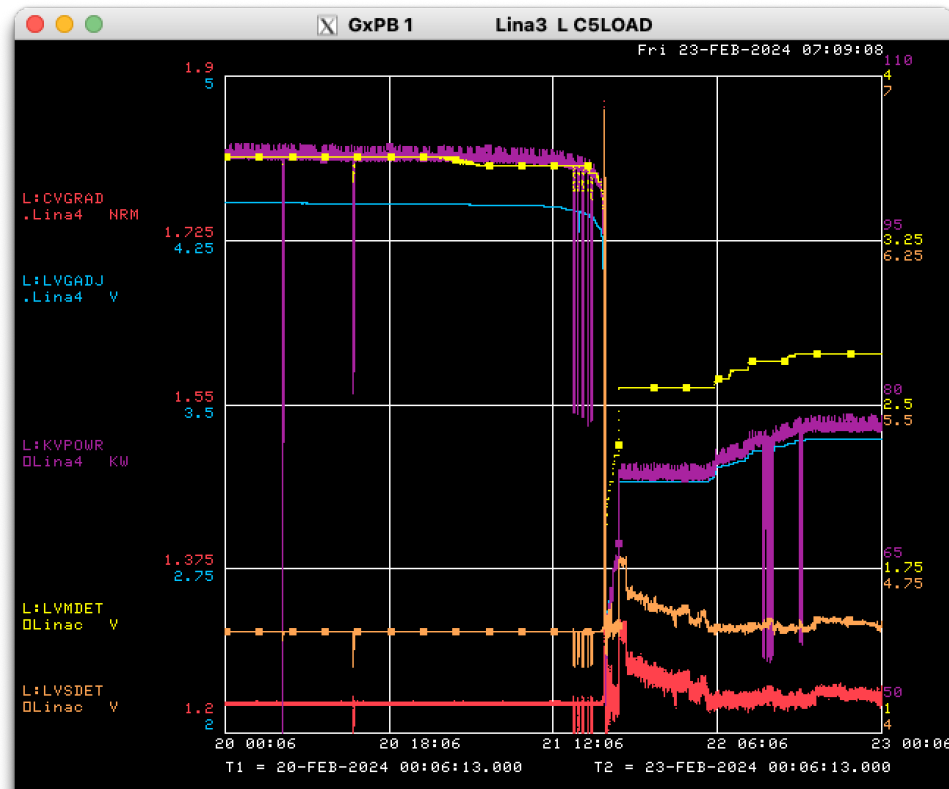
- Over the weekend & all week issues with KRFV (Vernier) cavity gradient regulation
 - Currently investigating, possible loose connection on LLRF board or board needs replacement
