Lawrence Berkeley National Laboratory Nonconformance Report (NCR)

Date: 11/8/23 QA Doc #: **MQXFA-NCR-0429**

Part Name: MQXFA Test Assy Quantity Impacted: 1
 Part Number: SU-1011-0518G Serial No. (if applicable): MQXFA12
 Additional Notes: _____

MQXFA12 Hipot Weakness Investigation

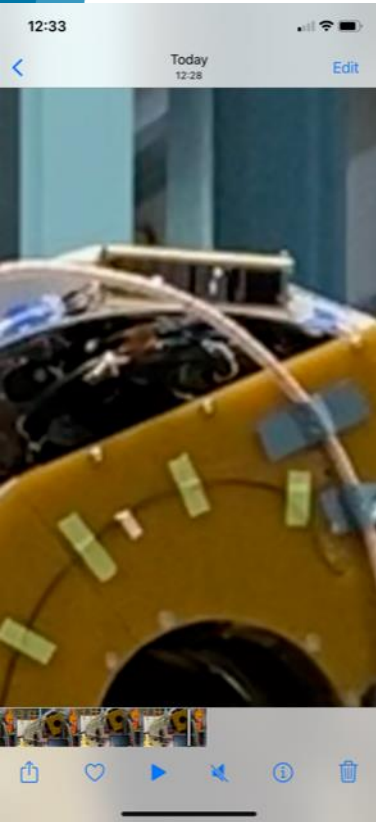
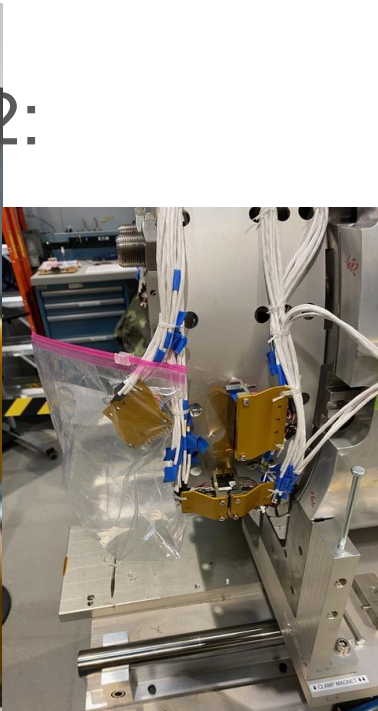
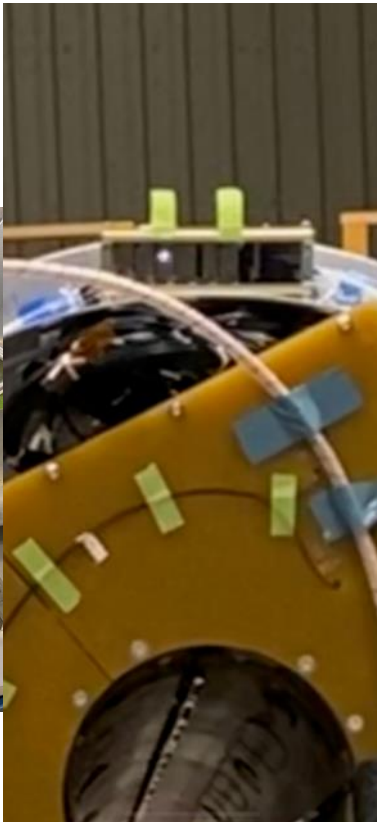
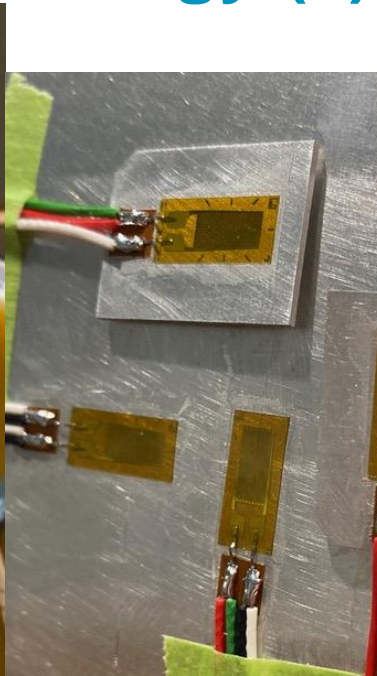
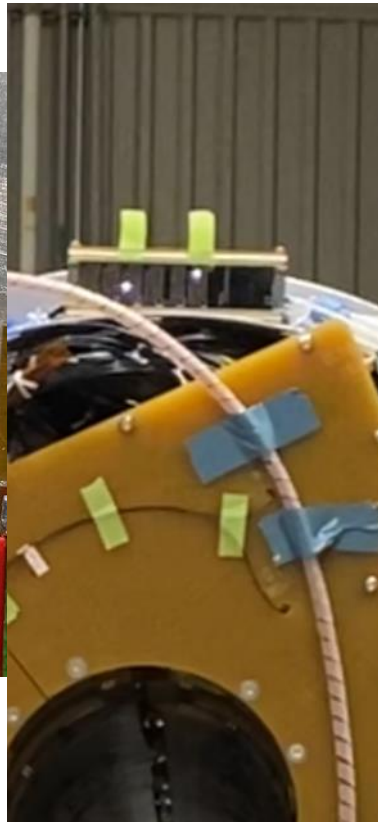
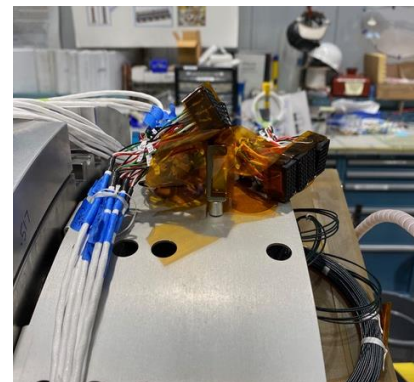
MQXFA12 EQC Chronology (2)

- Day 2 (Tue 11/8):
 - Hipot failed 3.65 kV
 - Video captured simultaneous flashes on pins on LE SG connectors 4-3, 4-6 (Shells/Coils, respectively)
 - Disconnected SG harness from RE end (Coils, Shell 7)

- Hipot failed 3.67 kV
 - Video captured flash on a single SG pin on 4-3 (shell)
 - Noticed Shell gauge with "low wire", attempted to move away from shell; reconnected RE SG harness

- *"Ground to ground" is a strange breakdown...*
 - Hipot failed at 3.51 kV
 - Video captured simultaneous flash on single pins of 4-3 and 4-6
 - Disassembled SG connector block on LE

- Bundled 4-1 to 4-3 connectors (shells) and Coils & rods (4-4 to 4-7) separately and protected with Kapton to skirt
 - Hipot passed 3.68 kV
 - FVT connectors (with Axon wires) were not connected to LE skirt yet

- Conclusion and Actions taken:
 - Protection of SG to skirts with Kapton is beneficial, Kapton layer added to LE top skirt

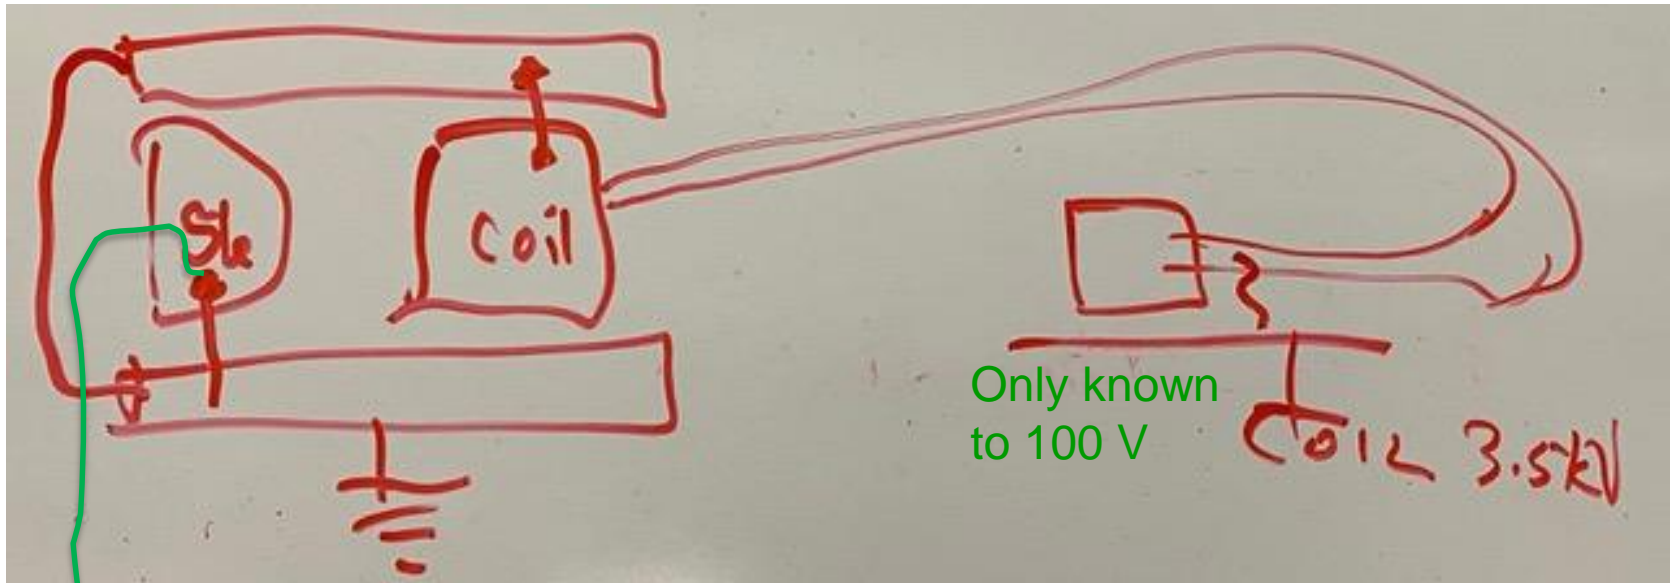
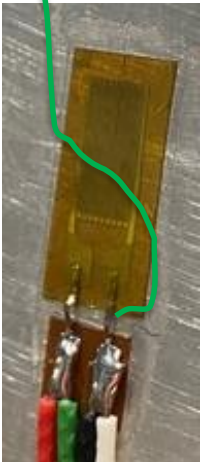
MQXFA12 EQC Hipot Diagnostics

Initial theory of path

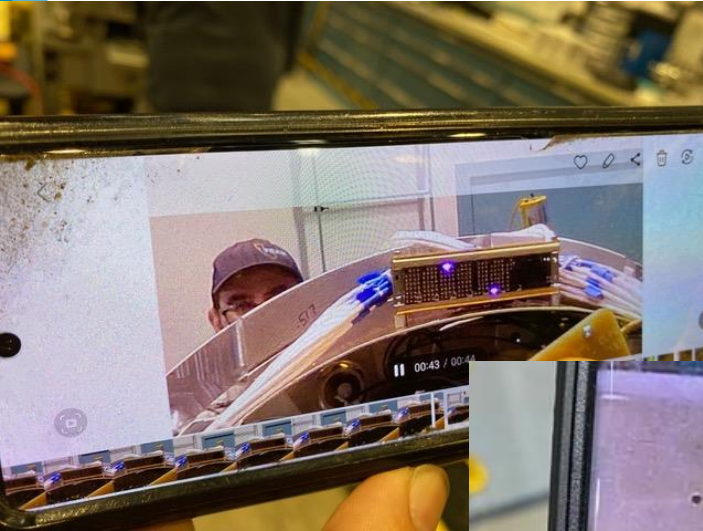
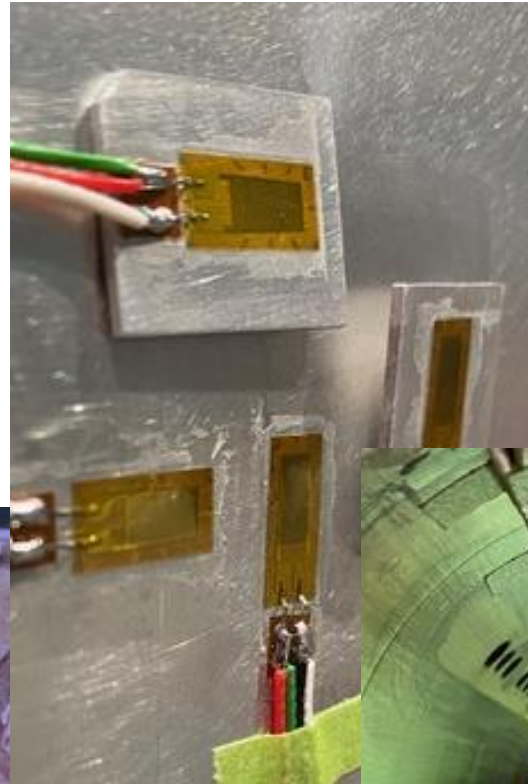
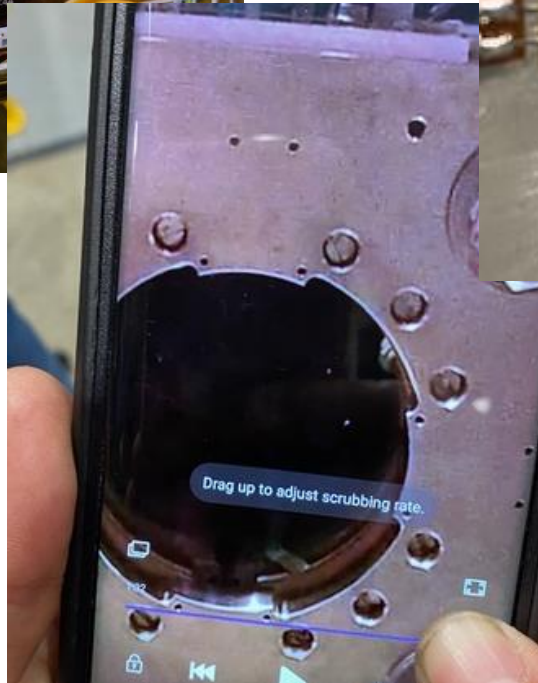
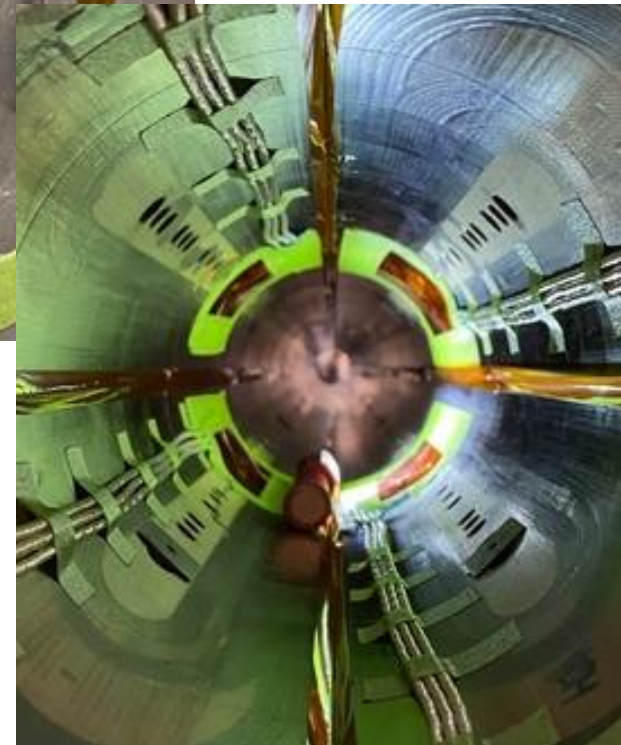
MQXFA12 EQC Chronology (3)

- Day 3 (Wed 11/9):
 - Hipot reached 3.68 kV, failed ~5 sec into hold
 - LE Video captured flashes on pins SG pins still (4-3 to 4-6)
 - RE video also captured flash reflection from Q2 inside bore
 - FVT connectors still not connected to LE skirt yet
 - Conclusion and Actions taken:
 - Remove SG connectors from coil from RE skirts
 - Re-soldered Shell 4RT gauge lead to add relief

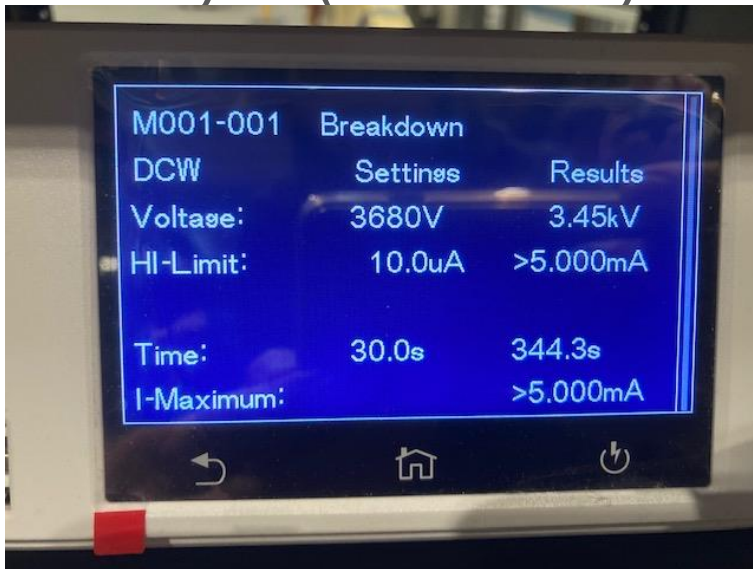
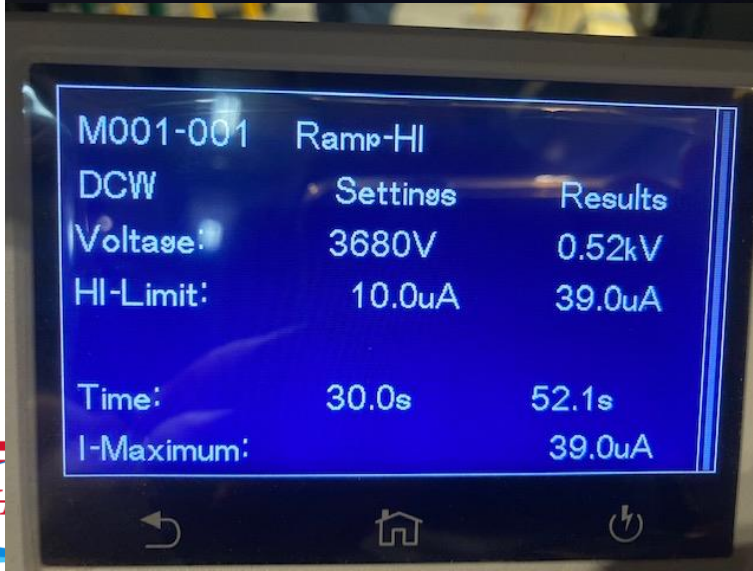
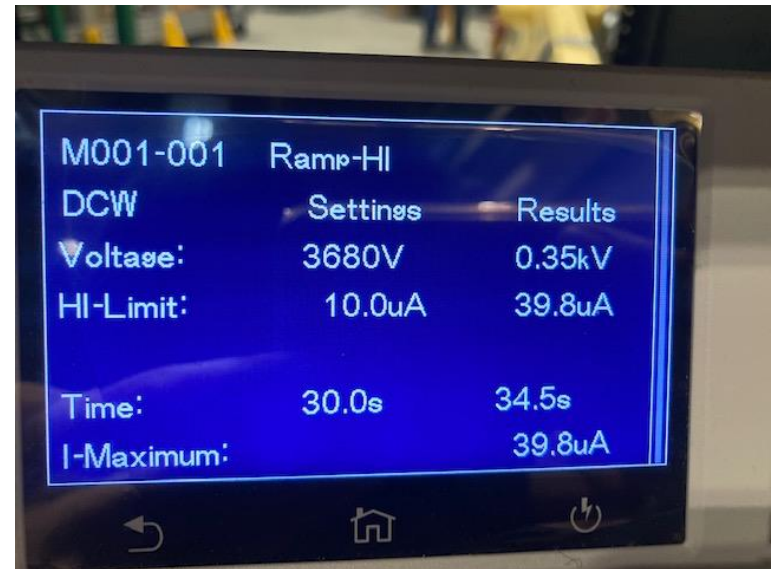
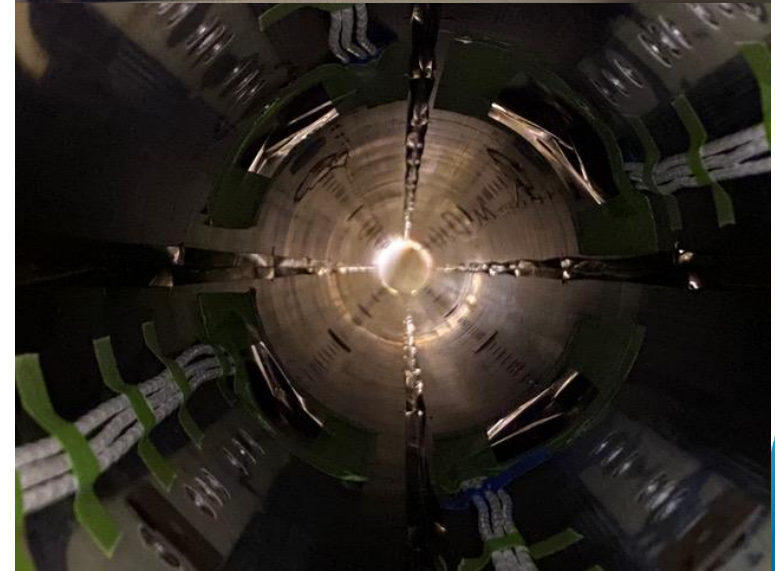
MQXFA12 EQC Chronology (4)

- Day 4 (Thursday 11/10):
 - Hipot coil to structure test failed at 3.45 kV
 - Did not see flash; heard "near FVT, or through bore"
 - Had disconnected RE SG connector block from skirts
 - Hipot test failed with high leak @350 V @39.8 μ A
 - Hipot test failed with high leak @520 V 39.0 μ A
- Diagnostics performed
 - Coil to Structure Open
 - Coil to Pole Diagnostics (11 segments, SG on Segment 10 from LE)
 - Q1: Open
 - Q2: 220 k Ω (Segment 10)
 - Q3: 40+ M Ω
 - Q4: 950+ k Ω (Segments 10, 9)
 - SG wires connected in groups (T, Z, per station)
 - All gauges open to coil

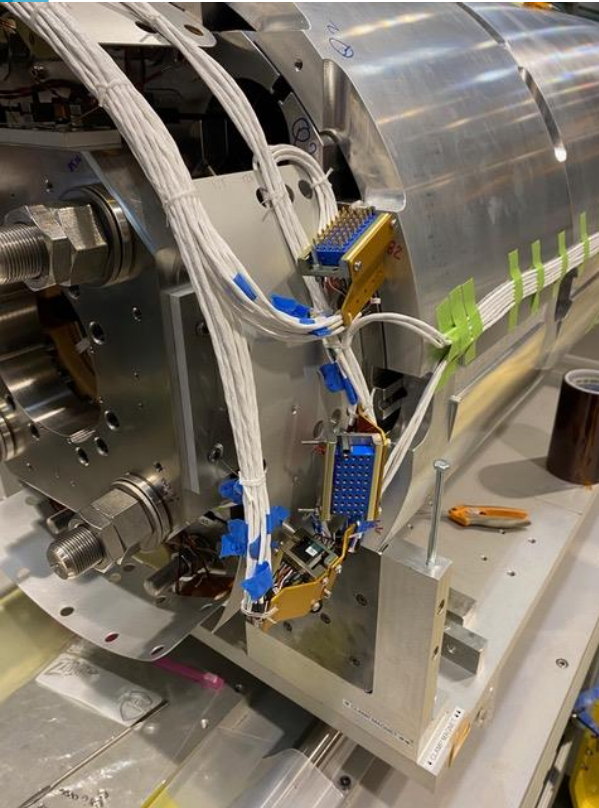
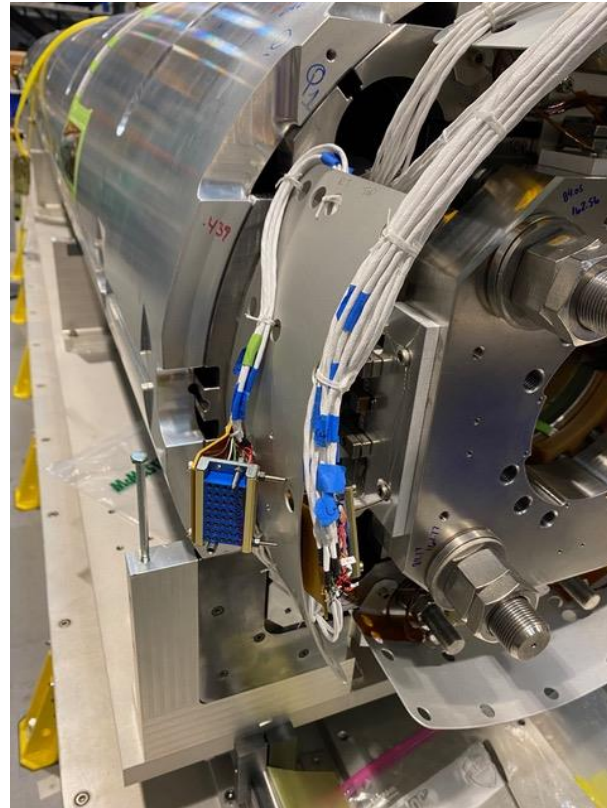
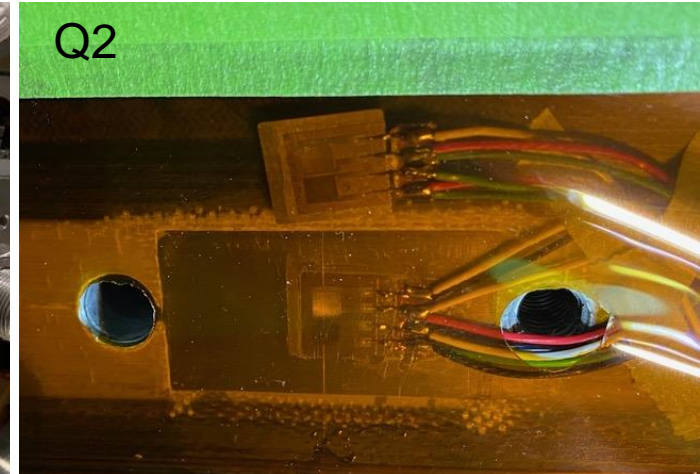
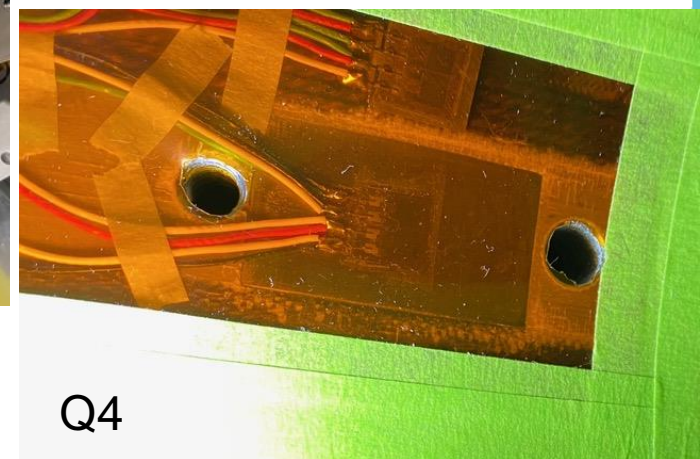
MQXFA12 EQC Chronology (5)

- Day 5 (Monday 11/14):
 - Coil SG connectors still not on RE skirts
 - Coil-Pole Diagnostics (11 segments, SG on Segment 10 from LE)
 - Q1: Open
 - Q2: 238 k Ω (Segment 10)
 - Q3: 35+ M Ω (Segments 11, 10)
 - Q4: 66 k Ω (Segment 10,9)
 - Pole-Structure continuity
 - All coil poles open to Structure
 - Coil-Structure continuity is open
 - Have not performed any operations since before the weekend

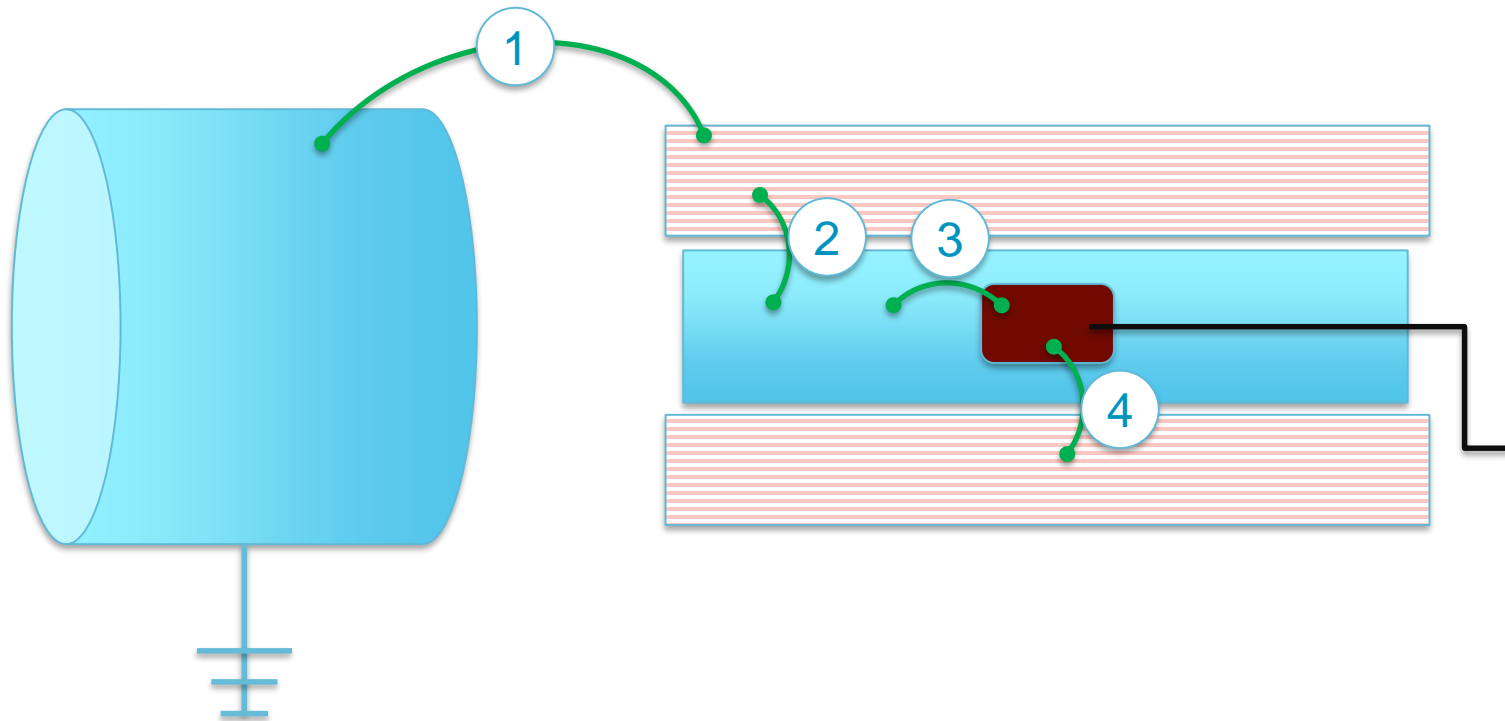
Present Continuity Checks

Pair	Status	Notes
1. Coil to Structure	Open	
2. Coil to Pole	Q2, Q4 weak	Passed 100V acceptance initially
3. SG to Pole	Open	
4. SG to Coil	Open

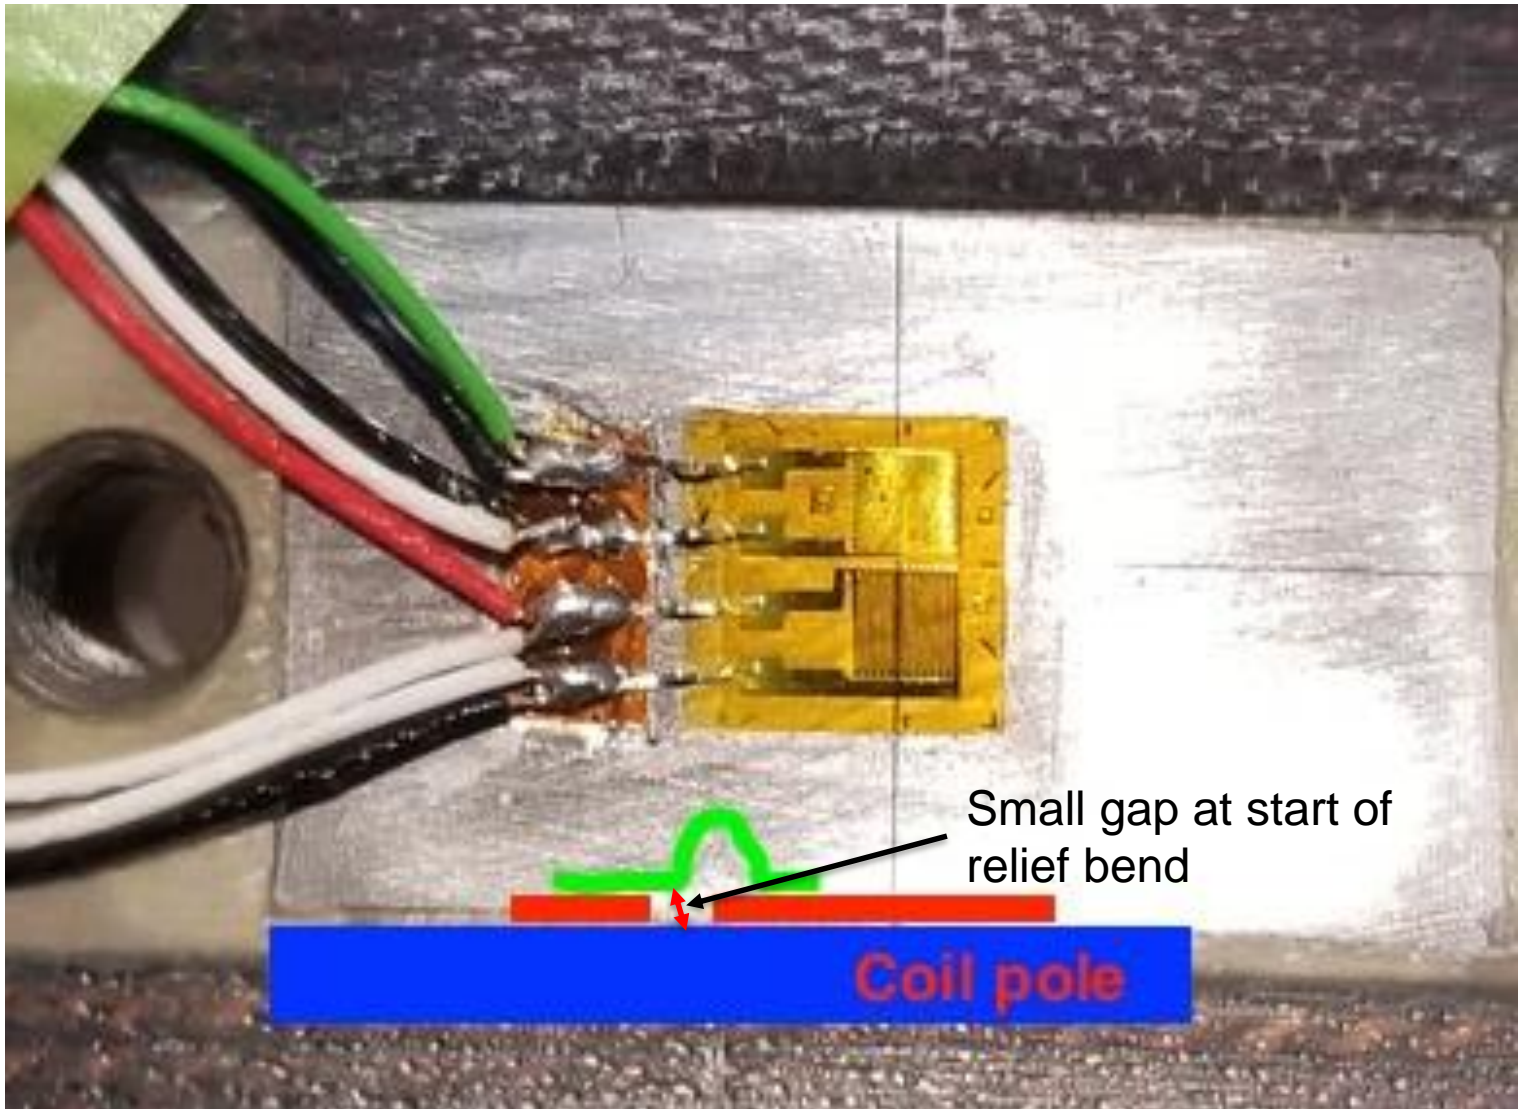
MQXFA12 Coils SG installation (several)

- Coils and SG all passed earlier (post-preload)
 - May still have had a weak condition that eventually broke down: coil-pole + coil SG-ground
 - Unknown: Coil-Pole integrity above 100 V
- Coil SG was installed by a new technician
 - Also reused some wiring from MQXFA06
- Shell 4RT gauge had a "close" wire to shell
 - After repair initially passed
