Luis Manzanillas 2024.03.27 LAPP

Context

Parameters for QA/QC

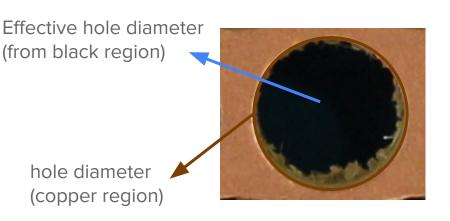
Bad Cu/drilling quality

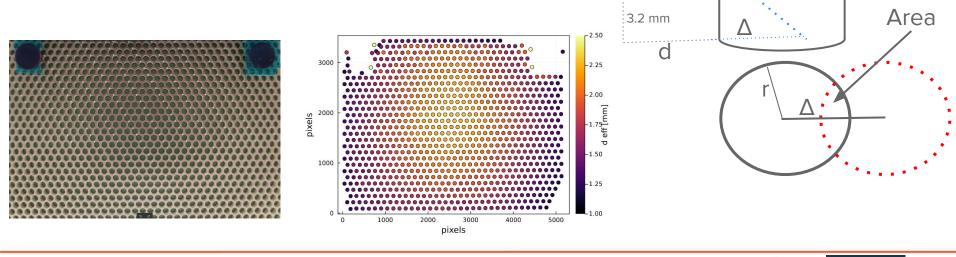
Results CRP7 - effective hole d

- Camera is placed above center of each photo
 - Shadow effect if go far away from the center
 - Given by distance of camera to anode and anode thickness
 - To look for small effects a correction is needed

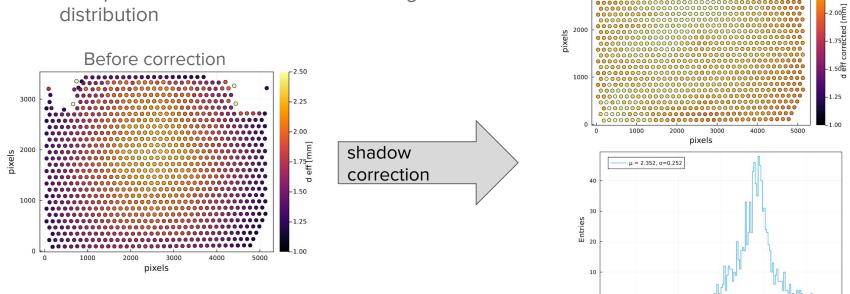
- Introduce a correction as described in previous slide
- If no problem we should have a "homogenous distribution

After correction

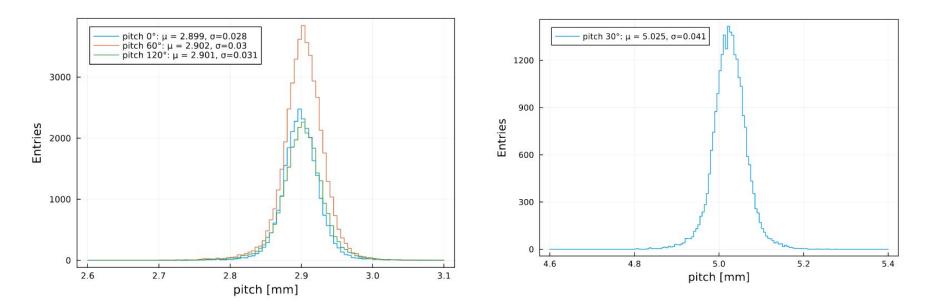
Pitch distribution

In general homogeneous everywhere

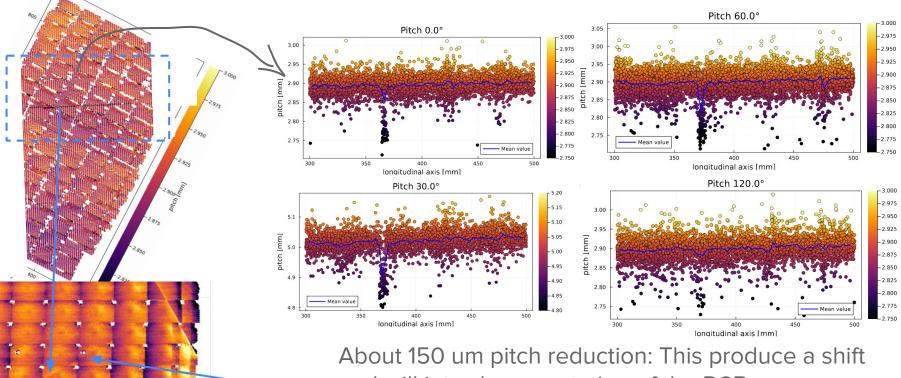
Pitch variations

and will introduce a rotation of the PCBs Can we see this effect in the photos?

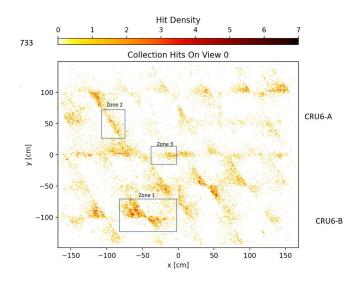
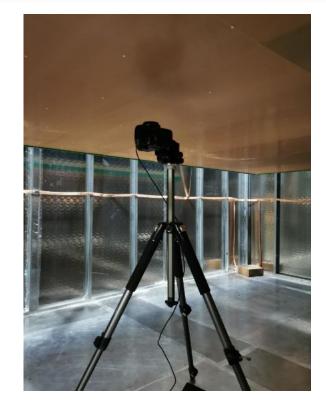
- Dominique photographed 3 regions of shield PCB of CRP 6 when suspended in Faraday cage after second cold box run
- Use analysis to confirm shift of PCBs in problematic regions

- Conditions less well controlled than when using setup in clean room
- Nevertheless:
 - A shift is clearly visible 0
 - Corresponds with pattern observed by Laura 0
 - The effective hole diameter in the worst part is 0 about 1.9 mm

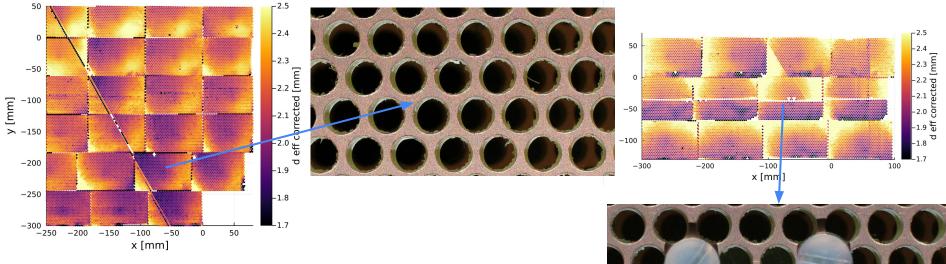
CRP6: Zone 2 and 3

- Same effect as in Zone 1
- Shift clearly visible

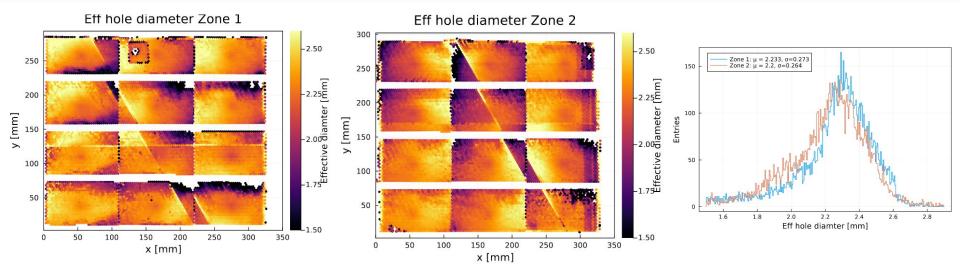
Effective hole diameter Zones 1 and 2

- Shift still present in both zones: Larger in Zone 2
 - Sanding the border of the PCBs seems to improve the alignment but shift still present
- Small rotation produces such a shift
 - If systematic reduced pitch (~150 um) pattern ~each 50 cm in all PCBs, then this can produce a rotation resulting in a shift (misalignment)
 - Do we have everywhere this reduced pitch pattern? -> Check Zone 3 of this new PCB to confirm effect

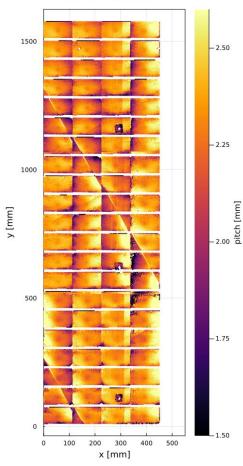
Effective hole diameter Zone 3

- Most of the regions show a very homogenous response
- Some shift is present but smaller than Zones 1 and 2
 - Effect might depend on the order of gluing: more shift in the parts glued at the end?
