CRP6 BDE Updates

CRP Consortium Meeting 4/24/2024

CRP6 BDE-related Changes

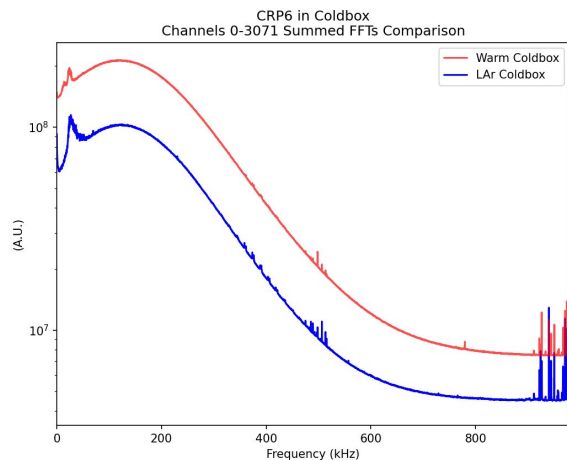
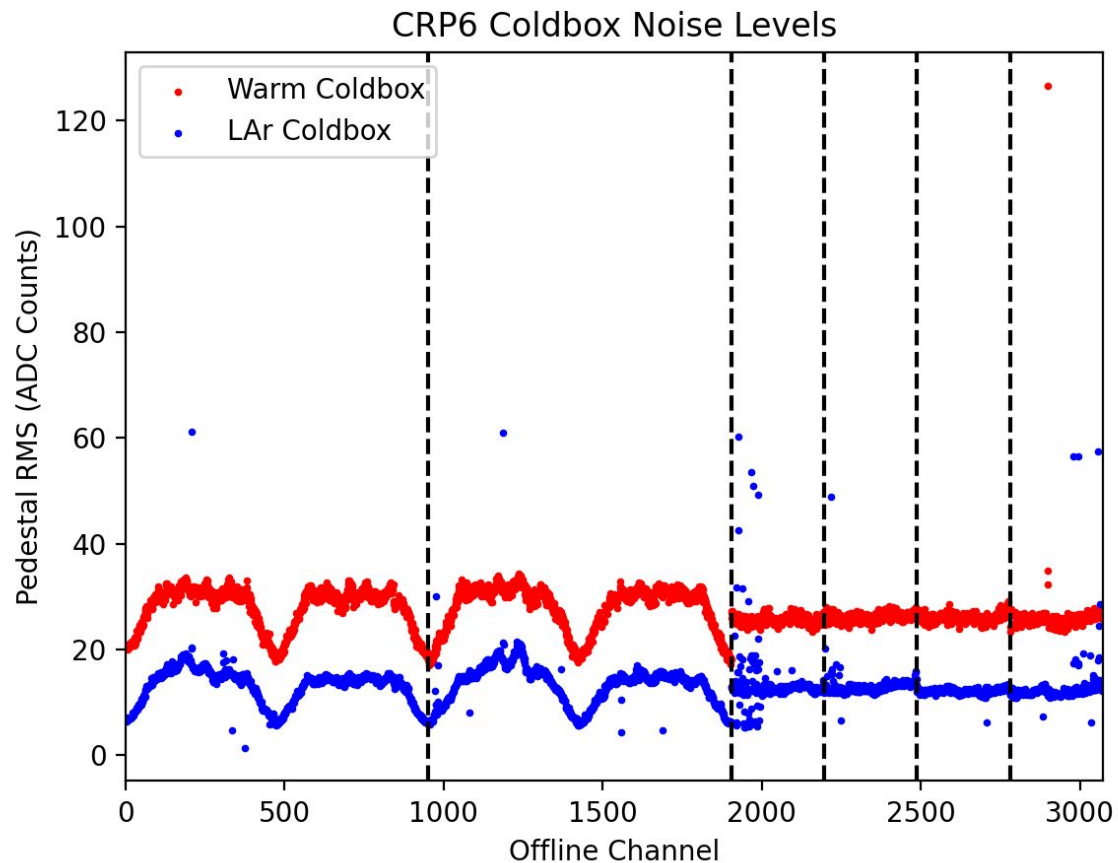
CRP6 Cooldown

- CRP6 cooldown saw the loss of several channel connections, in particular in one corner of B-side X plane
 - Like last time, these started appearing while still in gas

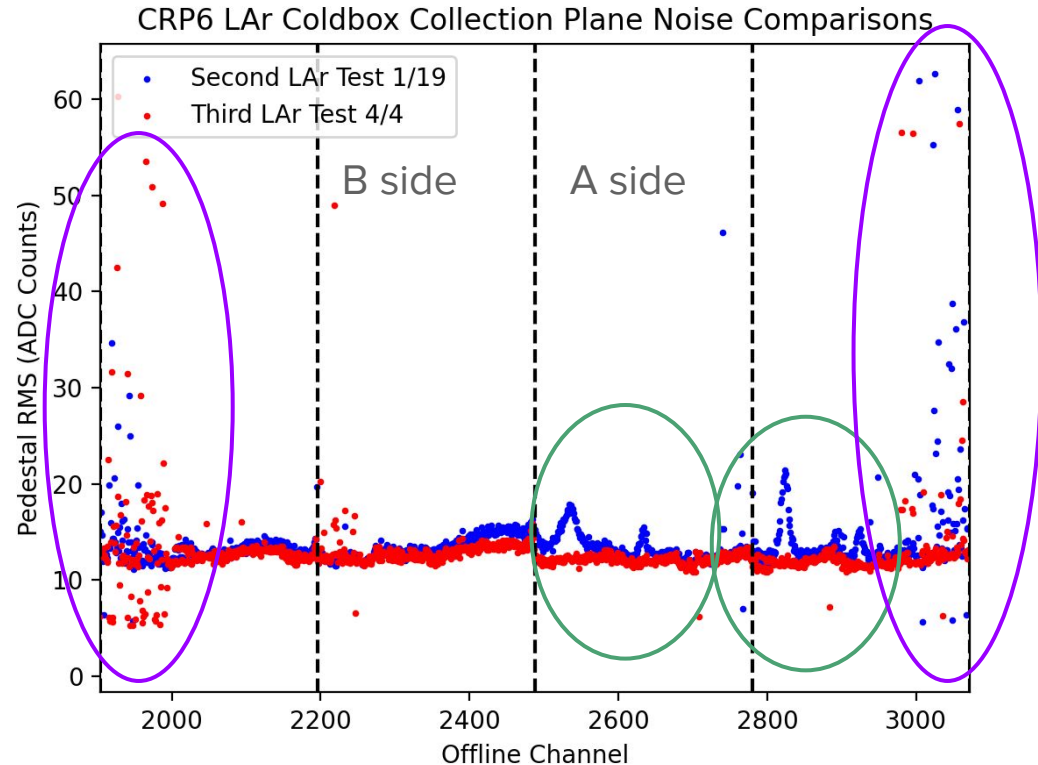
Collection Plane Behavior

- **Noise peaks on A-side** that were believed to be pickup from power cables running over them are now gone
 - Recall that some shielding was placed beneath the B-side cables prior to the January coldbox test already
- **Scattered high/low noise channels in CRP corners** are still present, appearing only at cold

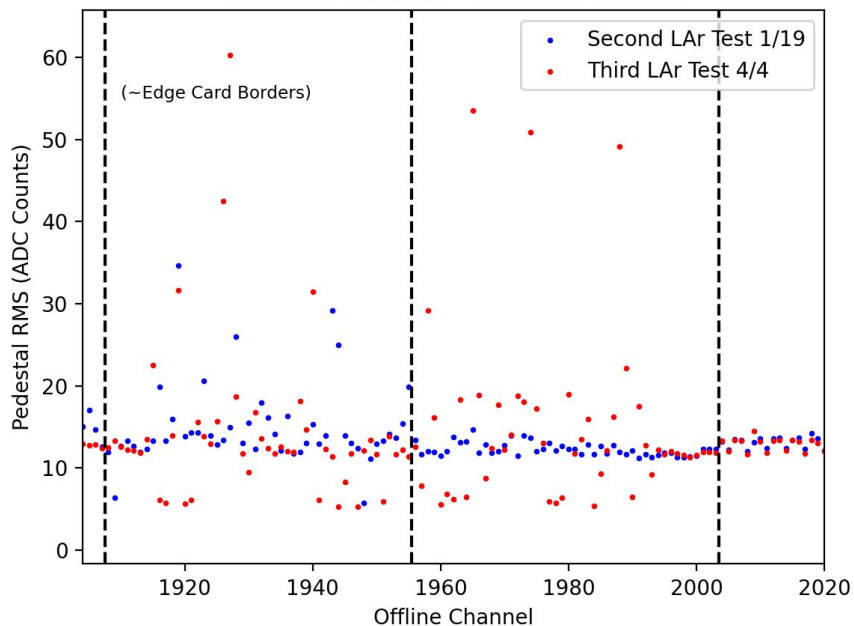
CRP6 LAr Coldbox - Collection B Side

- The random high/low noise channels seem unrelated to any electronics settings, and appear only at cold
- The problem seems worse on B-side and less severe on A-side during this cooldown

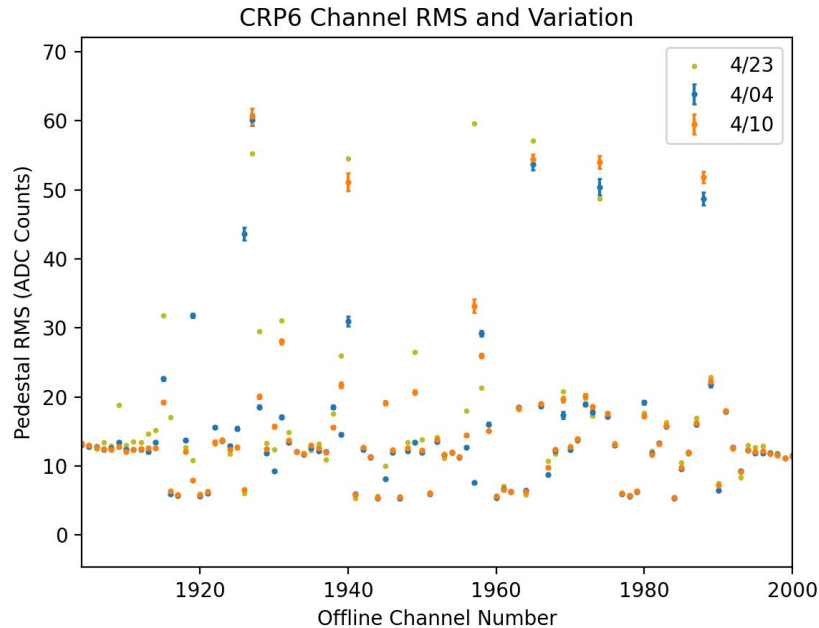
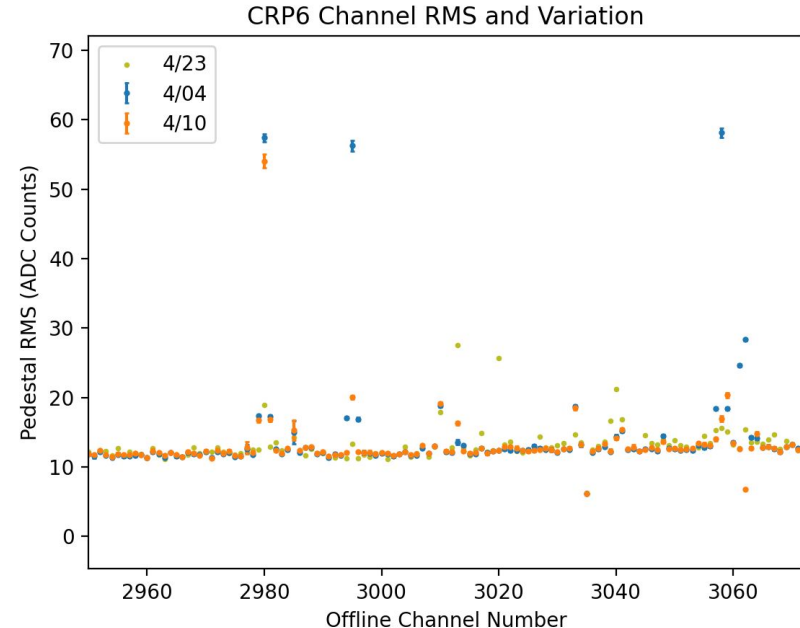
High/Low Noise Channel Stability

- The set of channels with abnormal behavior is fairly stable over time
 - Note: 4/23 dataset has cathode/CRP bias on

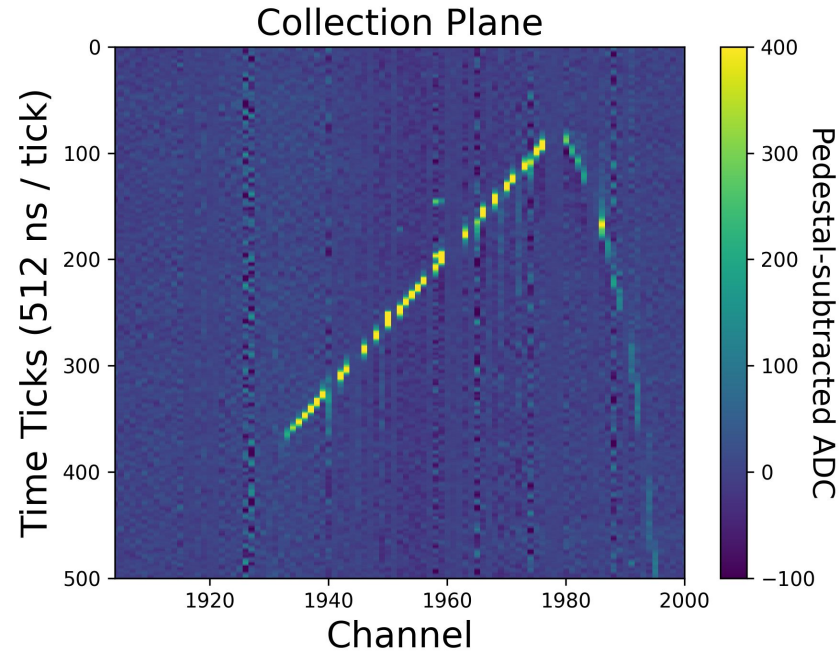
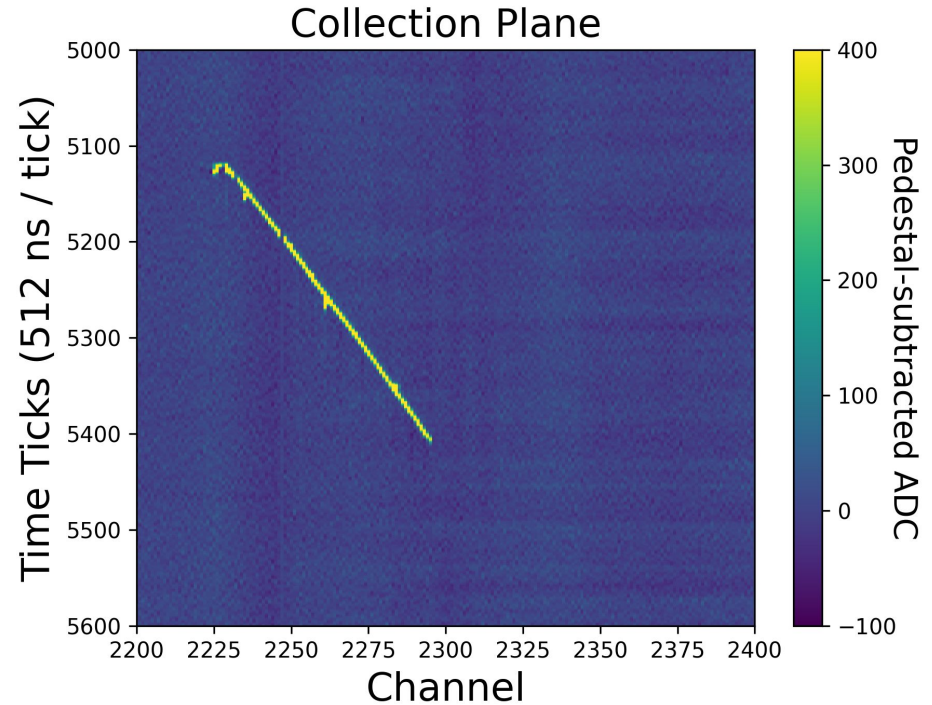
Broken Tracks

- Effect of the open collection channels clearly visible in tracks passing through the afflicted regions

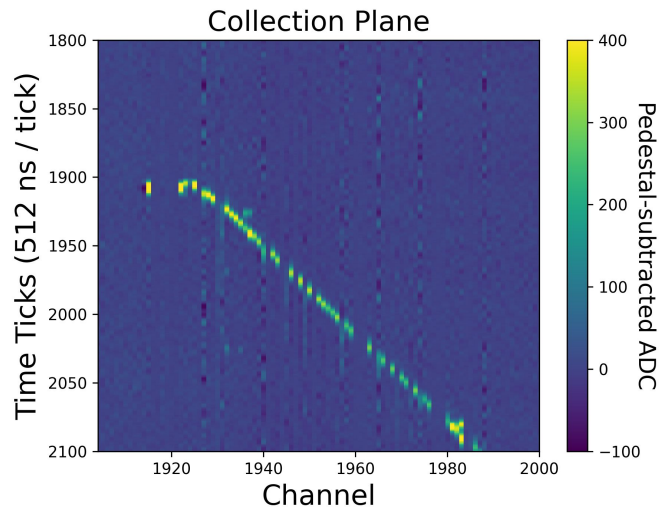
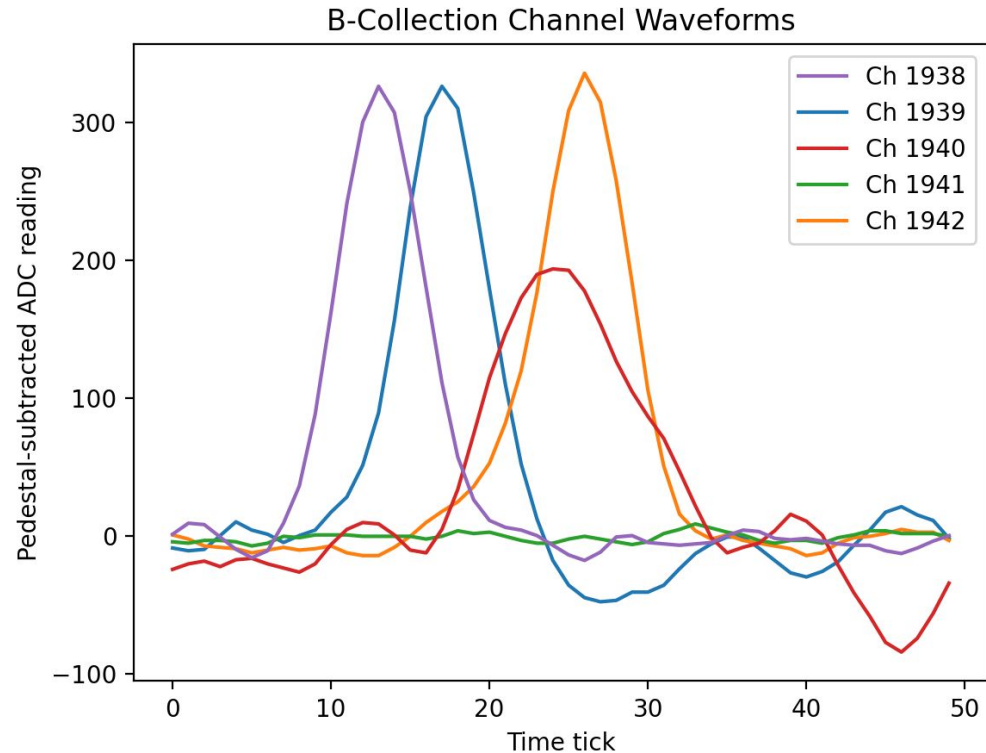
Charge on High/Low Noise Collection Channels

- Most (not all) high-noise collection channels still collect charge, but the timing and pulse shape are distorted
 - Not obvious that this can be explained just by noise effects

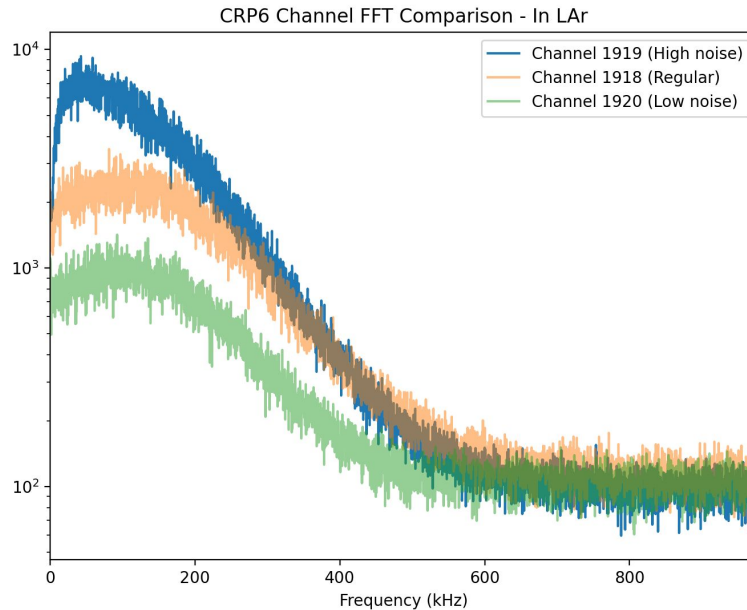
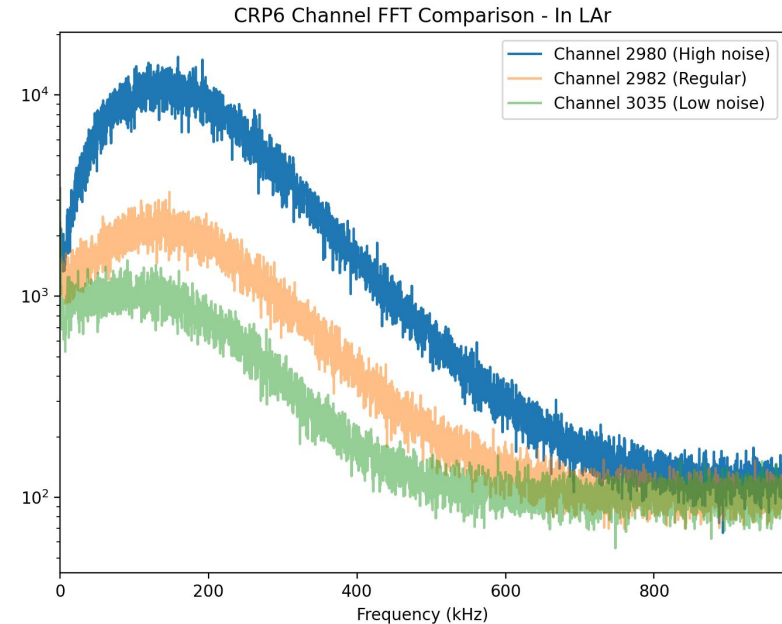
High/Low Noise Collection Channels

- The scattered high/low noise channels on the collection plane show no distinctive features in their noise power spectra
 - Consistent with being respectively improperly shorted to something and simply disconnected

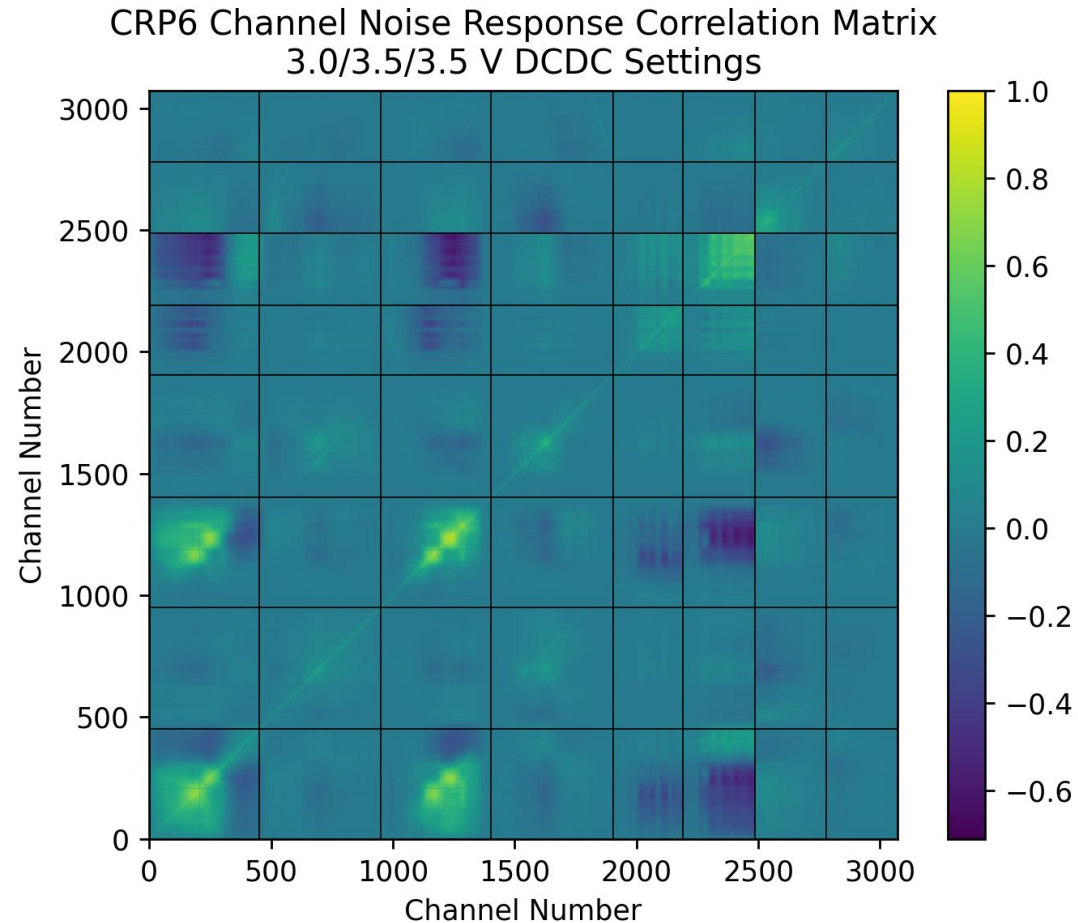
Noise Correlations

- **Correlation matrix of raw channel waveforms**
 - Note: at “nominal” DCDC settings, the shape is the same, but less intense
- **Notable features:**
 - Small positive-correlation squares corresponding to ASIC divisions
 - Large blocks of positive correlation on the high-noise B-side induction channels
 - Large anticorrelations between induction and collection noise on B-side
