Short between U channels on APA 12

Justin Evans, Anthony Ezeribe, Brian Rebel, Sotiris Vlachos

29th April 2024

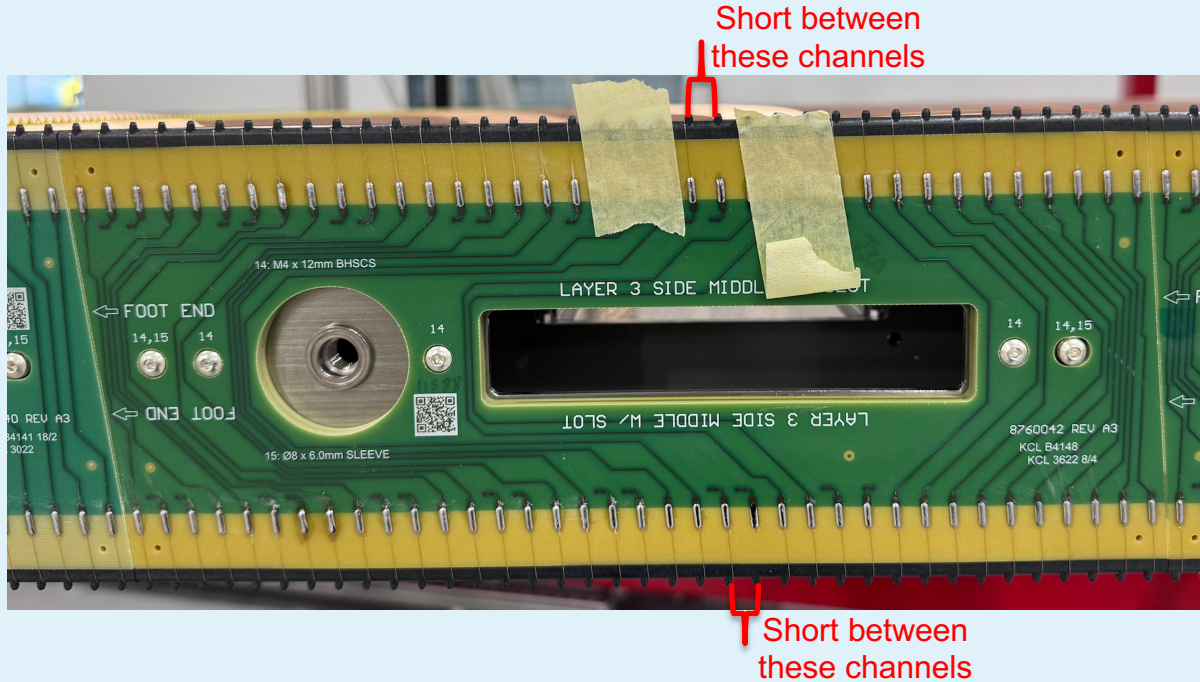
Short between U-layer channels

- These two channels show a physical connection within the U-layer wrap board shown

Layer & side	Head board & pad	Cold channel	Offline channel
Channel 1:	BU	3-33	3-6-3	287
Channel 2:	BU	3-34	12-3-8	286

We recommend that the U wires be kept in place on both these channels and the APA be completed with the short in place and recorded

APA experts agree that keeping the wires in place is the optimal decision

- Removing a wire would modify the drift field, which would reduce the physics performance of the APA
- The signals from these two shorted channels will still be useable

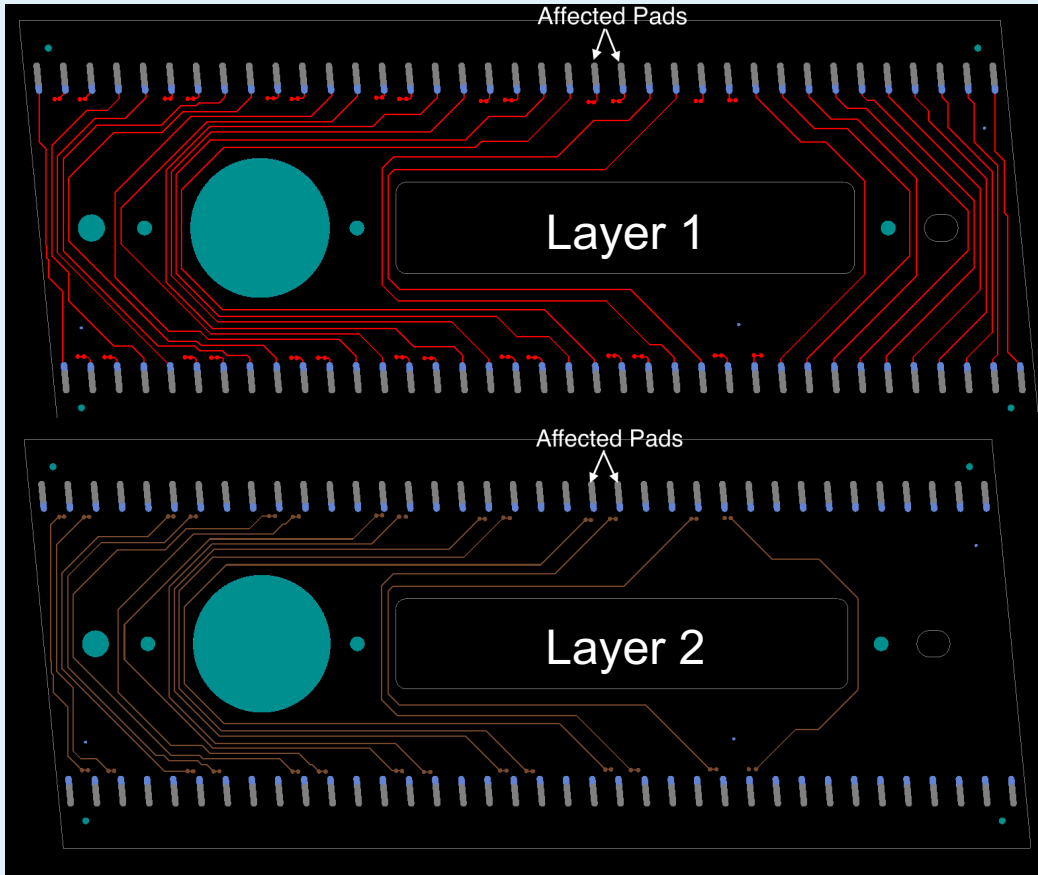
Short is on an inner layer

- The short is on the second layer of a multilayer board, hence this is very unlikely to be damage from a mishandling of the board
- No physical damage is visible on the board

It is unknown how this short came about
