ProtoDUNE-II APA Commissioning Report

Pip Hamilton

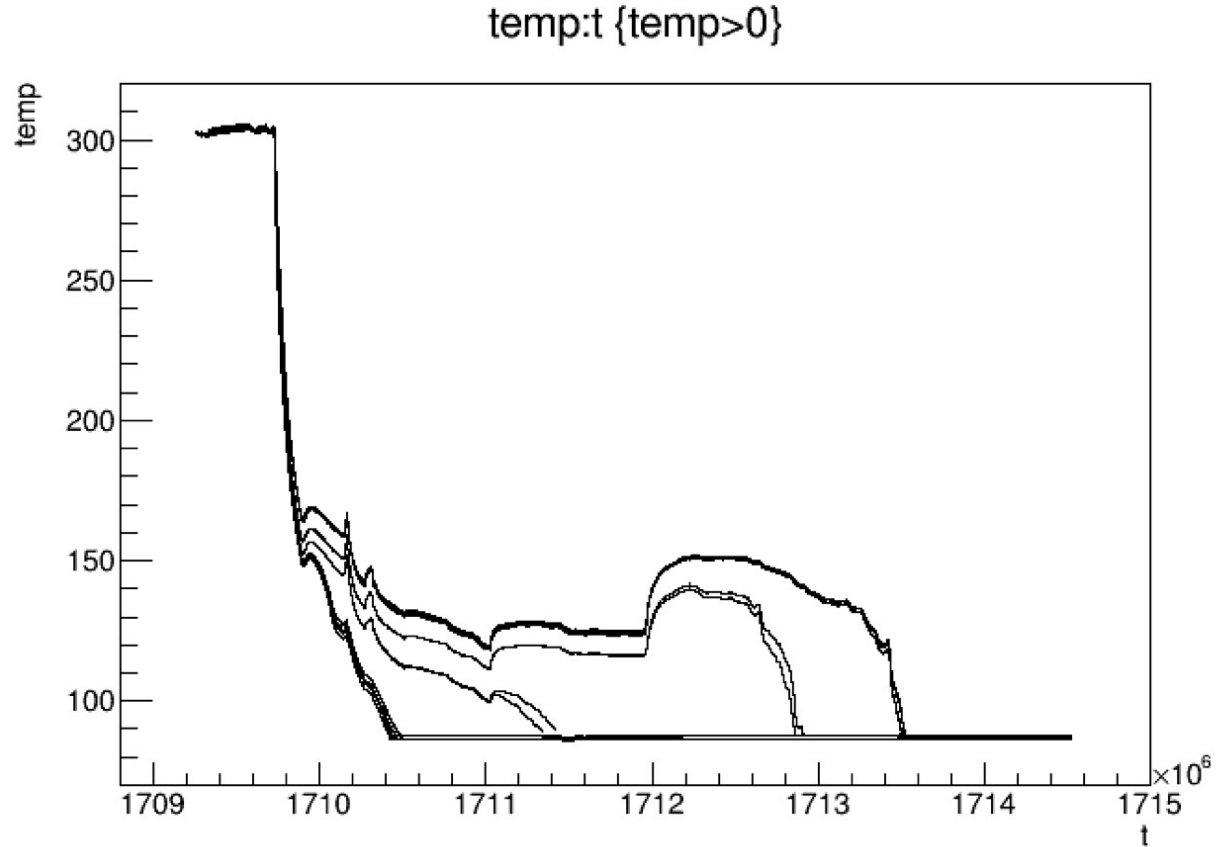
Cooldown

- Filling finished Fri 03/05.
- Temperature sensors showed a smaller temperature differential between top & bottom than in ProtoDUNE-1: ~60°C rather than ~100°C.

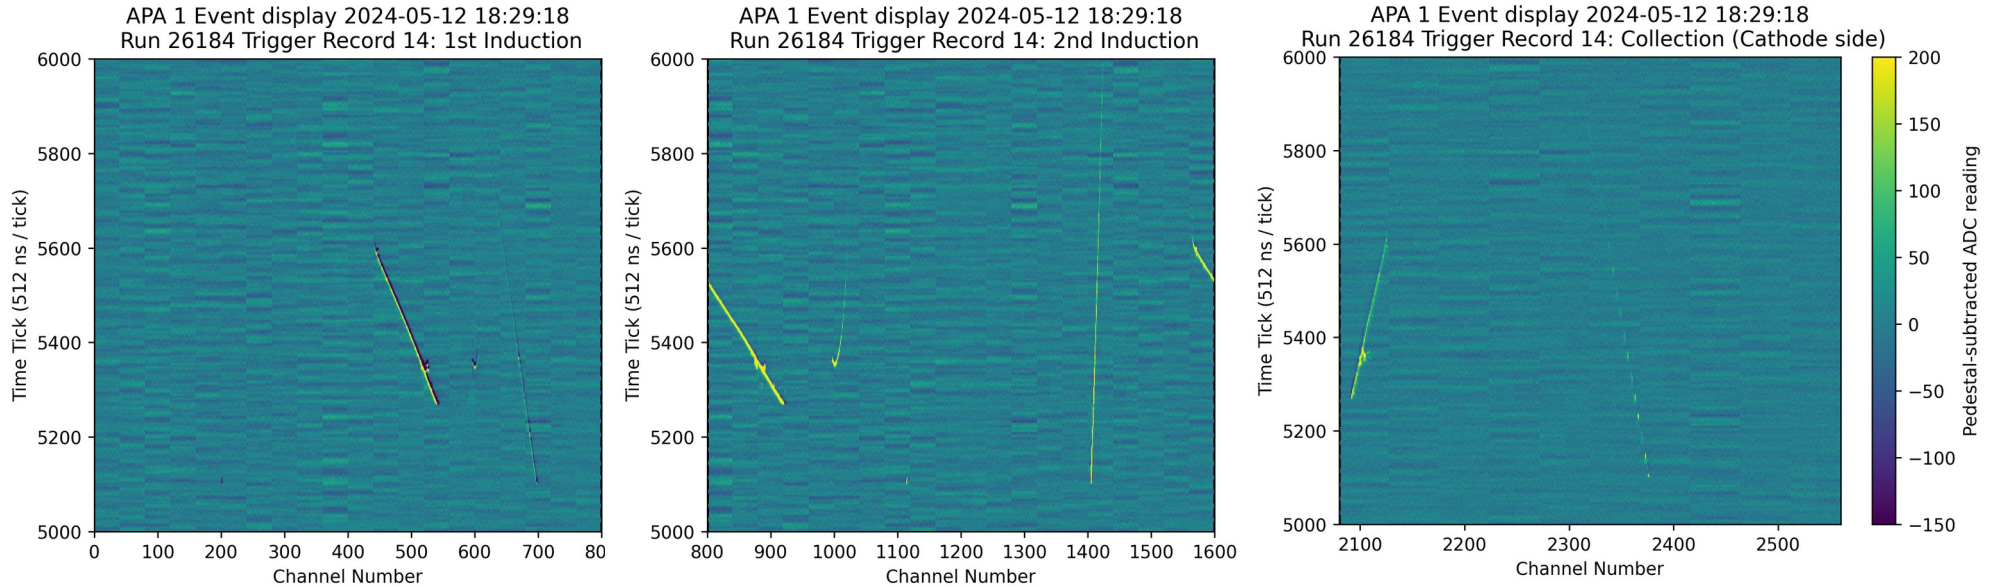
APA1 Bias Connection

Immediately after ramping the HV on Friday, it was observed in the control room that cosmic tracks in APA1 and 4 appeared faint in the collection plane & unipolar in the 2nd induction plane.

- *APA 4 was recovered by finding a loose connection.*
- For APA1, the connection fault has been identified to be in the cold, between the HV cable and the APA itself.
 - Planned to open the flange to investigate, but electrical tests show the cable itself is connected.
 - **Unlikely to be recoverable:** there is no way to drain the LAr in time for the beam run.

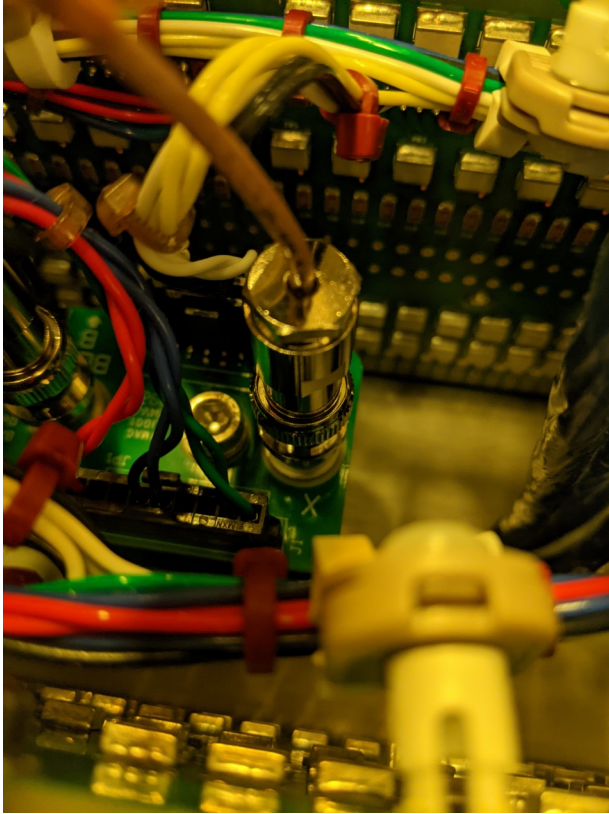
APA1 Bias Connection

Question of interest: is the fault at the SHV connector, or downstream?

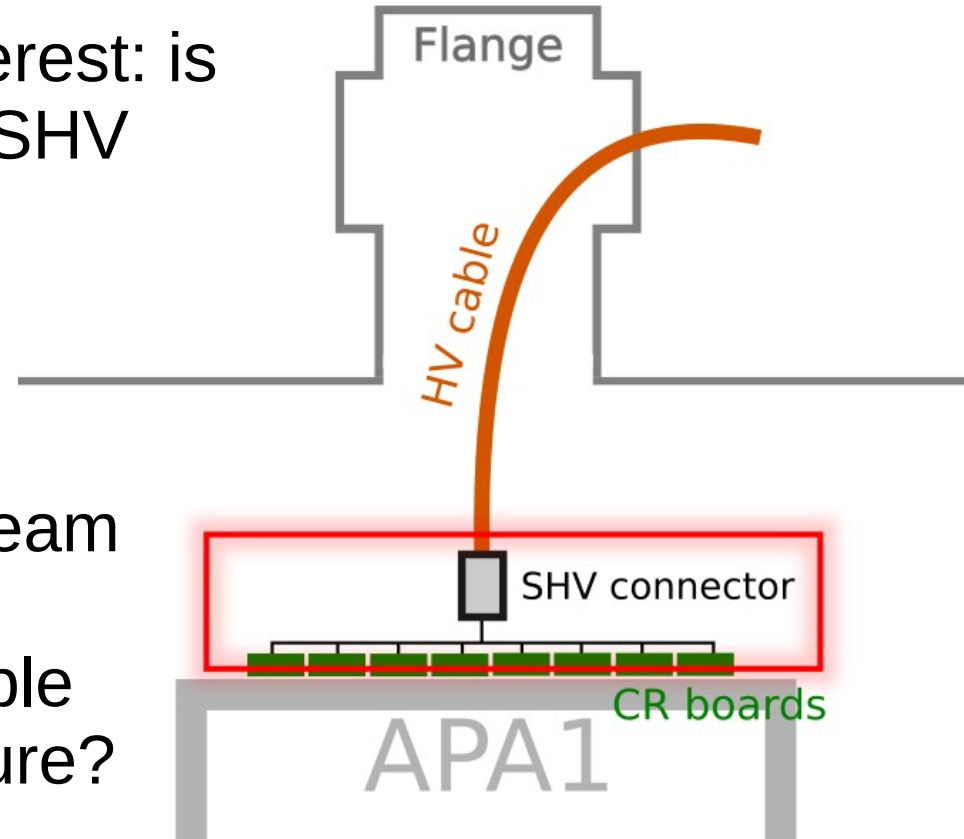
Do the downstream connections contain a possible single point failure?

- We should think how to avoid this happening again when repeated at scale in during FD installation.
- Procedural QC changes during installation – 2-person check on each connection.
- Hardware changes – the SHV connections for the field cage are not made directly to the boards but instead have a standoff, making them easy to connect with force.

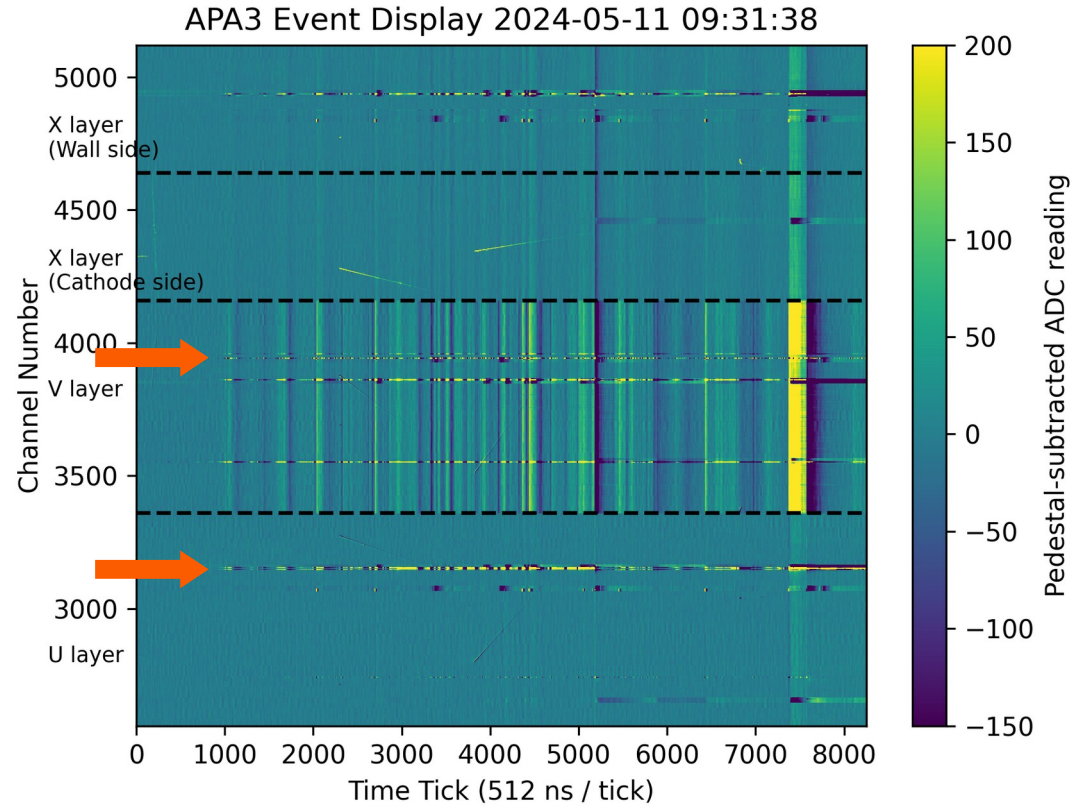
Short No. 1

- Developed during cathode ramp-up (in the 40-60 kV step), Friday 10/5. **Disappeared on Saturday 11/5 (~8pm)**
- U plane FEMB 7 channel 3153 (Single-APA channel 154) to (suspected) V plane FEMB 5 channel 3943 (Single-APA channel 964)
- Induced noise across U channel's FEMB, then whole V plane.

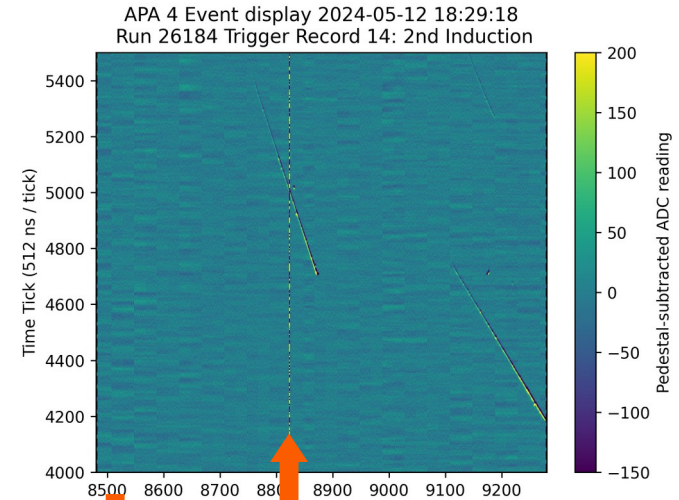
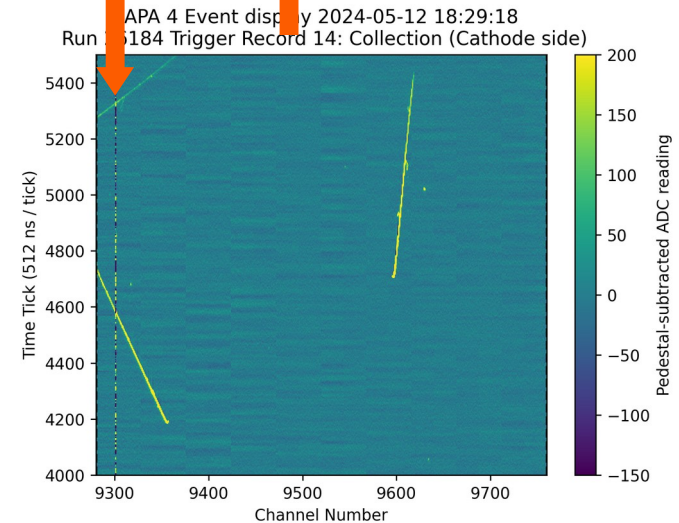
Short No. 2

- Developed Sunday 12/5 ~4am.
- X plane, FEMB 20 channel 9301 (SA 2101) to V plane FEMB 11 channel 8823 (SA 1204)
- No neighbouring channels affected.
- Currently still persisting.

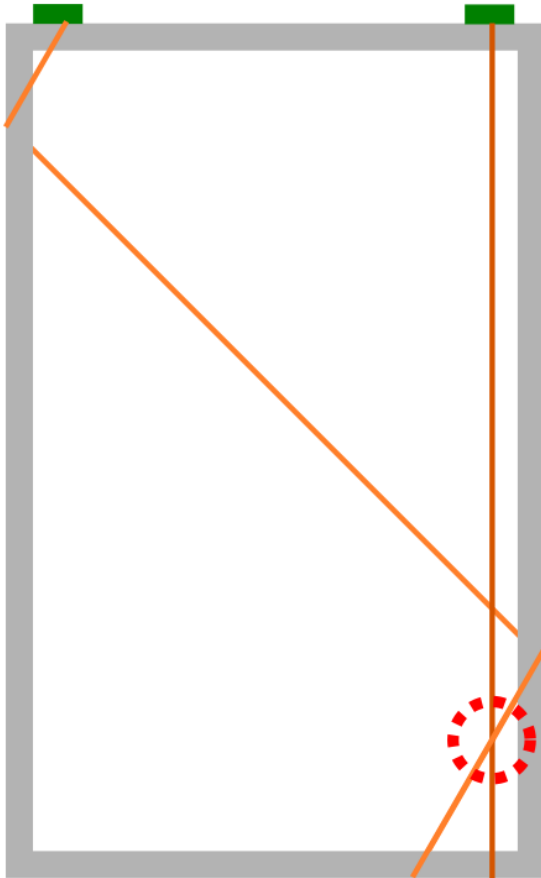
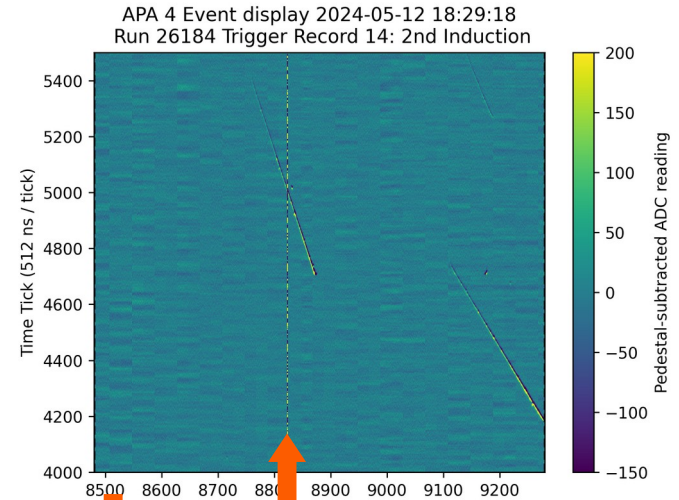
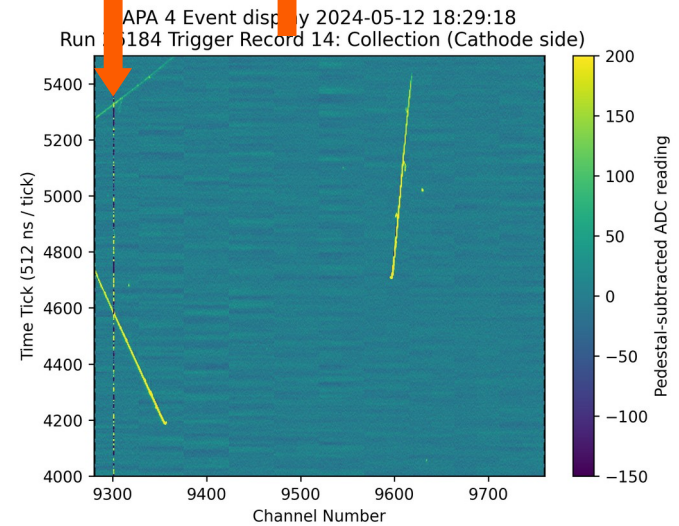
Short 3

- We don't yet know the cause of these shorts.
 - Debris?
 - Slack wires?
- Would be interesting to cross-reference them with the tension map.
- The current state is not a problem for physics (only 2 bad channels, no effects on neighbours) but we must continue to monitor to assure ourselves whether the situation is stable.
