APAs in ProtoDUNE-2

Justin Evans, Pip Hamilton & Brian Rebel

12th June 2024

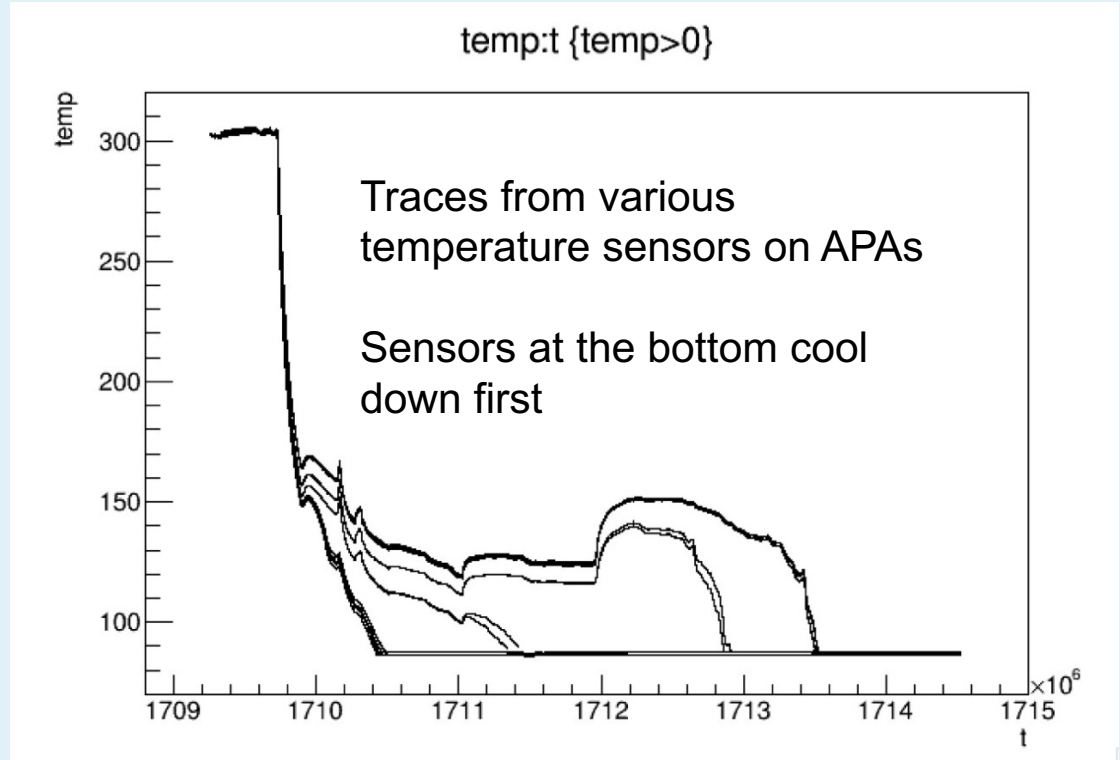
APA cooldown

APA cooldown went smoothly with the temperature difference between top and bottom of any APA not going above 60° C

- Our requirement is to keep this below 100° C

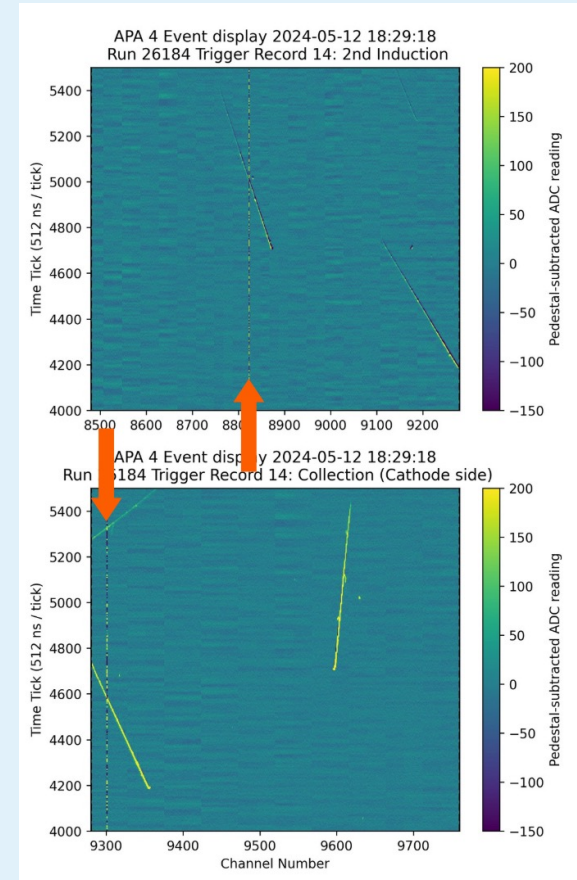
Possible loose material in TPC

Intermittent shorts are being observed

- Move around in the detector
- Appear and reappear on timescales of days, with some correlation to circulation and field ramps
- Sometimes between channels, sometimes whole layers

Currently the APA 1 G layer and the APA 4 U layer are shorted to ground

- Drawing μA currents, which does not stop us from operating

Hypothesis is some small amount of conductive debris in the detector

- Important to focus on minimizing the risk of any debris from our construction and installation

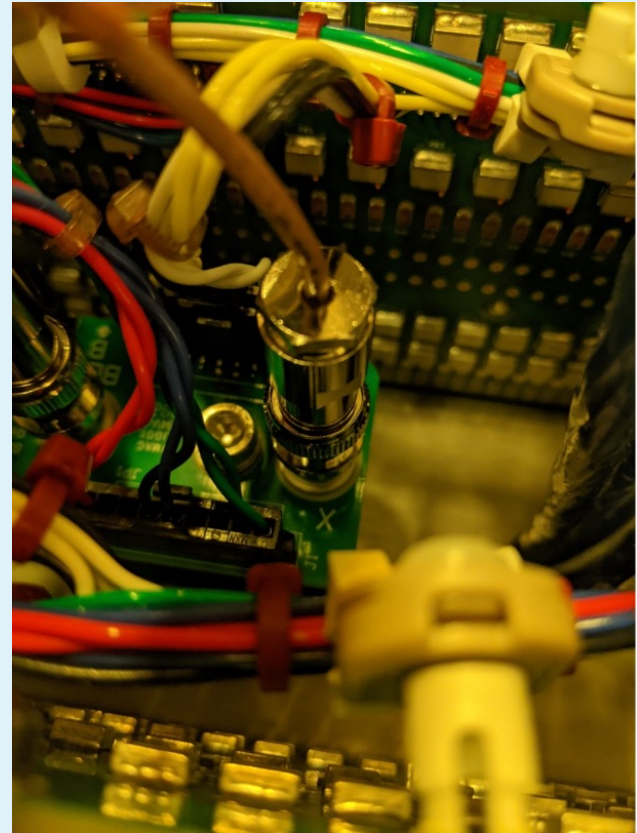
APA 1 collection-layer bias

There is no bias voltage on the collection layer of APA 1

- This means the last induction layer (V) is acting as the collection layer with unipolar signals, and there is very little signal on the collection (X) layer

Impedance measurements from the flange show that the loss of connection is between the HV cable and the APA itself

- Potentially a bad SHV connection into the SHV board

Installation procedures will be reviewed to make the SHV connection step easier and add additional QC testing

- Leave the CR board immediately in front of the SHV board off the APA until the SHV connection has been made
- Add an additional visual QC step to this connection, and use impedance measurements to check the connection
- A redundant X-layer SHV connection is being considered, but this has associated electrical and mechanical issues
