Analysis of MQXFA13 Test Non-Conformity

US-HiLumi-doc-4958
Other:
Date: March 12, 2024
Page 1 of 18

US HL-LHC Accelerator Upgrade Project

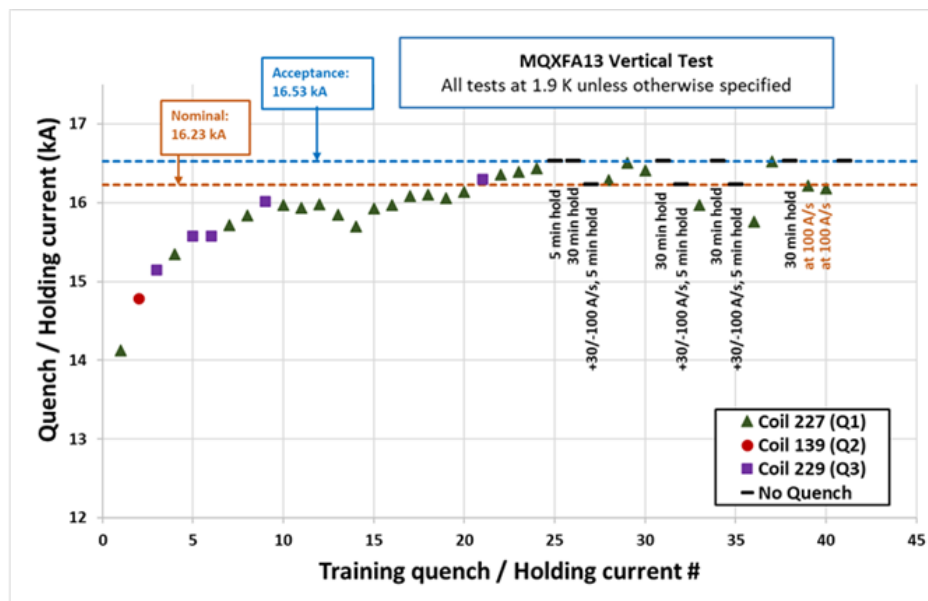
Figure 2.1: MQXFA13 training history

- Quench #10 (at 15969 A) had some unusual features: quench antenna signal 6 times larger than usual (Fig 2.2) and significantly faster voltage rise than all other quenches at similar current (Fig 2.3). It occurred in the lead end of coil 227 at 2.01 m from magnet center. After this quench MQXFA13 had 6 quenches at similar or lower current (as low as 15699 A). All of them in coil 227, and 5 of them in the same location of quench #10.

- After current ramp #27 (up at +30 A/s, down at -100 A/s) MQXFA13 quenched during ramp #28 (quench #25) at 16285 A. This quench started in coil 227 lead end at 2.01 m from magnet center.

- Subsequently, after 2 training quenches, MQXFA13 was able to hold again acceptance current.
- But after current ramp #32 (up at +30 A/s, down at -100 A/s) MQXFA13 quenched during ramp #33 (quench #28) at 15968 A. Also this quench was in coil 227 lead end at 2.01 m from the magnet center. This was the second quench in the current ramp following a ramp down from nominal at -100 A/s.

- The same behavior occurred after ramp #35 (up at +30 A/s, down at -100 A/s). MQXFA13 quenched during ramp #36 (quench #29) at 15759 A. Also this quench was in coil 227 lead end at 2.01 m from the magnet center.

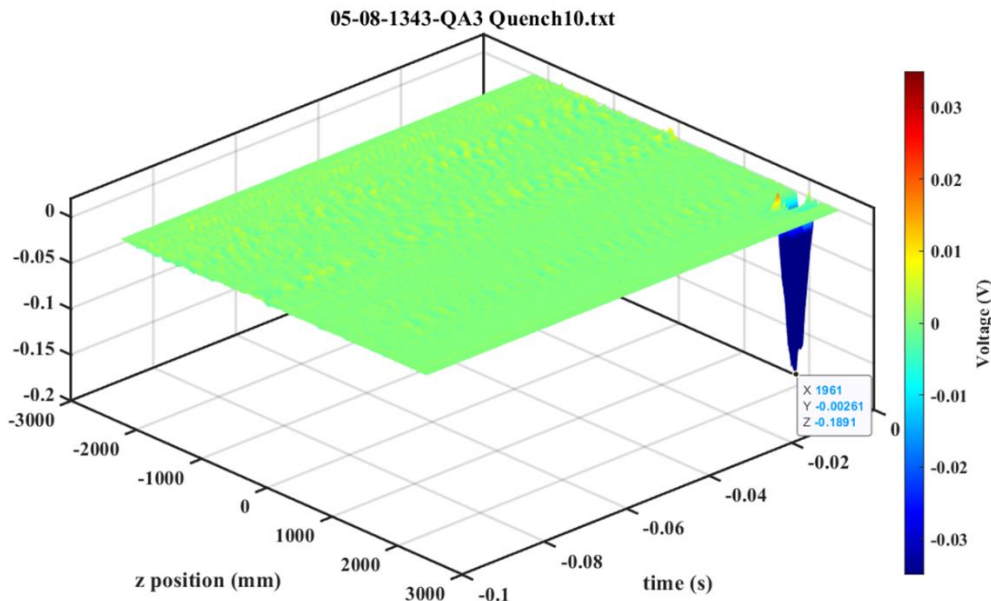
Figure 2.2: Quench antenna signal before detection of quench #10. The typical quench antenna signal strength ranges between +/- 30 mV (shown by the color bar on the right). The signal during quench #10 reached 189 mV.

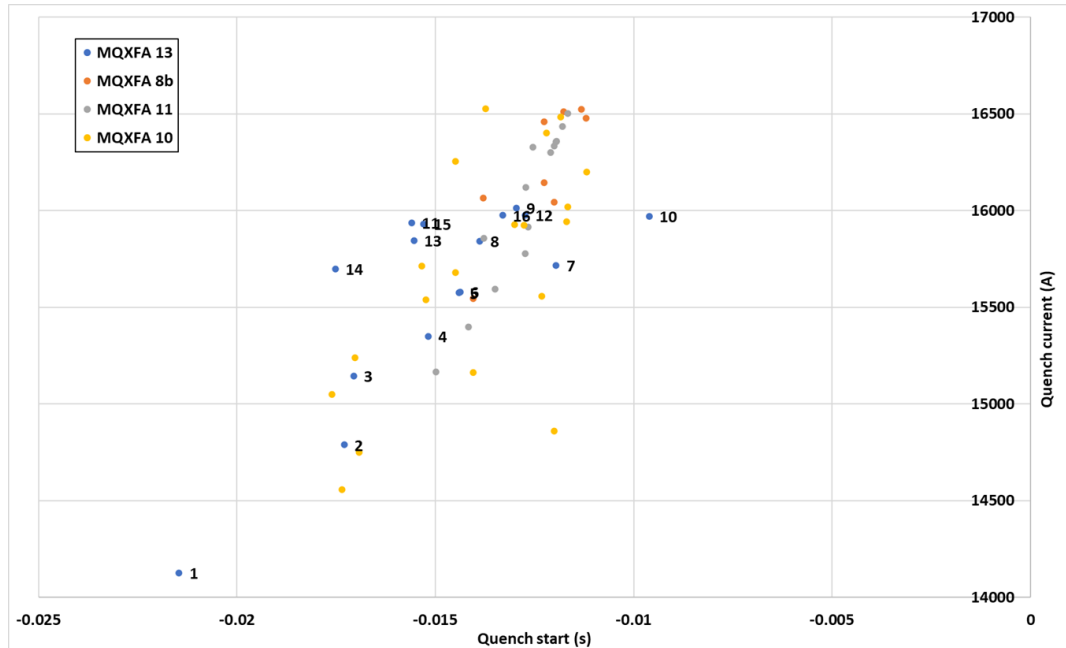
Figure 2.3: Time from quench start up to detection time ($t=0$) in four MQXFA magnets. Quench #10 of MQXFA13 had shorter time to detection than all other quenches even those at higher current.

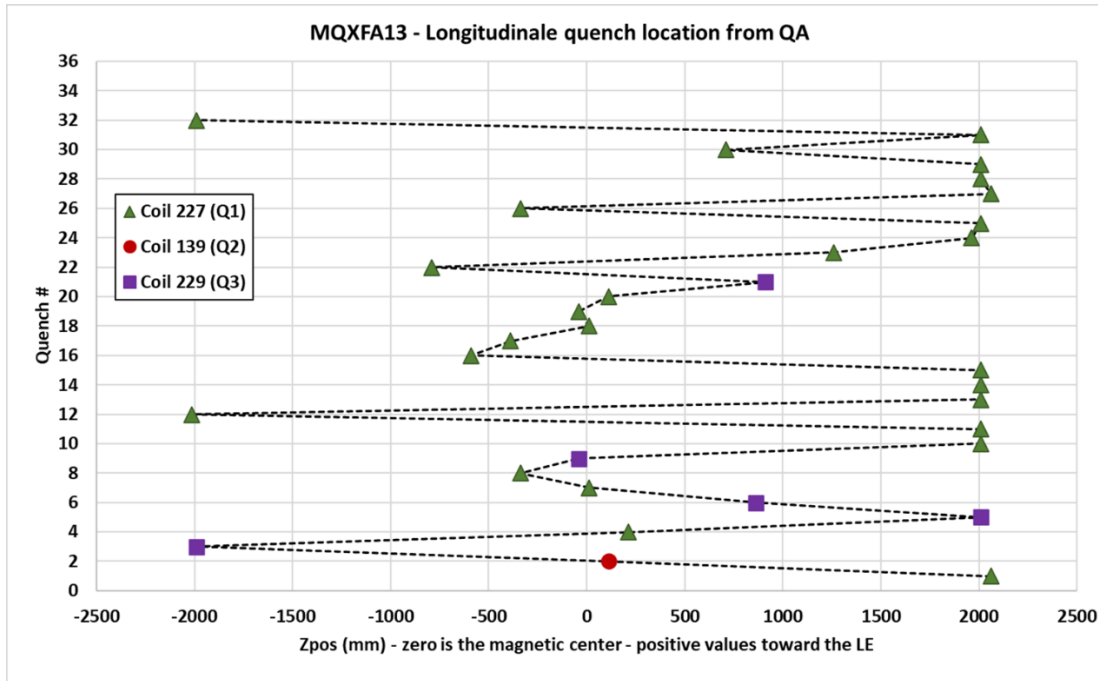
A quench antenna with full length Z-coverage was used during the magnet test. It is made of 111 50 mm-long flex circuits. Theta detection was achieved using 12 full length Dipole and quadrupole buck radial circuits. In Fig. 2.4, all quench positions along Z-axis observed during the magnet training are displayed. A large number of quenches in coil 227 (Q1) took place in the same longitudinal position along the coil, at ~2000 mm from magnet. This location corresponds to the beginning of the lead end of the coil, and is consistent (within the quench antenna error of +/- 50 mm) with the location of the damaged areas found in the limiting coils of MQXFA07 [4] and MQXFA08 [5].

Figure 2.4: Summary of quench localization based on quench antenna along the coil axis.

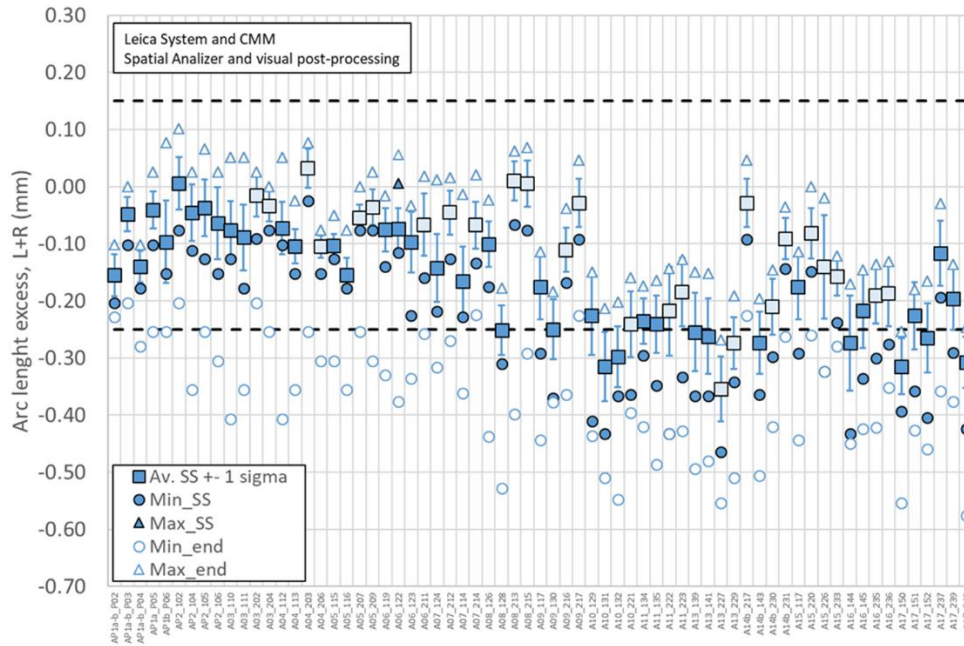
Analysis of CMM data showed that coil 227 was among the coils with the smallest arc length in the ends ever tested, together with the other coils in MQXFA13. Figure 3.1 Shows the arc length excess (difference between coil OD arc length and the nominal value) in several locations (average, maximum and minimum in the straight section, plus maximum and minimum in the ends). This observation triggered the FE analysis shown in the following chapter.

Figure 3.1 Coil arc length excess (difference between coil OD arc length and the nominal value) in several locations: average, maximum and minimum in the straight section (full markers), maximum and minimum in the ends (empty markers).

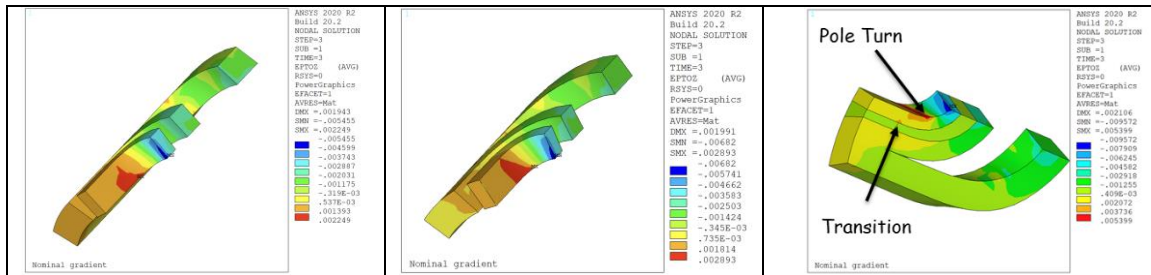
Figure 5.2: Longitudinal strain in the coil end region, considering nominal prestress and perfect initial contact conditions between the coil and the collars (left); introducing the radial size deviation measured on MQXFA13 coils (center); and lowering the room-temperature prestress to 50 MPa (right).

The model results reported in Figure 5.2 show an increase of the longitudinal strain in the end region due to the MQXFA13 coil geometry: with nominal contact conditions, the peak longitudinal strain is equal to 2249 $\mu\text{m}/\text{m}$. When introducing the measured radial size deviation, this becomes equal to 2893 $\mu\text{m}/\text{m}$. The effect is worsened when the azimuthal prestress is reduced: considering a room temperature pole stress of 50 MPa in the magnet center, the peak strain becomes equal to 5399 $\mu\text{m}/\text{m}$. All the models show partial separation arising between the end-spacer and the wedge. Two critical regions were identified in the coil: the pole turn, and the last pole-block turn in the proximity of the wedge/end-spacer transition. While the numerical peak strain is always located on the former, it is reasonable to expect further intensification of the transition strain due to the sudden local support variation introduced by the wedge/spacer separation. This effect cannot be correctly quantified in this global magnet model because of the relatively large dimension of the coil elements.

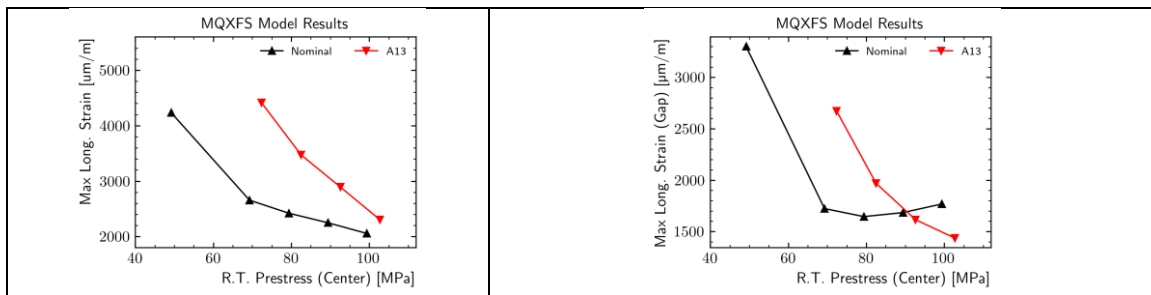
Figure 5.3: Peak longitudinal strain as a function of the applied room temperature prestress on the pole turn (left) and on the wedge/end-spacer transition (right) when considering nominal and measured (A13) coil geometries.

The variation of the strain in the two critical regions as a function of the applied prestress is provided in Figure 5.3. The results suggest that prestress reductions result in an increase of strain, and that a critical level (knee) exists where small variations of prestress result in large strain increases. The critical prestress level is increased by the reduced size of MQXFA13 coil ends.

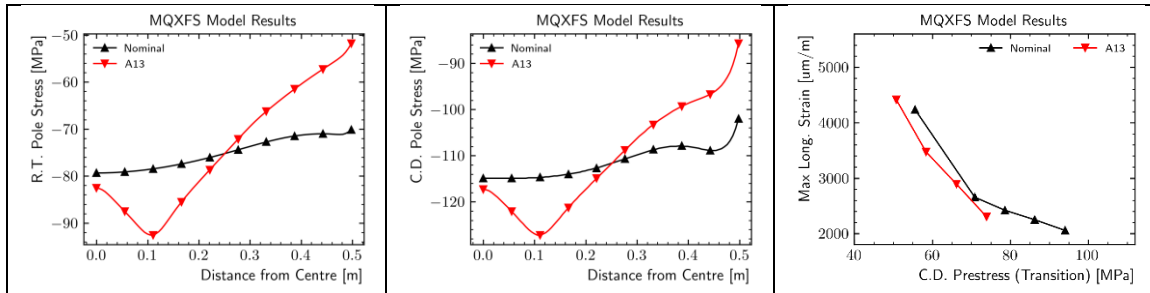
Figure 5.4: Left and center: prestress variation along the magnet length at room temperature (left), and after cooldown (center). Right: maximum longitudinal coil strain as a function of the pole prestress in the transition region after cooldown.

The longitudinal strain level in the transition region is governed by the azimuthal prestress applied in that region. Figure 5.4 shows the computed stress along the winding pole for the nominal and MQXFA13 coil geometries. The smaller ends result in a prestress reduction of more than 20 MPa at cold. This prestress reduction seems to be the only significant parameter in driving the peak strain: the relationship between pole stress after cooldown at the transition longitudinal location and the peak longitudinal strain is not a function of the coil geometry (see Figure 5.4, right). As a consequence, no differences are expected between the reported results and those that would be computed on a full-length model of the magnet.

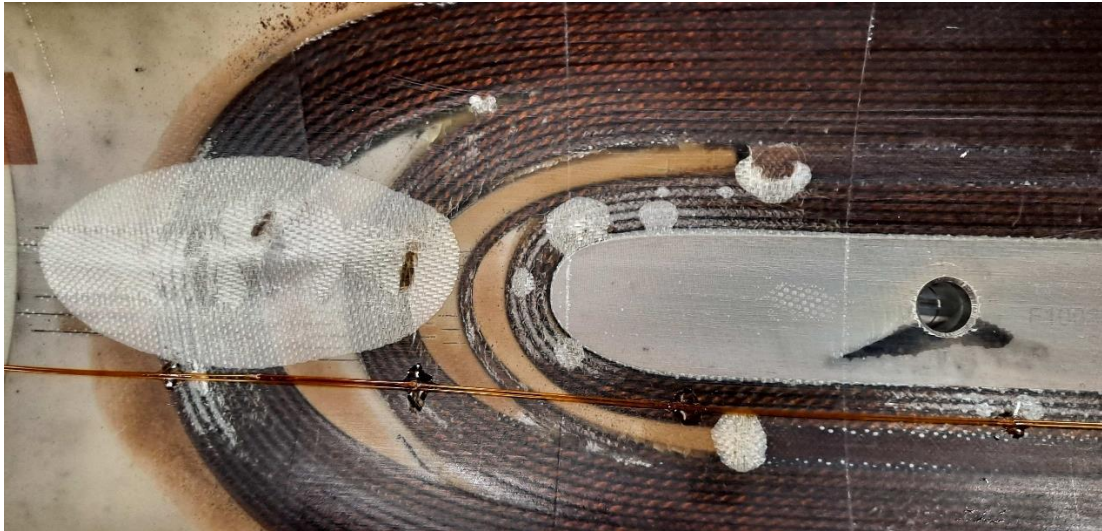
- There is a large bubble (delamination of the insulation on coil inner surface) at coil tip starting after the second end spacer. This bubble is typical in MQXFA coils after test.
- Four small bubbles/delaminations are visible in the pole block close to the pole tip. They may be signs of quenches in that area.
- There is a small bubble/delamination at each transition between wedge and end-spacer. This is the area where broken filaments were found in coils 213 and 214 [4-5].

Figure 6.1: Inner surface of coil 227 in the LE region after test.

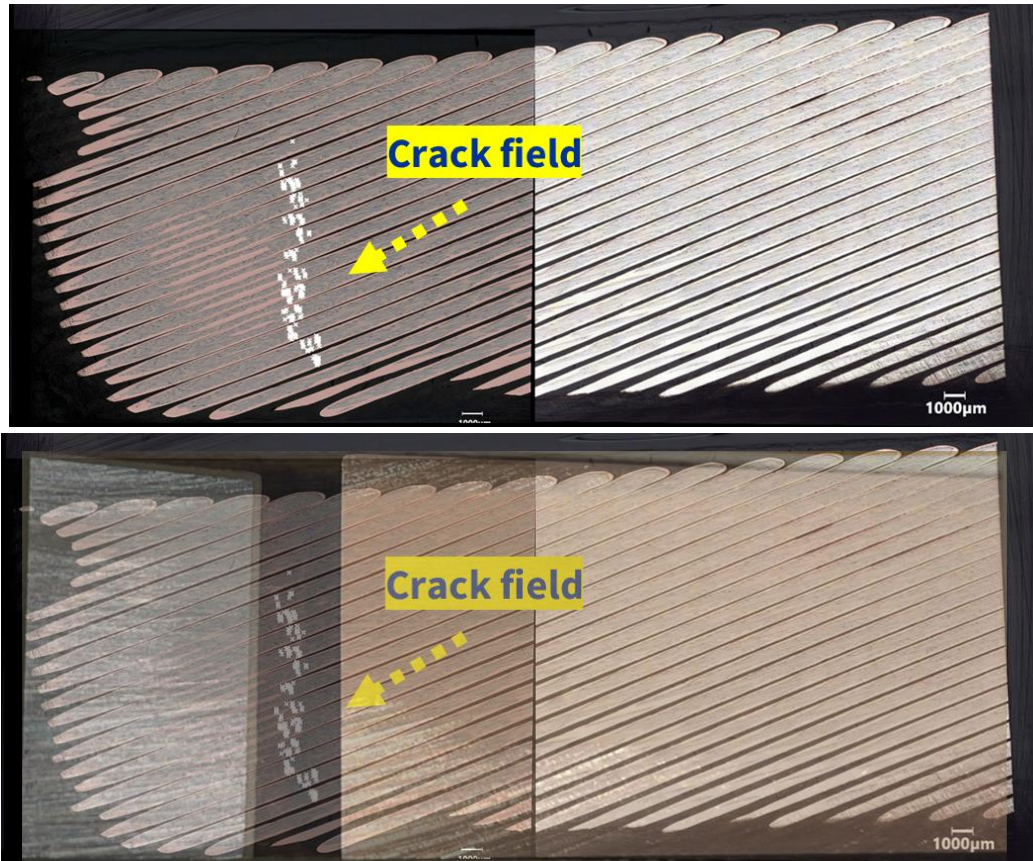
- 180 filament cracks (Fig 6.5 top) were found on the cable facing the wedge-spacer transition in the pole block on the layer jump (LJ) side.
- 210 filament cracks (Fig 6.6) were found on the cable facing the wedge-spacer transition in the pole block on the opposite side to the layer jump (OLJ).

- No filament cracks were found on both cables (LJ and OLJ) facing the wedge-spacer transition in the midplane block.
- All filament cracks are located in the short segments between the wedge and the end spacer as shown in Fig 6.5 bottom.

Figure 6.5. Top: Locations of broken filaments in the cable facing the wedge-spacer transition in the pole block on the layer jump (LJ) side. Bottom: A semi-transparent picture of wedge (right) and end-spacer (left) has been overlapped to the top picture in order to show the position of the crack field with respect to wedge and end-spacer.

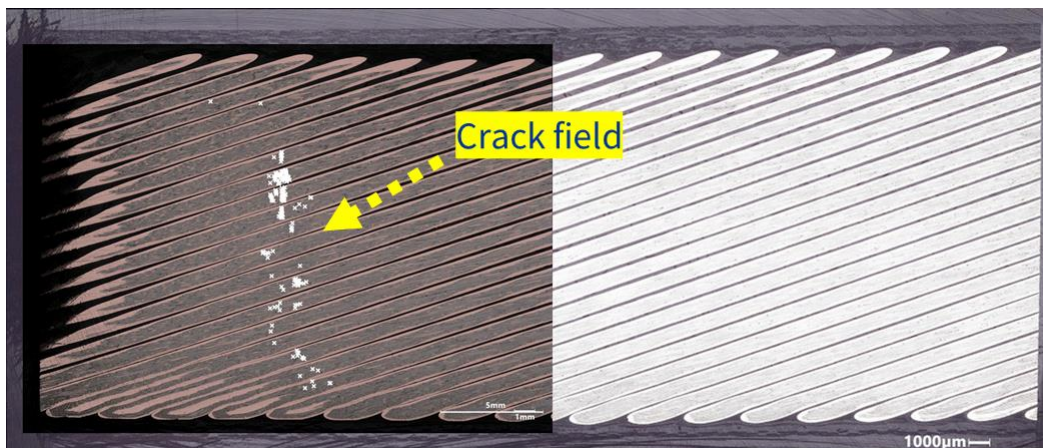
Figure 6.6. Locations of broken filaments in the cable facing the wedge-spacer transition in the pole block on the side opposite to the layer jump (OLJ).

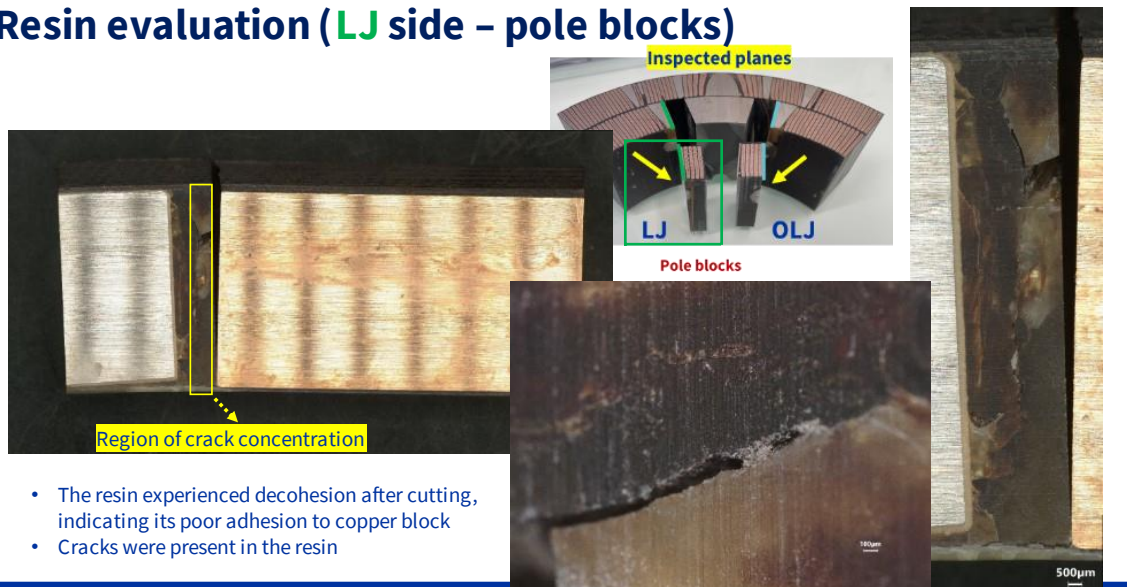
Resin evaluation (LJ side – pole blocks)

- Cracks in the glass-filled epoxy were found between wedge and spacer in the Layer Jump side, and the epoxy separated from the wedge after cutting showing poor adhesion (Fig 6.7). Fewer cracks were found in the glass-filled epoxy in the Opposite to Layer Jump side.

- The resin experienced decohesion after cutting, indicating its poor adhesion to copper block
- Cracks were present in the resin

Figure 6.7 Cracks in the glass-filled epoxy between wedge and spacer in the Layer Jump side
