News from Ferrara

HPK Italy

We started tests on HPK Italian lot
Received:

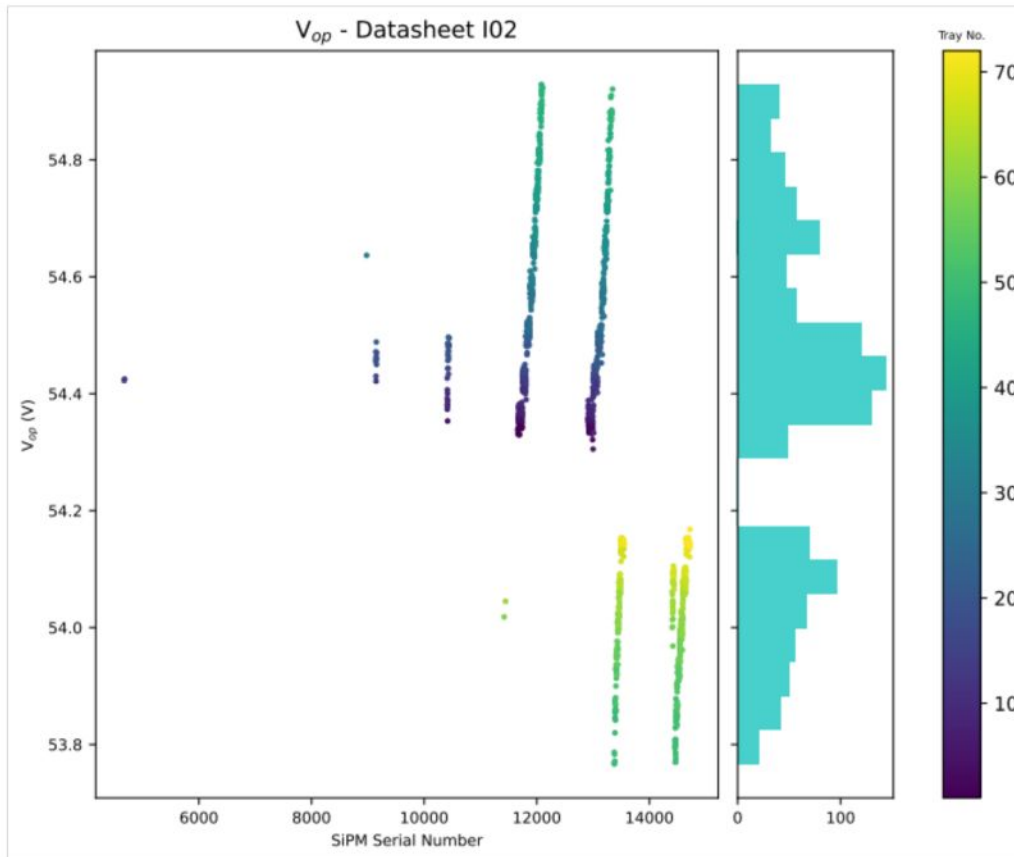
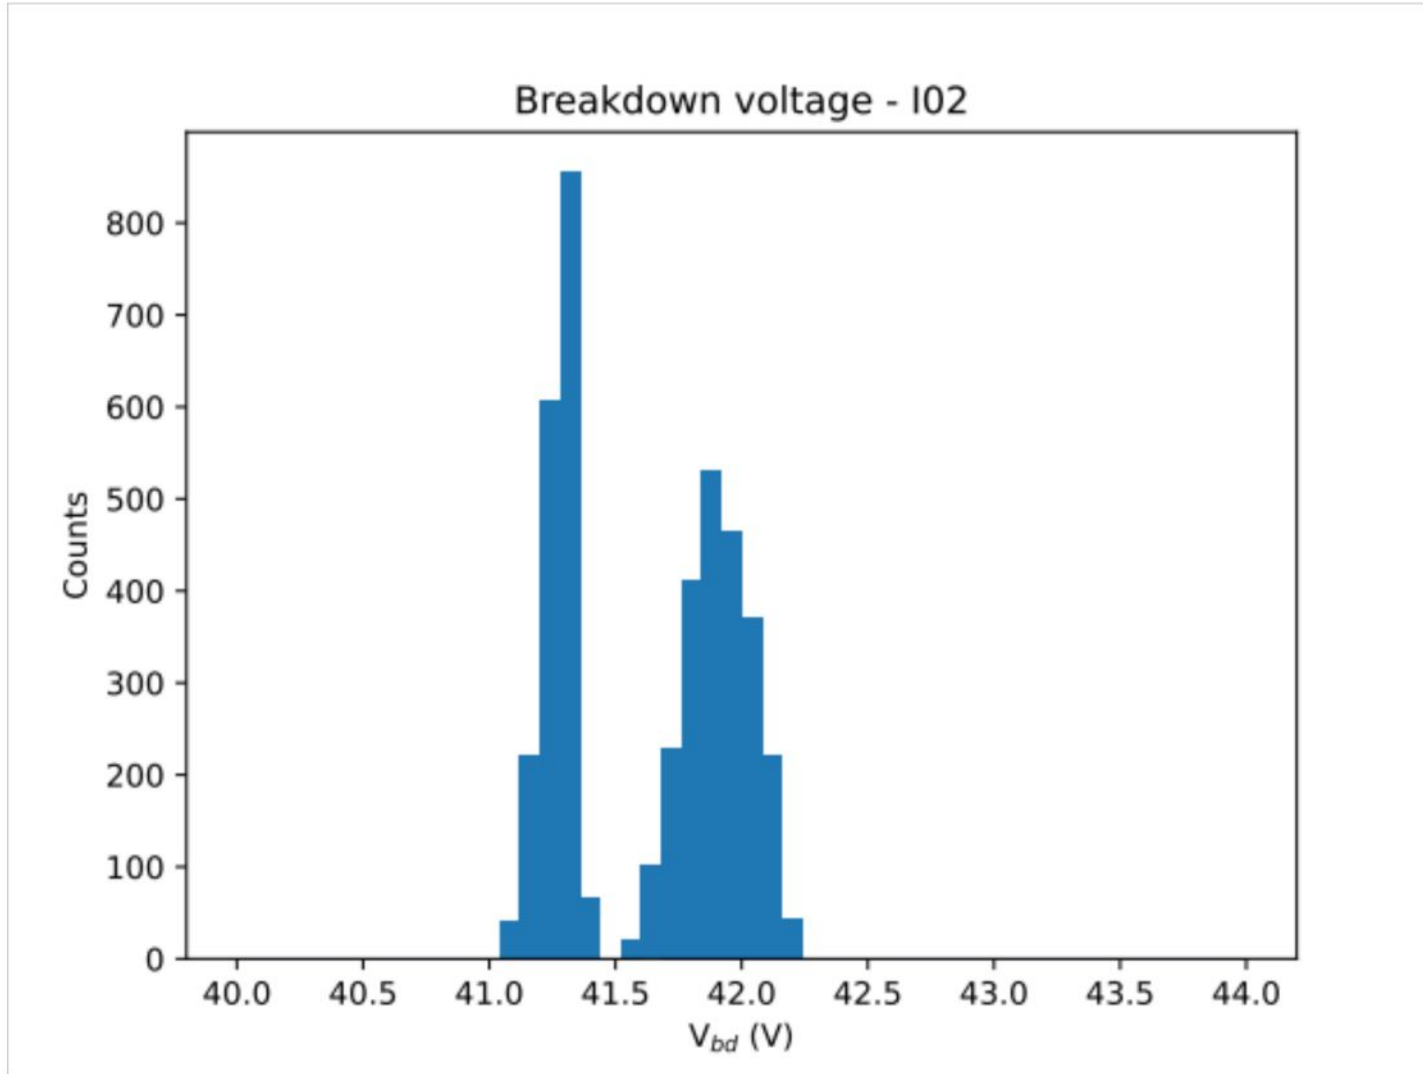
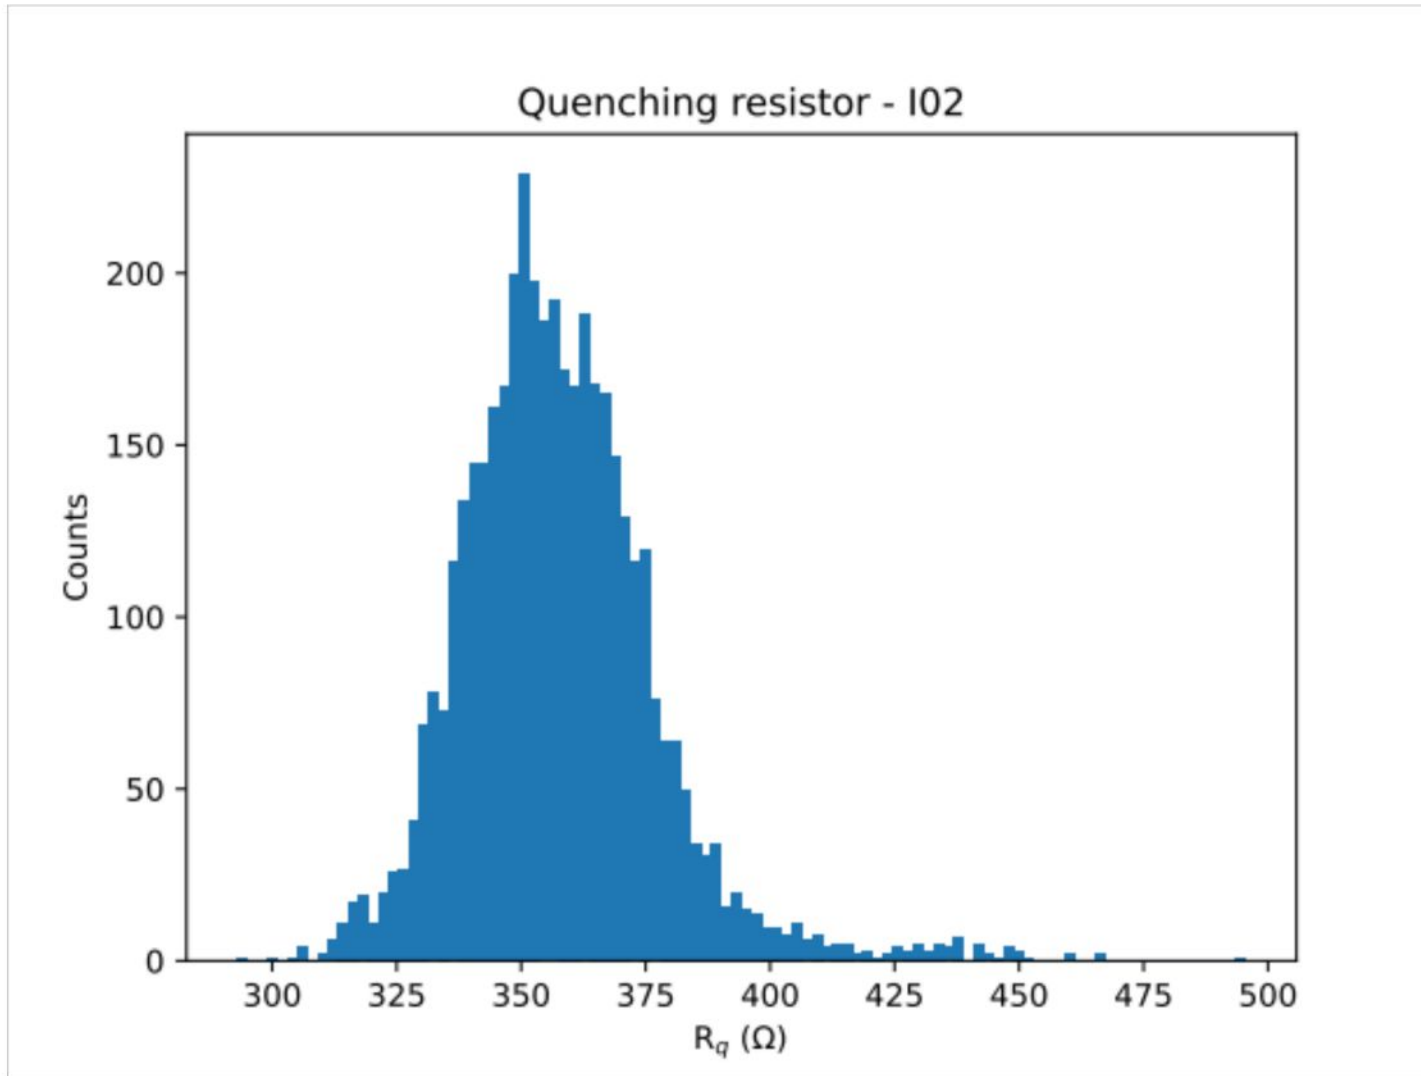
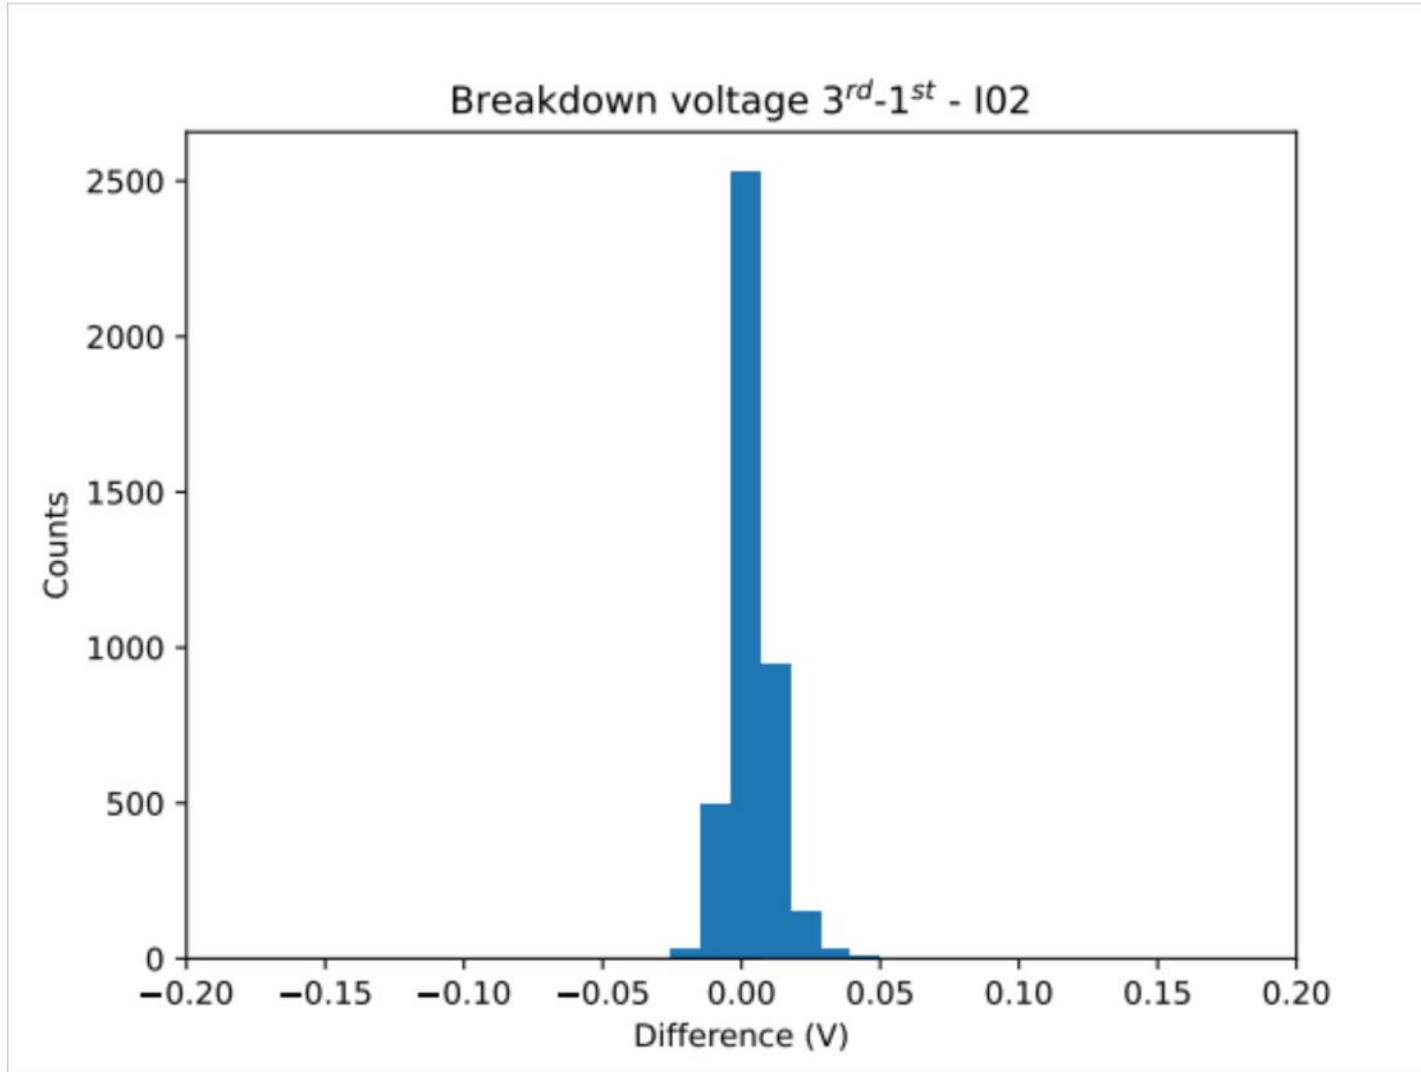
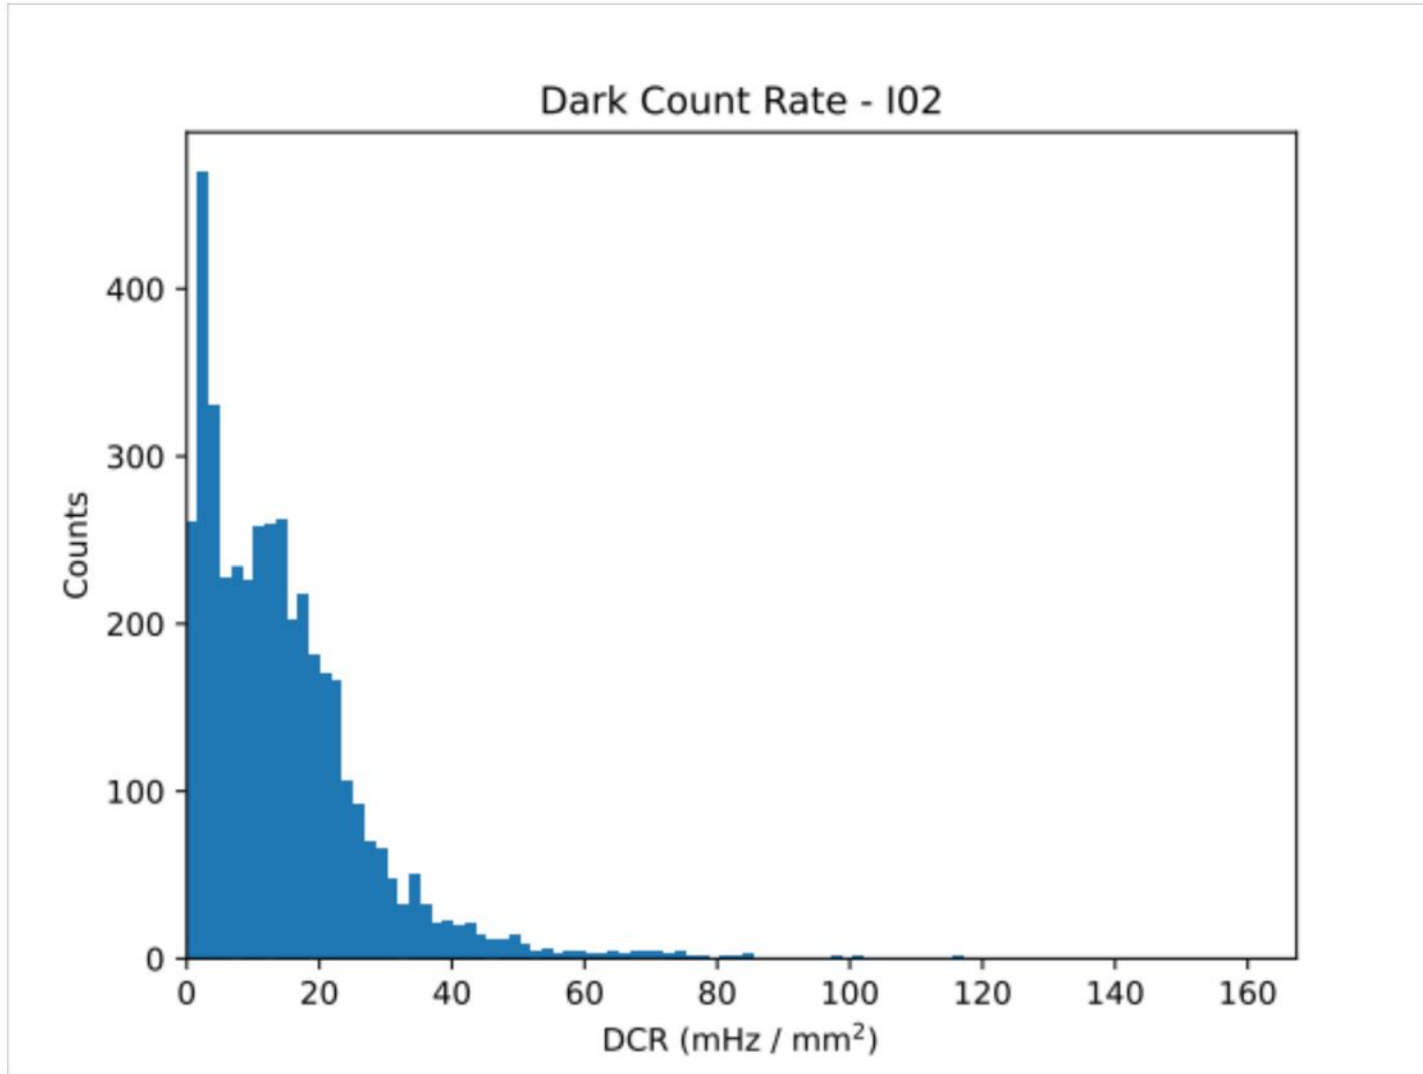
Box 5:

- Results similar to Spain lot
- No strange SiPM found
- All good

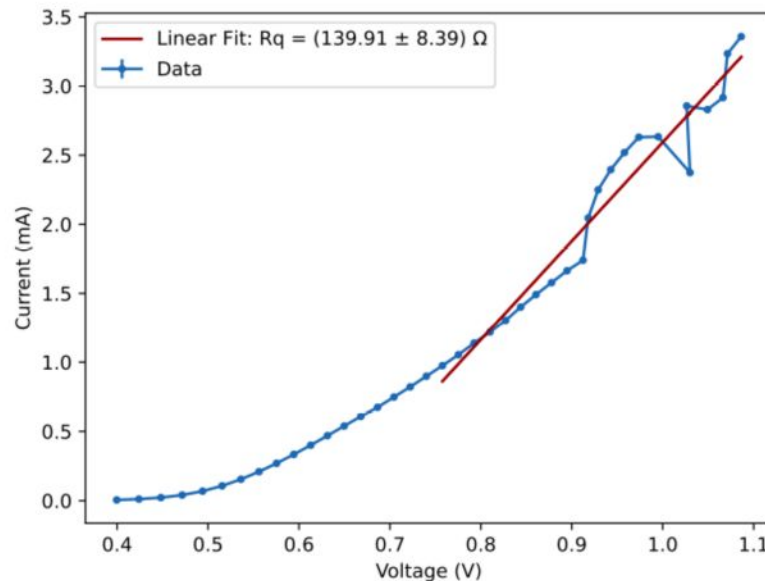
- Tray 52 board n.13415
During the tests (starting from IV at room) a SiPM shown a strange behaviour (signal present-missing): it seems a bad electrical contact!

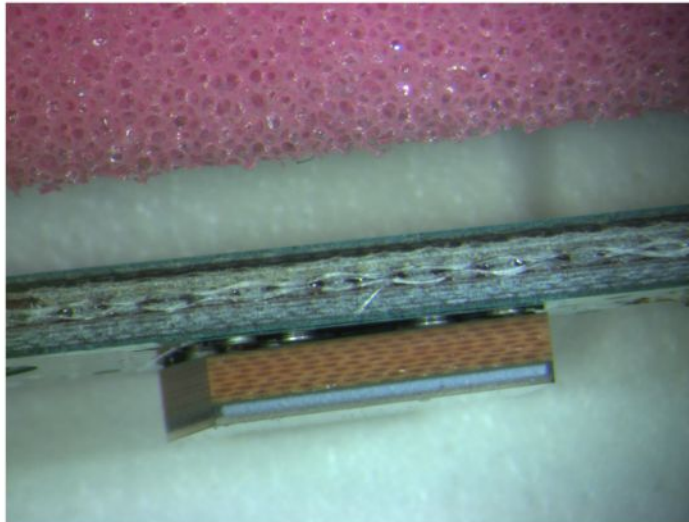
- After measurements and thermal cycles the SiPM looked not well attached at the board and simply moving it, it detached from the board.
- Also the next SiPM was strange (see fig1) and detached after moving it with the finger (very low pressure)

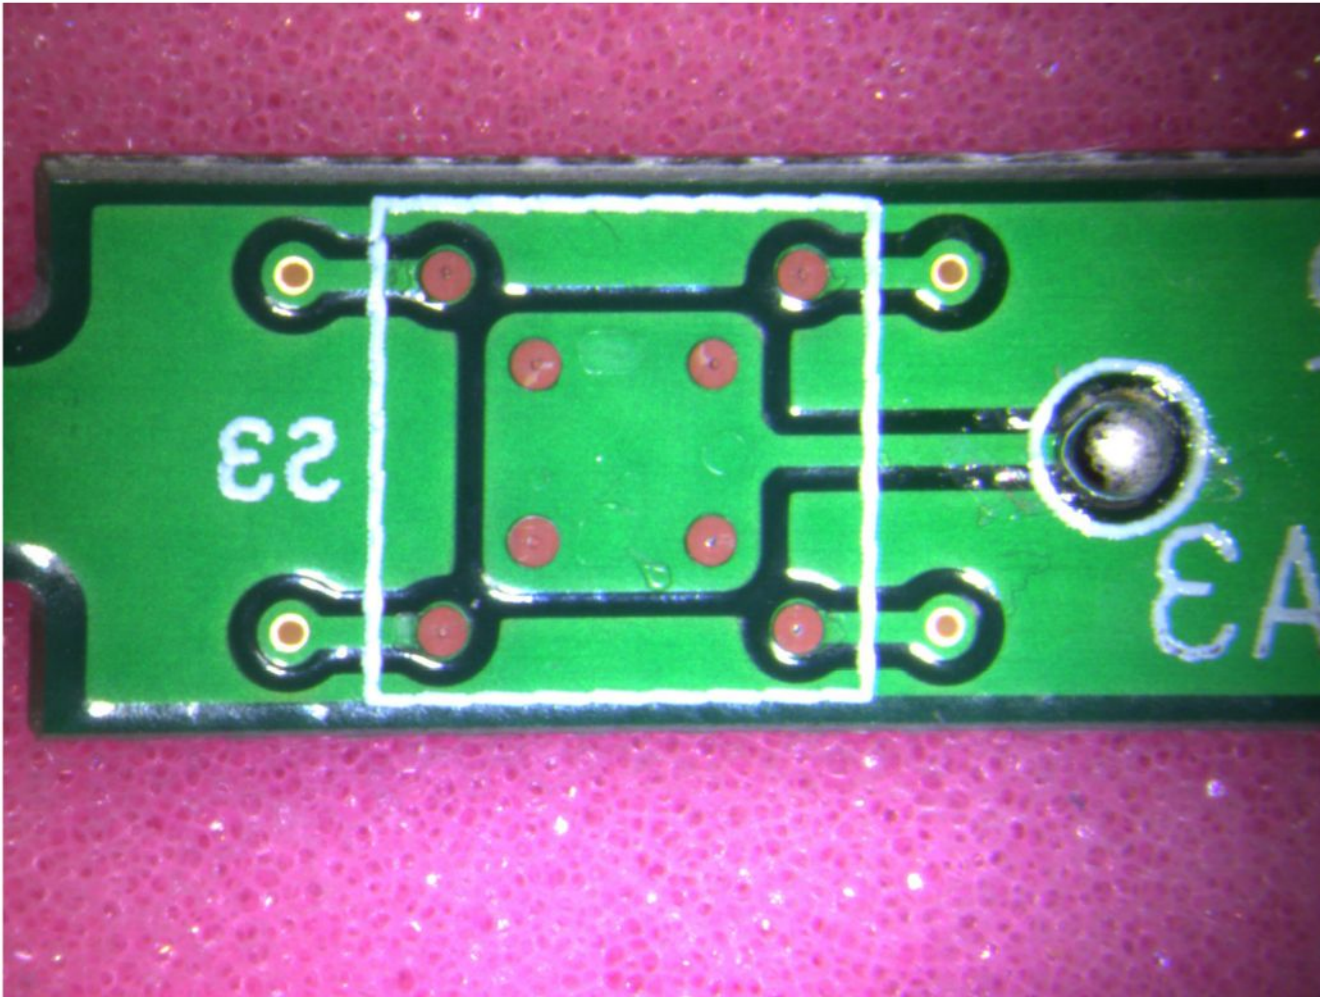
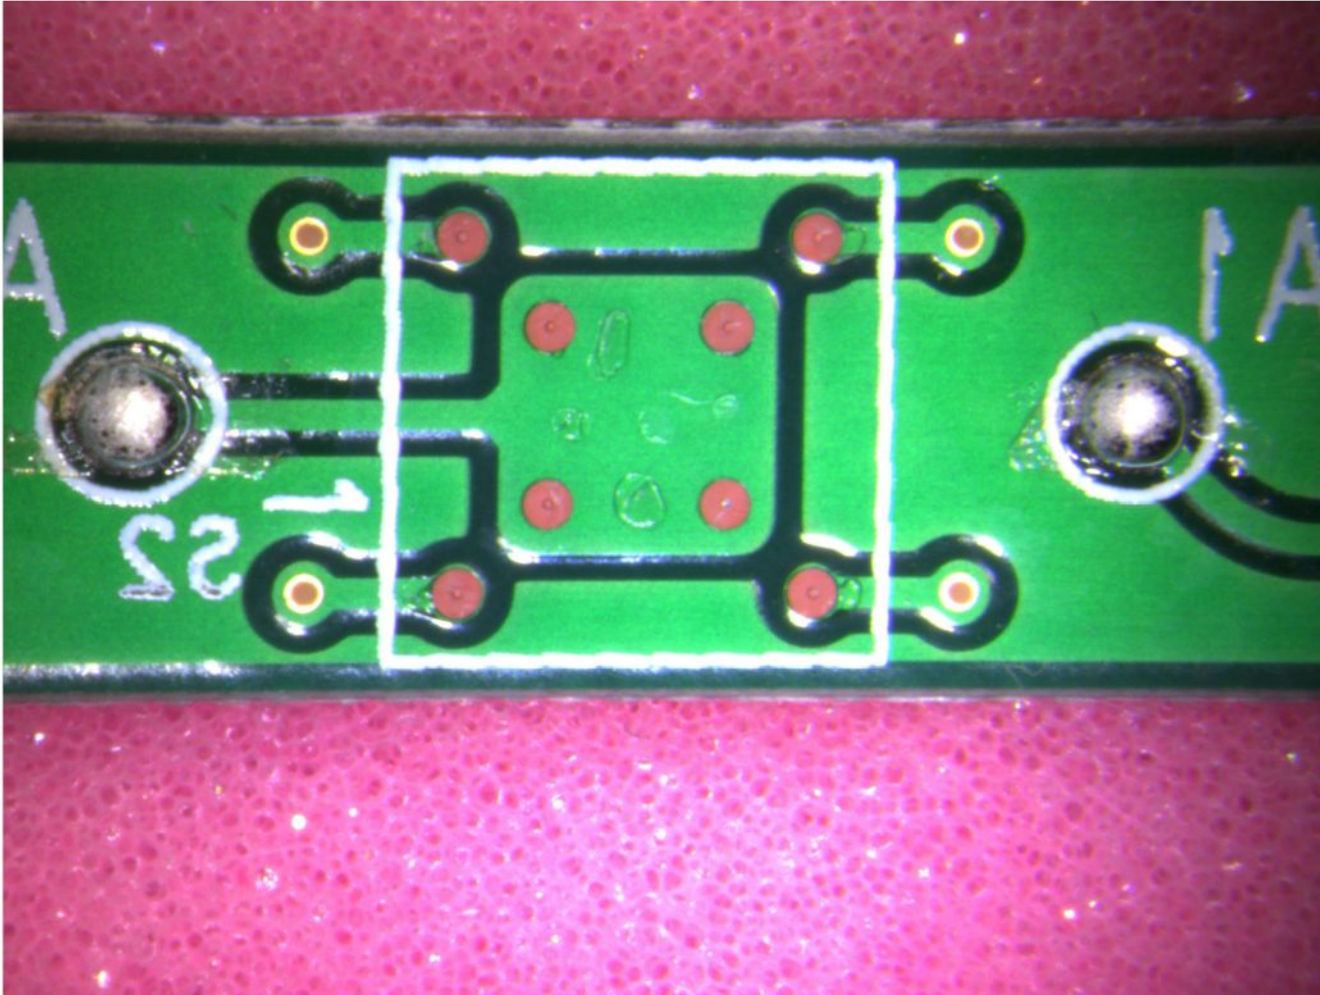
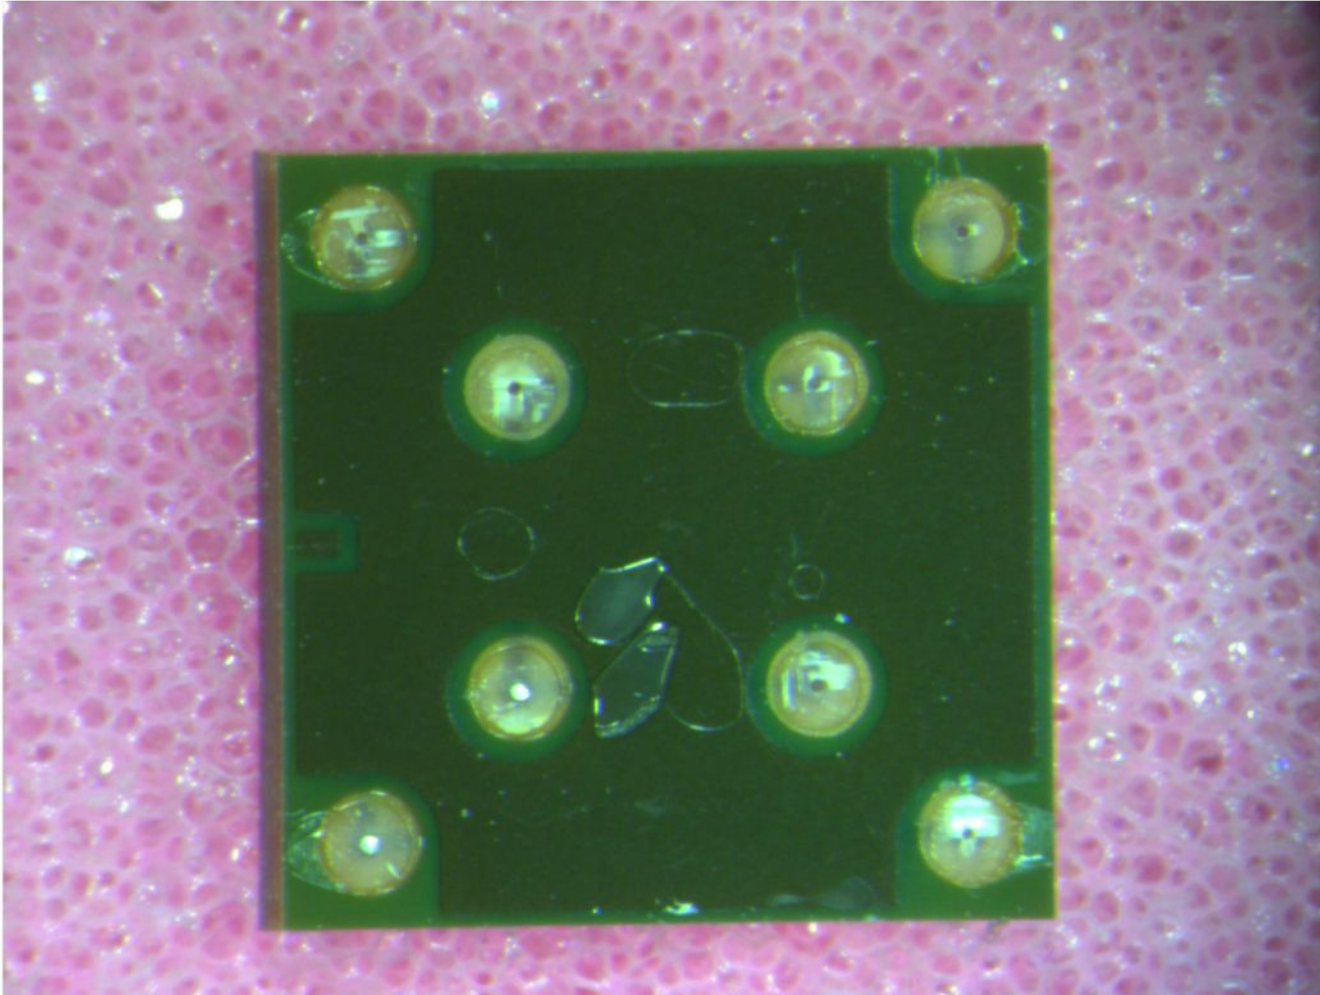
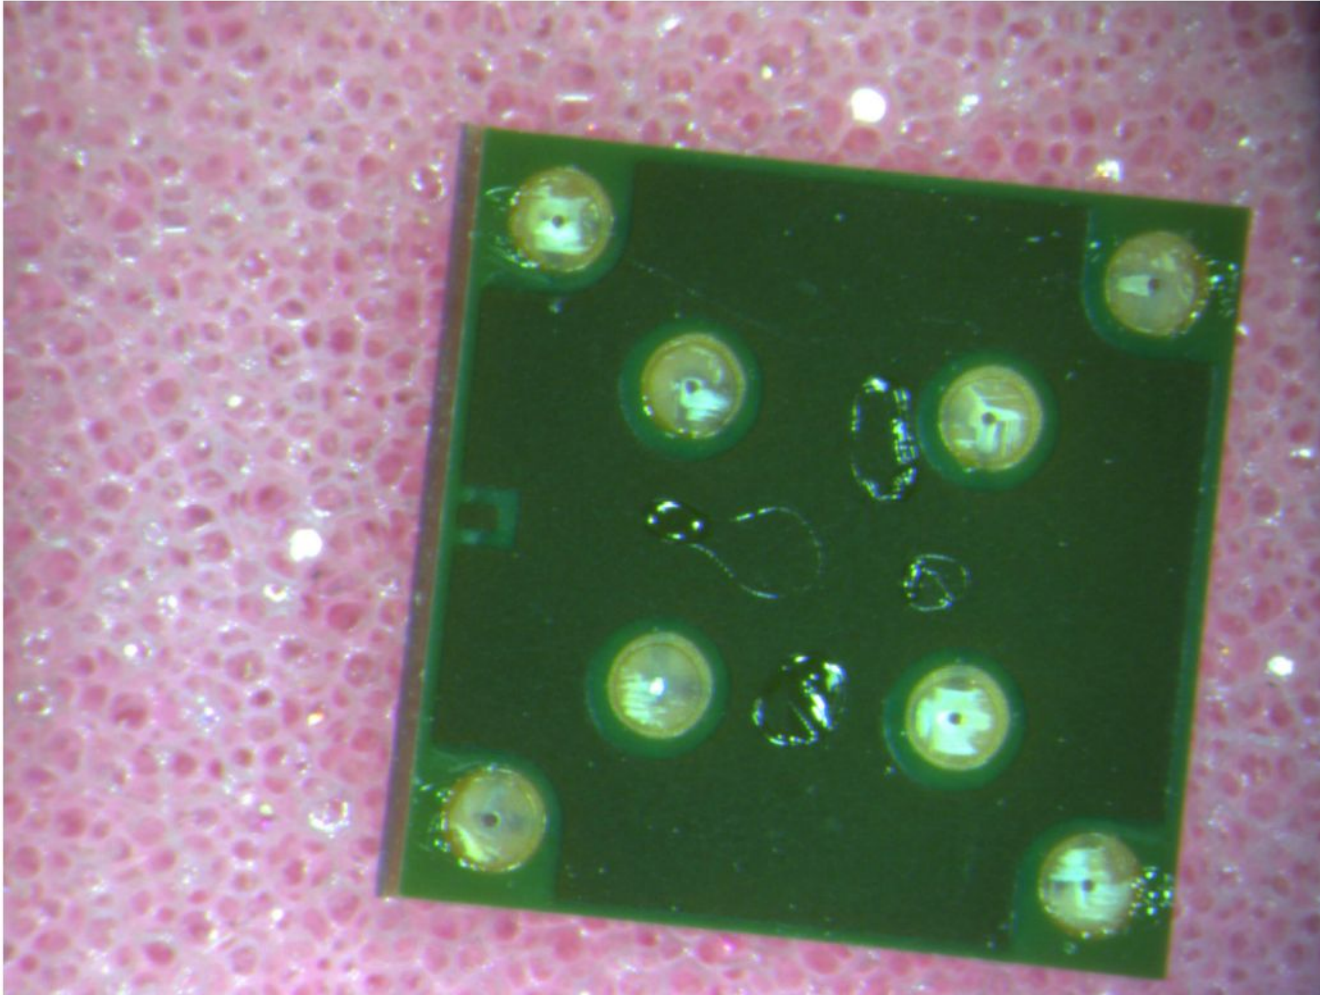
- Box 6 Tray 52 board n.13415

- Tested 600 boards (400 from box5 & 200 from box6)
- Box 6 Tray 52 board n.13415: 2 SiPM detached: one strange results one good results during measurements
- Box 6 tray 61 board n.13475: 1 SiPM detached: strange results during measurements
- Looking at the picture it seems that soldering material is absent/very poor?
- We place the SiPM detached in the tray and re-closed the gray bags
- We marked these sensors in the database tables as “detached”
