APA14 Broken Wire

Overview

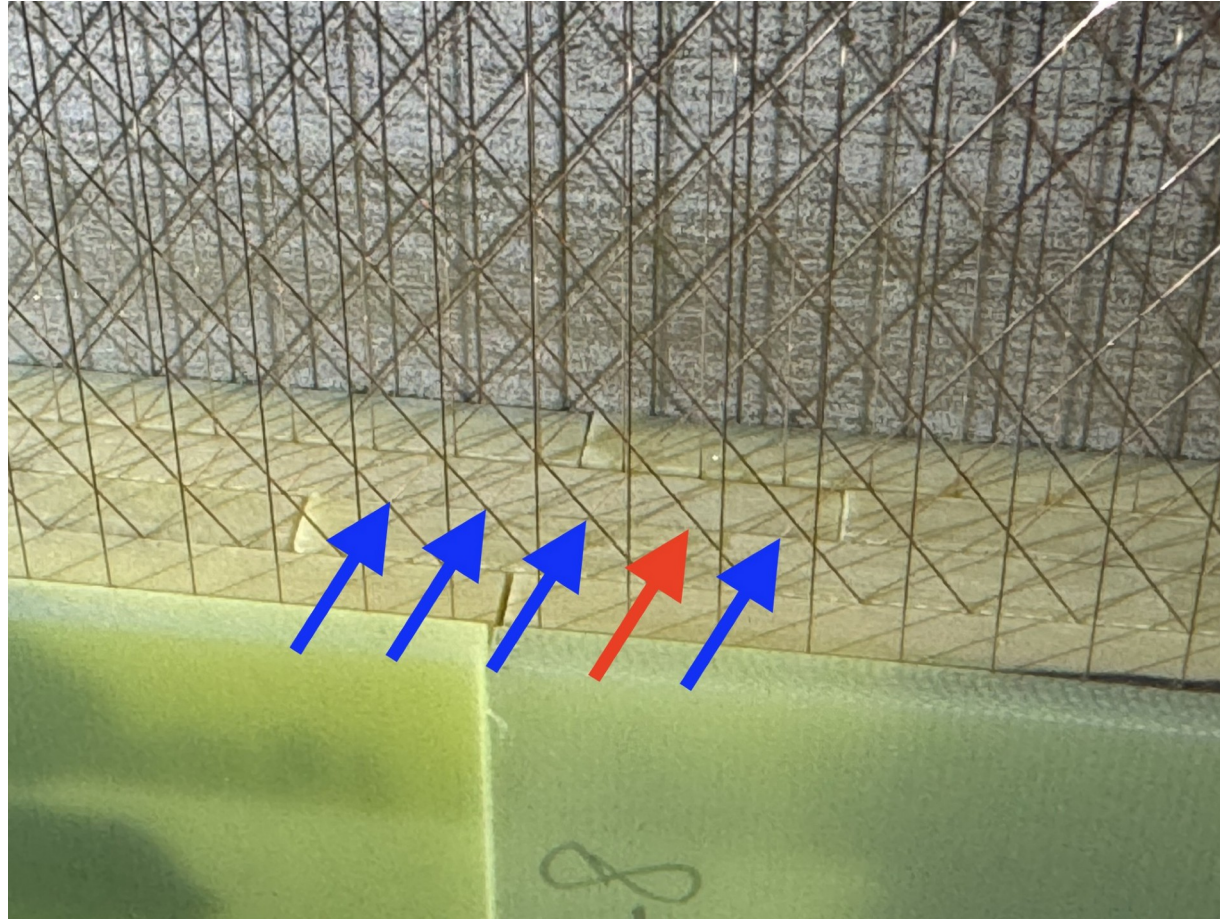
- On removal from the cold box, it was observed that a wire on APA14 had broken.
- From the CE readout we observe that this wire broke during warmup over the weekend (Sat morning), at a temperature of ~ 270 K.
- The wire is on the V layer, 2nd from the edge of its head board, and broke at the soldier joint.
- The Compliance inspection report (with photos) can be found on EDMS here: <https://edms.cern.ch/document/3181578/1>

- Daresbury will send an expert to remove the broken wire, and take samples for electron microscopy + load testing.
- APA14 must be cold cycled again.
 - Questions: with full instrumentation? With a preceding DWA measurement?
- Both APAs received a shock during transport (report: <https://edms.cern.ch/document/3177756/1>), so the outcome of the cold test of APA15 will give some indication of whether there is a causal link.
