Update on Tianlai Hardware Status

Jixia Li

2024/11/26

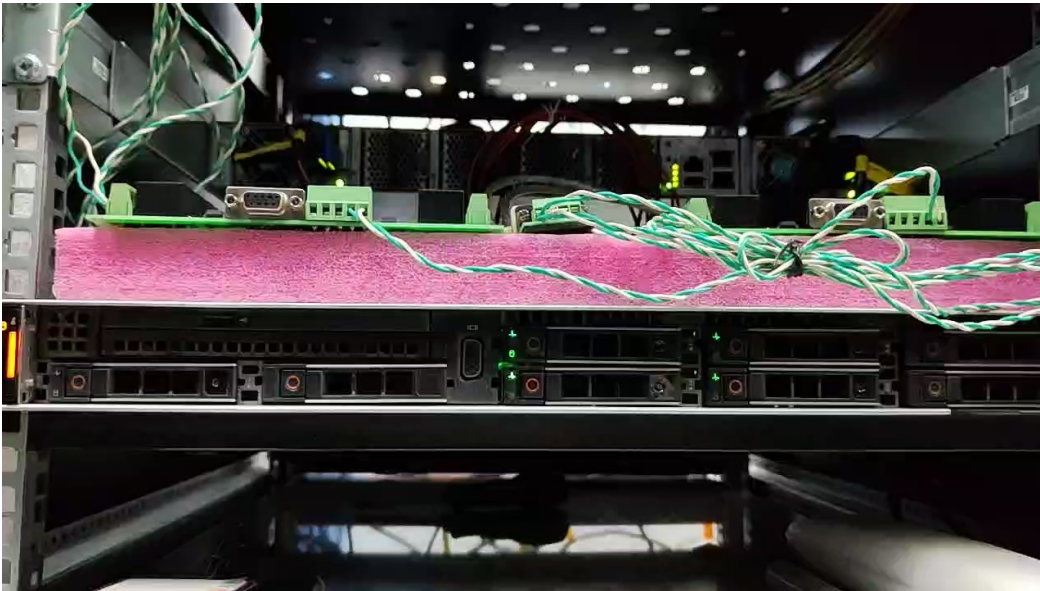
- Cylctrl server system SSD failed.
 - Server sent to Guangdong for repair.

Timestamp ▾	Message
2024-11-04 01:30:01	Fault detected on drive 0 in disk drive bay 1.
2024-11-04 01:29:59	Fault detected on drive 1 in disk drive bay 1.
2024-11-04 01:29:16	Drive 1 in disk drive bay 1 is operating normally.
2024-11-04 01:29:13	Drive 0 in disk drive bay 1 is operating normally.
2024-11-02 03:41:21	Fault detected on drive 0 in disk drive bay 1.
2024-11-02 03:41:19	Fault detected on drive 1 in disk drive bay 1.
2024-11-02 03:40:33	Drive 1 in disk drive bay 1 is operating normally.
2024-11-02 03:40:30	Drive 0 in disk drive bay 1 is operating normally.
2024-11-02 03:35:58	An unsupported event occurred.
2024-11-02 03:35:58	A problem was detected during Power-On Self-Test (POST).
2024-11-02 03:34:53	Fault detected on drive 1 in disk drive bay 1.
2024-11-02 03:34:50	Fault detected on drive 0 in disk drive bay 1.
2024-11-01 11:20:52	Multi-bit memory errors detected on a memory device at location(s) DIMM_A4.

2024-11-01 11:20:52	An OEM diagnostic event occurred.
2024-11-01 11:20:51	An OEM diagnostic event occurred.
2024-11-01 11:20:51	An OEM diagnostic event occurred.
2024-11-01 11:20:51	An OEM diagnostic event occurred.

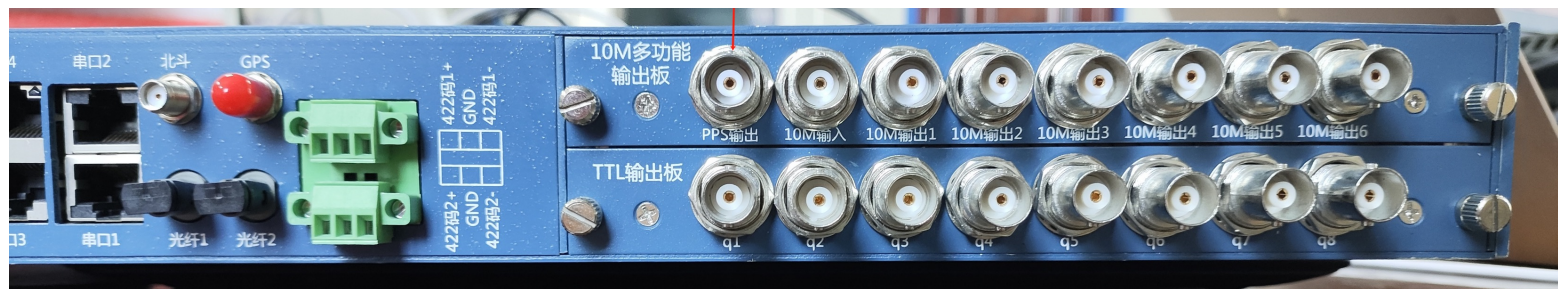
- No-correlation problem between roach boards turns out to be caused by false output of 1PPS signal.
- Upgrade GPU card from GTX690 to RTX3080 for 2 Xengine servers.
- Roach 7 netboot resolved by setting environment variables in u-Boot.

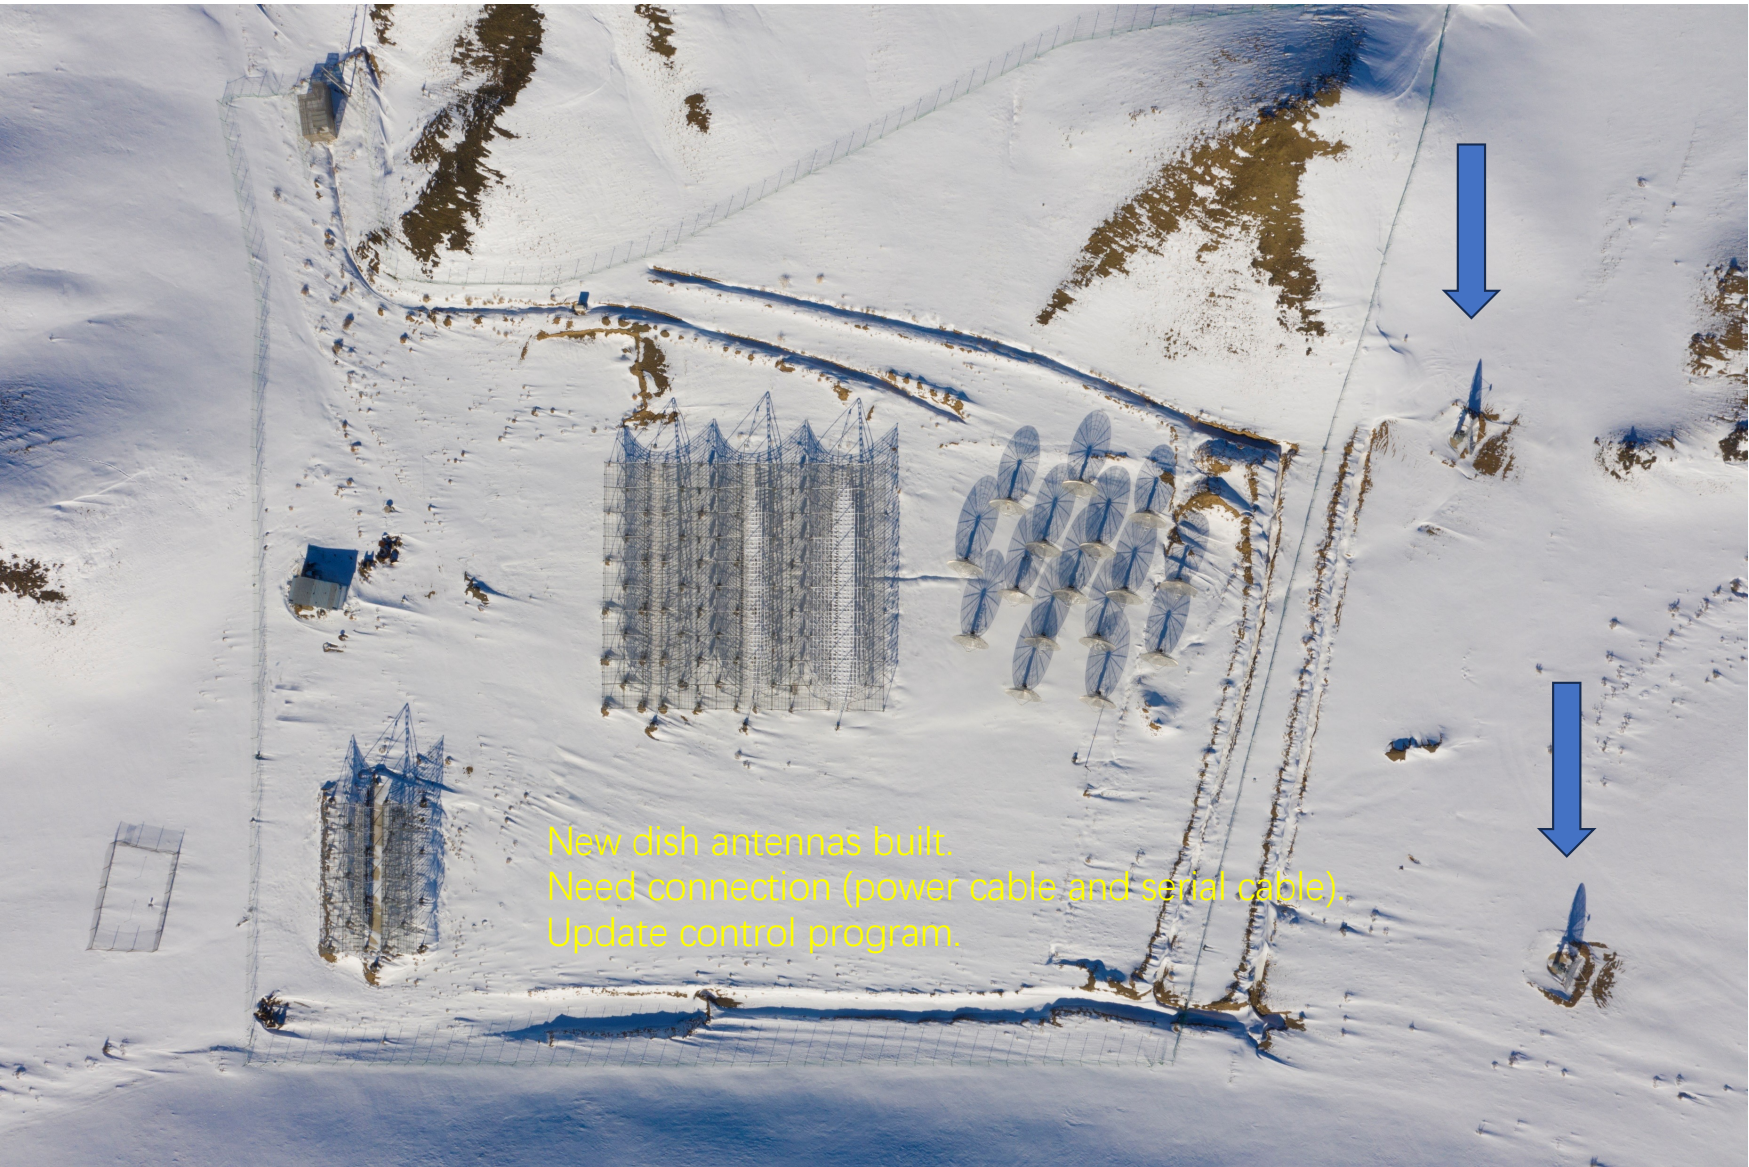
New dish antennas built.
Need connection (power cable and serial cable).
Update control program.
