# Problems wire bonding ColdADC & COLDATA

David Christian

Fermilab

December 11, 2024

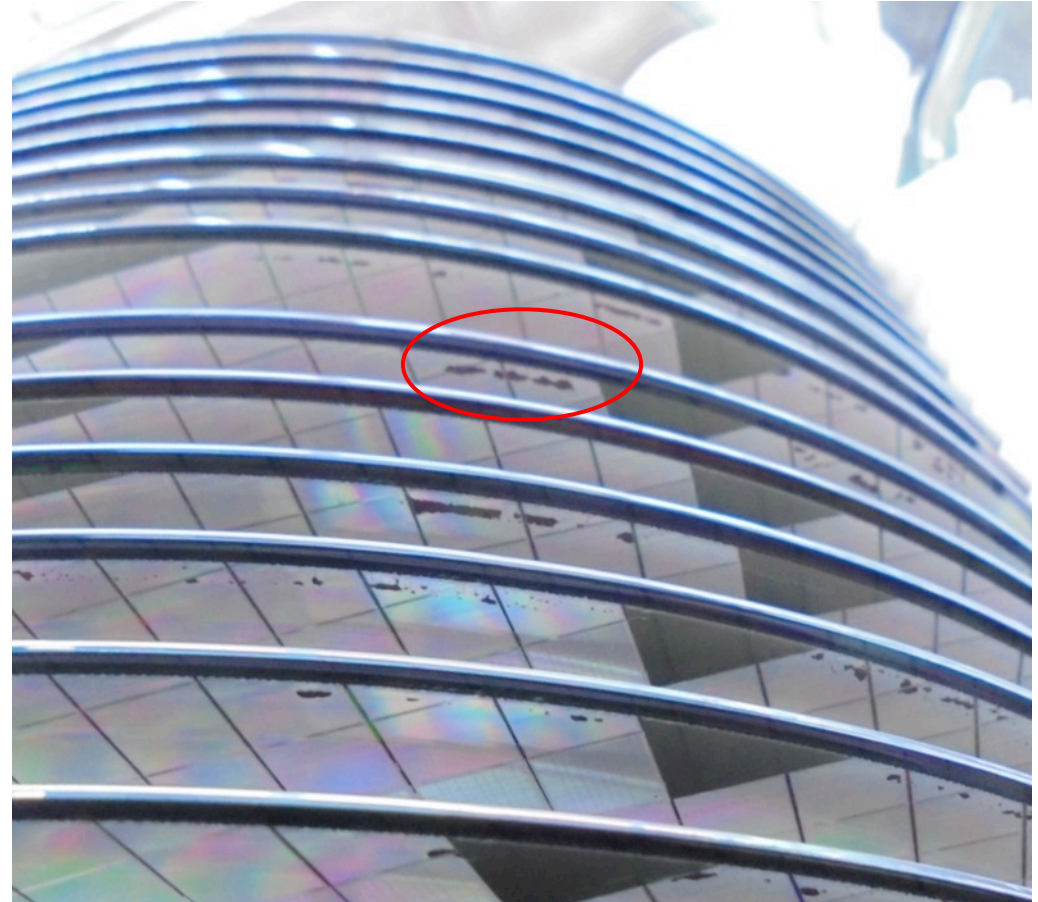
- March 22, 2024 – Confirmation that lots NBMY62.00 & NBNA38.00 were received by ASE in Taiwan.
- April 22, 2024 – Defects observed on incoming wafers.
  - “operators observed glassivation issue”  
***There are risks with using these wafers and we require waiver that we are ISE/ASE is not liable for any yield issues or quality issues with the assembly of these wafers.***  
***It has risk to taping BG tape non-sticking on wafer edge due to uneven surface.***  
***It has risk to encountering wafer crack and bond pad contamination during grinding process.***
- Contacted Kostas Kloukinas (CERN)
  - He had not seen similar damage before, and he forwarded my email to IMEC with the request to contact TSMC for advice.
  - We gave the OK for ASE to thin one set of 25 wafers.

- TSMC examined the images and observed delamination affected only non-functional devices. “The wafers will not have been shipped if they did not comply with TSMC WAT (Wafer Acceptance Test). This delamination should not affect the other (fully processed) die on the wafer.”
