Run II Operations Summary

R. Dixon

PAC October, 2006 - R. Dixon

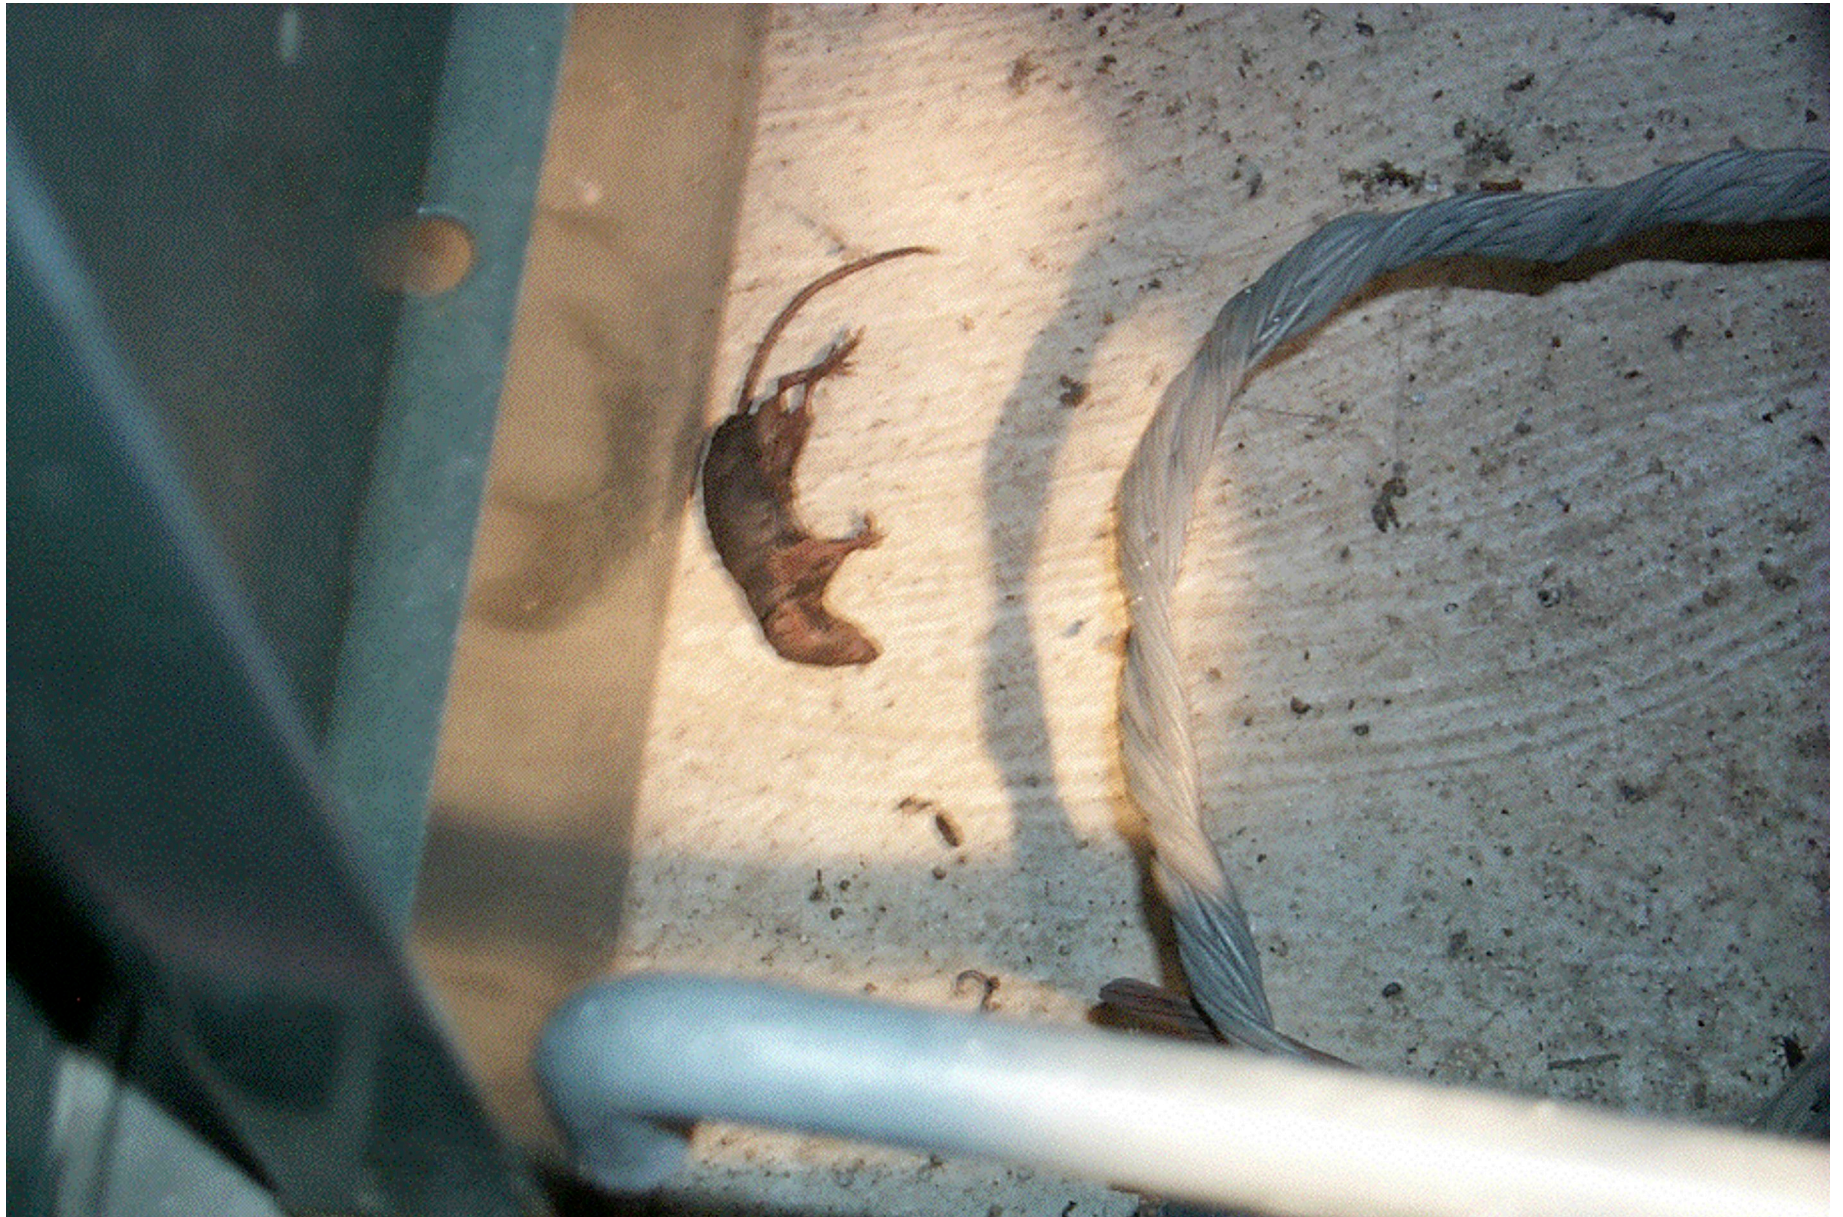
The Culprit

- HEP store 5008 happily spinning
 - Record # pbars injected into Tev, record # pbars reach HEP start
- Mouse seeks Feeder 46B cubicle as possible new, cozy home
 - Flashover + resulting nasty power glitch affects many systems
 - Many UPS units switched over
- Tevatron ramp begins to dump on A2 power supply trip
 - Beams aborted cleanly
- 1.2 sec into ramp dump, D3 QPM reboots (Quench Protection Monitor)
 - Why? Glitch not filtered out by UPS? UPS tested fine later...
 - As designed, QPM fired heaters, generating whole-house quench
- ≈4 sec into ramp dump, ground fault developed in D3
 - D32-5 dipole failed

- Replaced Accumulator Quad (A:6Q14)
- Fixed Water Leak in HV101
- Replaced D32-5, D33-1, and D35 spool (broken corrector-- not damaged in Mouse Incident)

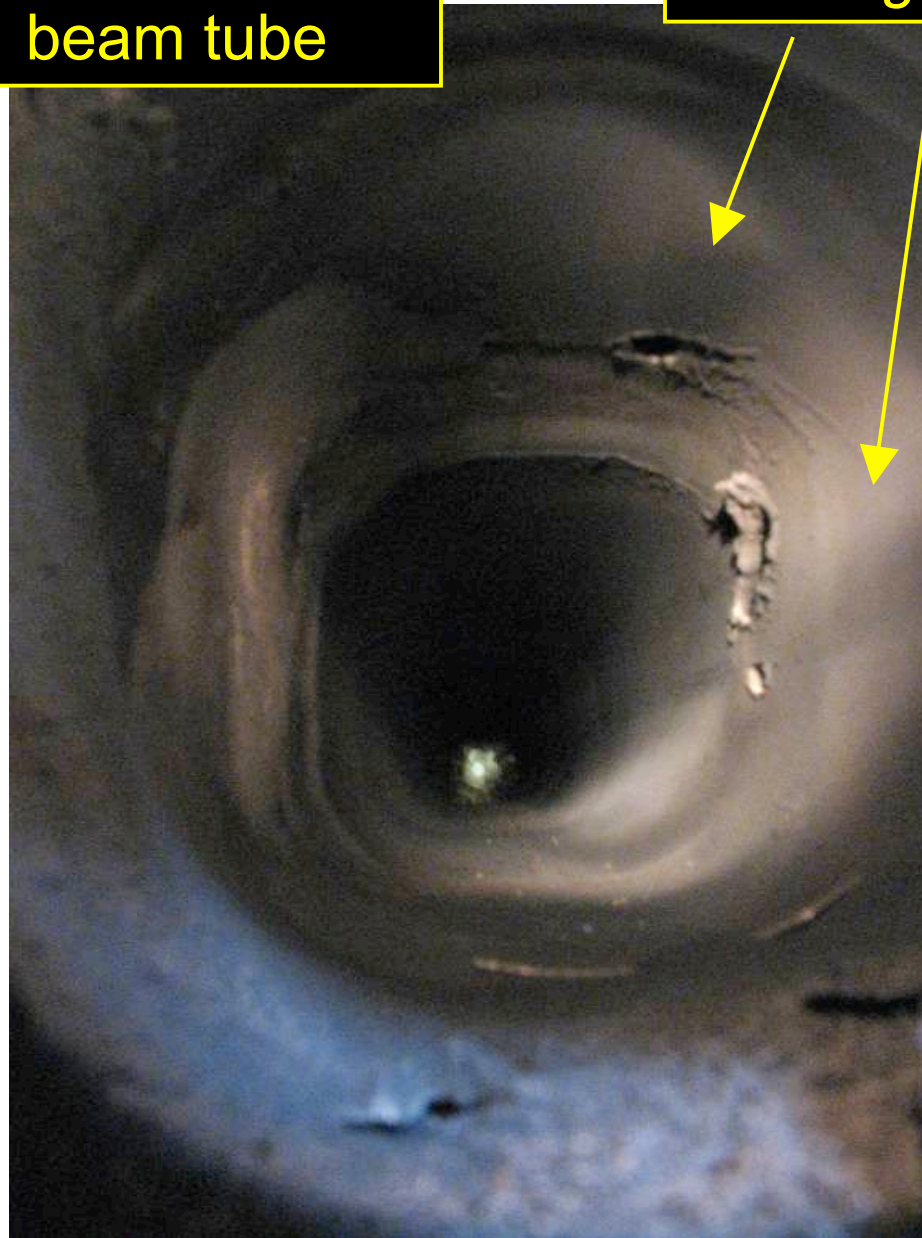
D32-5 dipole
beam tube

*Holes from
arcing?*
