# MICE Spectrometer Solenoid Repair

# MICE Spectrometer Solenoids

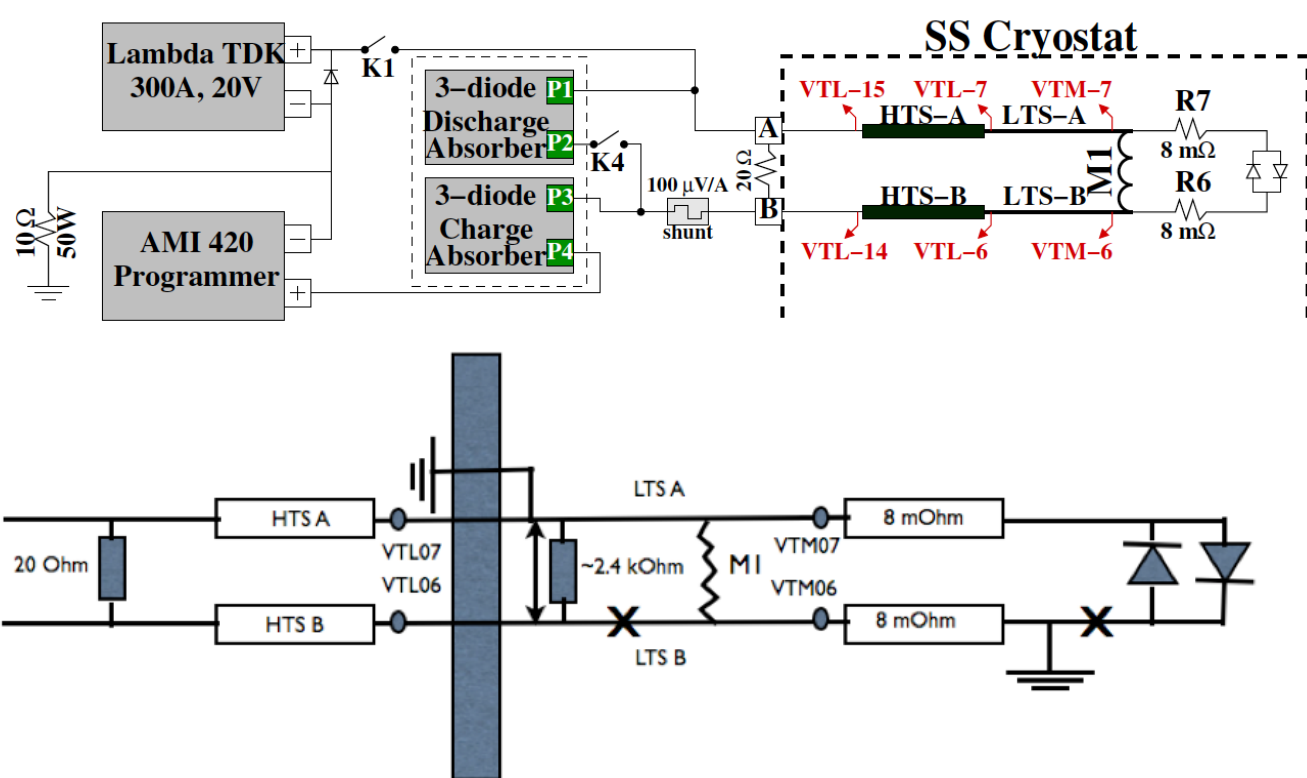
# M1 circuit after fault

Diagram of the M1 circuit. Resistance (four wire and two wire) measurements revealed:

- Lead A has hard short to ground,
- LTSA is shorted to LTSA through 2.4 kOhms and LTSA is not connected to the M1 coil on the Lead B side.

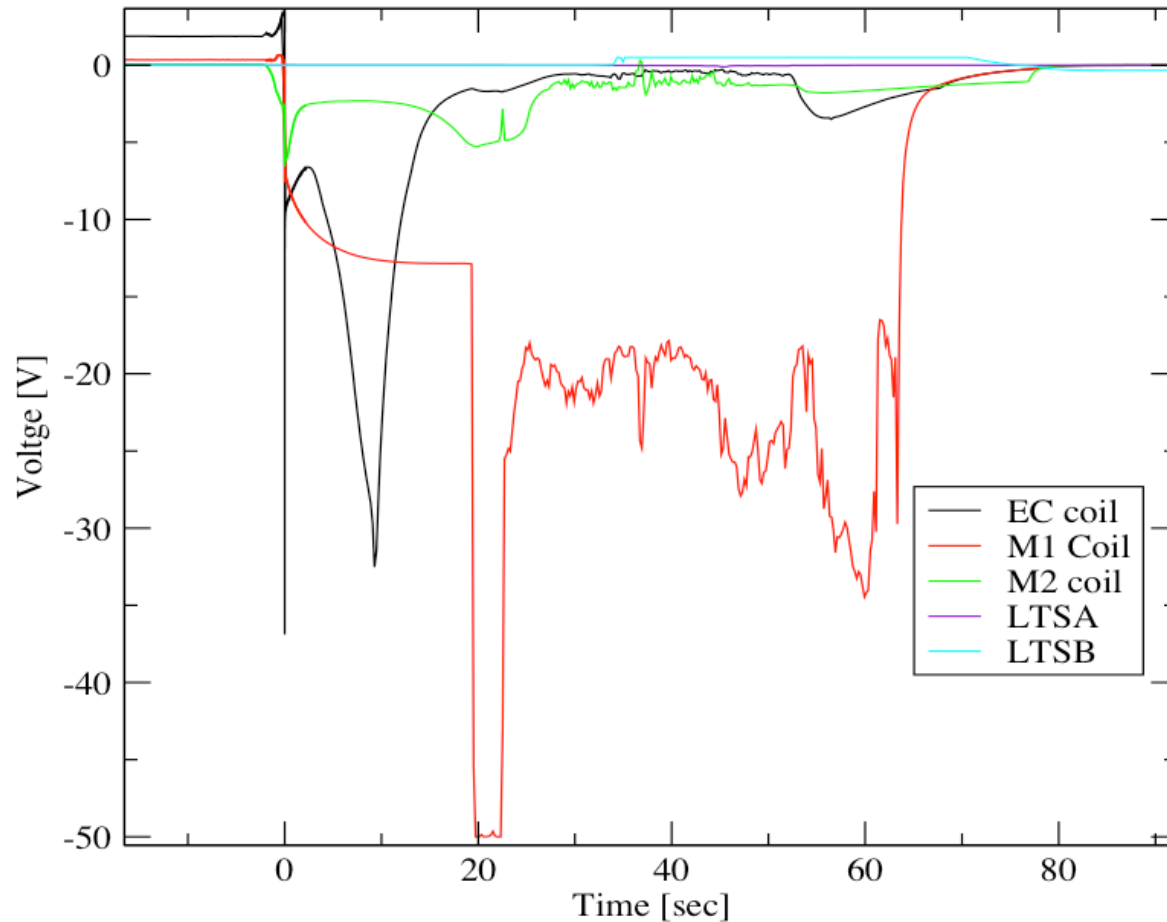
Quench on September 13th

- Quench initiated on ECE and initially proceeded normally
  - There is no evidence that any LTS leads were involved initially
- At  $\sim 20$  sec, the internal QP for coil M1 failed
  - The voltage on the coil increased rapidly and, it appears that an arc at the LTS power feed through (from vacuum to LHe volume) occurred which burned out the lead and effected M2 (the power leads for M1 and M2 utilize the same 4 pin feed through).
- What caused the QP failure?

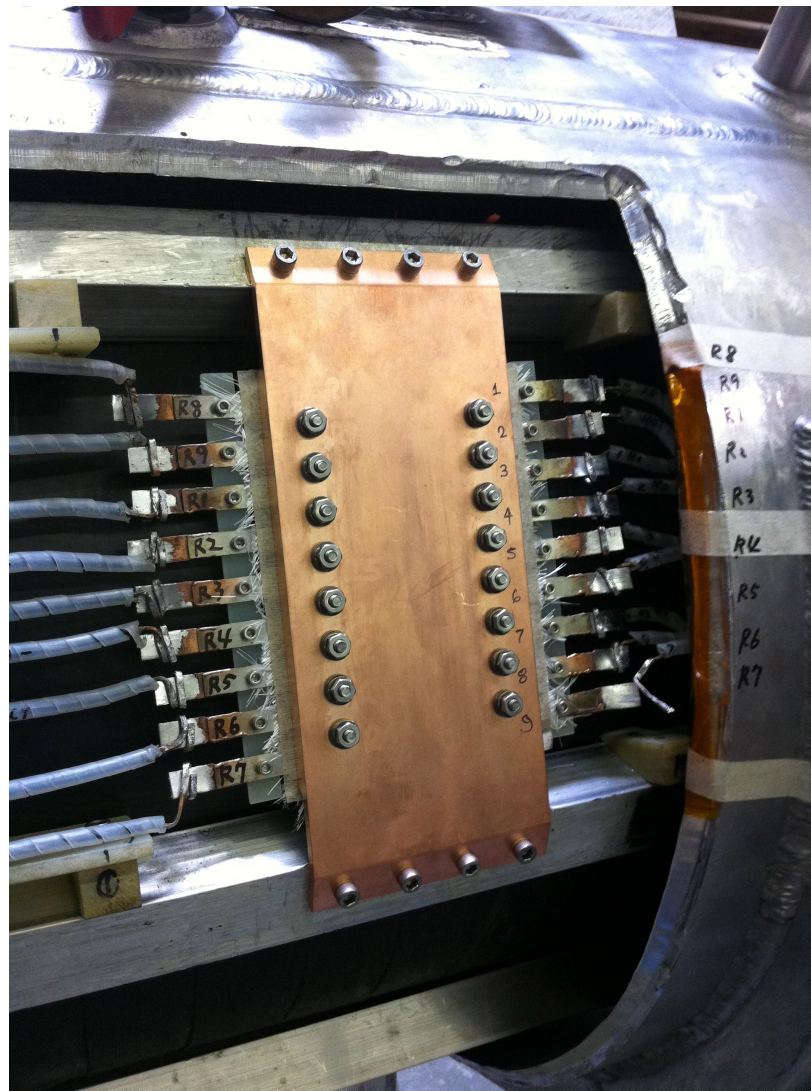
This is a photo of the QP pack for SSD/SS1. What is not known at this time is exactly how the terminations were made. Did Wang follow the procedures used on SSU/SS1?

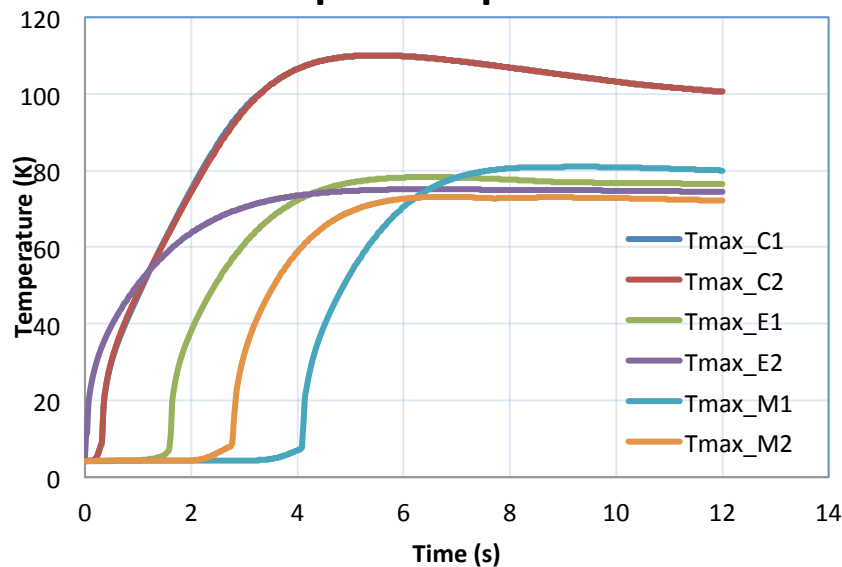
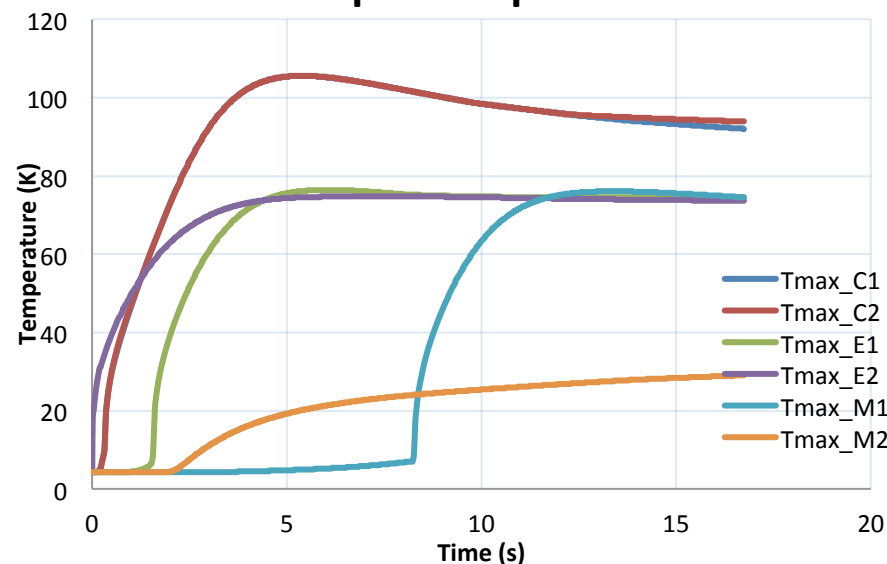
- Compared the results with (case I) and without (case II) M2 powered.
- Quenches were initiated in E2 in both cases.
- The quench current in case I is 265A in all coils.
- In case II, the quench currents in ECE and M1 are 260A and 250A, respectively.

- Time to Q for M1 increased by  $\sim 2X$
- However, overall scale in simulation does not agree with data
  - There is a qualitative understanding
    - LHe & gas not modeled exactly
    - The thermal properties of the mandrel + insulation between coils and the bobbin are not precisely known
    - The starting location of the quench will affect the heat propagation from the hot spot to the mandrel, this will cause time difference. The model is always set so that the innermost layer initiates the quench.
- Given the above, there is qualitative agreement:
  - The quench delay of M1 increased by  $\sim 2X$ , from 10 seconds to 20+ seconds.
