LQ Instrumentation and Quench Protection

Helene Felice

LARP Collaboration Meeting 14

April 26-28 2010

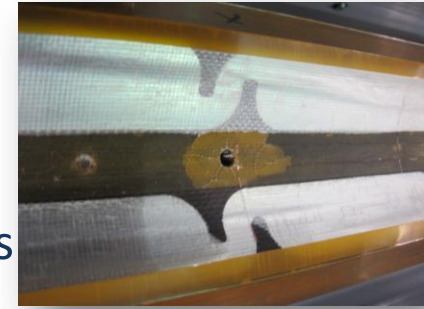
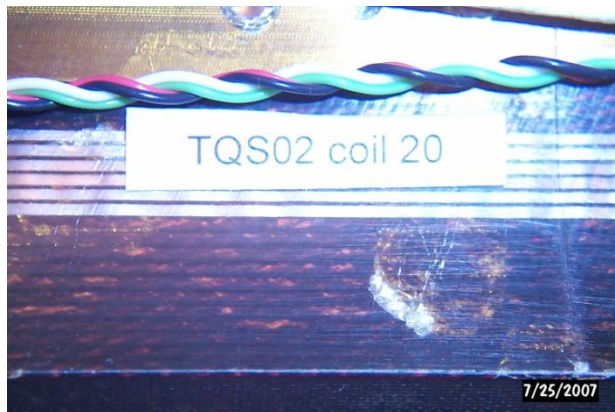
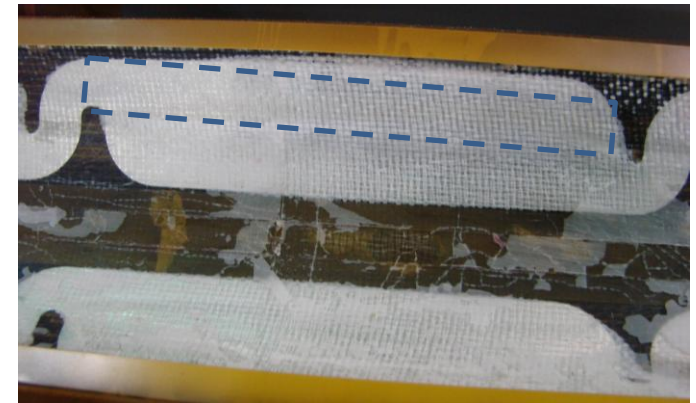
- Delamination on coils Inner Diameter
- Different from “TQ-style” bubbles
 - larger => only underneath the large sections of the heaters
 - No conductor exposed
 - Not clear if bubble underneath stainless steel or only glass sheet => impact on heater performance ?
- Possible causes:
 - Superfluid helium + quench (only 2 quenches) \Leftrightarrow TQ
 - Heat from heaters on ID \Leftrightarrow LQ

Coil 6 (showing epoxy “peeling” related to double impregnation, already observed before test)

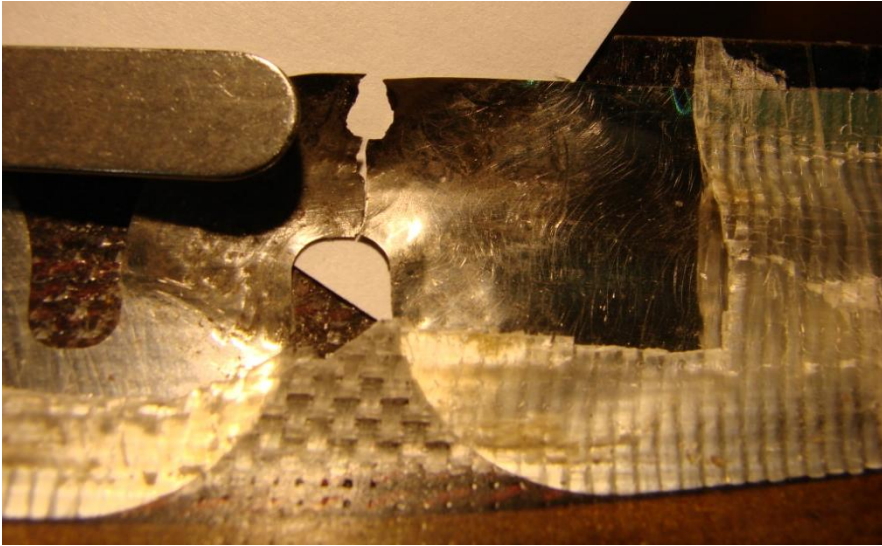
Coil 7 PH A01 observation

- Black spot observed on a heating station
- the glass has been peeled off
- the carbon cleaned
- the Kapton underneath the trace has been cleaned/removed

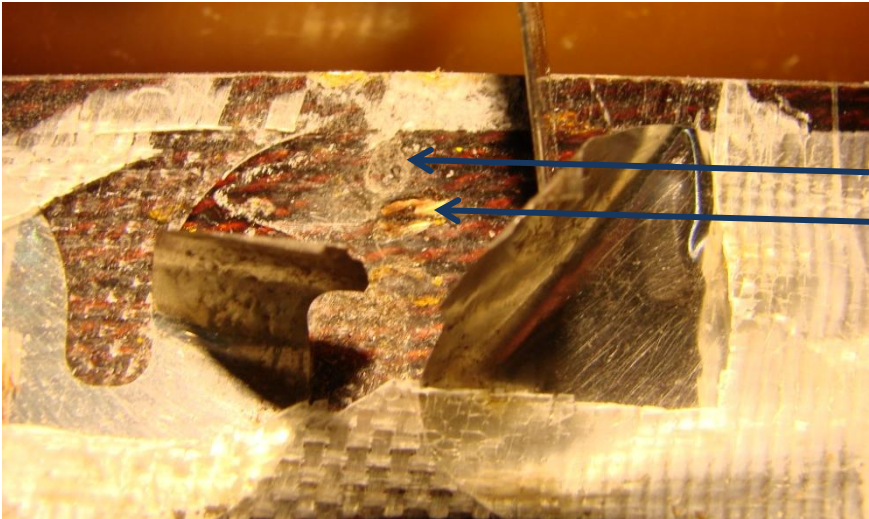
Spot where the heater was burnt
Some conductor exposed

- Hipot performed => OK to 1 kV at 1 μ A

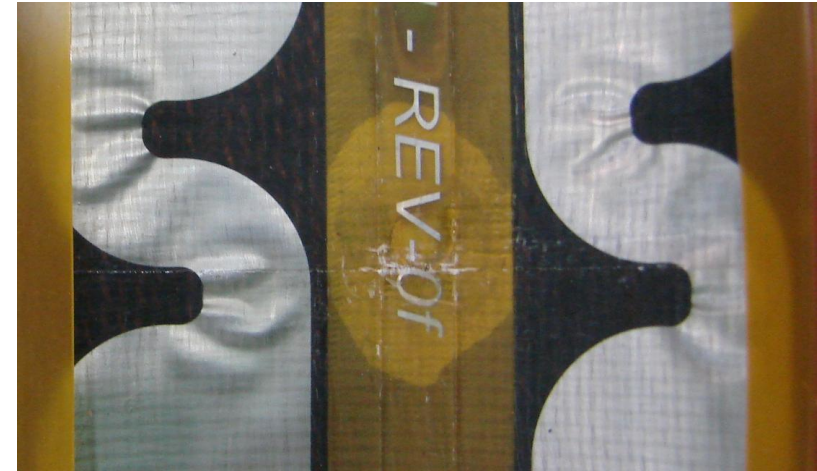
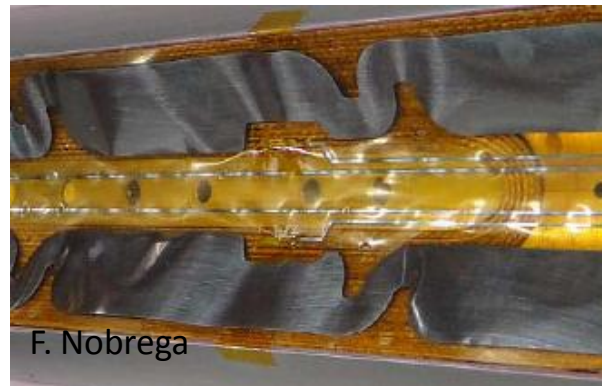
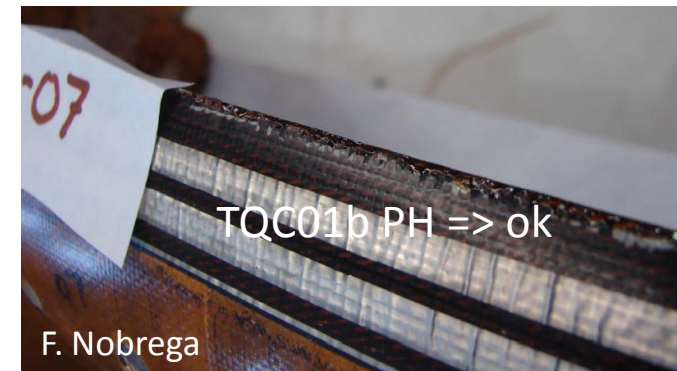
- Repair performed before LQS01b assembly
 - Coil 09 station 4 strain gage repaired
 - Modif of T compensator thickness
 - Rods SG repair
- Coil 10 instrumented
- Coil 11 and 12 at LBL
 - Coil 12 PH post-impregnation visual inspection => wrinkles everywhere along layer 1 PH
