MICE Spectrometer Solenoid (Pre-) Review Initial Impressions

Jim Kerby (ANL)
RAL, Oct 27, 2015

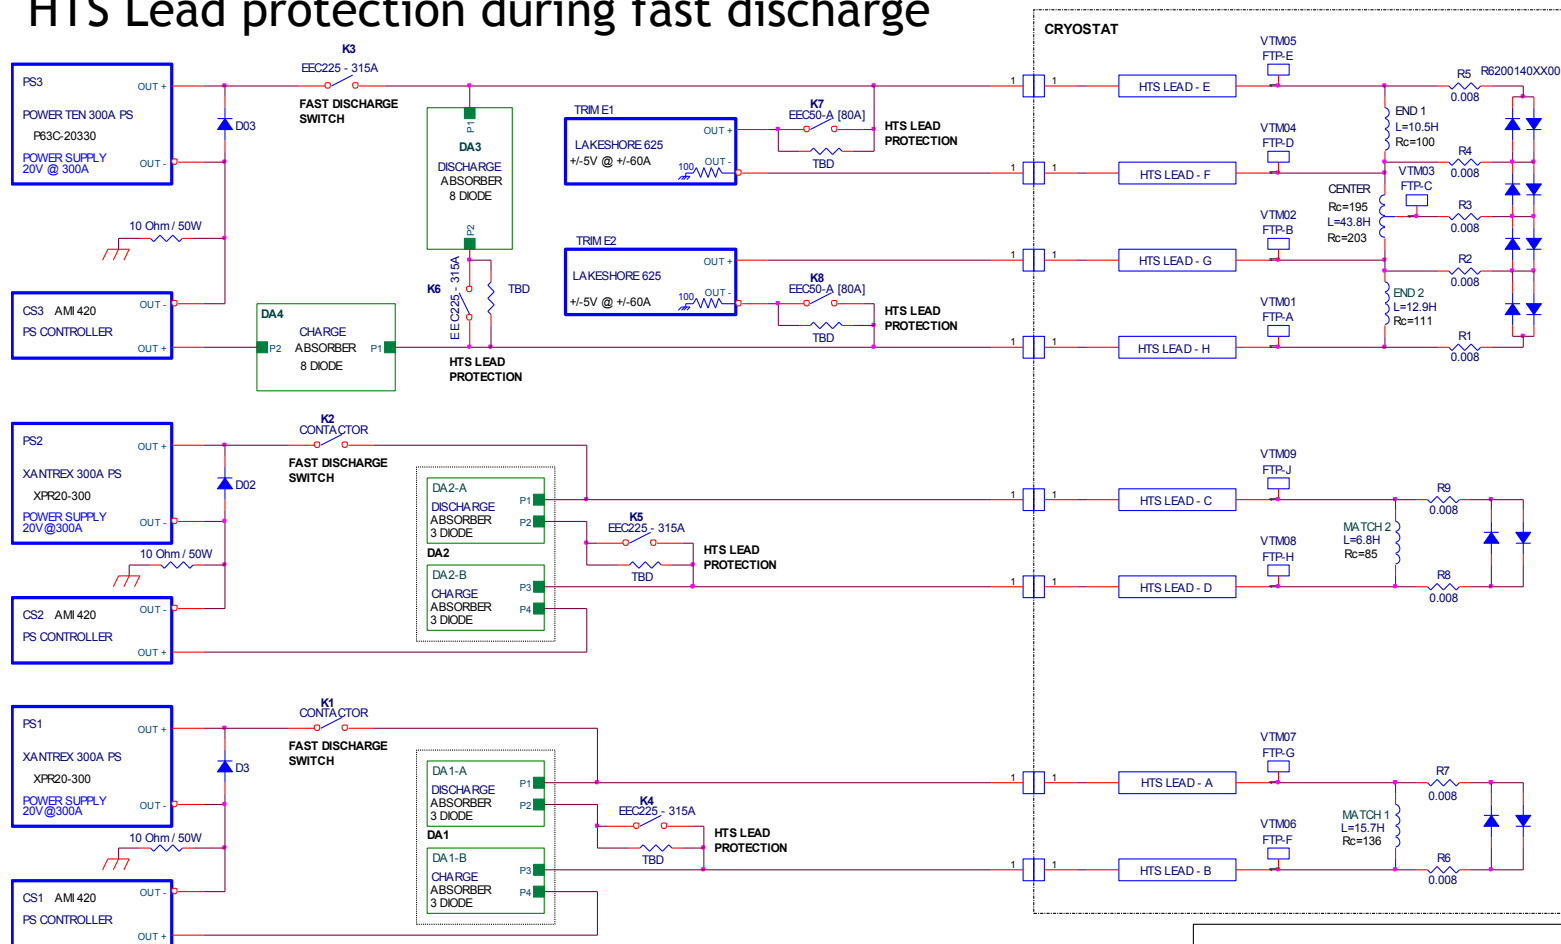
LBNL/MICE: DC PATH [“As Built”]

- Added 5 contactors to system
 - HTS Lead protection during fast discharge

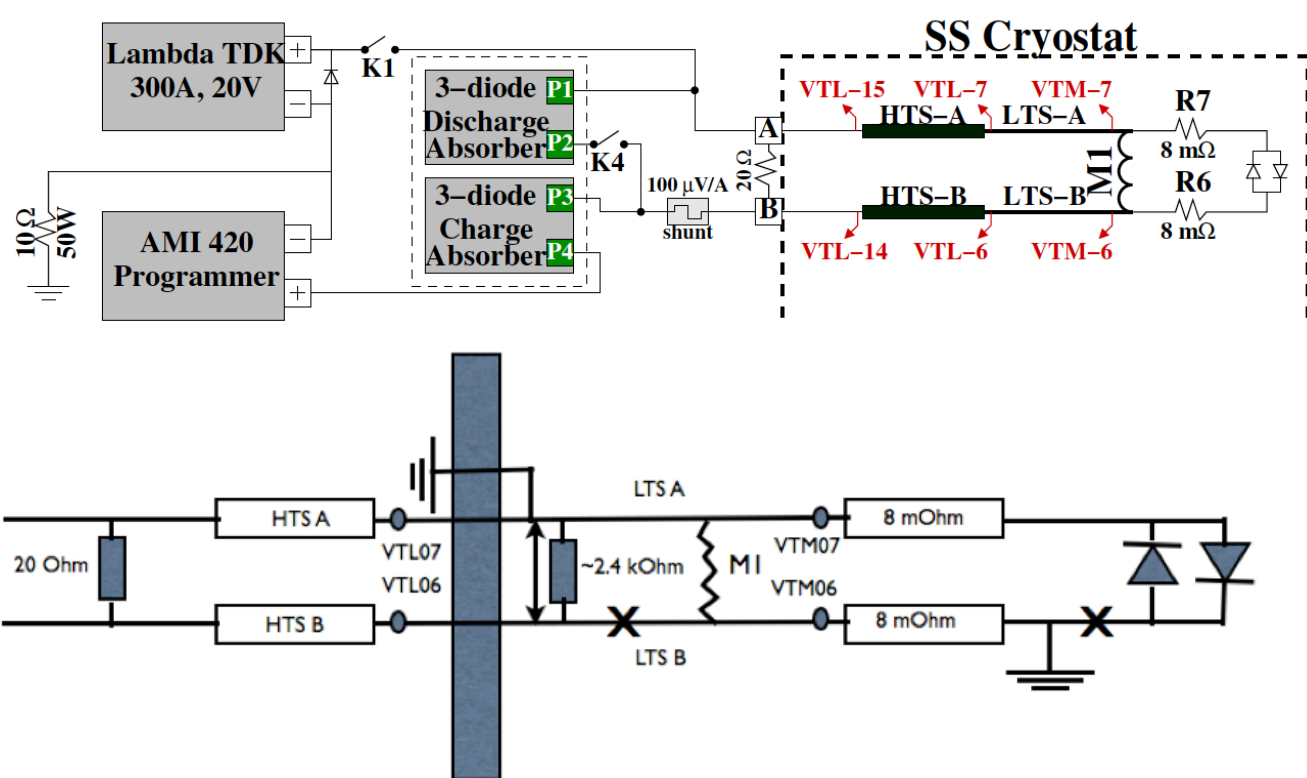
M1 circuit after fault

Diagram of the M1 circuit. Resistance (four wire and two wire) measurements revealed:

- i) Lead A has hard short to ground,
- ii) LTSB is shorted to LTSA through 2.4 kOhms and LTSB is not connected to the M1 coil on the Lead B side.

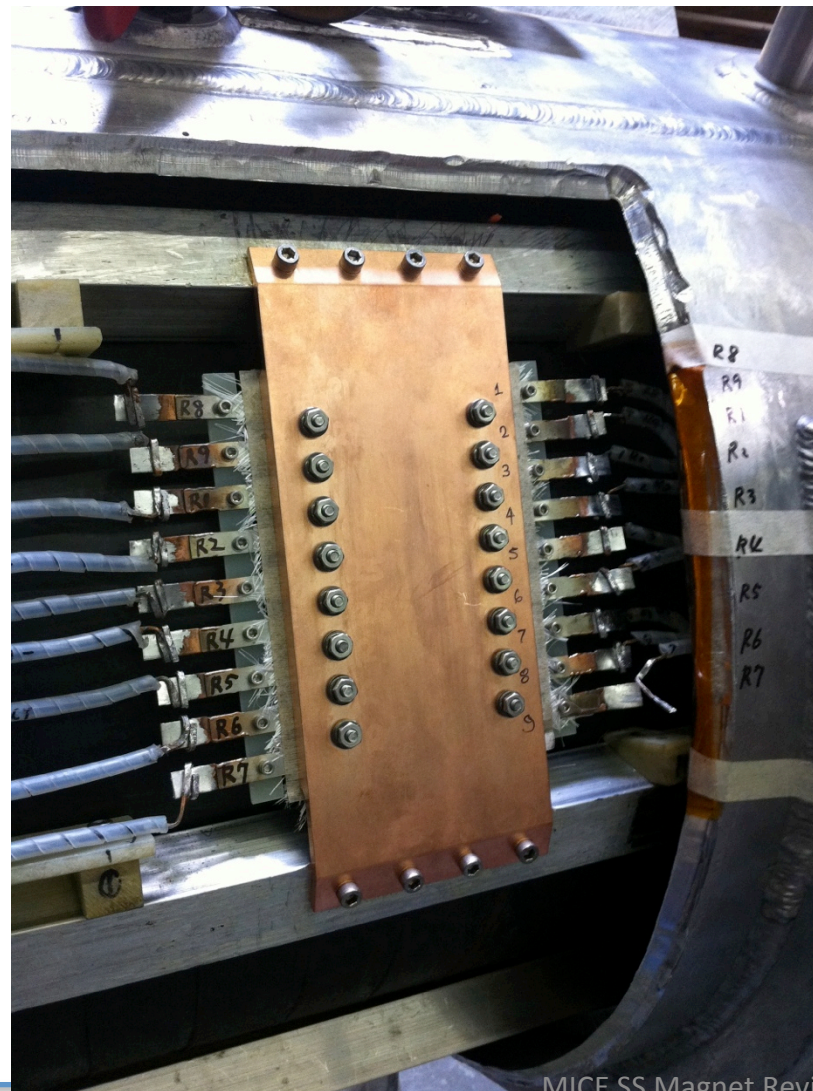
SS1/SSD Diode Pack

This is a photo of the QP pack for SSD/SS1. What is not known at this time is exactly how the terminations were made. Did Wang follow the procedures used on SSU/SS1?

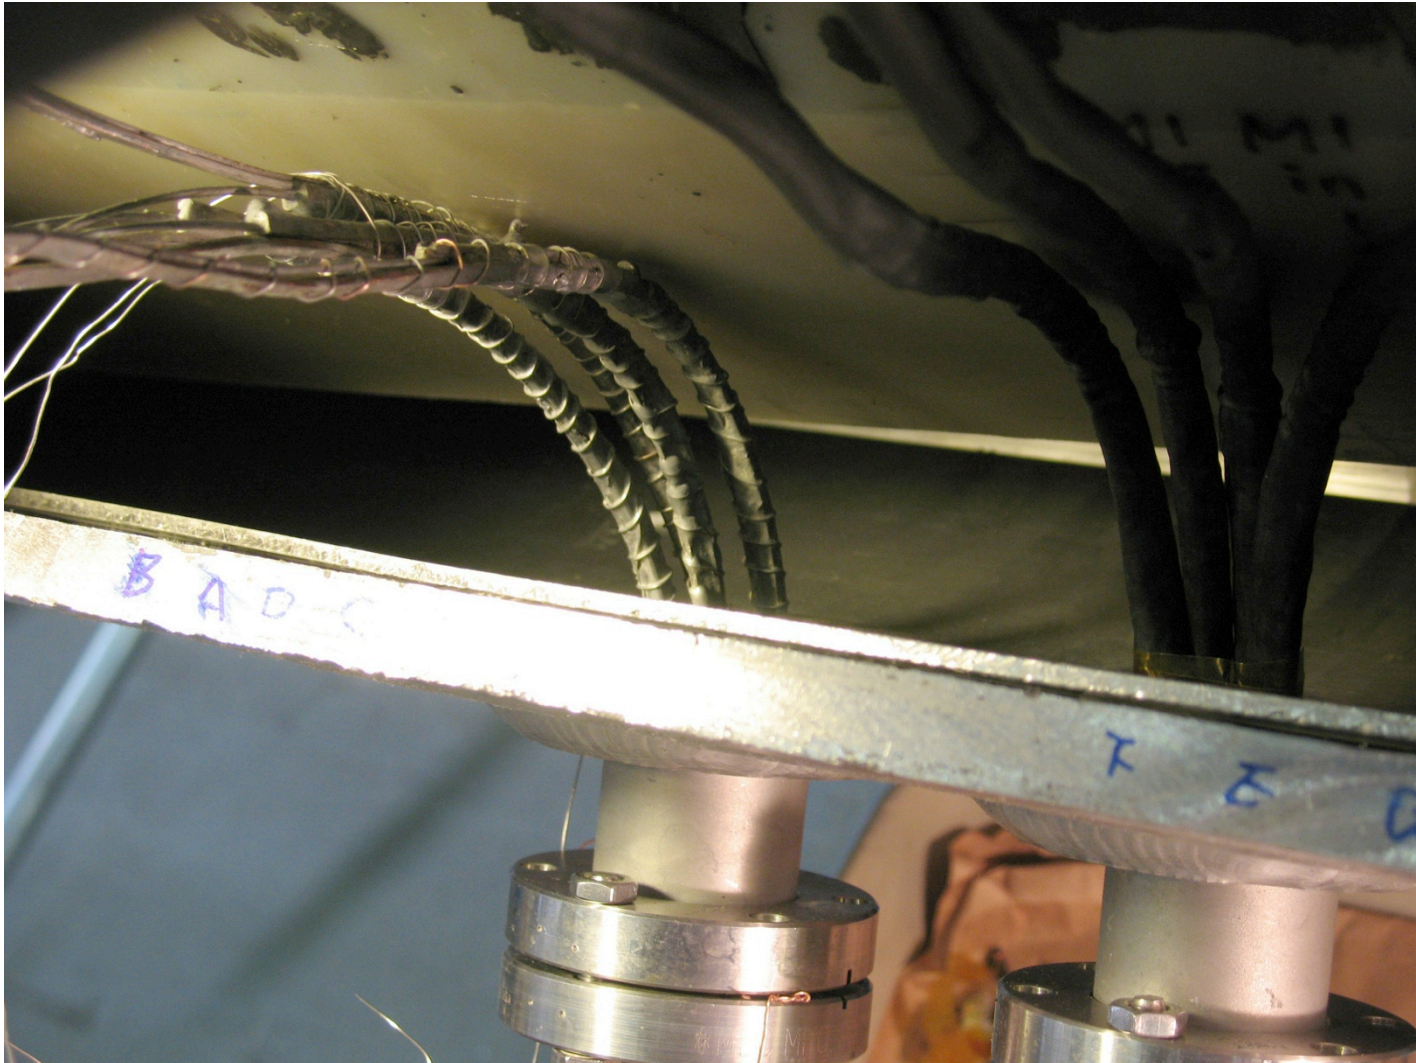
Feedthrough

- Quench initiated on ECE and initially proceeded normally
 - There is no evidence that any LTS leads were involved initially
- At ~ 20 sec, the internal QP for coil M1 failed
 - The voltage on the coil increased rapidly and, it appears that an arc at the LTS power feed through (from vacuum to LHe volume) occurred which burned out the lead and effected M2 (the power leads for M1 and M2 utilize the same 4 pin feed through).
- What caused the QP failure?

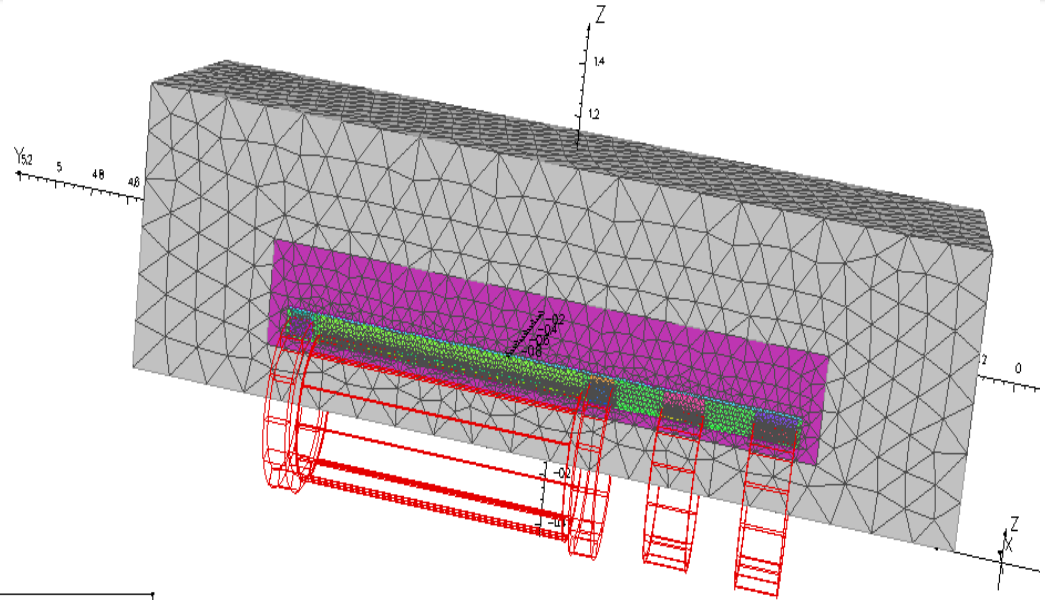
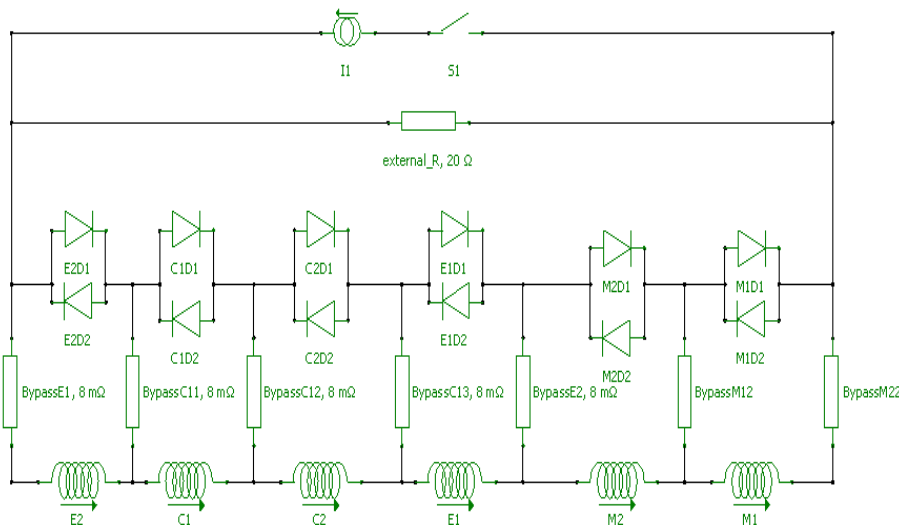
PSU Configuration (Preliminary for SSU)

- Quad model built in VF
- Quench initiated in the inner layer of the E2 coil.

- All coils are powered by a single powers supply.
- A 20 Ω external resistor goes across all the coils.
- Switch opened when the overall voltage across the E2 coil exceeds 0.2V.

- We suggest no further full powering of SSD or SSU occur until a revised power system is designed, understood, tested, and implemented.
- Proceeding with the Step IV program is probably fine after this change.
 - Risk for further incremental damage is probably contained to the area already damaged and in need of repair.
 - Some noticeable portion of Step IV can be accomplished without M1 or M2 if needed...

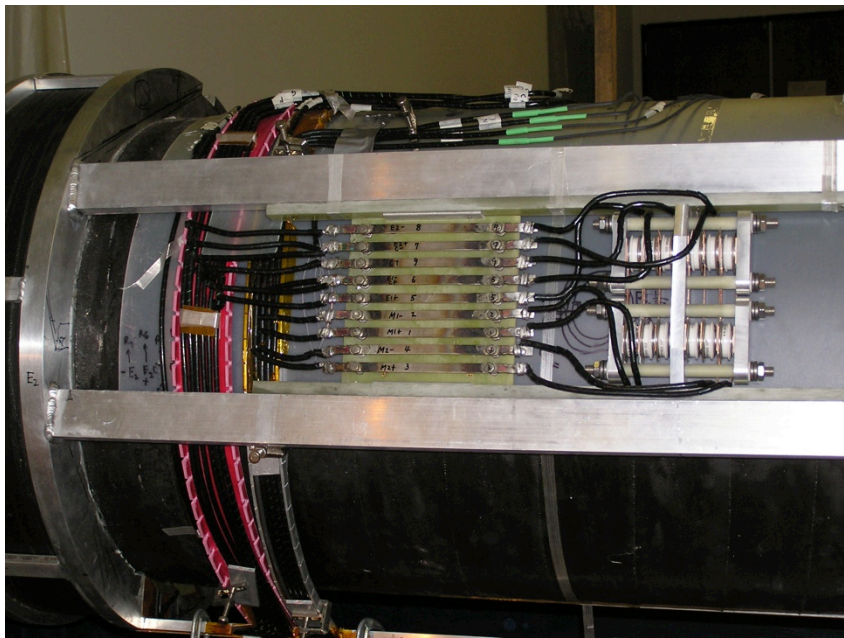
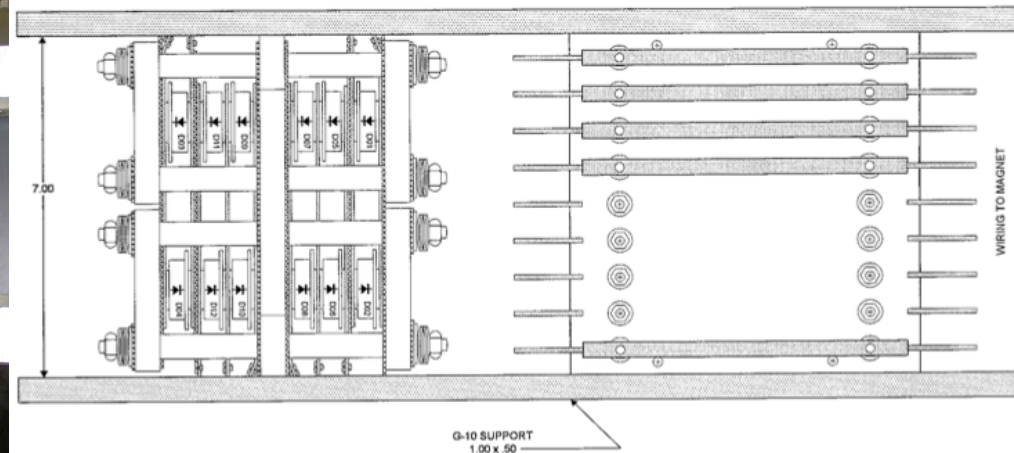
Protection circuit: diodes+resistors

- >3V forward voltage drop (needs to be measured cold)
 - Forward voltage drop decreases as temperature of diodes increases
- Resistor: strip of Stainless Steel
 - Designed to comfortably support bypass current during “normal” quench decay (~6s)
 - Temperature rise during ~6s decay is <~300K
