# The Tianlai 21cm intensity mapping experiment

Xuelel Chen

National Astronomical Observatories,  
Chinese Academy of Sciences

Fermilab, 2016.09.26

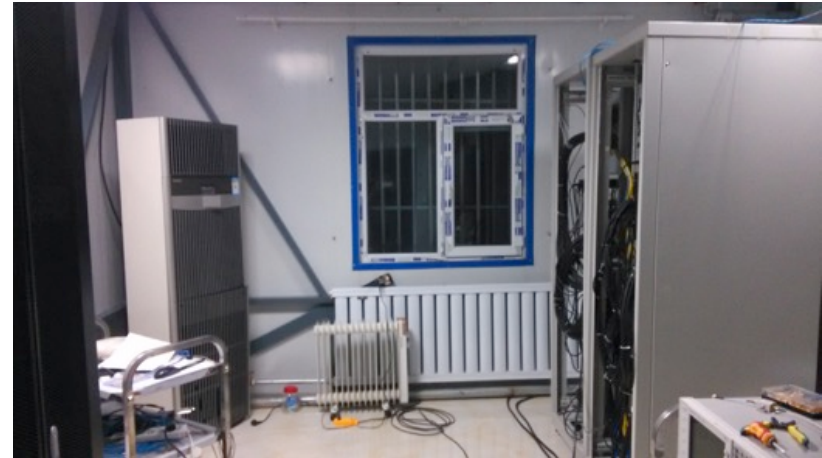
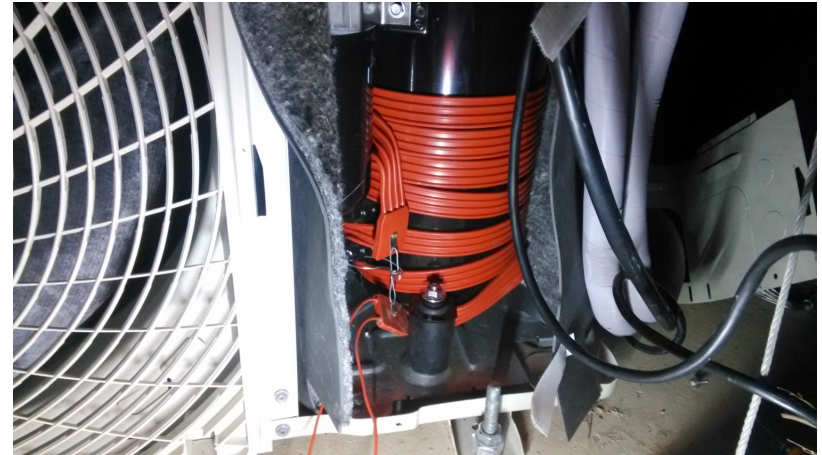
- Digital correlator a strong heat source, 8.5 kW
- Small computer room, correlators are tightly arranged, need active cooling even during winter
- Added fan to help cooling, still insufficient
- The civil use AC we purchased (same as used in IA) does not work in winter due to freezing of compressor, added heater

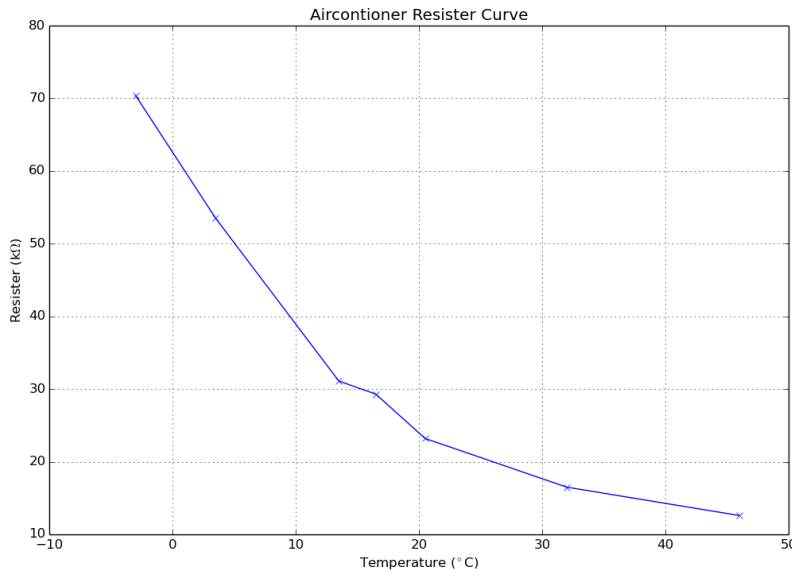
- Working room temperature too high:  
cheated sensor by changing thermistor resistance, so that 5°C is realized (Jixia Li)

Thermistor resistance as function of temperature.

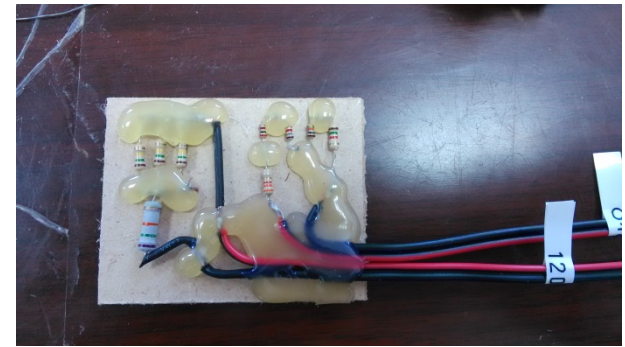
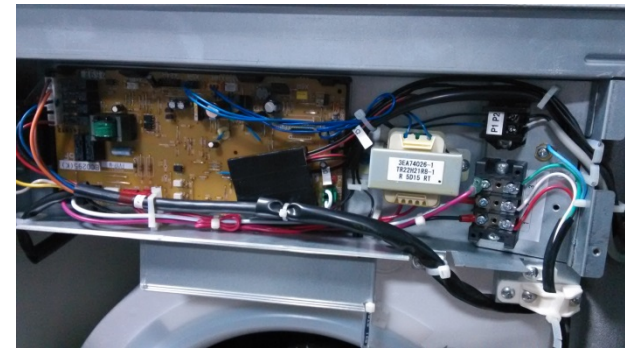
# working, but still problematic

Refrigerating fluid pressure too low

High: 1.25MPa; Low: 0.8MPa

Normal values:

High: 2.4~2.5MPa; Low: 0.6~0.9MPa

Note: we added fluid according to weight written in the label of the compressor (R410A/3.2kg)

We decide to replace with an industrial AC soon

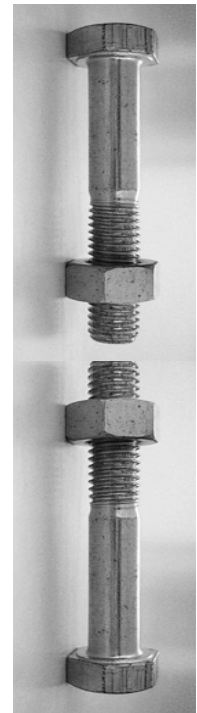
- Antenna Sloshing:  
the two opposite bolts along one line are too long and blocking each other, these are now replaced with one single long bolt (fixed in Nov. 2015)
- Stuck at high elevation angle  
restricted to  $< 88.5$  degree
- Pointing precision too low  
reprogrammed firmware on antenna motor controller,  
improved pointing precision from 0.5 degree to  $< 0.04$  degree.

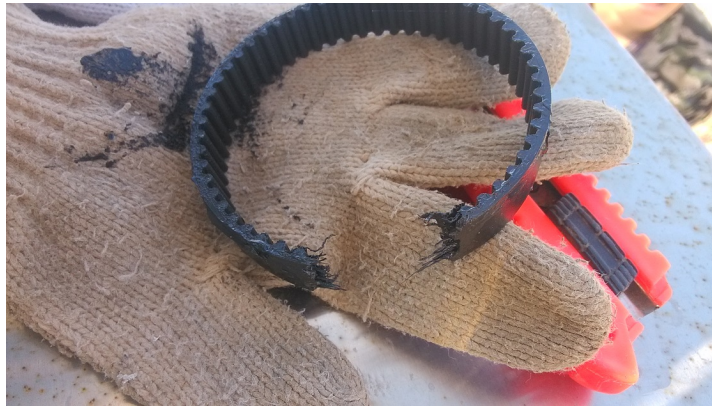
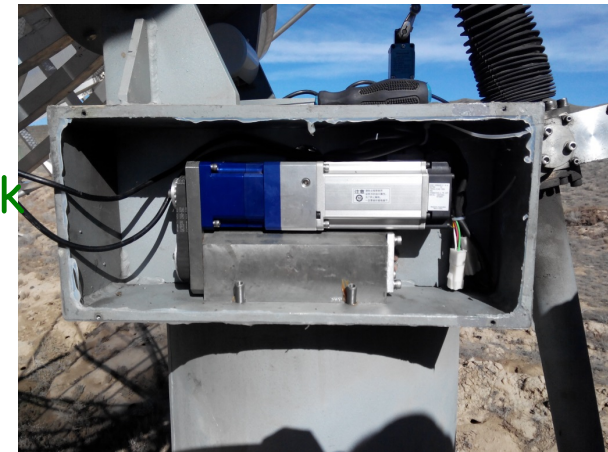
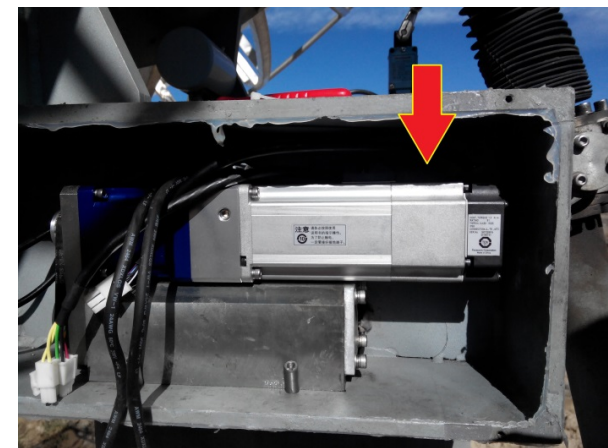
- No response at low temperature  
a warning LED fail at low temperature, removed  
this LED

- Antenna Stuck and broken belt  
slack screw drive, added dowel to help fix the  
motor (Nov. 2015), and rotate antenna for break  
in. Store the belt on site (relatively easy to  
replace).

- Pointing shift under wind  
the motor lacks self-locking mechanism,  
replaced with new motors on Sep. 25 2016

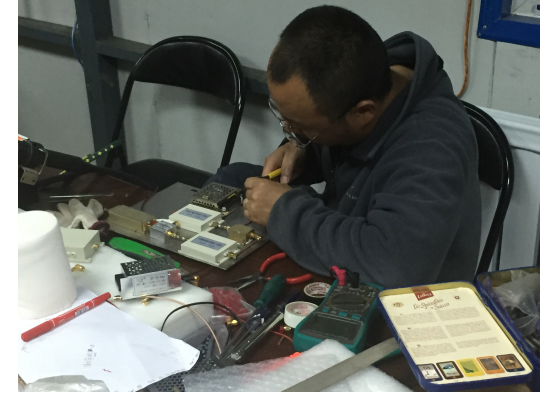
- Damaged a few times due to lightning  
Added insulation and surge protector
- Amplitude too high or too low  
Adjust amplitude of the system
- Temperature variation from 1-3 dB (day time) to 9-12 dB (night time)  
will add temperature controlled box

Surge protector DC block

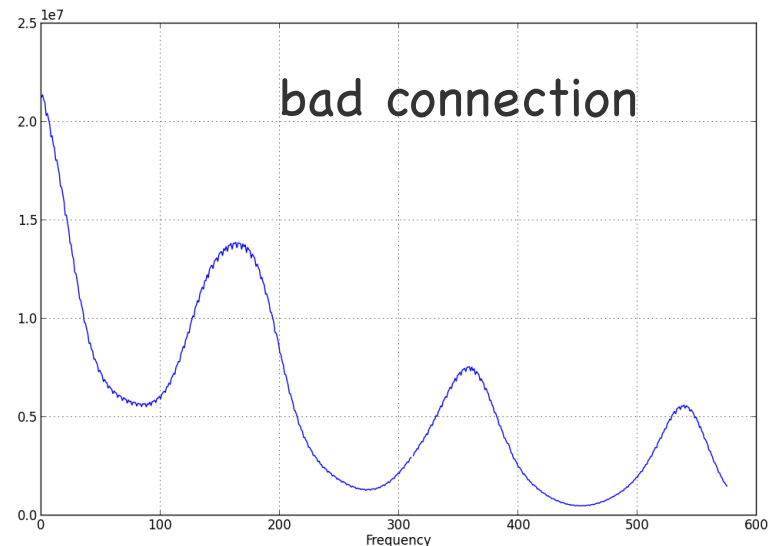
- Connector malfunction (1 case),  
replaced with a new one.
- SMA-SMB cable bad connection cause reflection  
reconnected with a new cable
- Optic transmitter malfunction  
1 case, replaced
- Optic receiver malfunction:  
1 case, DC power failed, repaired.

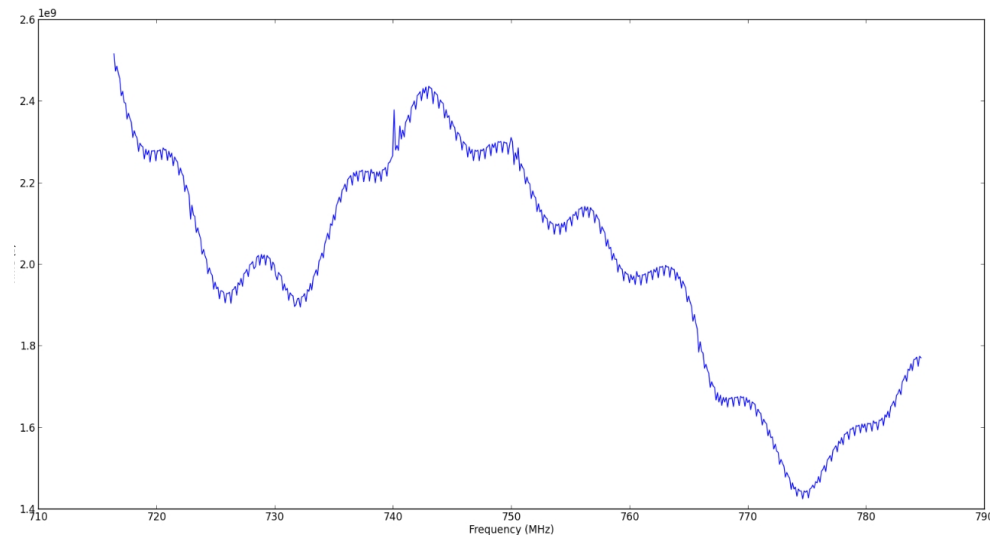
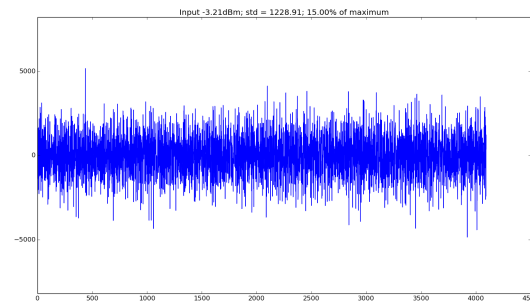
Trough every 4 frequency channels:

after much test, we found that analog input level too low (<0.5%)

Now, we set the level to be 5~6%, leaving much space for the Sun (<8dB) and calibrator source (~10dB).

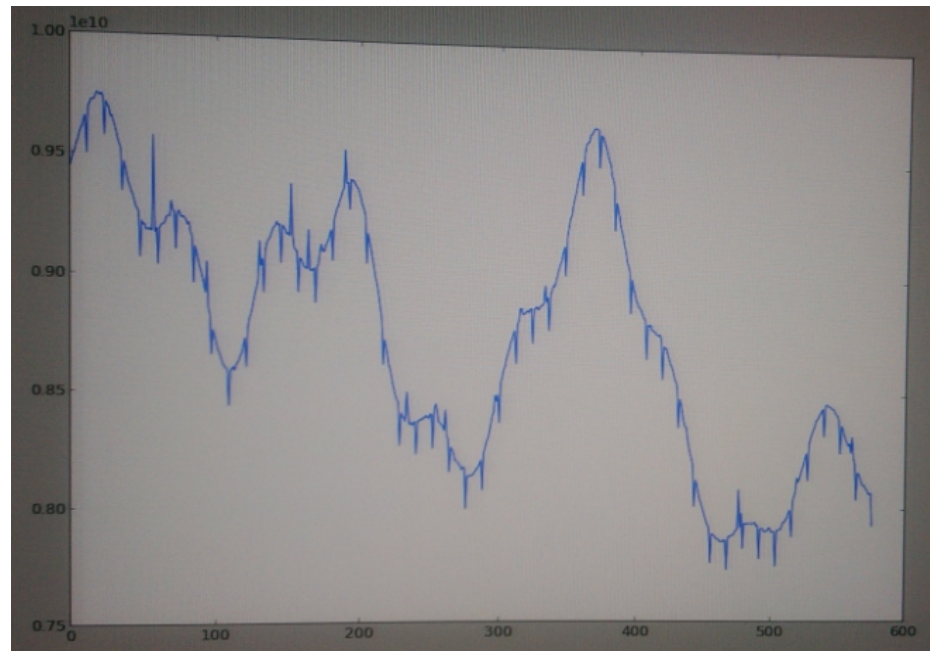
- Trough every 12 frequency points in channels 117-115

Time delay in DSP core improperly set

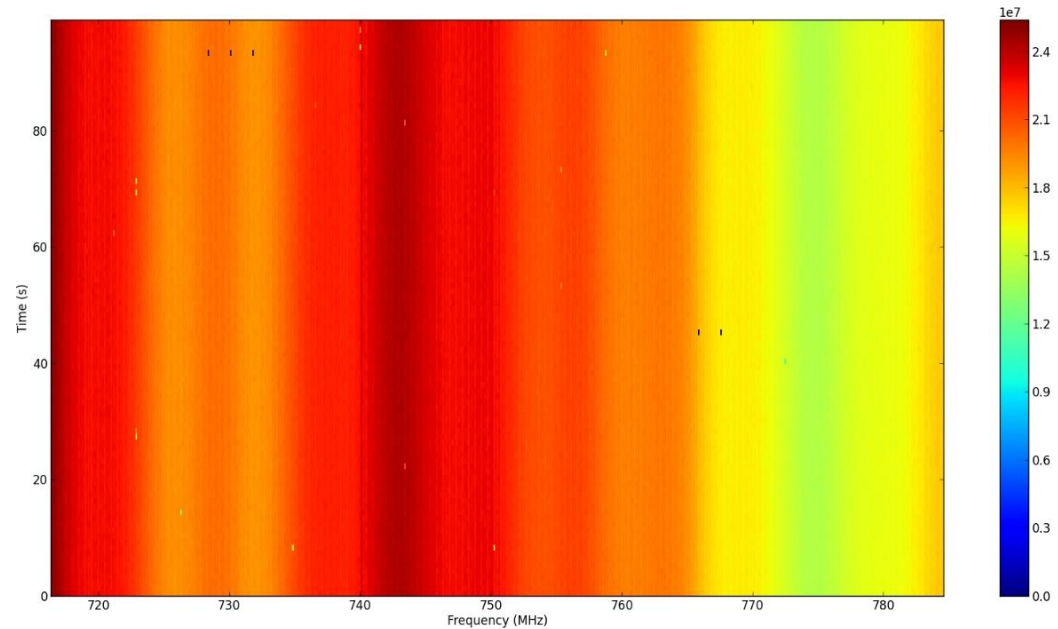
- Data loss randomly due to too heavy computing load

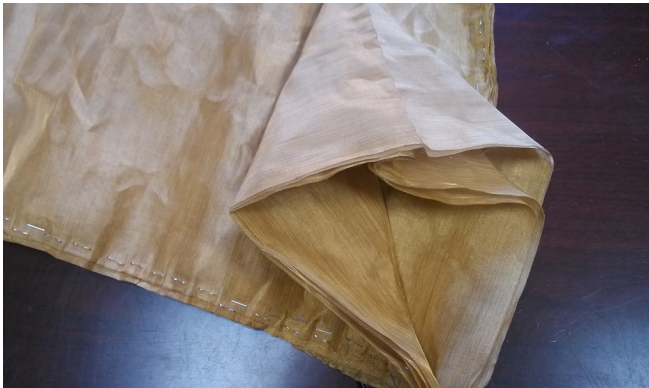
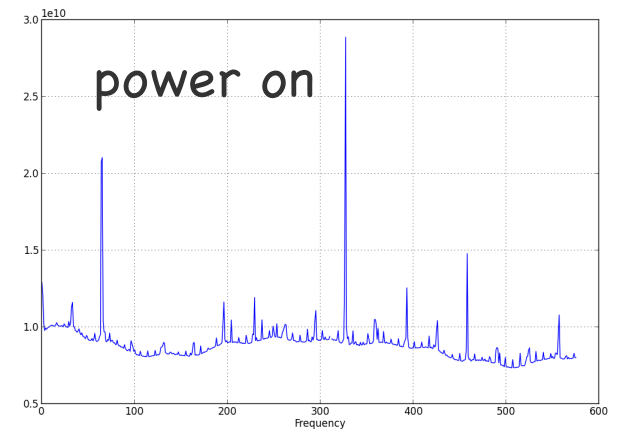
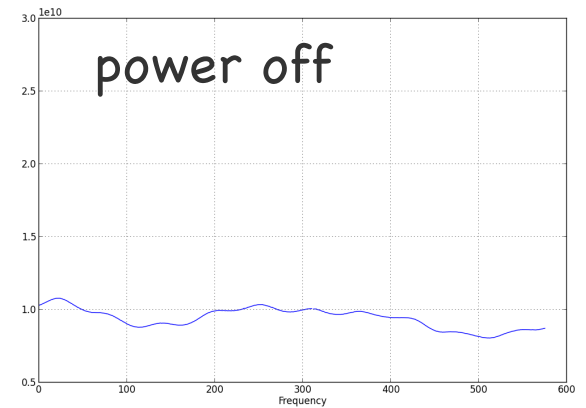
RFI came from various devices on site.

- Motors of dish antennas
- Serial server
- Telephone
- Network devices
- PDU (Power Distribution Unit; network man
- Camera, weather station...

Shield with copper net but no effect

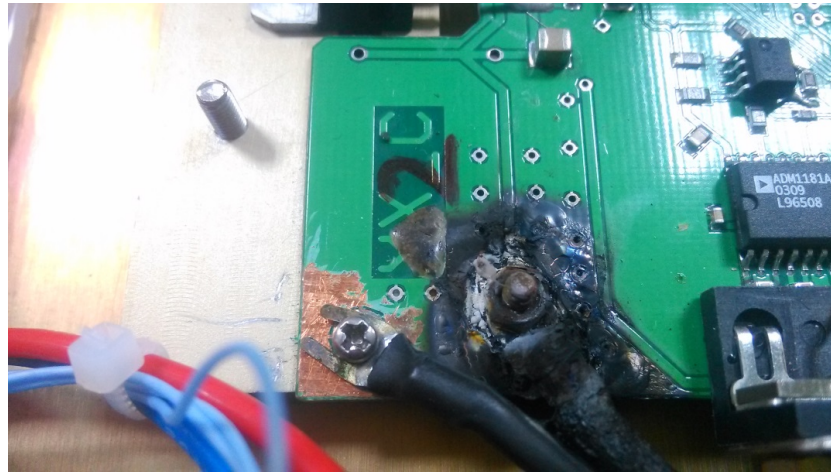
- ❑ **Frequency down converter:** The inner DC power lines are not properly connected to the circuit board. It results in short circuit.
- ❑ All of the 17 converters have been repaired now.

The burnt cable

The design itself is bad. The positive line is isolated from the negative area by a plastic sheet. When it's working, this area is hot and the plastic get burnt.
