Voltage Divider Board

WA105 TB Meeting

Review committee report

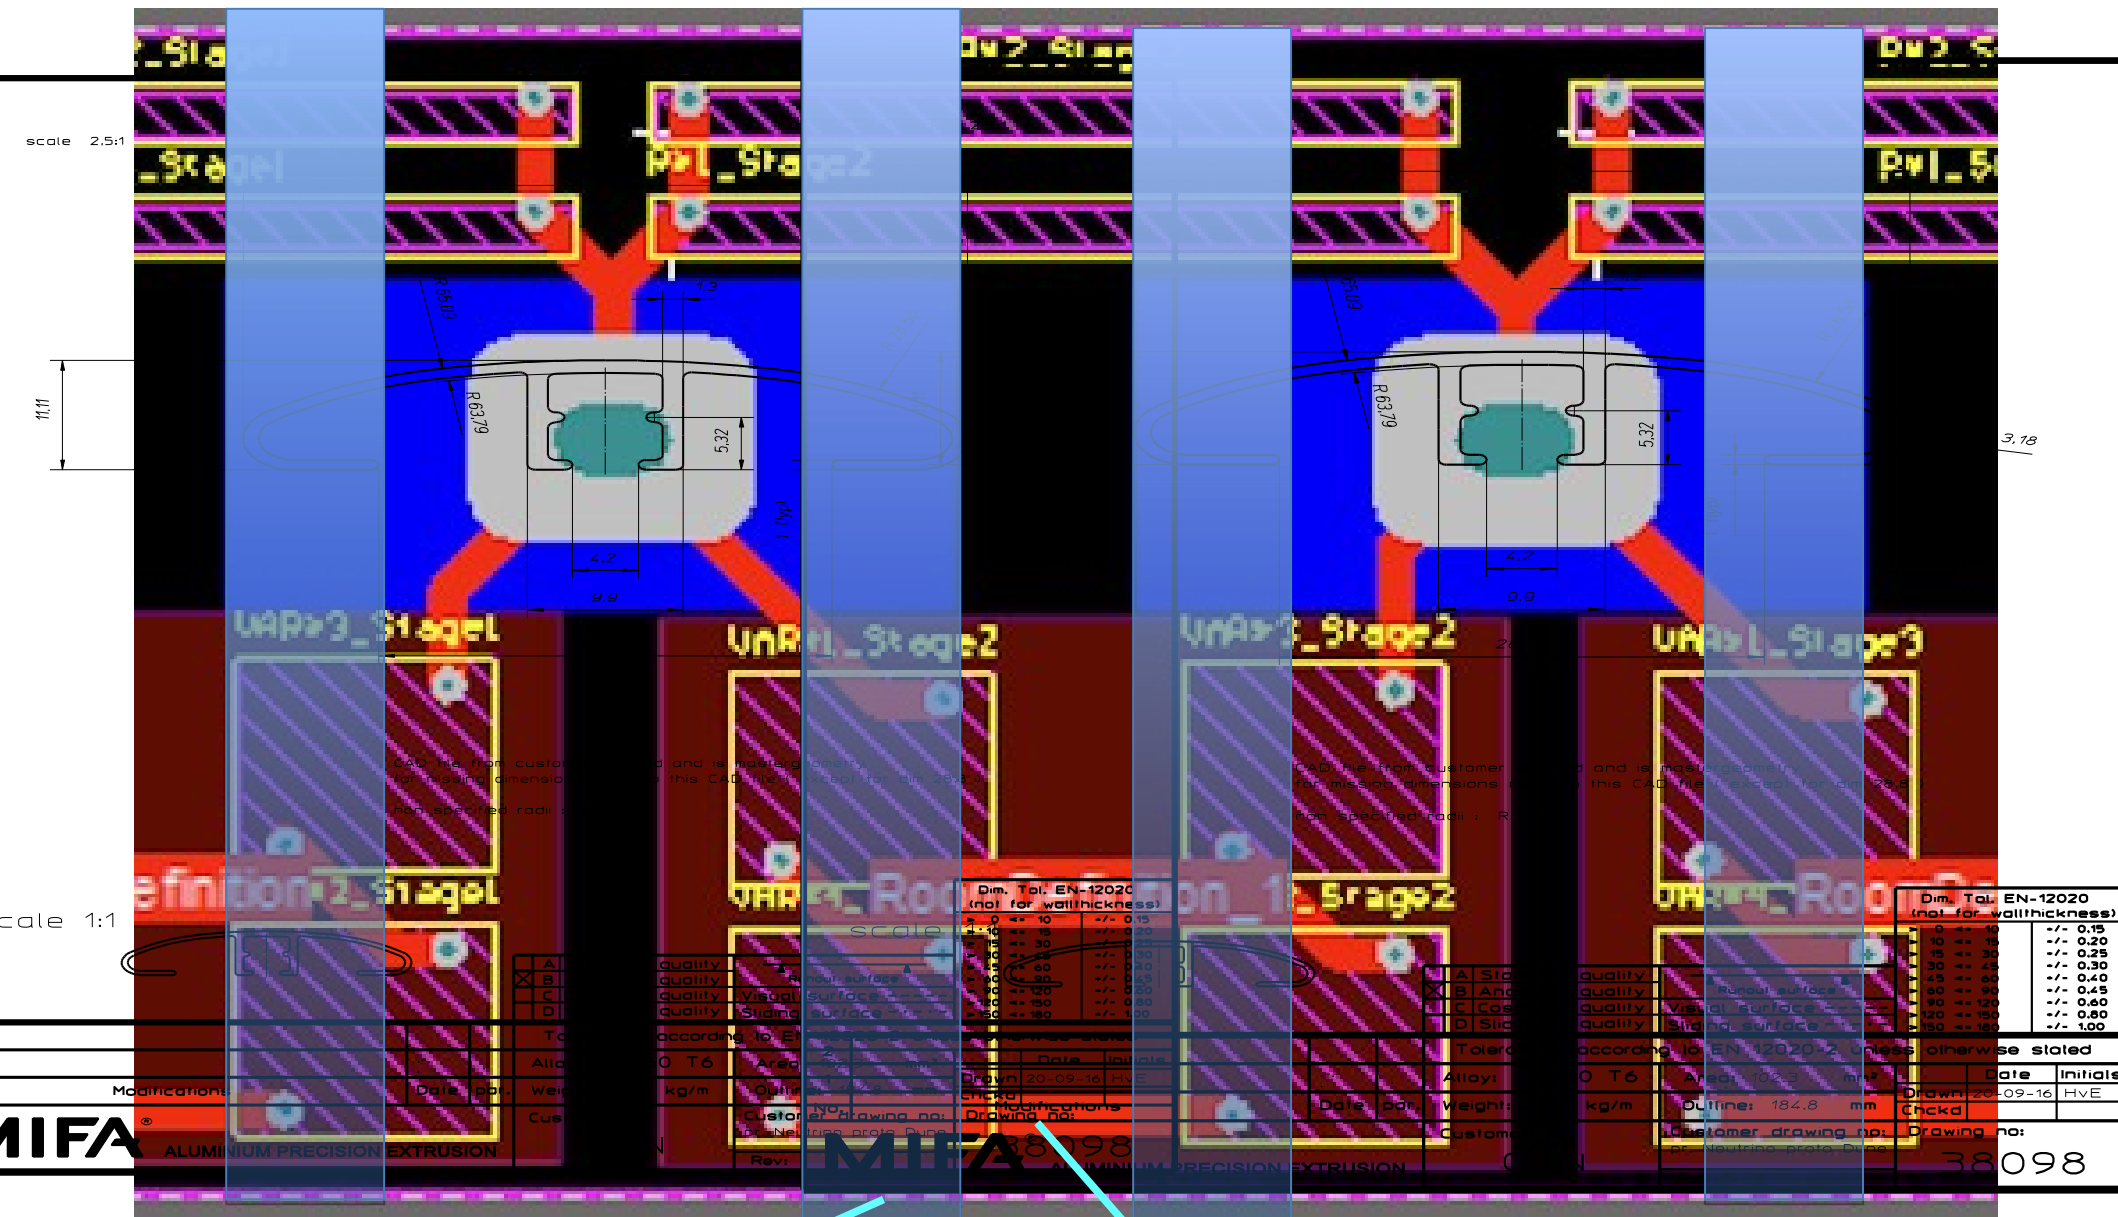
- “The UTA group should verify that the through hole (solder bump) locations on the resistive divider boards are not shorting out or come close to the Al profile when mounted”.

1st issue : Shorting between two Profiles

- *Remove the shorting point between varistors*
- *Soldering bump both for the resistors and varistors should not touch the Alu profile.*

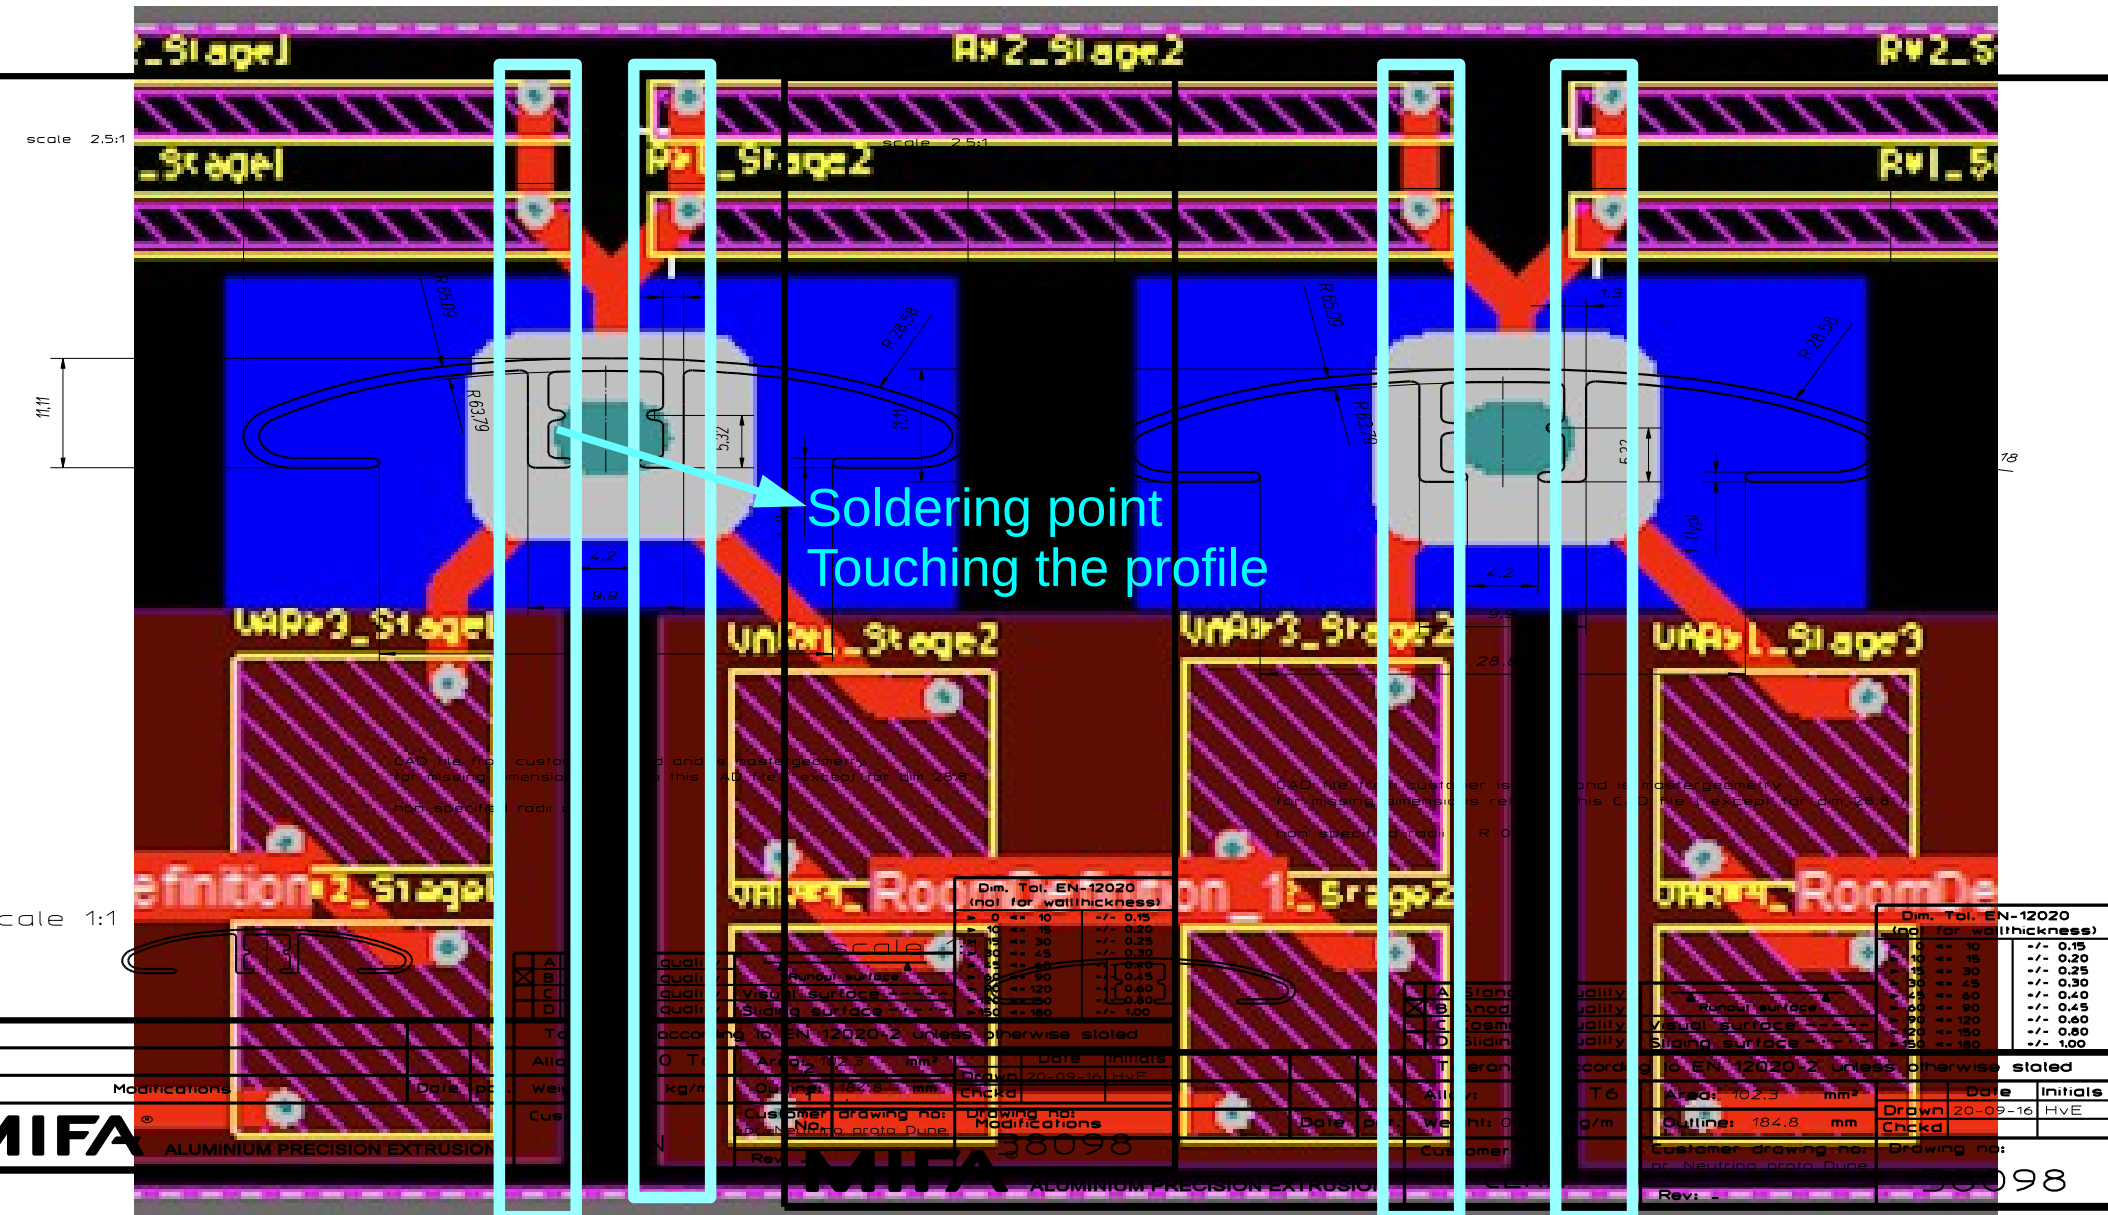
2nd issue: Soldering bump touching Alu profile
