HORN PROJECTS AT COLORADO

Horn Projects at Colorado

Second spare Horn 1 project

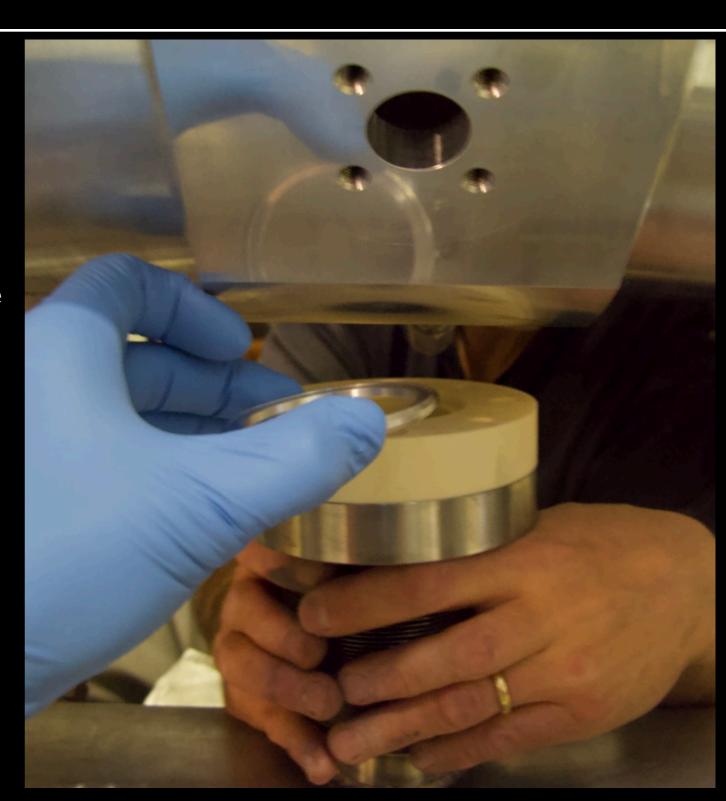
- A fundamental problem
 with this crushing
 procedure is that before
 the ceramic is in full
 contact with the horn, the
 seal acts as a fulcrum
- A region of the ceramic (roughly the red dots in cartoon) is in substantial shear and/or tension
- Ceramics have poor strength in tension!

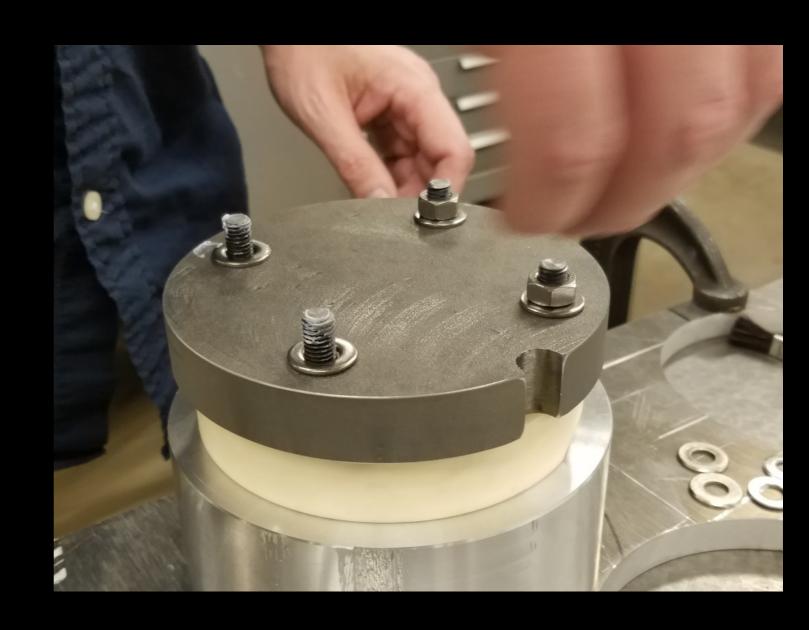
- We built a test fixture for this concept
- Seal crushed to ceramicmetal contact with much less torque: 150-200 in-lb vs. not fully crushed at 400+ when the ceramic broke on the horn!
- Why would this be different?

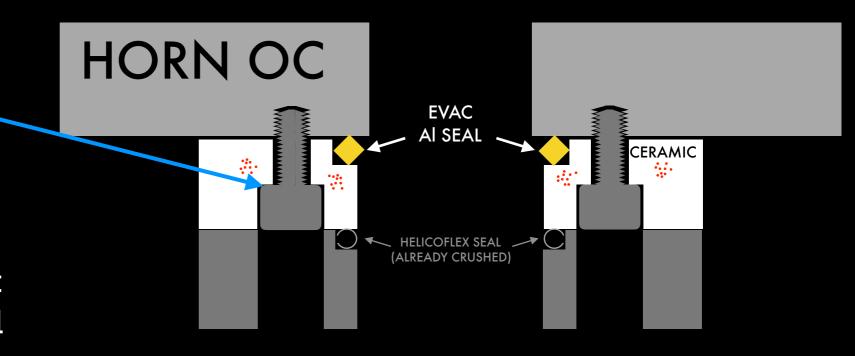
- There is friction between the screw head and the ceramic counterbore
- If friction is high, a significant fraction of the torque applied to the bolt is not translated into axial force on the ceramic
- Reduced this effect by making thin custom Al glide washers to sit inside the ceramic counterbore

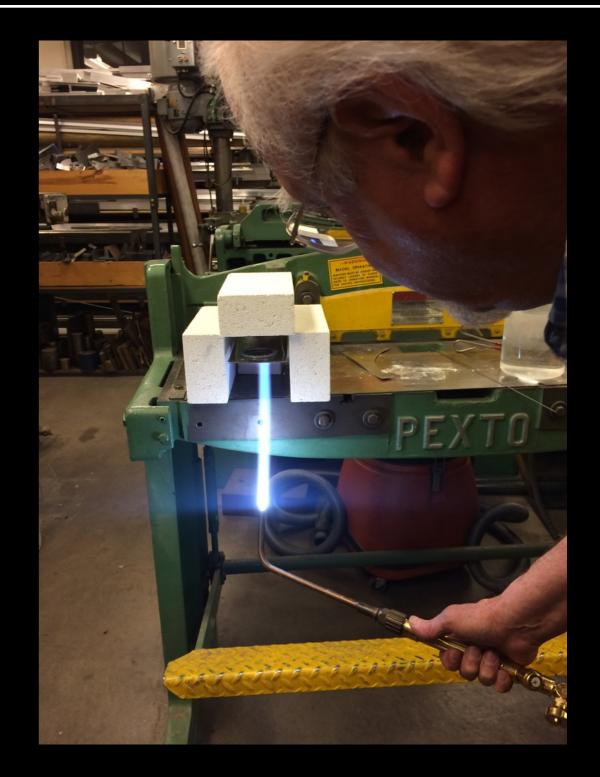
- The two previous horns we built had this same seal design and (though it was difficult) we crushed the seals with stainless bolts and the seals did not leak.
- Change in seal alloy hardness?
 - We tried new and old stock seals and no significant difference seen.
 - We used a Rockwell hardness tester on the seal materials. Results were difficult to interpret, but showed no significant new-old difference.
 - We even tried annealing the seals but were unsuccessful.

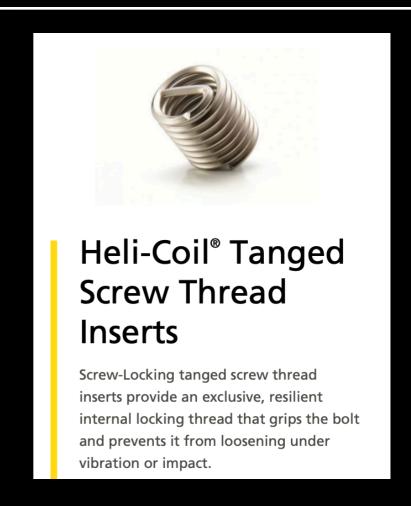
- Only candidate we have now: Helicoils in the tapped holes in the OC
- These are thread inserts designed to improve strength and resist vibration
- Outer conductor vendor put these in all tapped holes; previous horns we built did not have these
- We did ensure the coils were properly seated before inserting screws, but this did not affect the tightening
- Previous horns made in Japan likely used helicoils, but we do not know how they crushed the seals
- Helicoil hypothesis does not explain the ceramic failure problem though.

For next horn: plan to specify no helicoils; replace 8mm with 10mm screws
