# Status of Stripline Feedthrough Prototype Development

T. Sekiguchi

2019. 10. 23

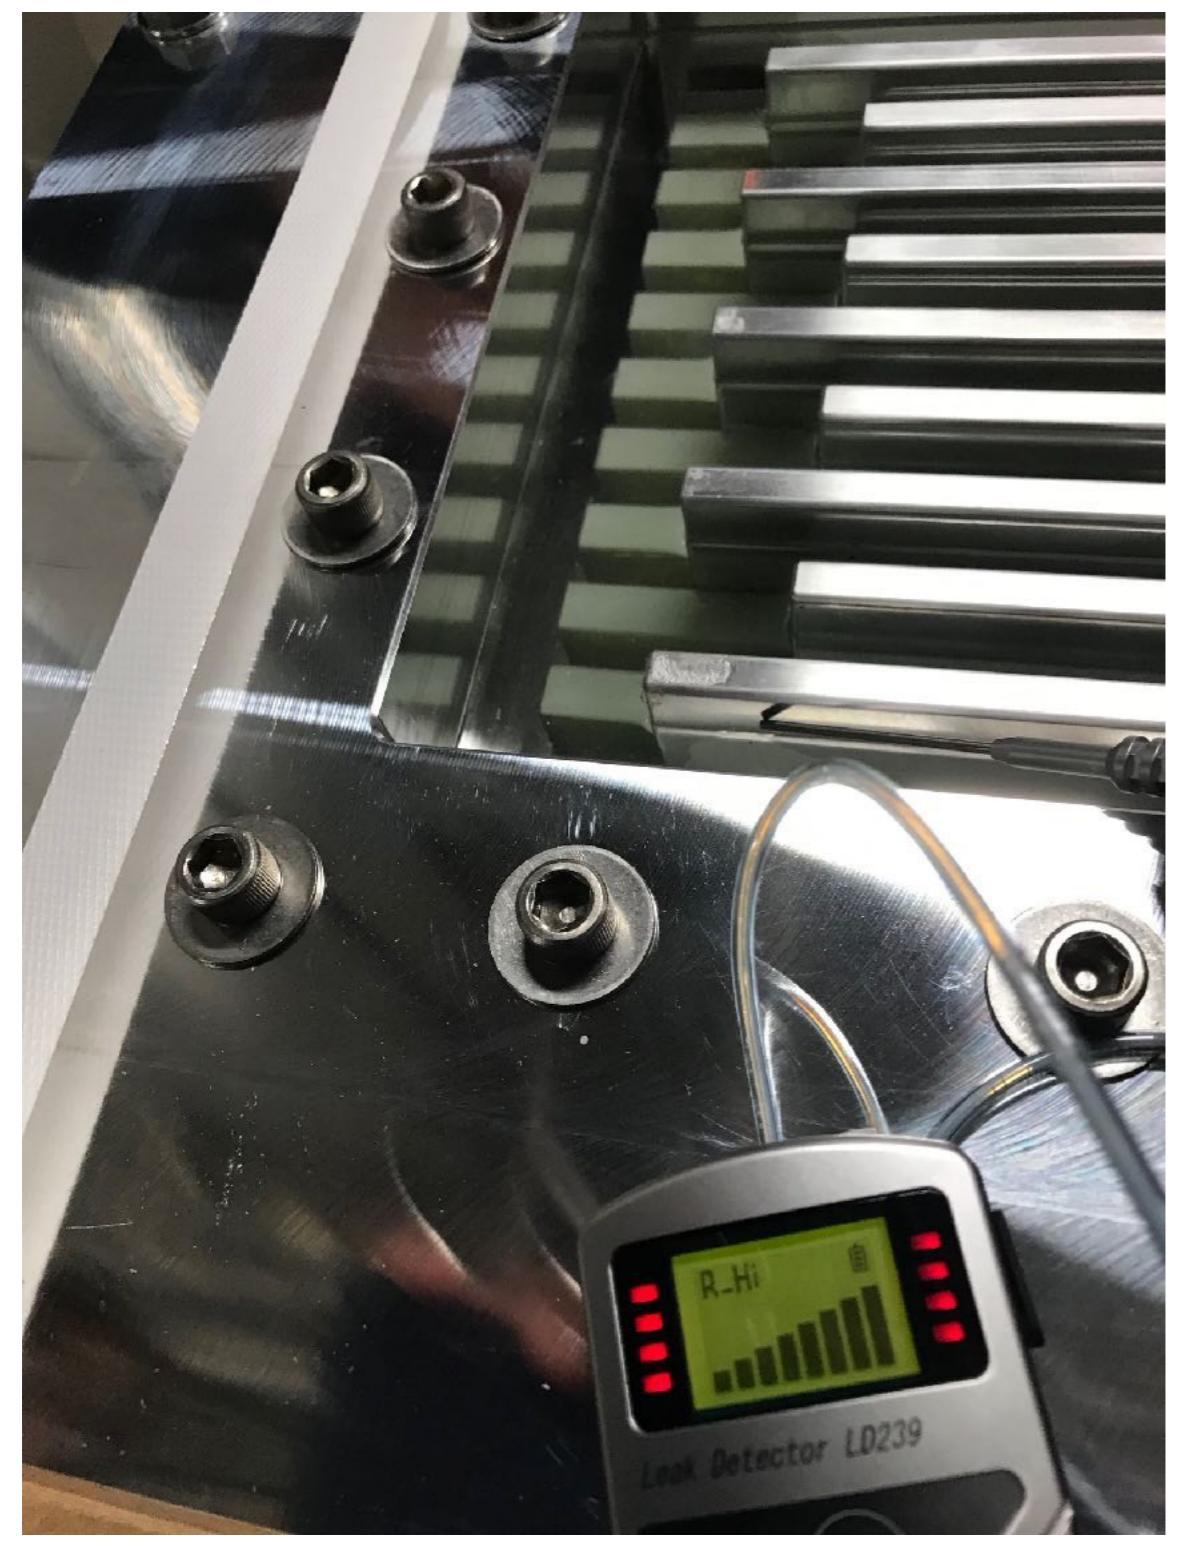
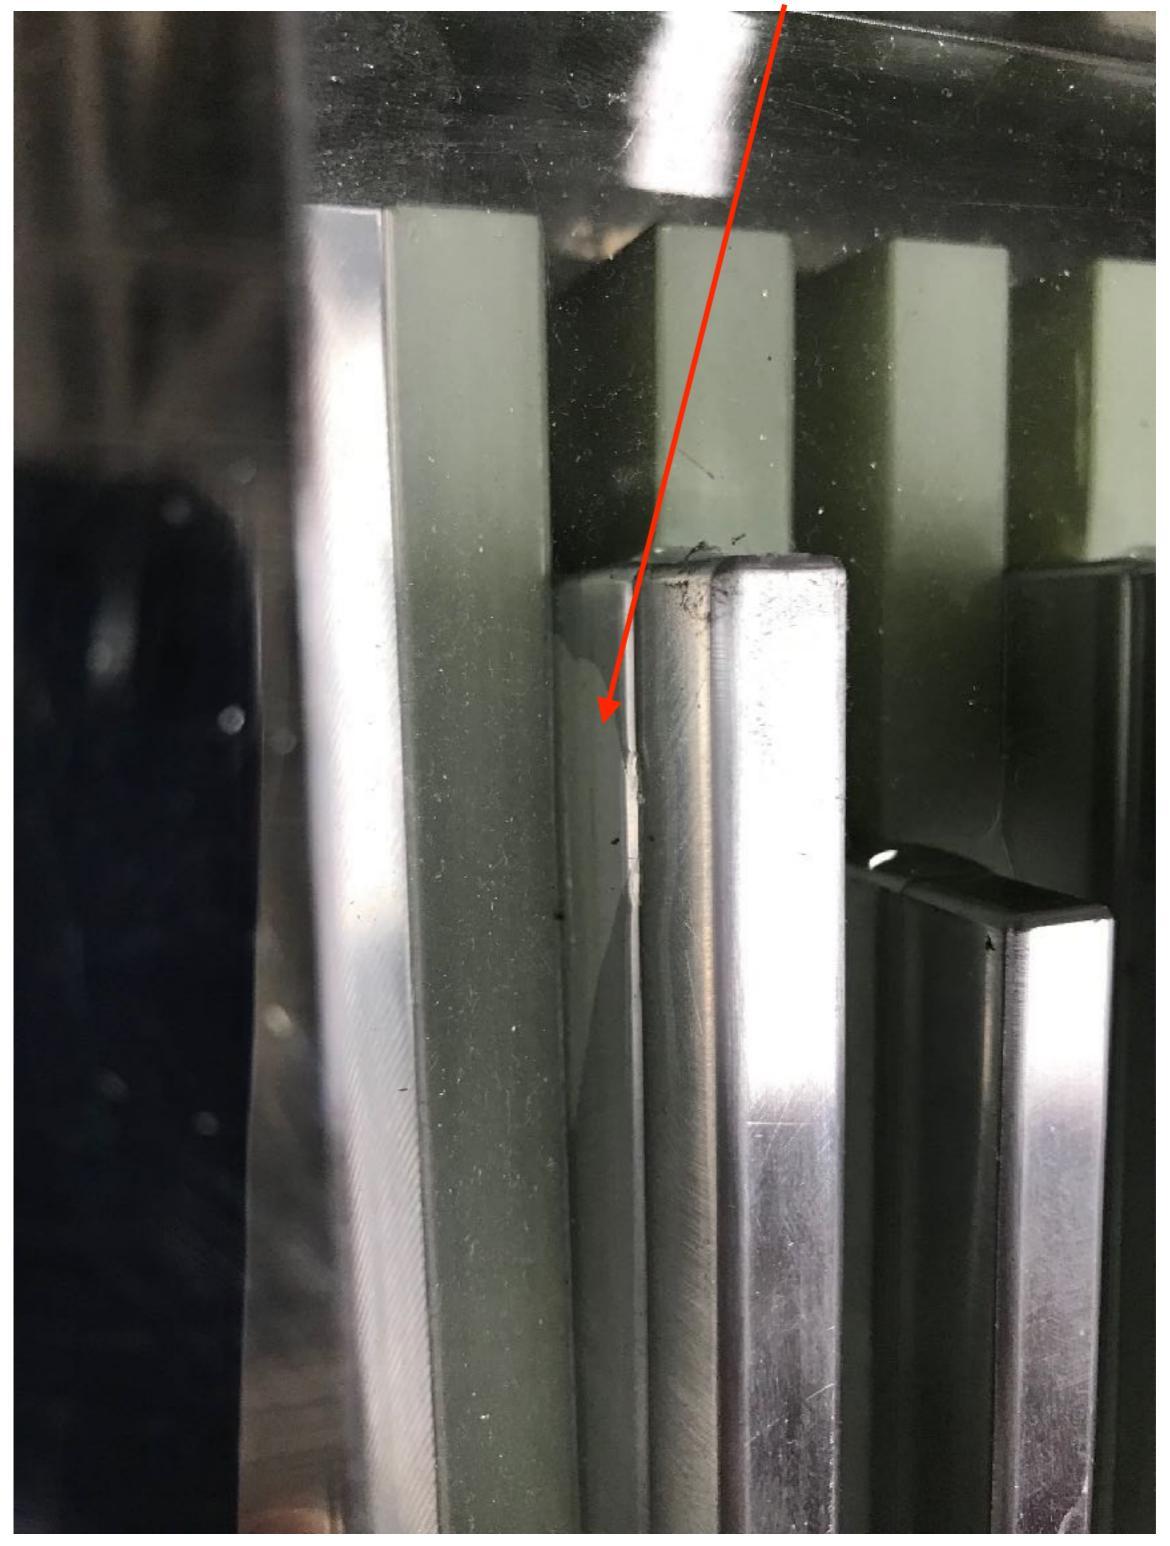
• He leak observed from stripline surface

#### Sylgard detached from stripline

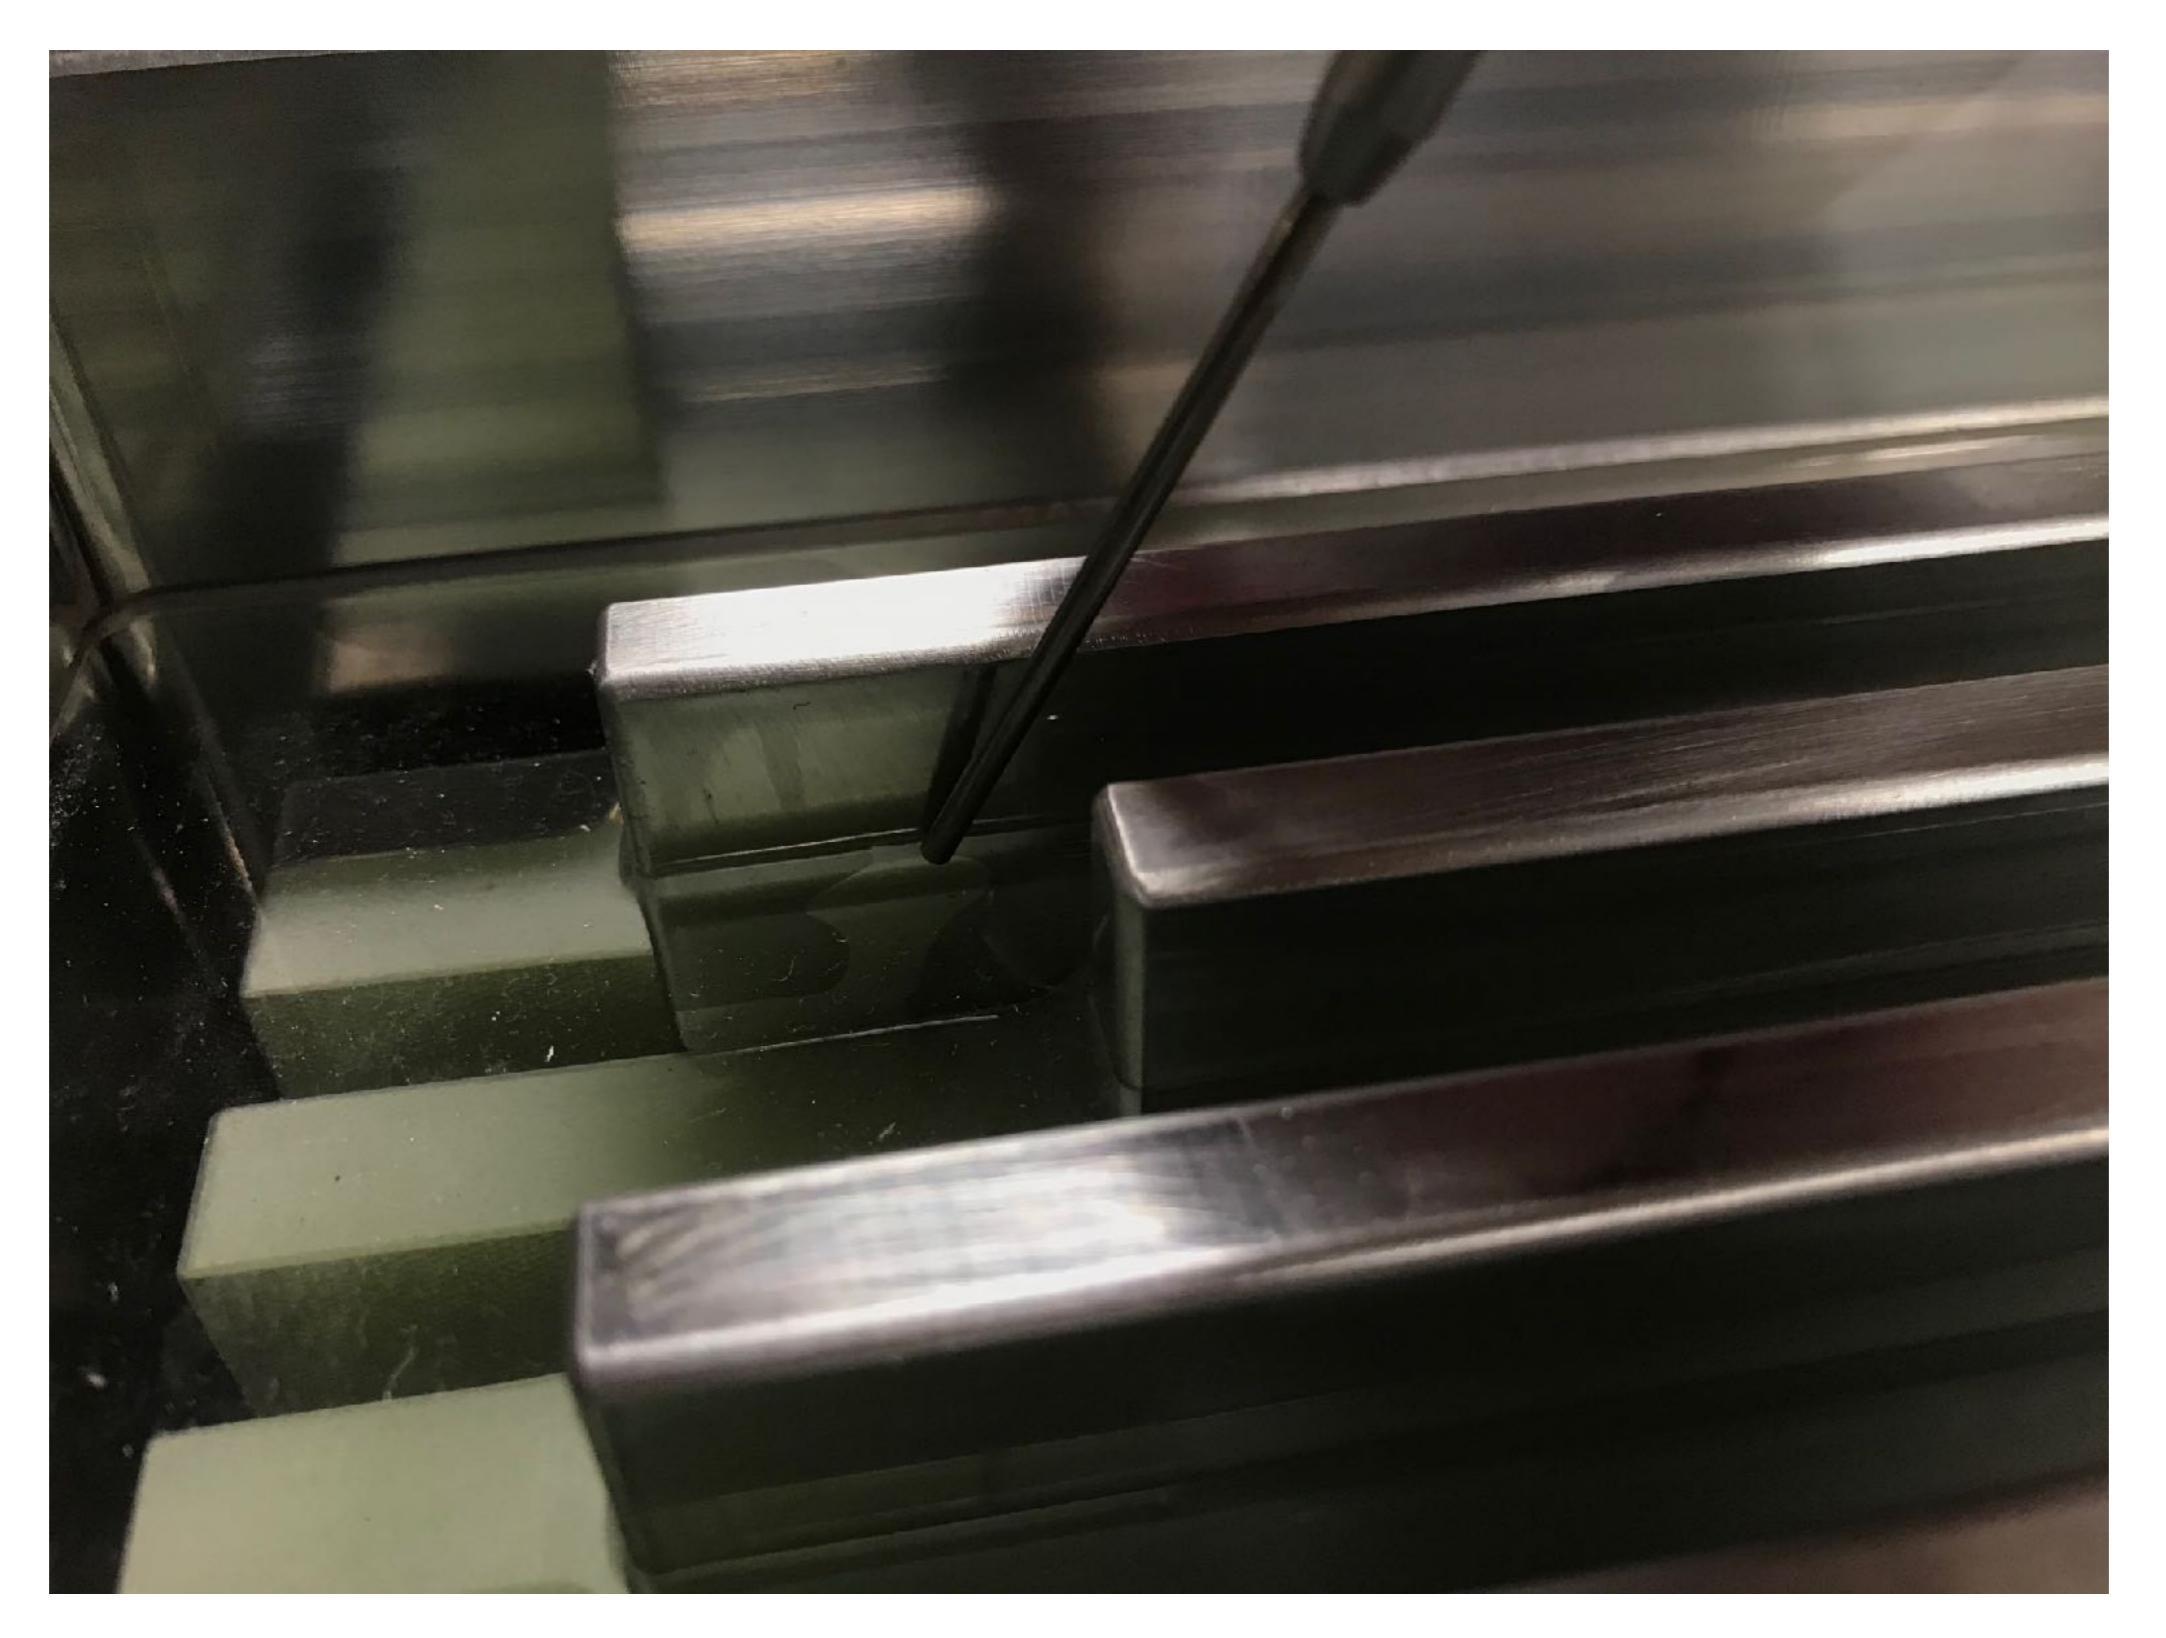
• Another He leak point at stripline

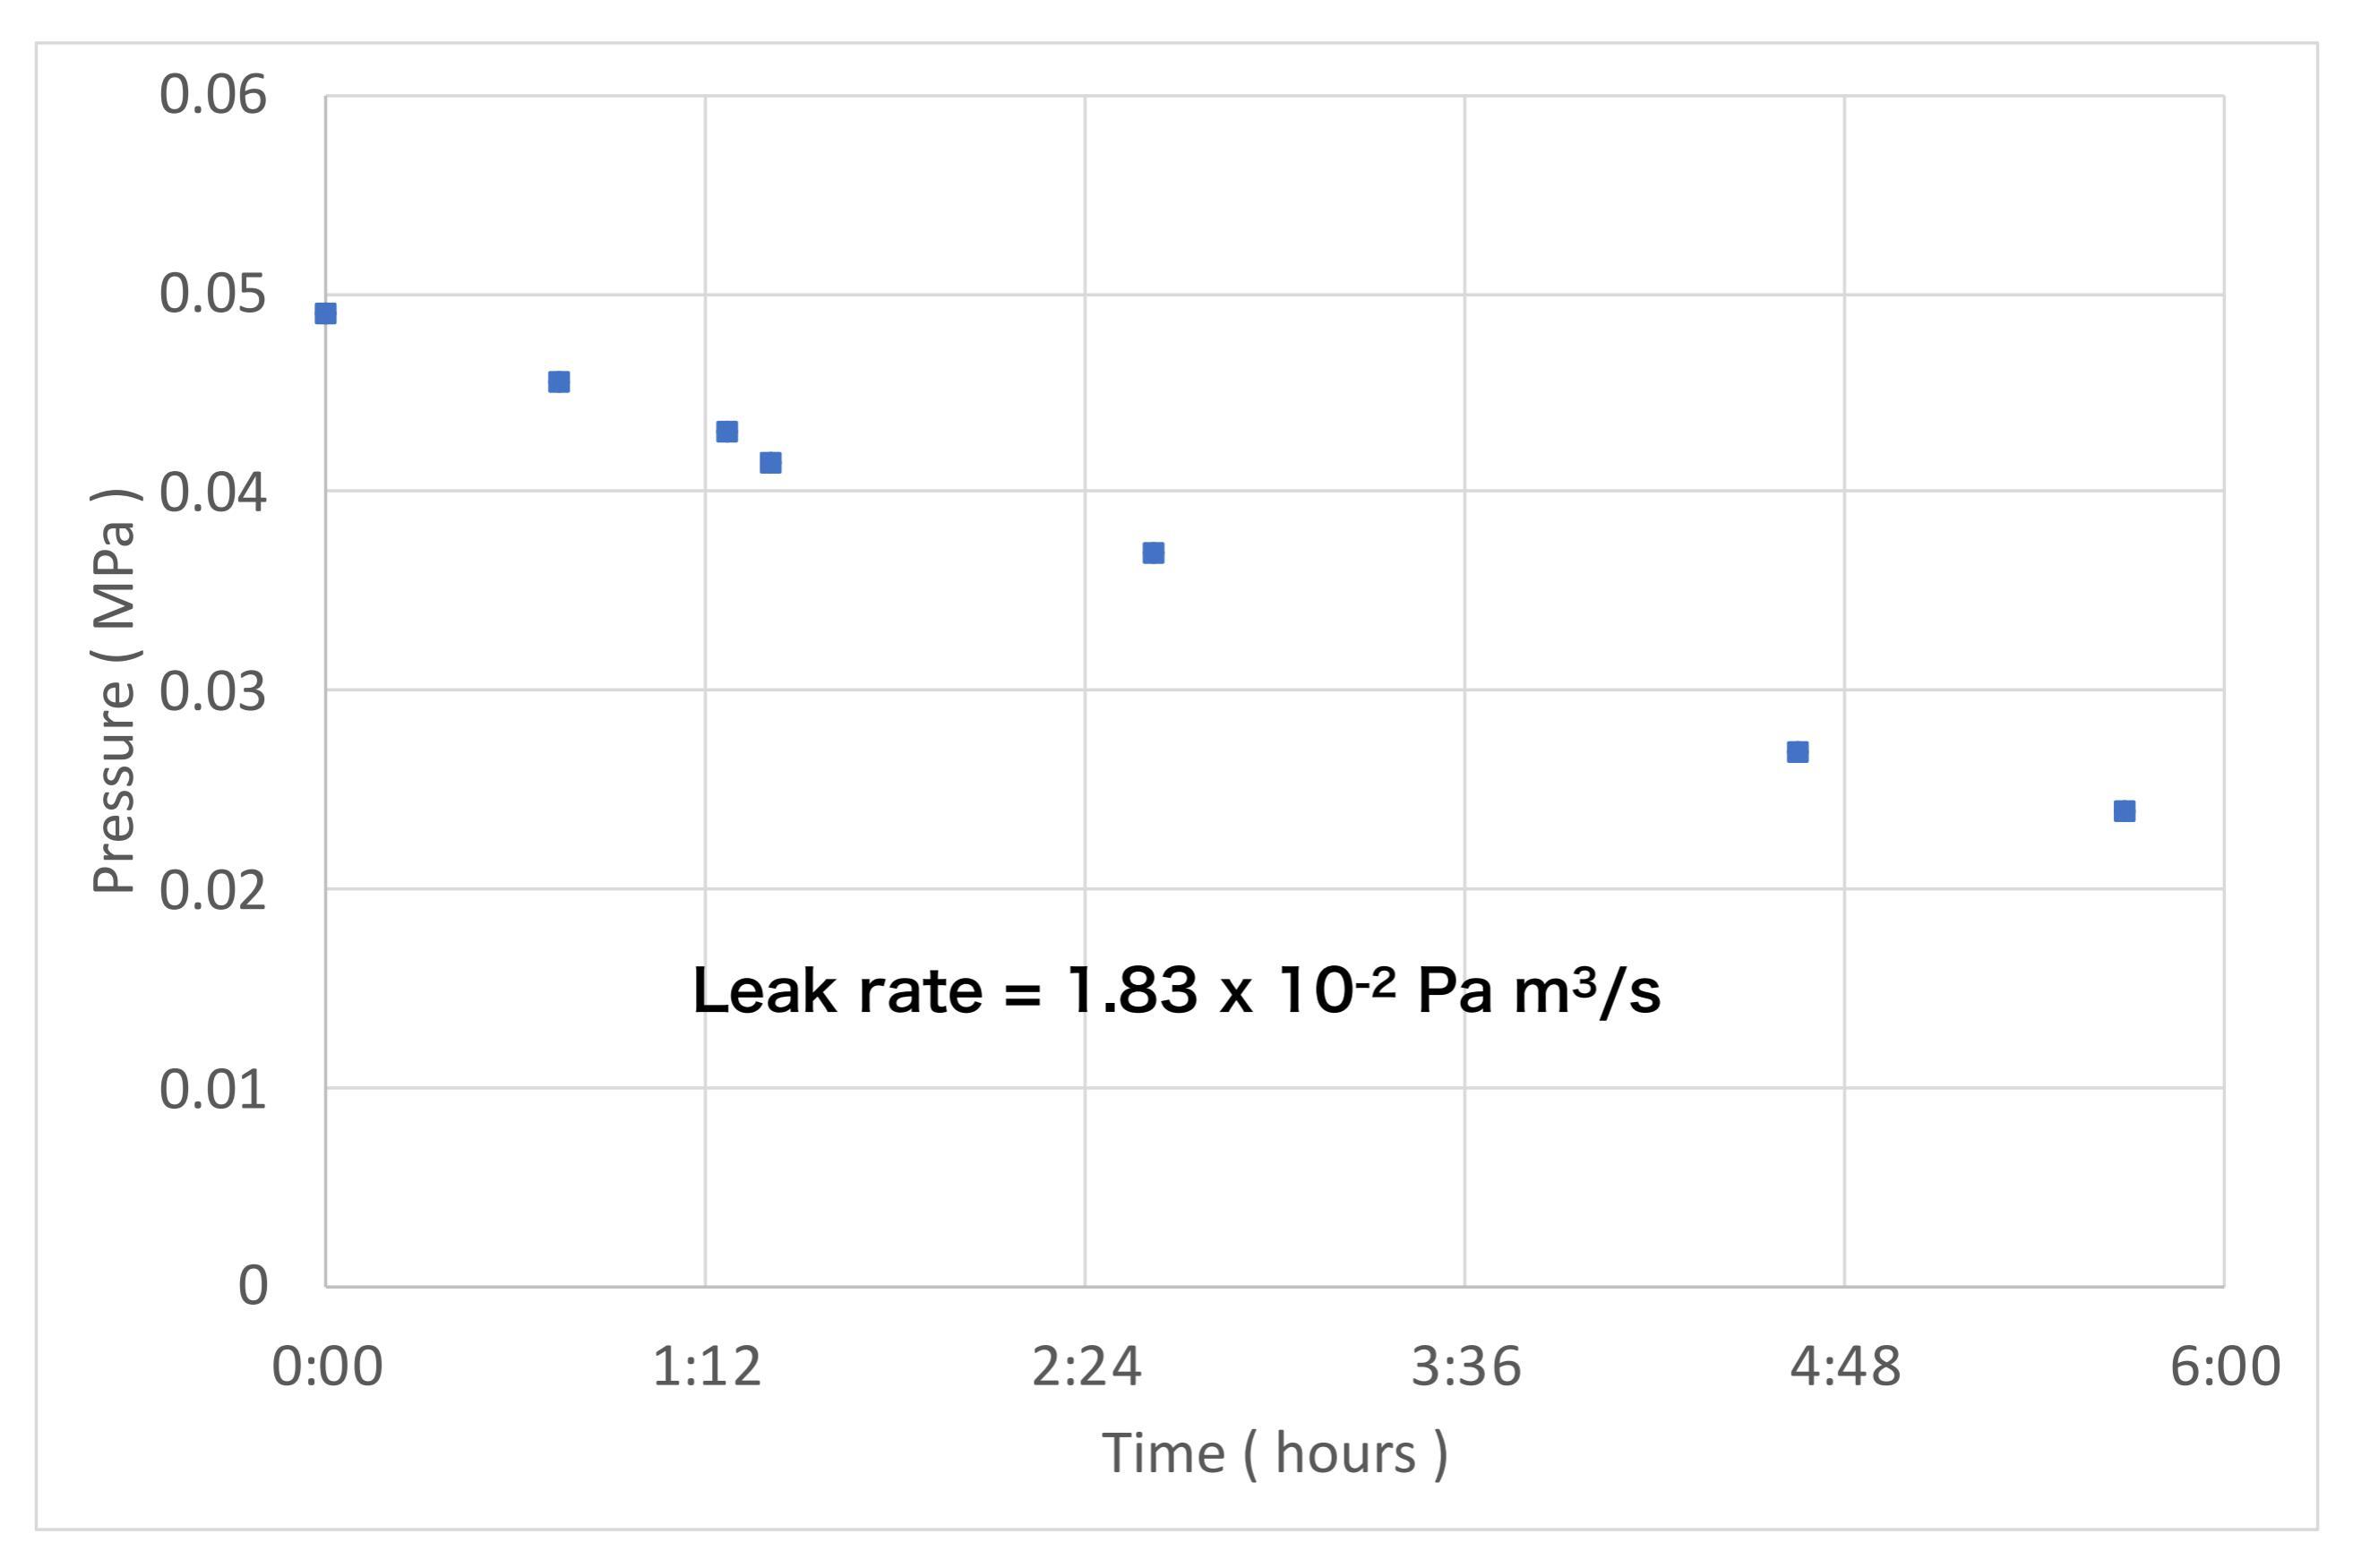
### **He Leak Rate**

- Actually 0.15 MPa gauge N<sub>2</sub> pressure applied
- The prototype once evacuated which might break the sealing
- 0.05 MPa He pressure applied to the prototype
  - Observed He leakage at least from two points
  - Observed leak rate =  $1.83 \times 10^{-2} \text{ Pa} \cdot \text{m}^{3}/\text{s}$

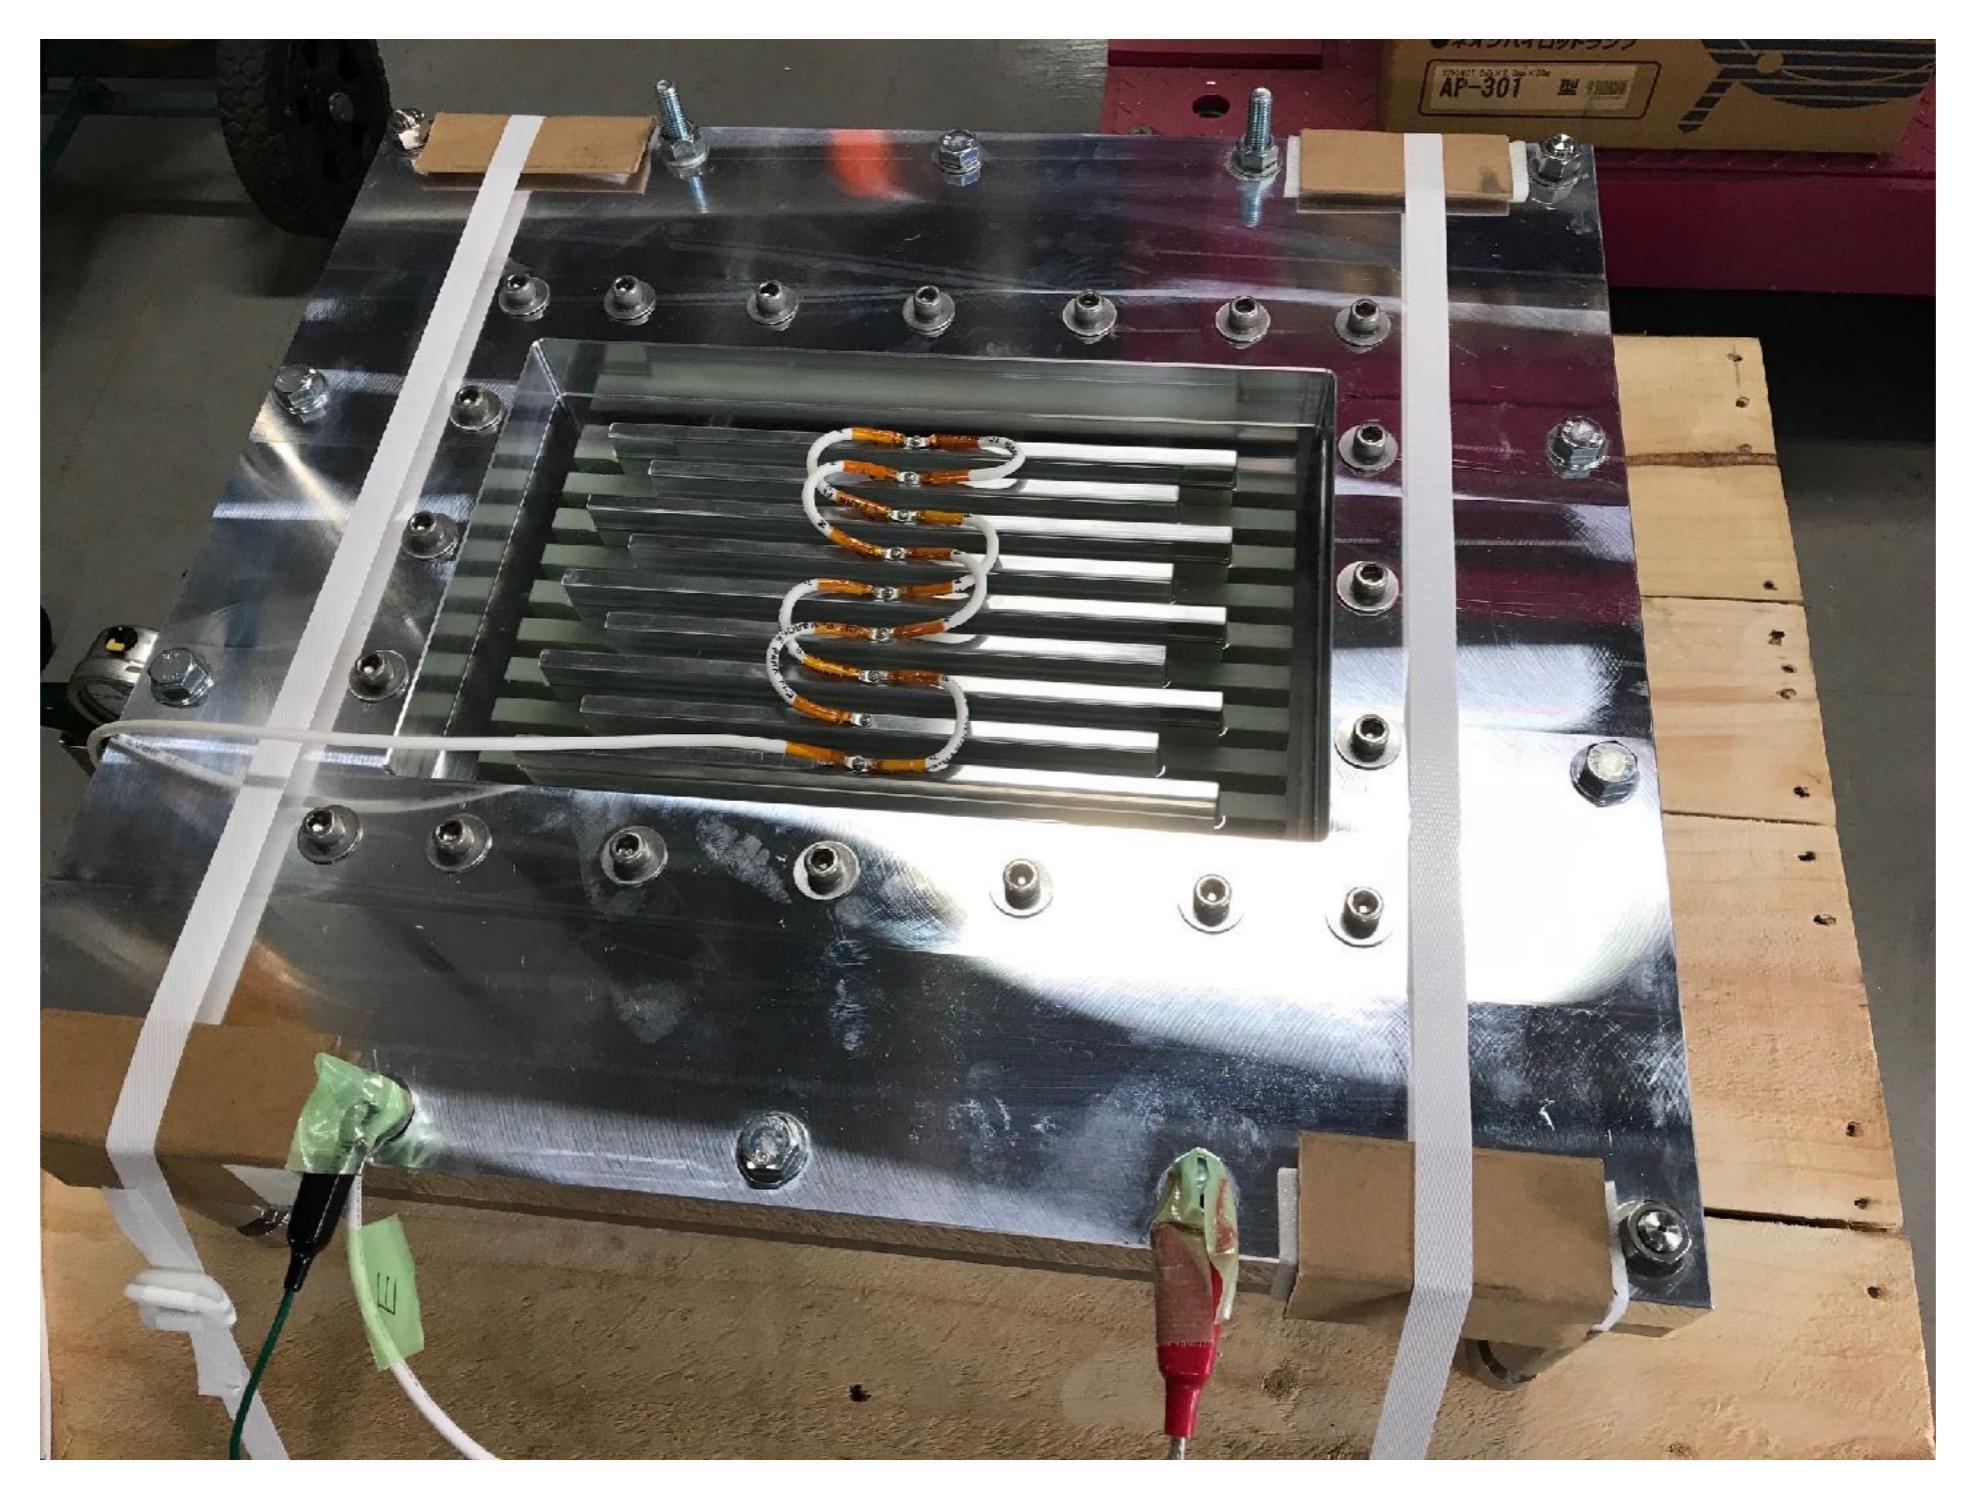
- All electrodes vs ground
- Leakage current suddenly increased at ~3.5 kV

- Withstand voltage to be ~3 kV which doesn't satisfy requirement of 5 kV
- Proposed countermeasures
  - Pretreatment of aluminum surface needed
    - Apply a primer between striplines and Sylgard
    - Roughing aluminum surface
  - These pretreatment should be tested with simple test pieces

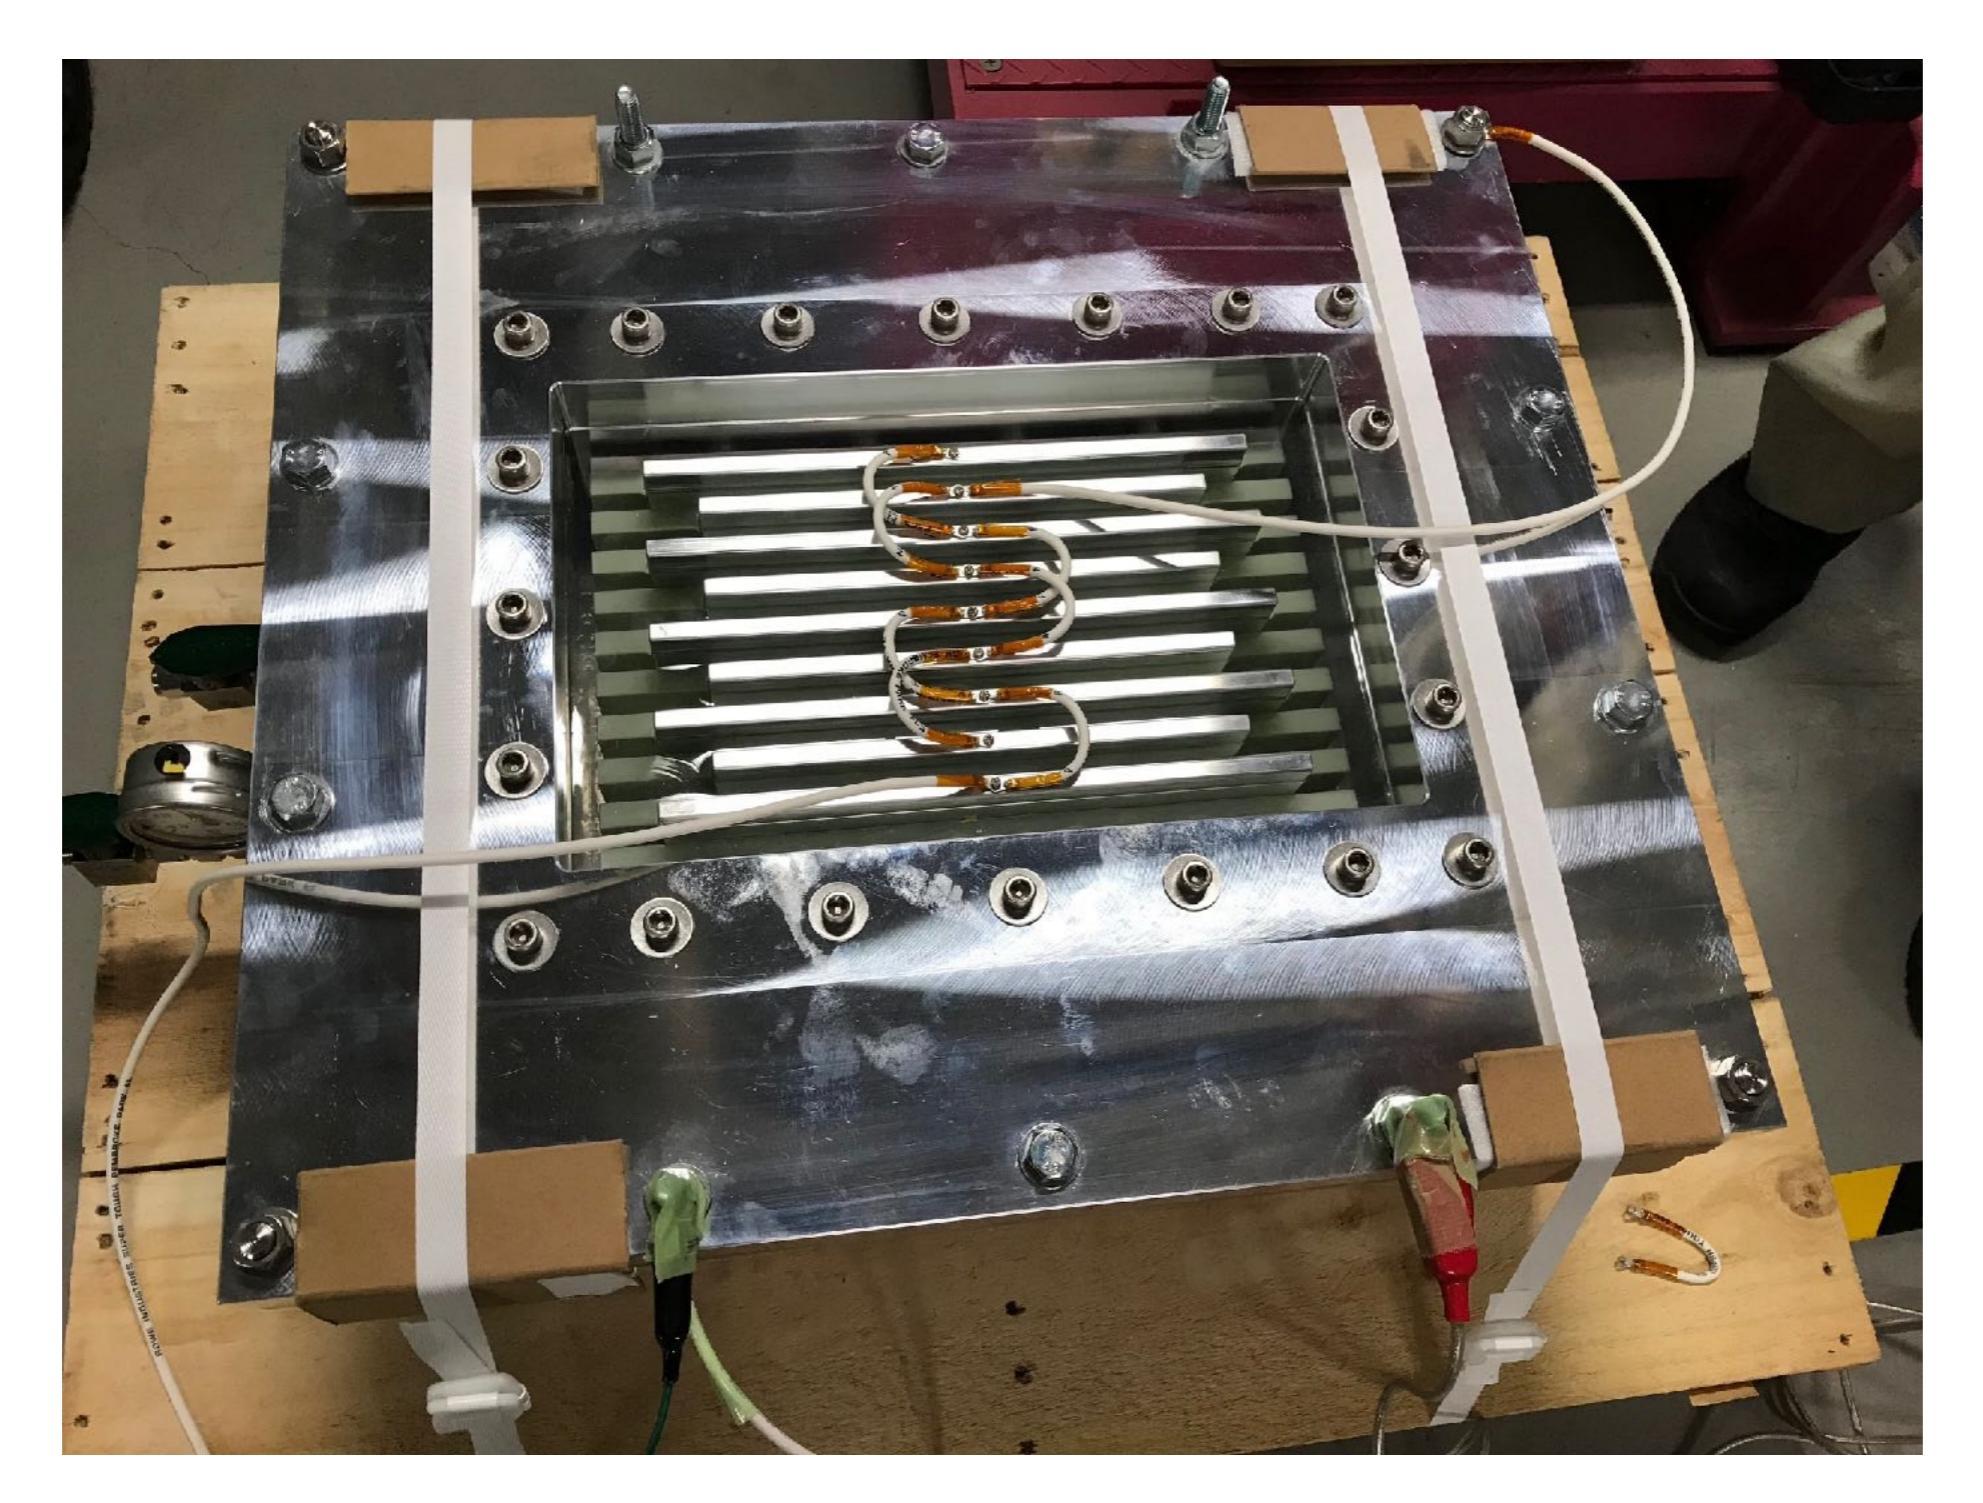
- Positive-side vs negative-side electrodes
- Leakage current suddenly increased at ~3.0 kV

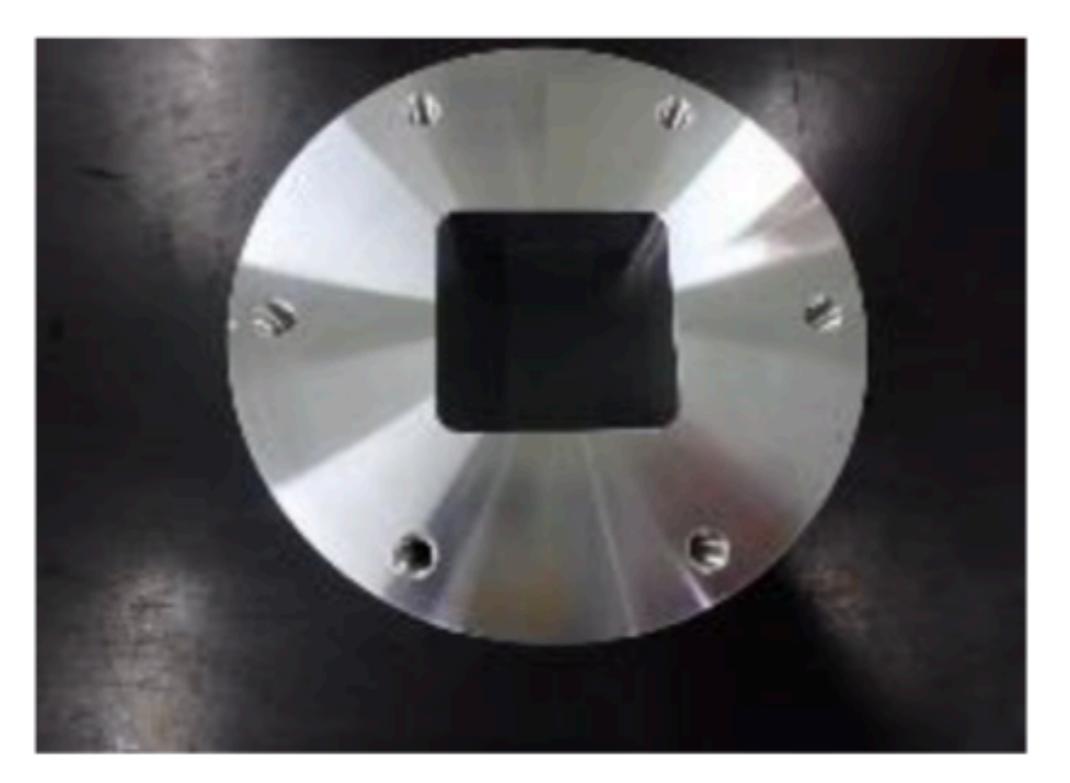
Window piece

RTV applied to the surface and wait for 24 hours

- RTV actually got hard in a short time
- Difficult to make a smooth surface

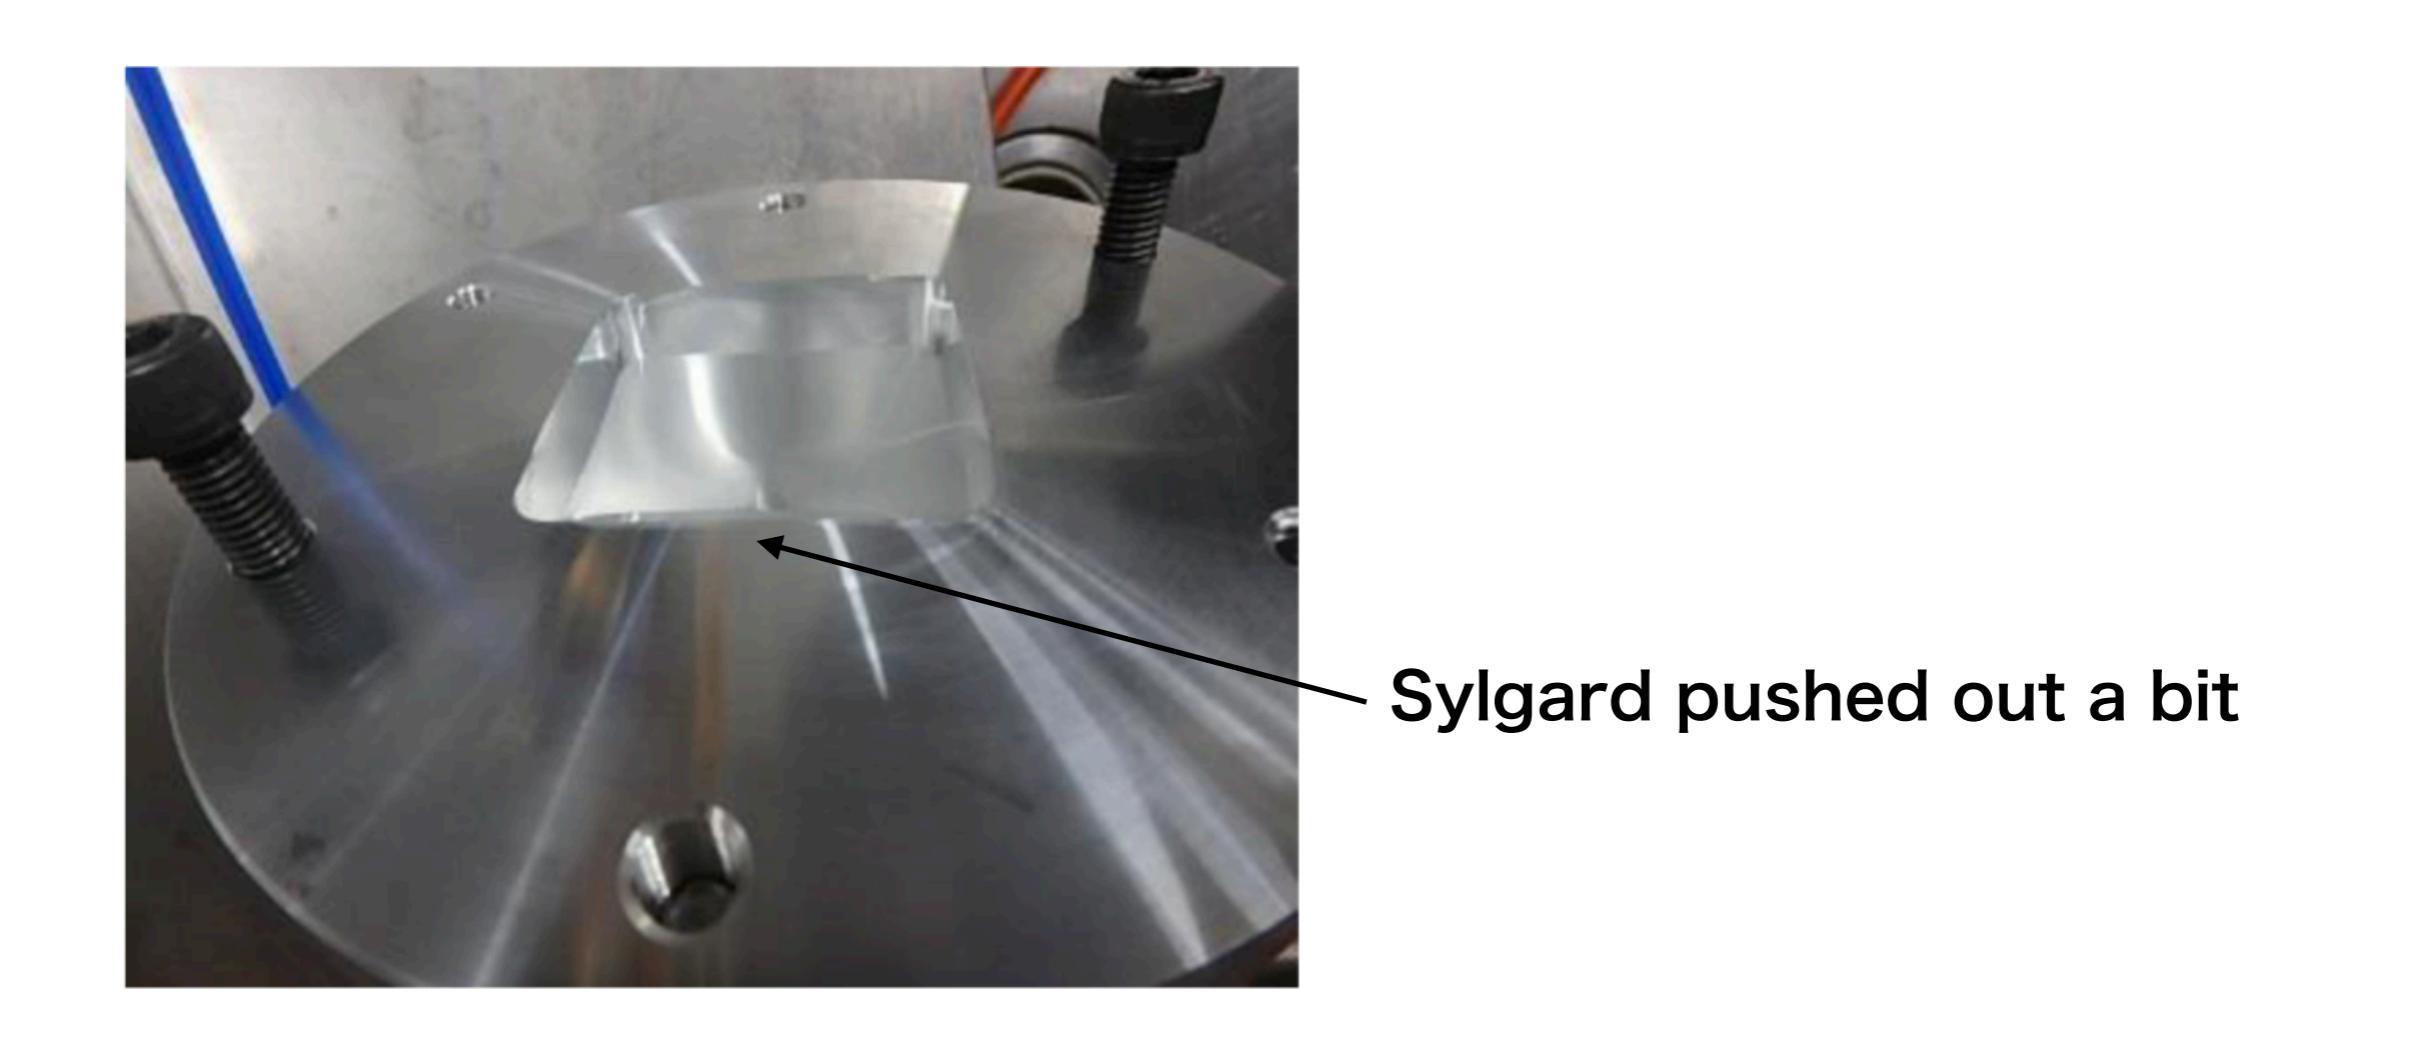
# **Sylgard Only**

- Pressure applied gradually, but large sound heard around 0.04 MPa
- Then pressure dropped immediately
- Due to a clean surface Sylgard didn't withstand that pressure

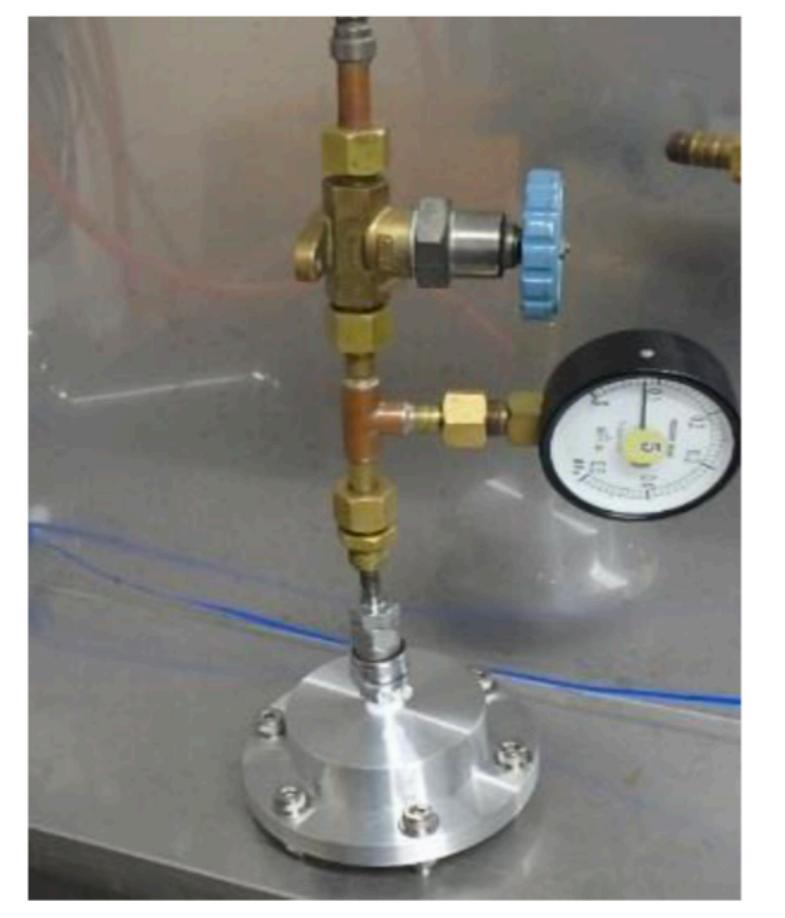
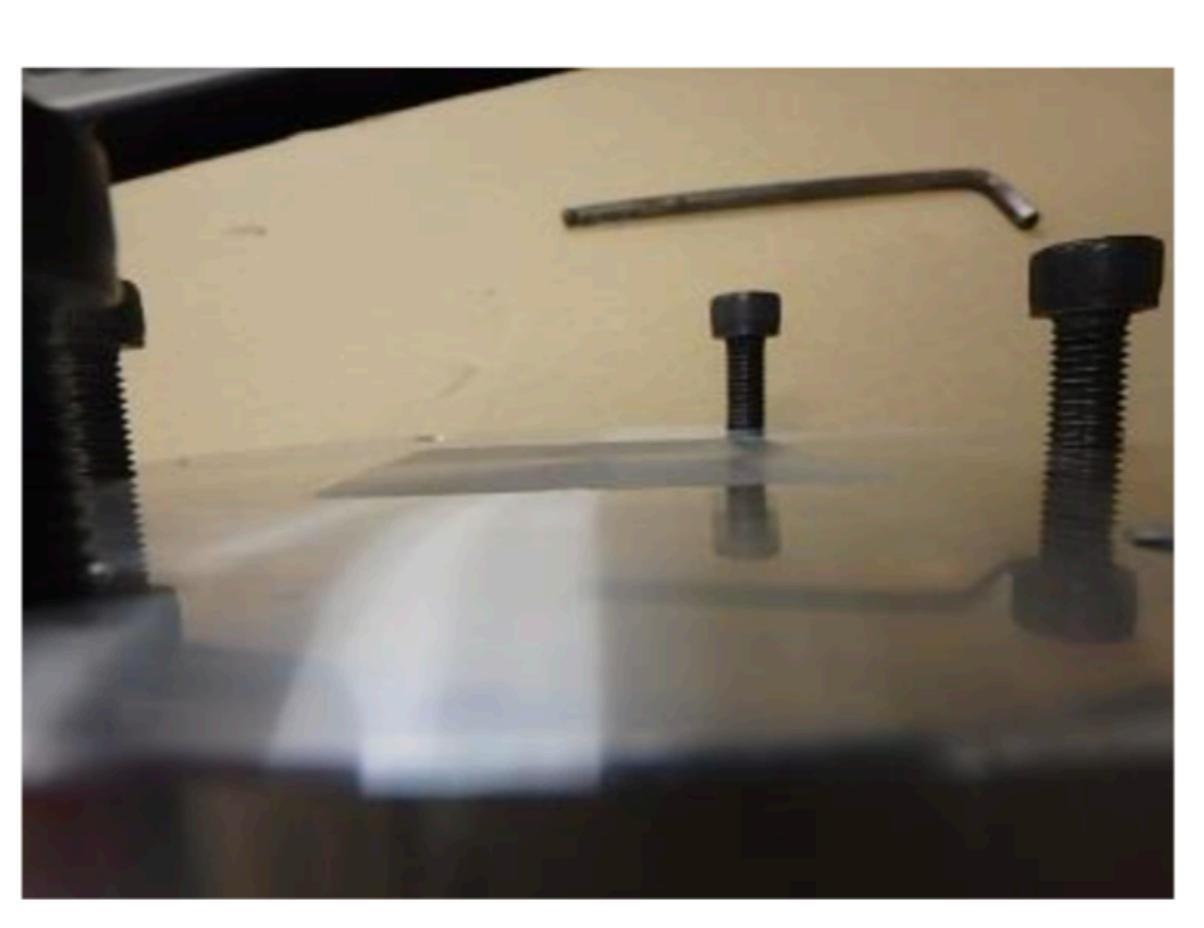
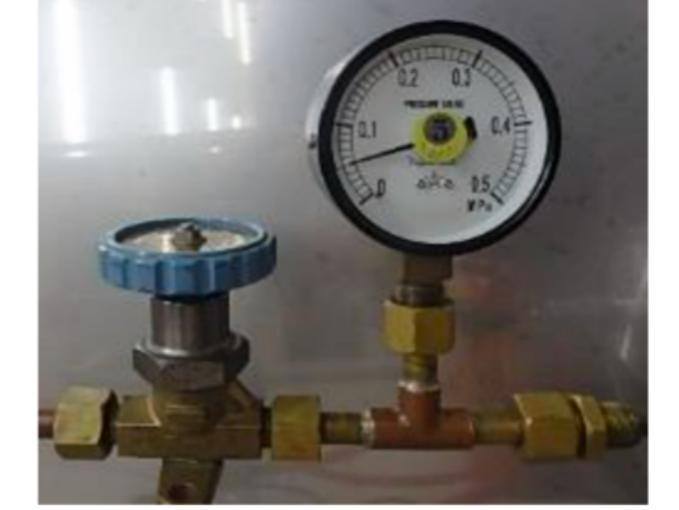
# **RTV + Sylgard**

- 0.05 MPa pressure applied for 24 hours
- Sylgard surface didn't move during this period
- No pressure drop observed after 24 hours

- RTV + Sylgard is promising
- Longer-term tests will be performed at KEK
