# Status of Stripline Feedthrough Prototype Development

T. Sekiguchi

2019. 10. 23

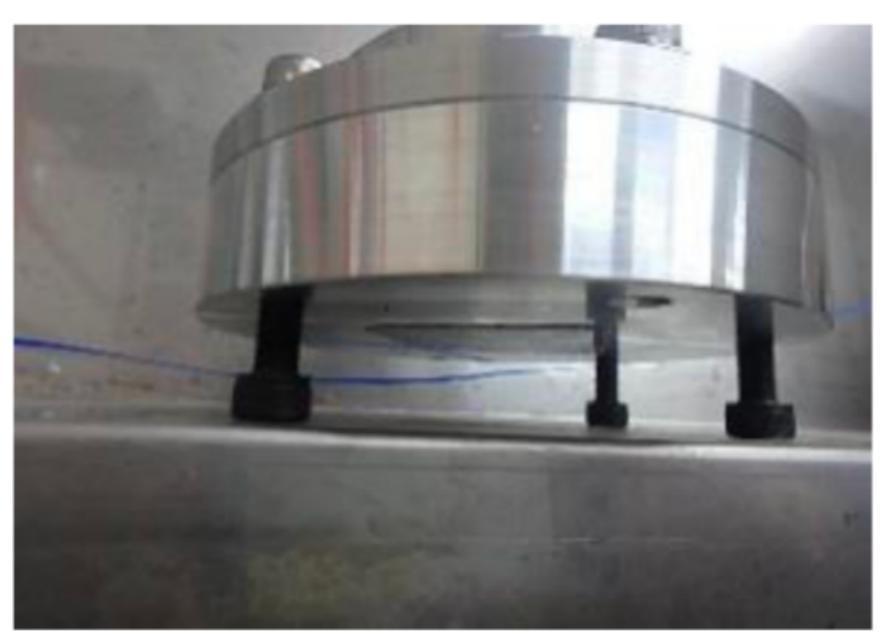
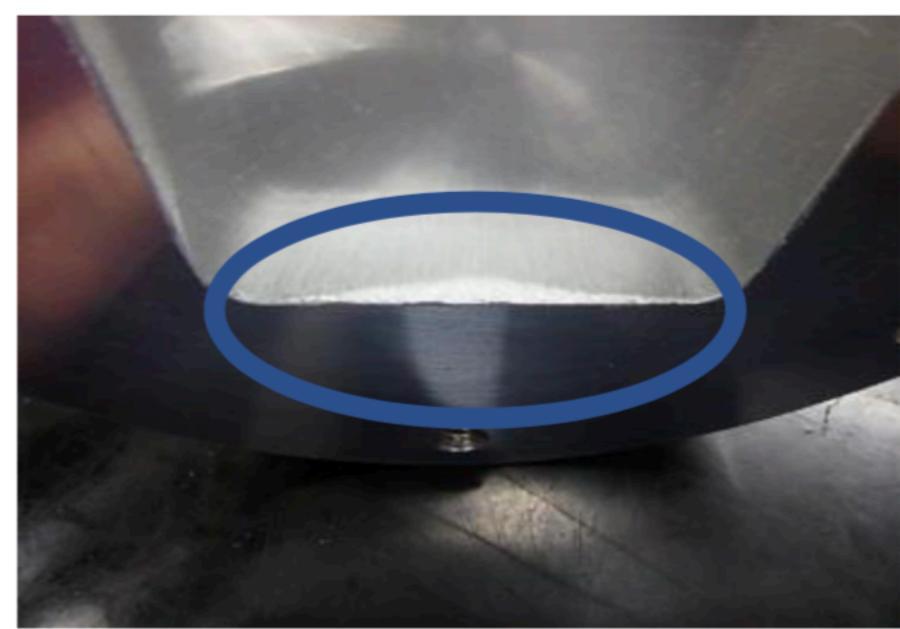
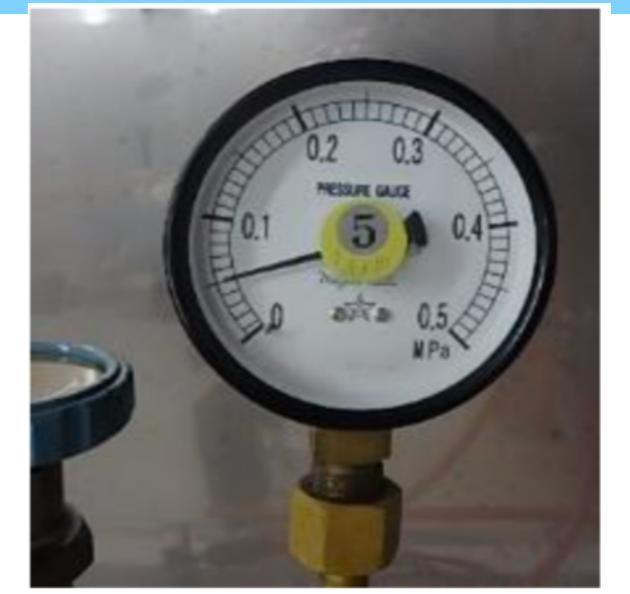
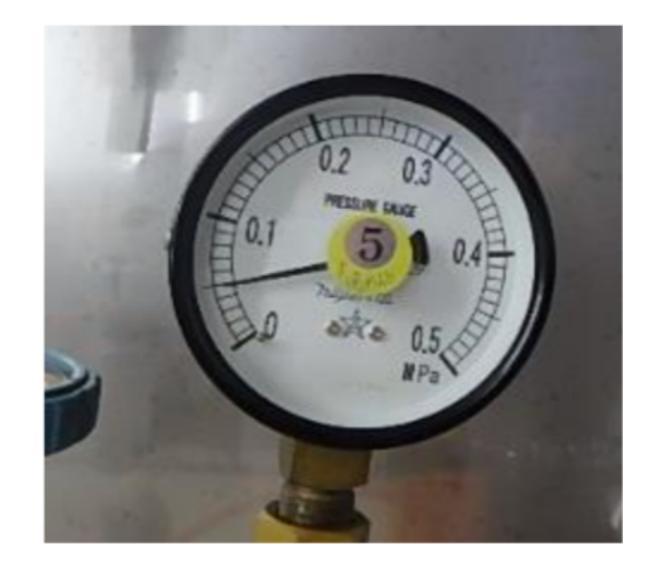
# **Blast + Sylgard**

Sylgard moved a bit

- 0.05 MPa pressure applied for 24 hours
- A slight pressure drop (~0.002 MPa) observed
- Sylgard surface inside the vessel moved a bit

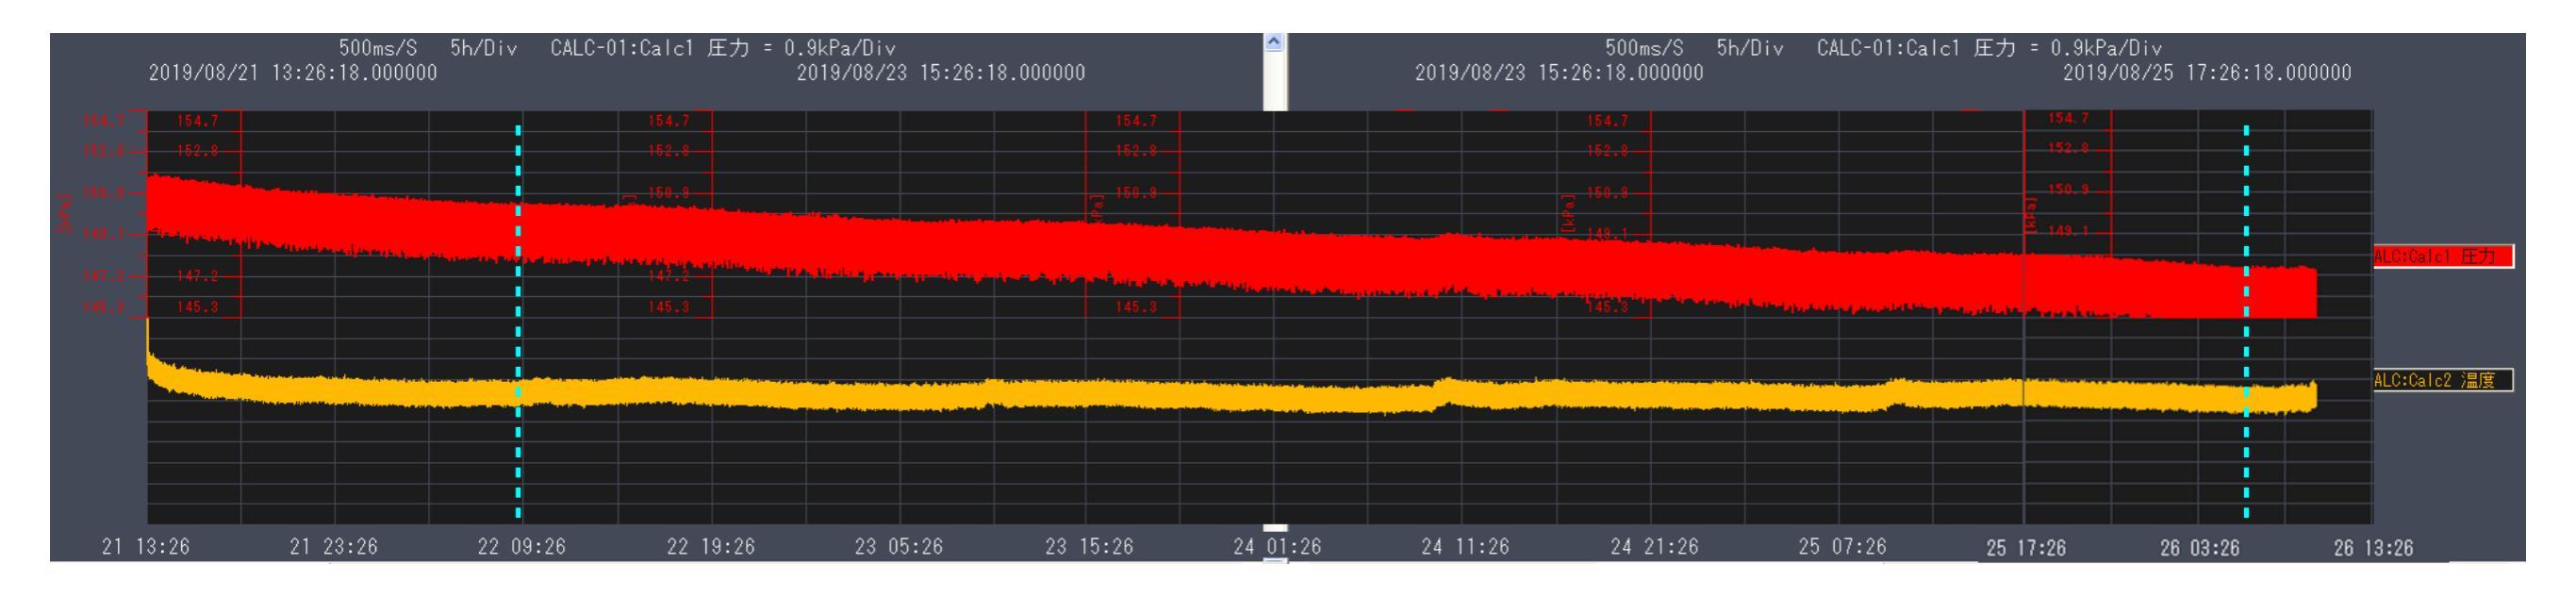
- Pressure test performed during August 21-26
- 0.05 MPa gauge pressure applied to the test piece with Sylgard + RTV
  - 149.1 kPa @ August 22 5:00am
  - 146.8 kPa @ August 26 9:00am
  - -2.3 kPa for 100 hours
  - Temperature variation during this period 2.5°C
- Measured leak rate to be 6.3x10<sup>-7</sup> Pa•m<sup>3</sup>/s

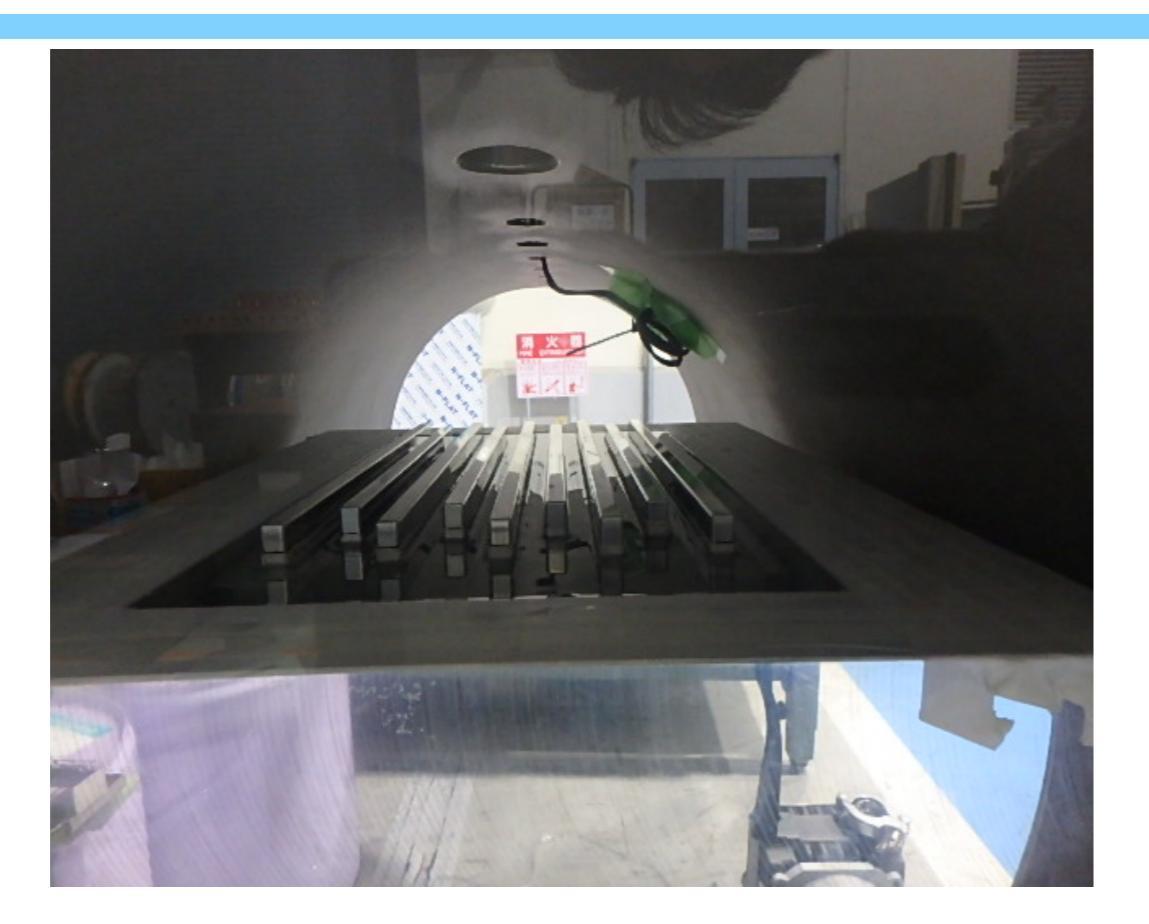
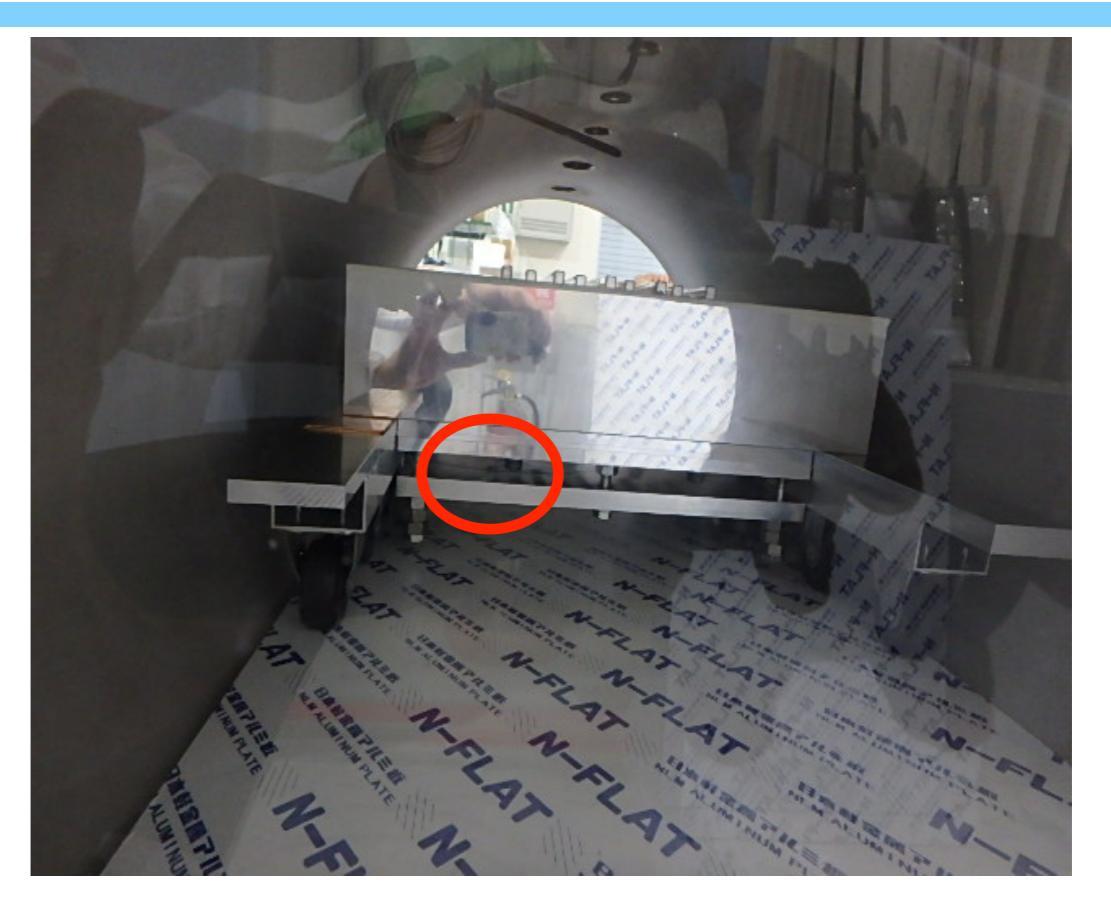
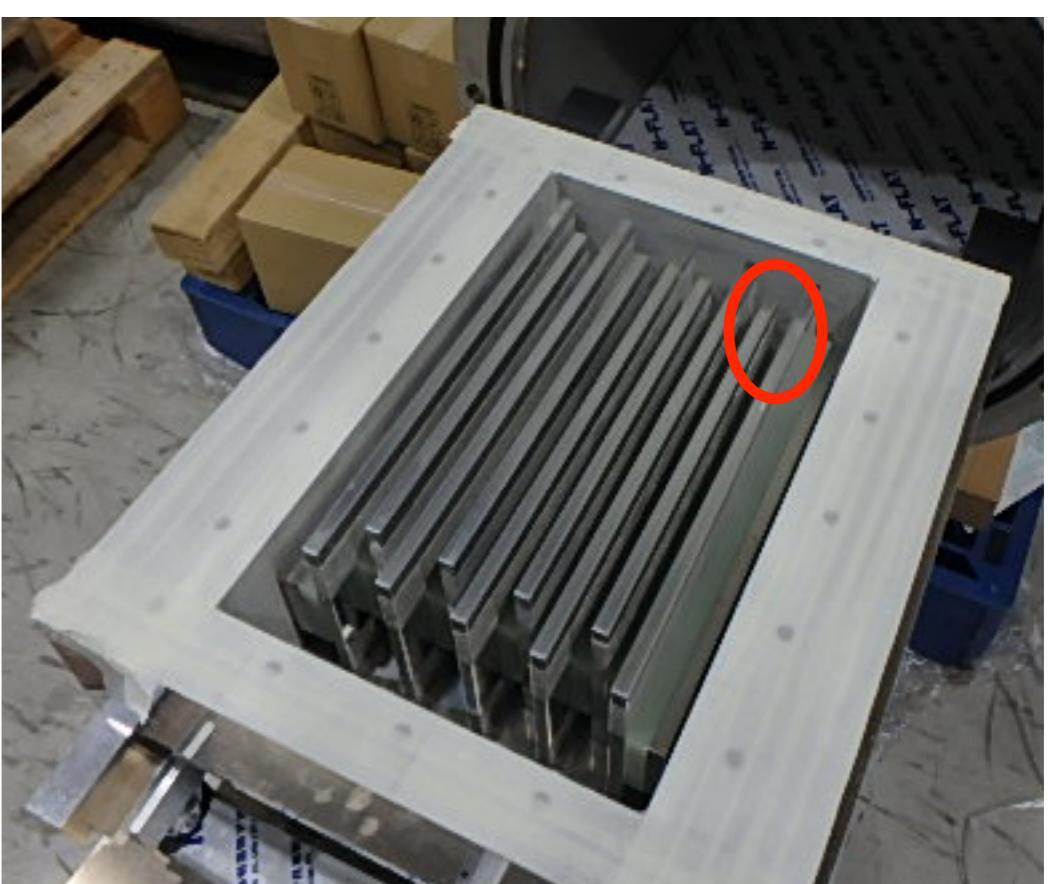
- Vacuum degassing in the chamber
- Tiny leakage of Sylgard occurred
  - But significant improvement on sealing
- Then waited 48 hours for curing
- Add small amount of Sylgard to the leaked point
