# DUNE-SP

# Technical Integration

Consortium to Consortium Mechanical Interface Actions Post Ash River  
Oct. 2019

January 23rd, 2020

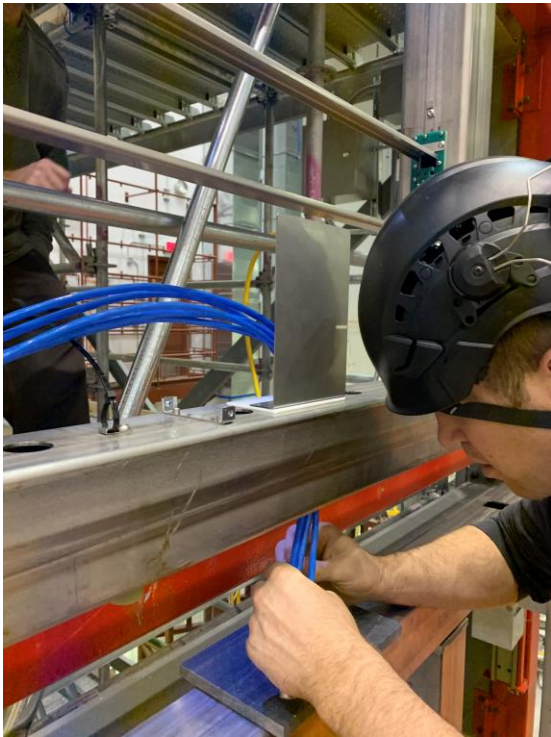
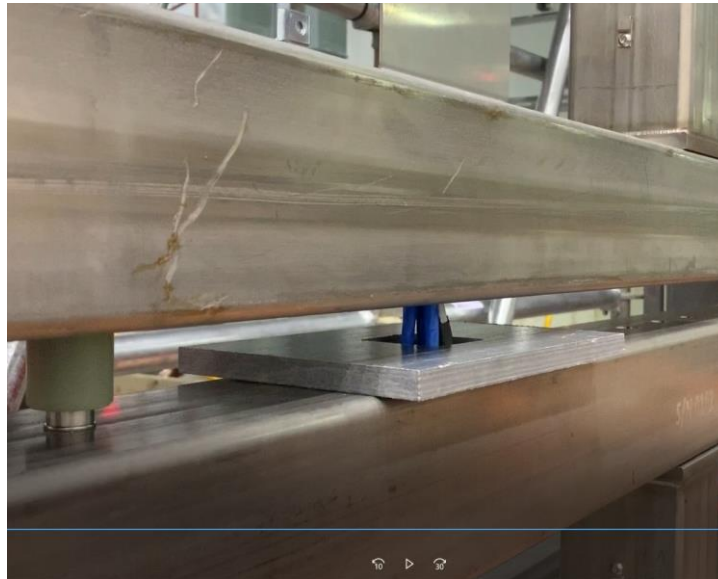
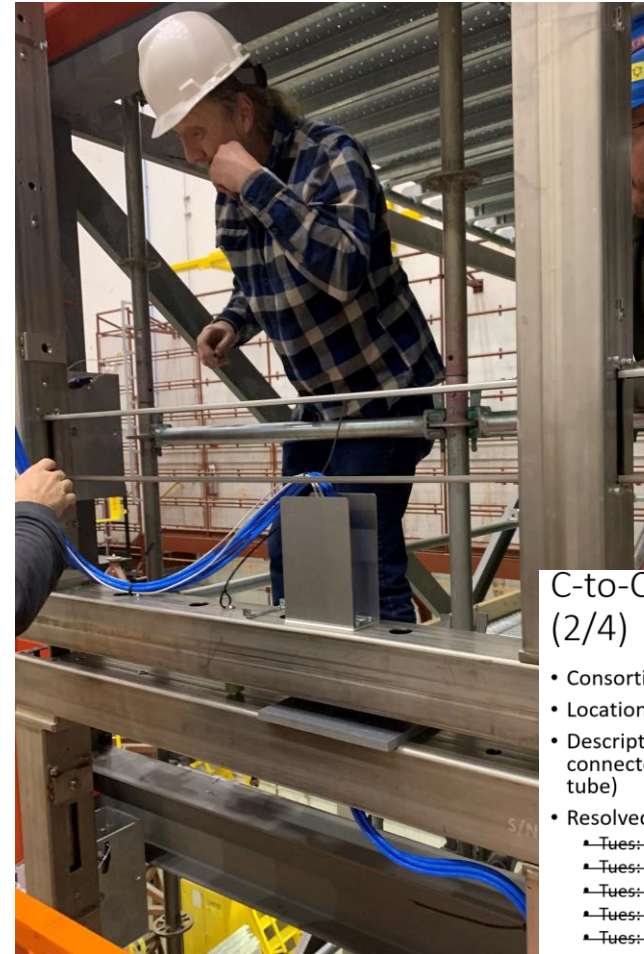
# C-to-C Mechanical Interface Action Items (3/4)

- Consortium to Consortium: APA to PDS
- Location(s): Foot tubes
- Description: PDS cables (upper foot tube) connected to PDS junction block (lower foot tube)
- Resolved on December 18<sup>th</sup>, 2019:
  - ▲ Tues: 1-a.
  - ▲ Tues: 1-b.
  - ▲ Tues: 1-c.
  - ▲ Tues: 1-d.
  - ▲ Tues: 1-e.
  - ▲ Tues: 2-

- Tuesday:
- 1- PD cable tests
    - a. Need more clearance on c redesigned connector loca clearance, also added a 6"
    - b. New connectors work wel these.
    - c. New design for the cable t cables in two bundles one
    - d. Issue with orientation of t the top APA, they need to position so the cable does around opening in sheet n
    - e. Bottom of the lower PD ra linkage, this needs to be fi the bottom idea.
  - 2- Guide pins: The guide pins did no stop damage to the PD connector sooner and be tapered to center
  - 3- Tried installing APA linkage with t nlar- This step cannot be done t
