Facility/Hardware

MTA Accelerator Readiness Review

2020 September 9

Reconfiguration & Installation Status

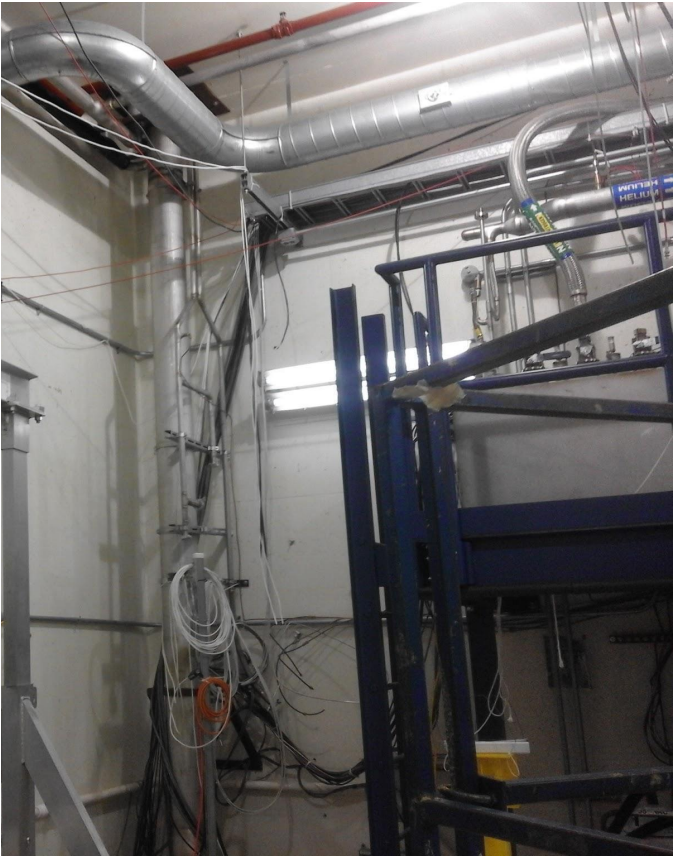
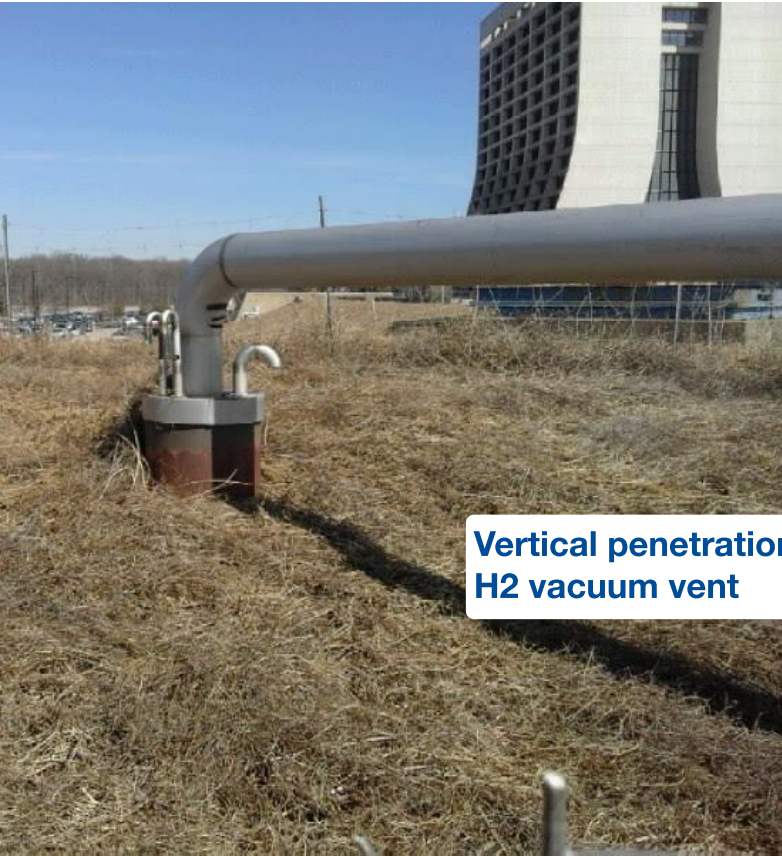
Vertical penetration through berm for H2 vacuum vent

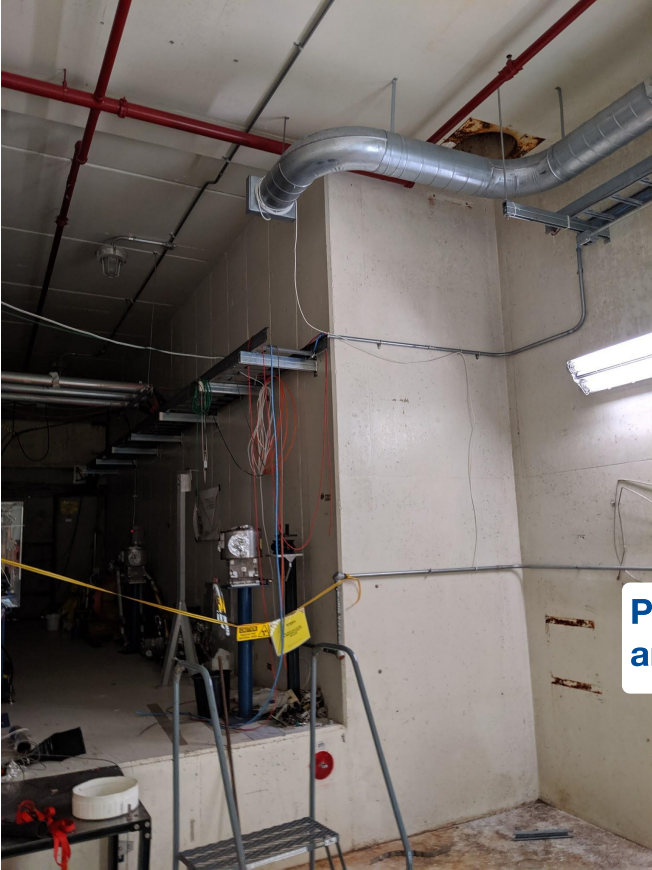
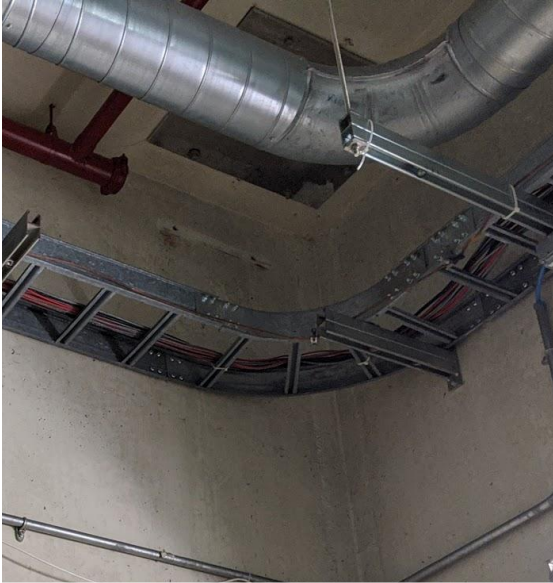
Piped cleared away, penetration capped and filled with sand (+ 3' poly beads)

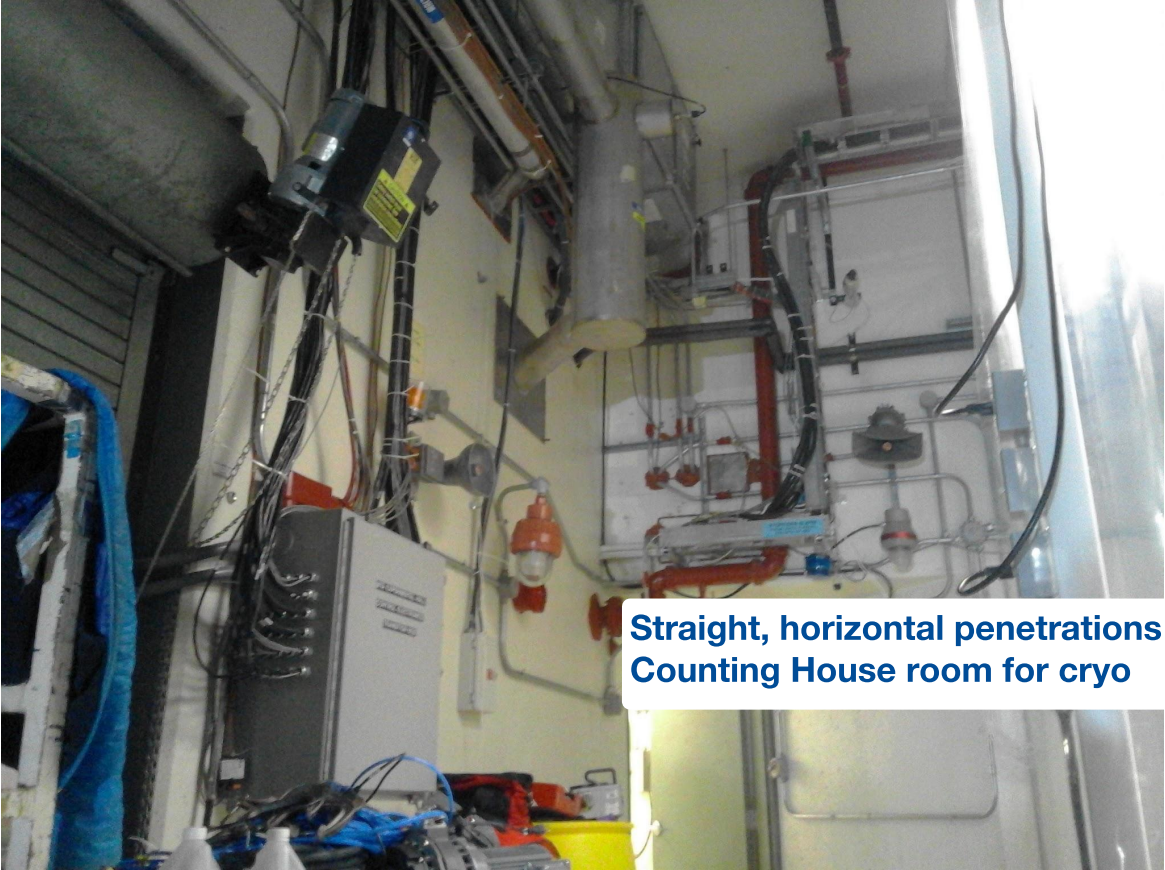
Straight, horizontal penetrations to Counting House room for cryo

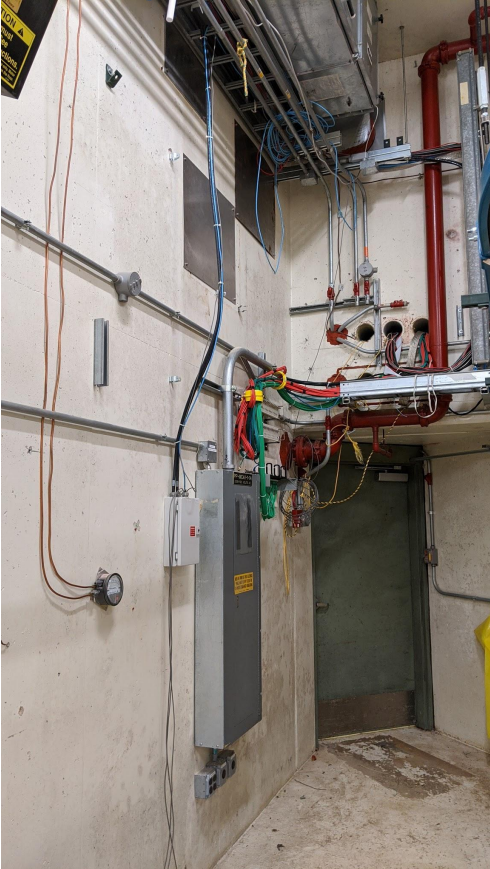
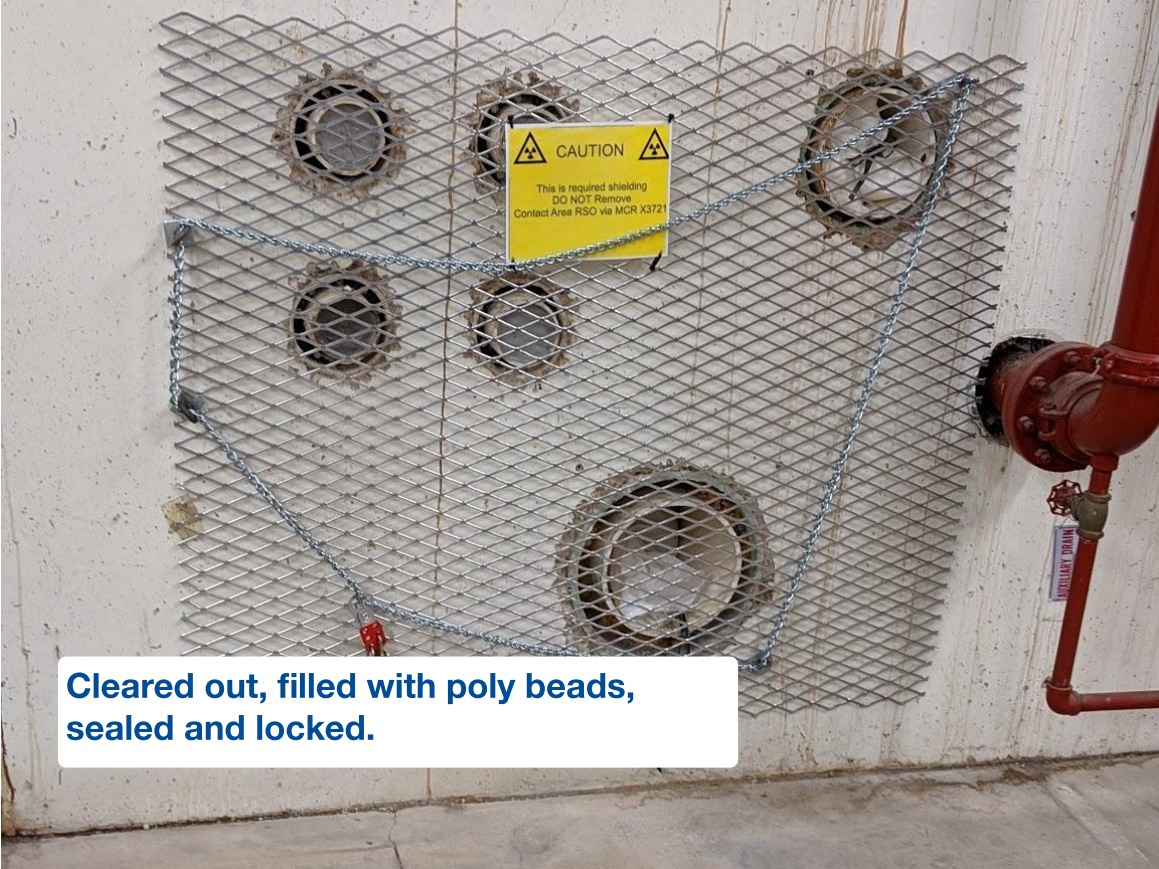
Cleared out, filled with poly beads, sealed and locked.

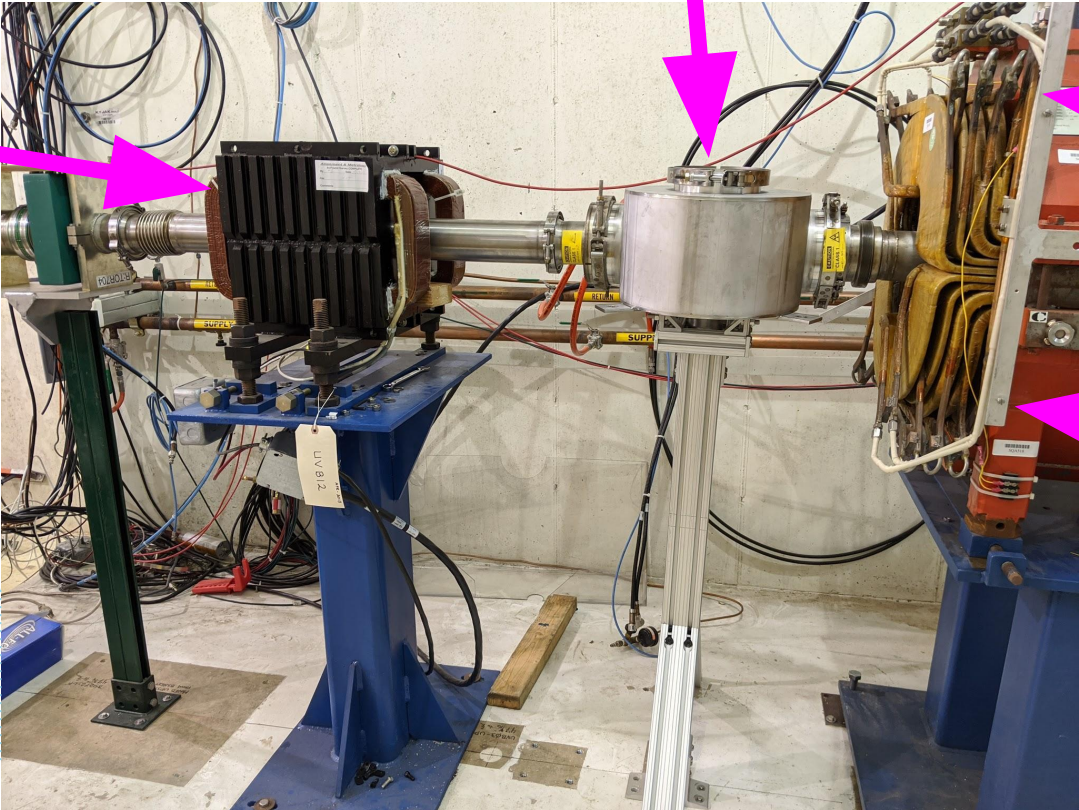
Stripping Foil

Stripped protons bent
down 1.678° to flat &
level

Upward H^- ion
beam pitch: 1.678°

0.004" grade-4 Ti alloy beam window mounted on an empty multiwire frame, with lab-standard vacuum vessel, drive arrangement, and position controls

- Expected ~100.0% electron **stripping** efficiency based on areal density (45.0 mg/cm², cf Booster's 0.30 mg/cm² carbon foils).
- Expected additional **scattering** ~0.290 milliradians (98% containment).

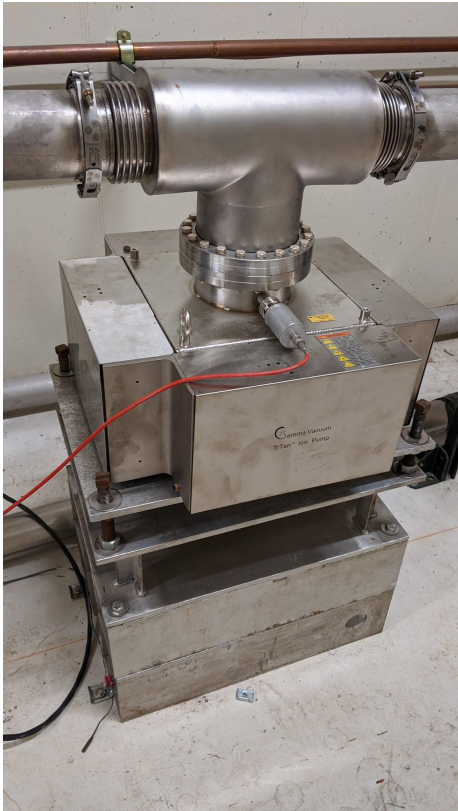
**Replaced Ion Pump
IP03:**

**Gamma Titan 600 L
Conventional Diode**

**$1.6E-6 \rightarrow 5.0E-8$ Torr
(First 72 hours)**

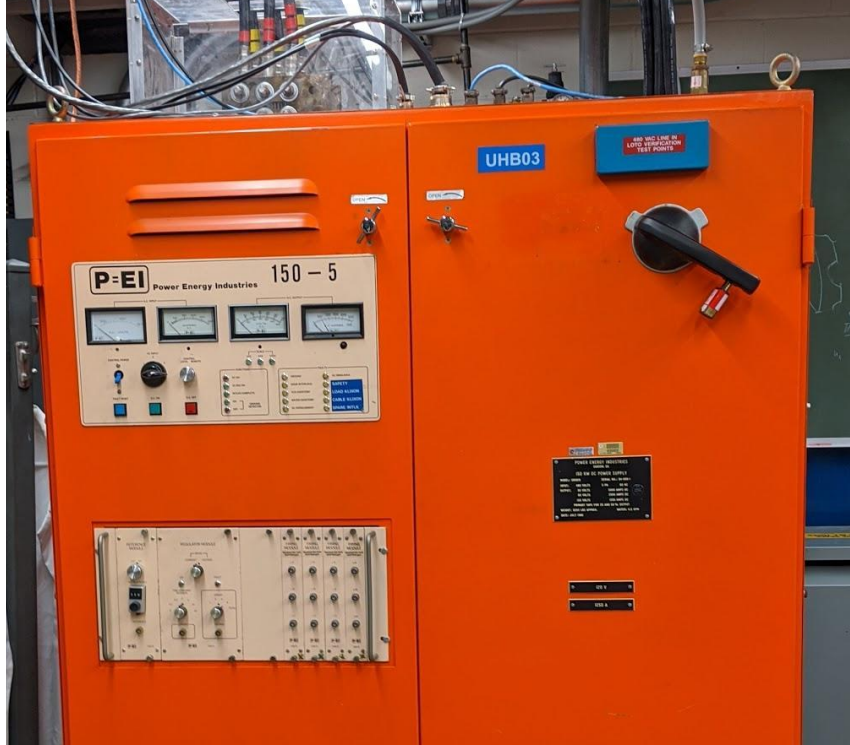
Restored power to 1250 A, 120 V PEI power supply via critical device contactor

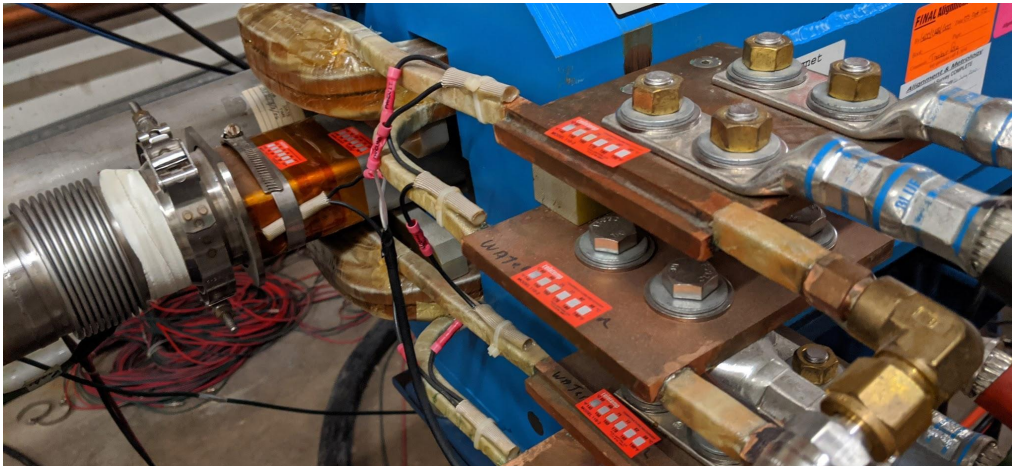
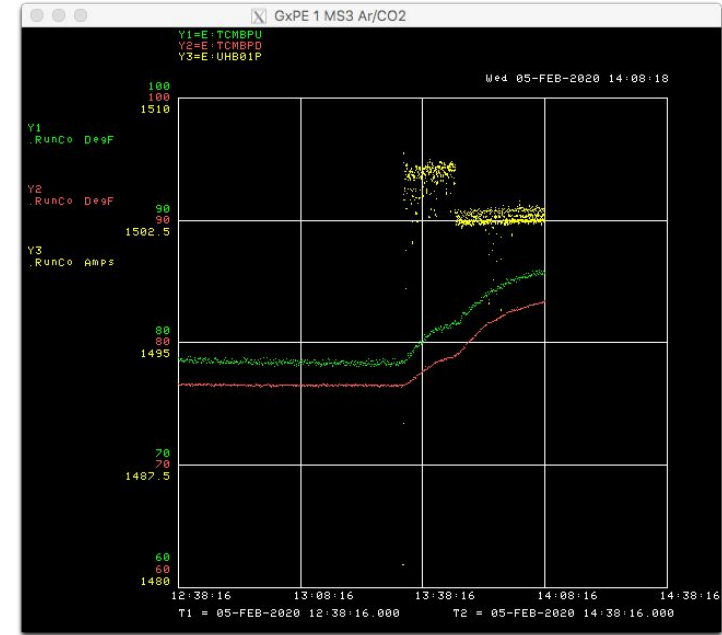
Made use of down time Wed 2020-02-05 to test pulsed magnet with internal and external (\$02) triggers.

- Beampipe heating effect: $<90^{\circ}$ F equilibrium, (safety limit: 150° F)

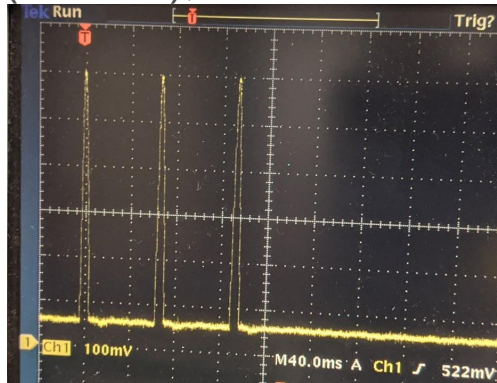
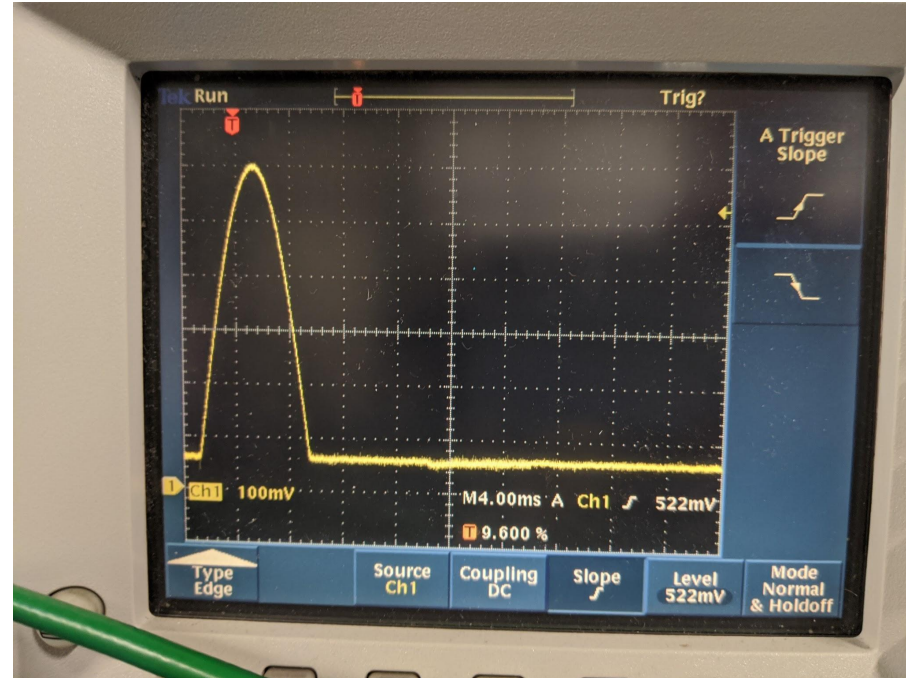
Made use of down time Wed 2020-02-05 to test pulsed magnet with internal and external (\$02) triggers.

- Waveform is a healthy sine arc
- Amplitude (current) correct correspondence to reference voltage at 960 V (1567 A), variation ~ 20 A (0.2%)
