Update on Ionization Laser System (IoLS) activities at CERN

Mattia Fani - Los Alamos National Laboratory

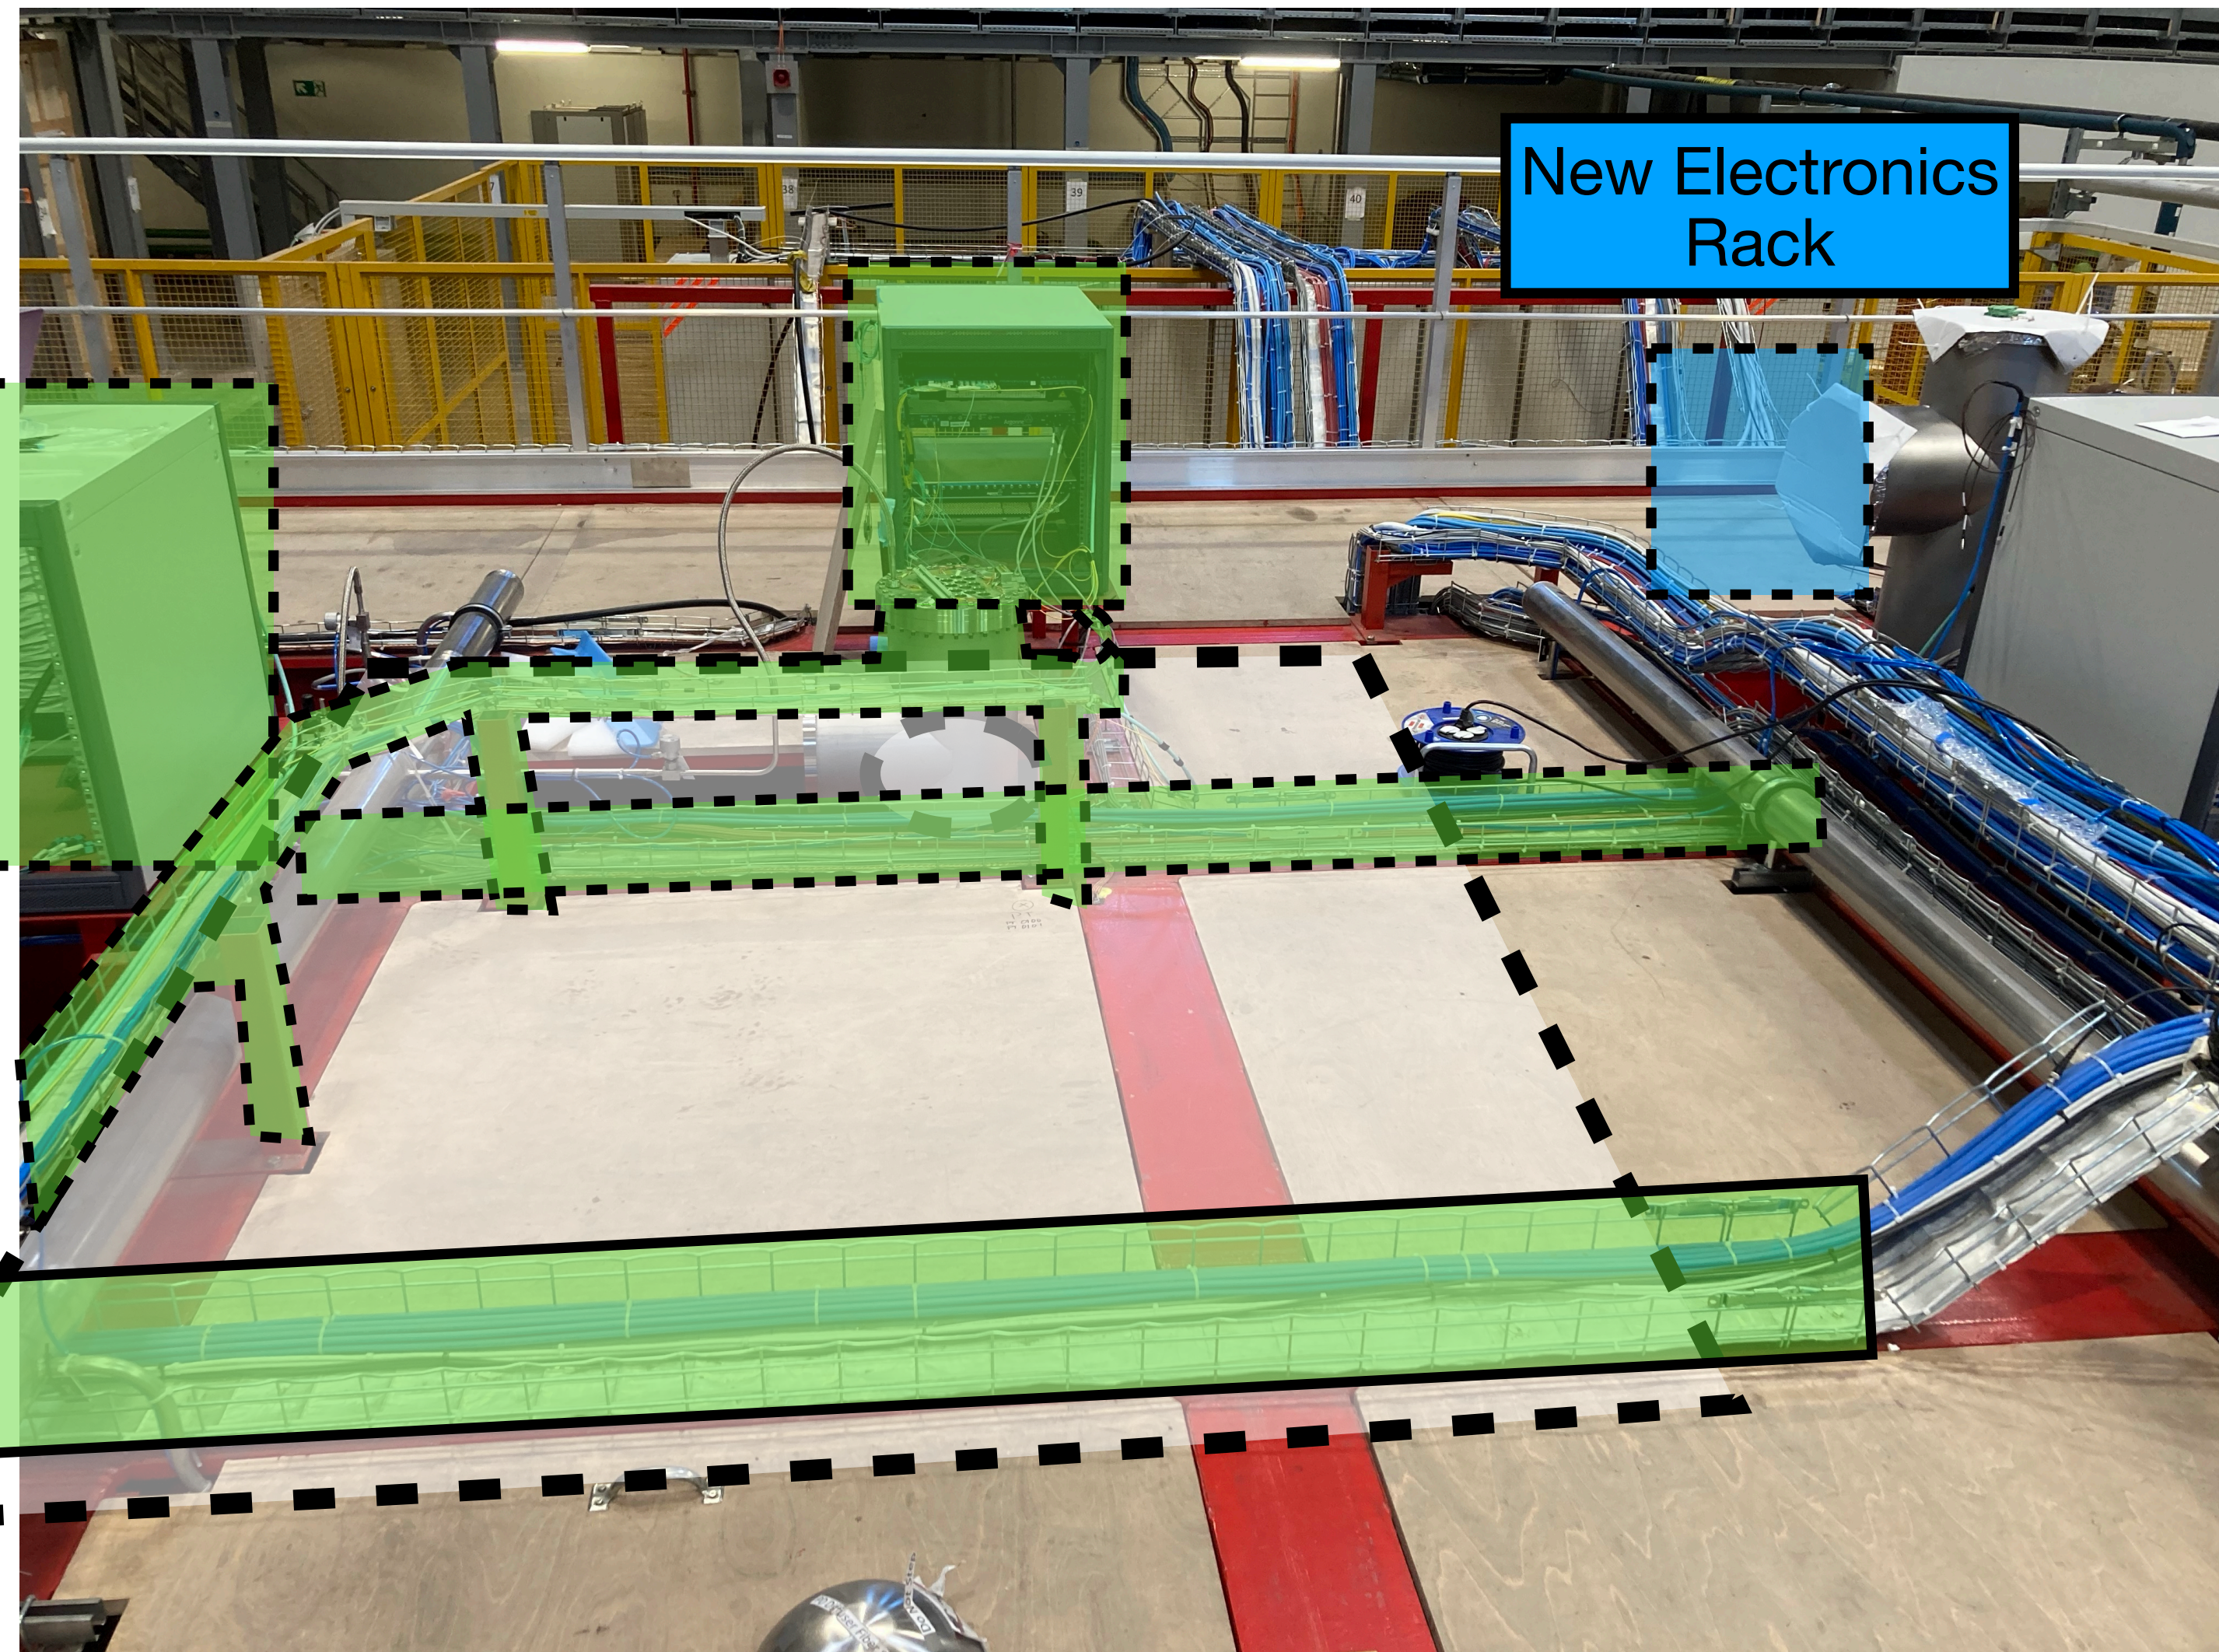
Tent space preparation for Periscope 1

- Obstacles identification and removal
 - Electronics racks + supports
 - Lifted cable tray + supports
 - Ground cable tray
 - Preexisting flange + connections
- Reroute cables
- Safety interventions
 - Remove harmful ground points
 - Cover remaining cable tray

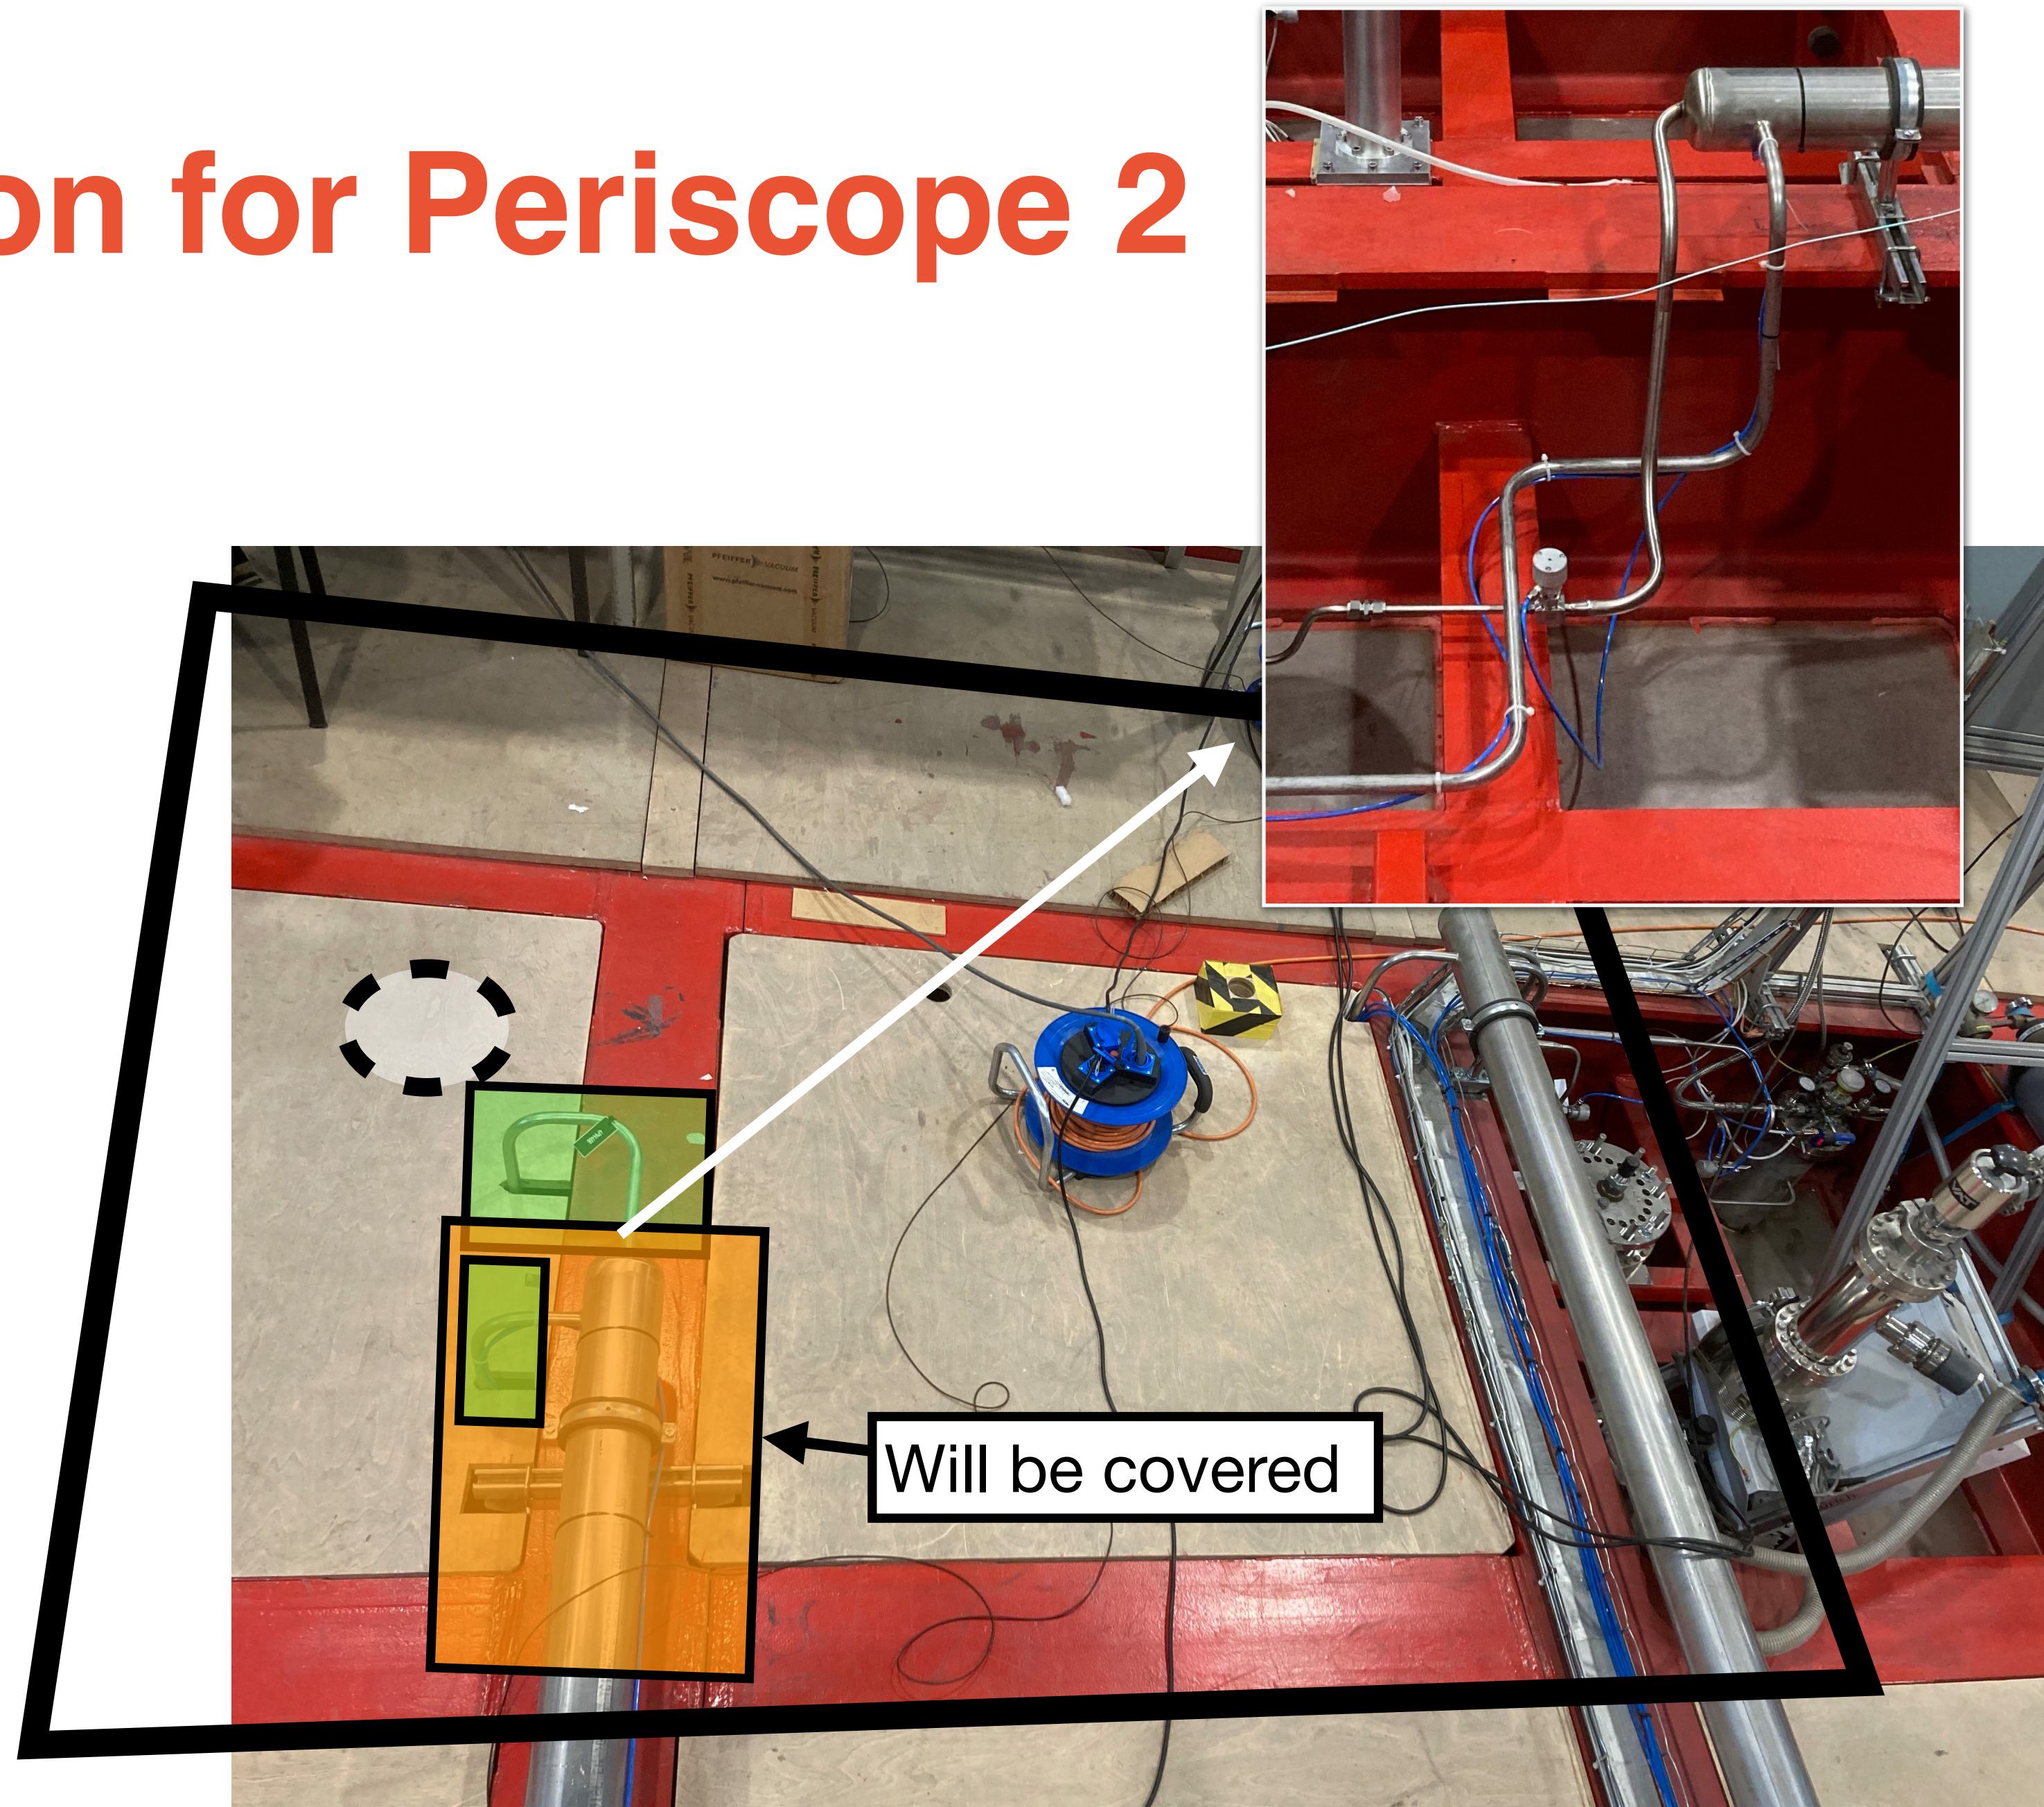
Tent space preparation for Periscope 2

- Work space evaluation
 - Clearer than P-1 site
 - Flange already clear
 - Close objects are not removable
- Check conditions for installation of laser components
 - Will require crane
- Safety interventions
 - Cover + **modify vacuum pipes**

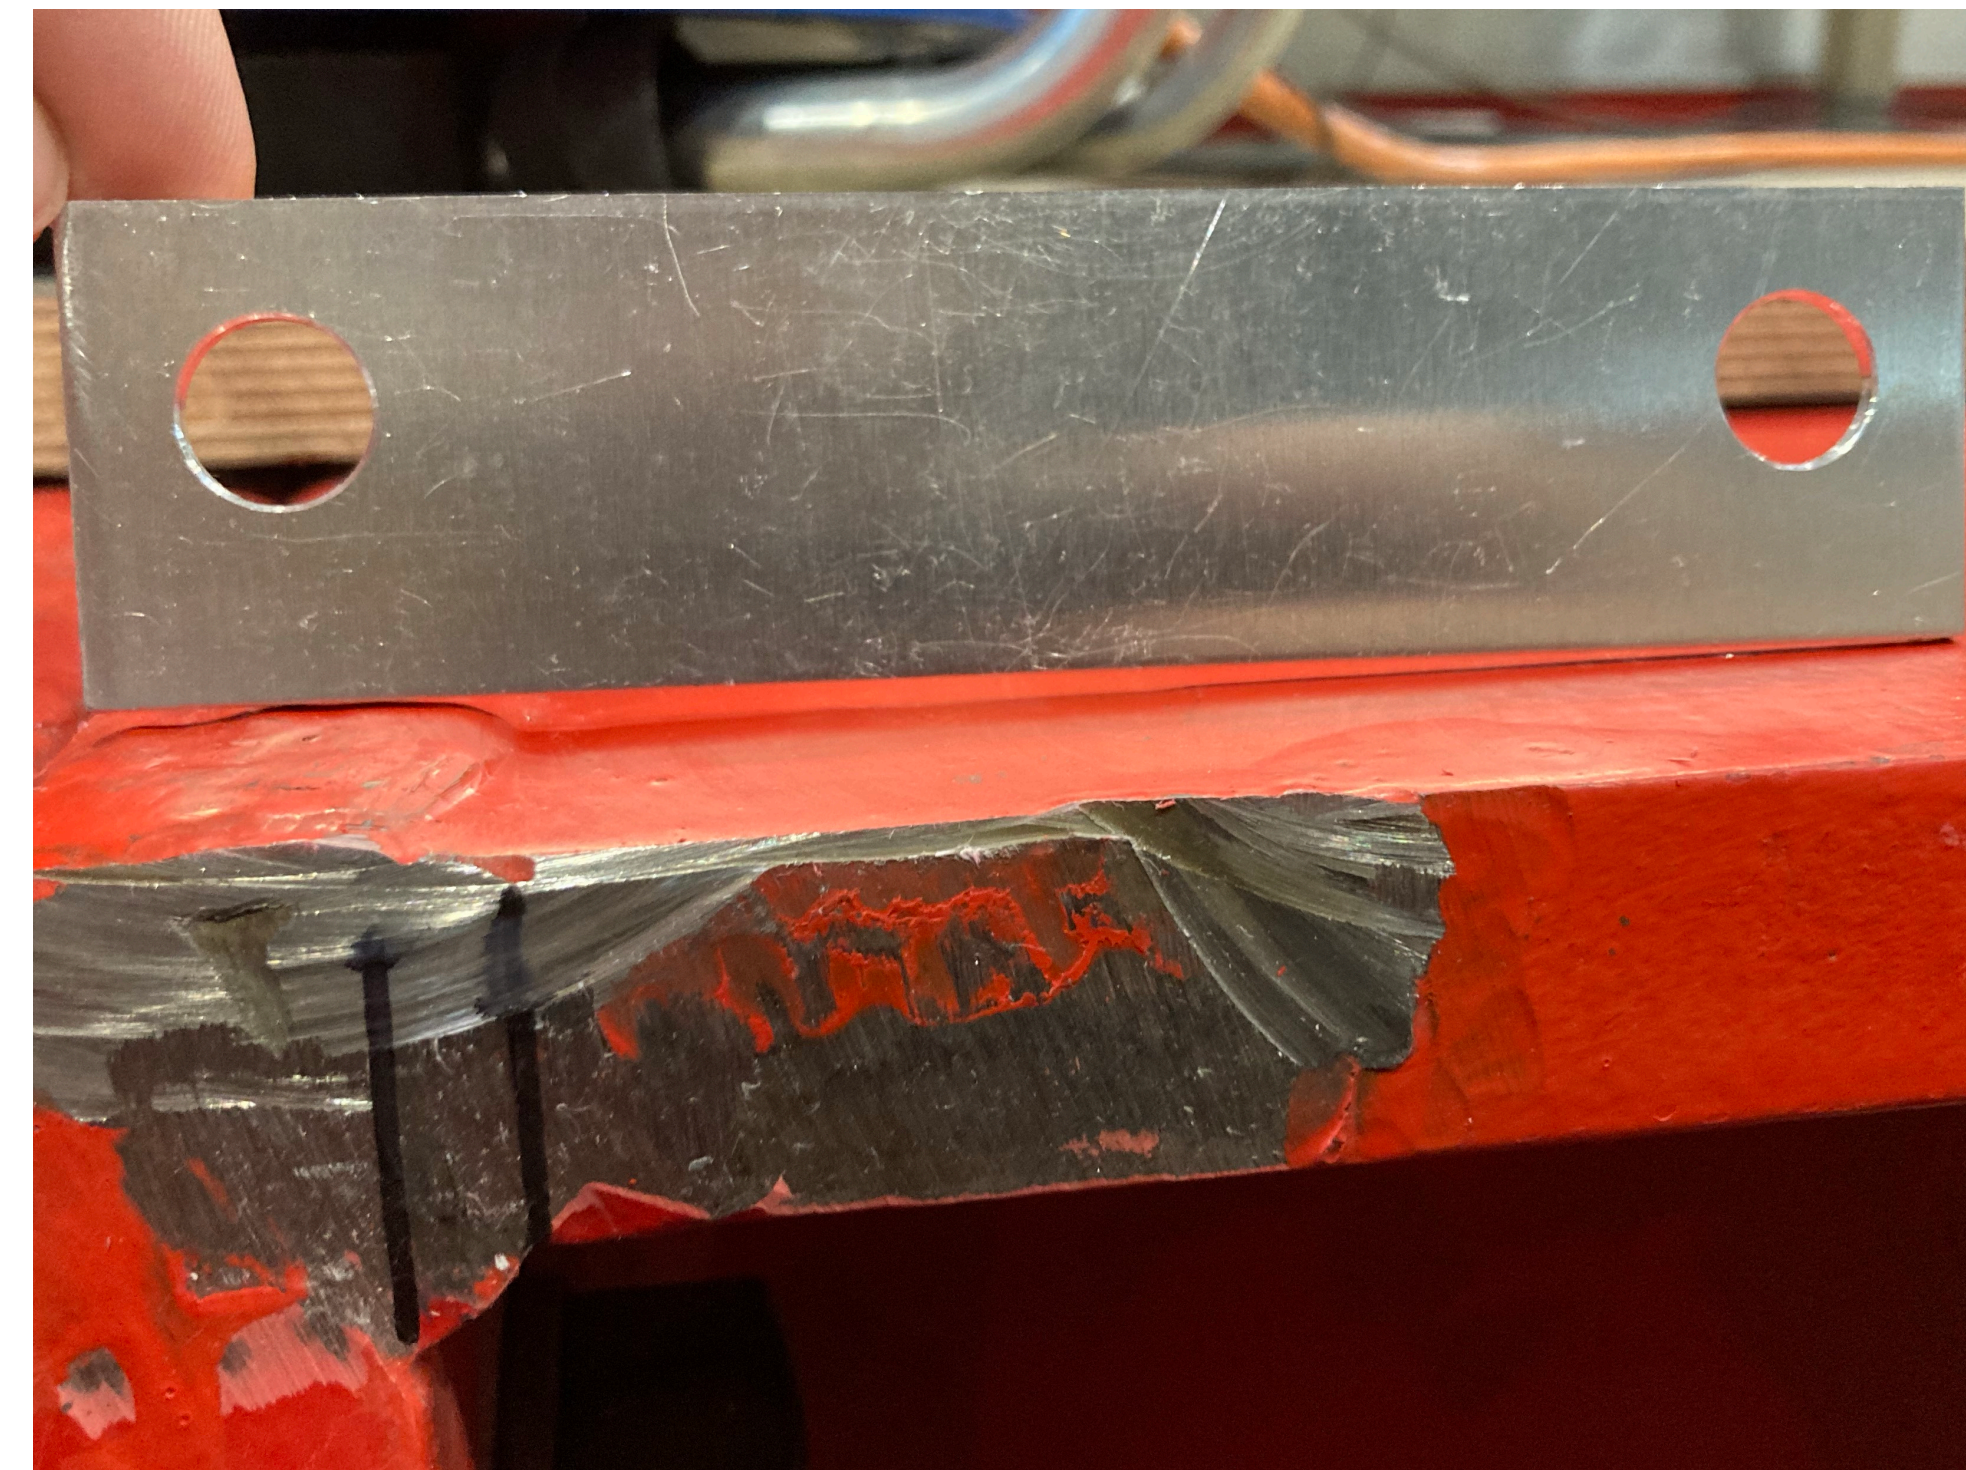
- LL1: **OK**
- SL1 - original: 2 mm additional Al plate (in place)
- SL3 - **modified**: 2 mm additional Al plate (in place)

- LL2 **modified**: needs additional Al plate (in place)
- SL2 - **modified**: 3 mm additional Al plate (in place) + 2 mm GF10 (in place) + 2 mm Al plate (in place)
- SL4 - **modified**: 3 mm additional Al plate (in place) + 2 mm GF10 (in place) + 2 mm Al plate (in place)

● **WARNING**: distances on model \neq reality (a few mm)

- Cryostat beam welding points make surfaces uneven
- Beam thickness not uniform at mm precision

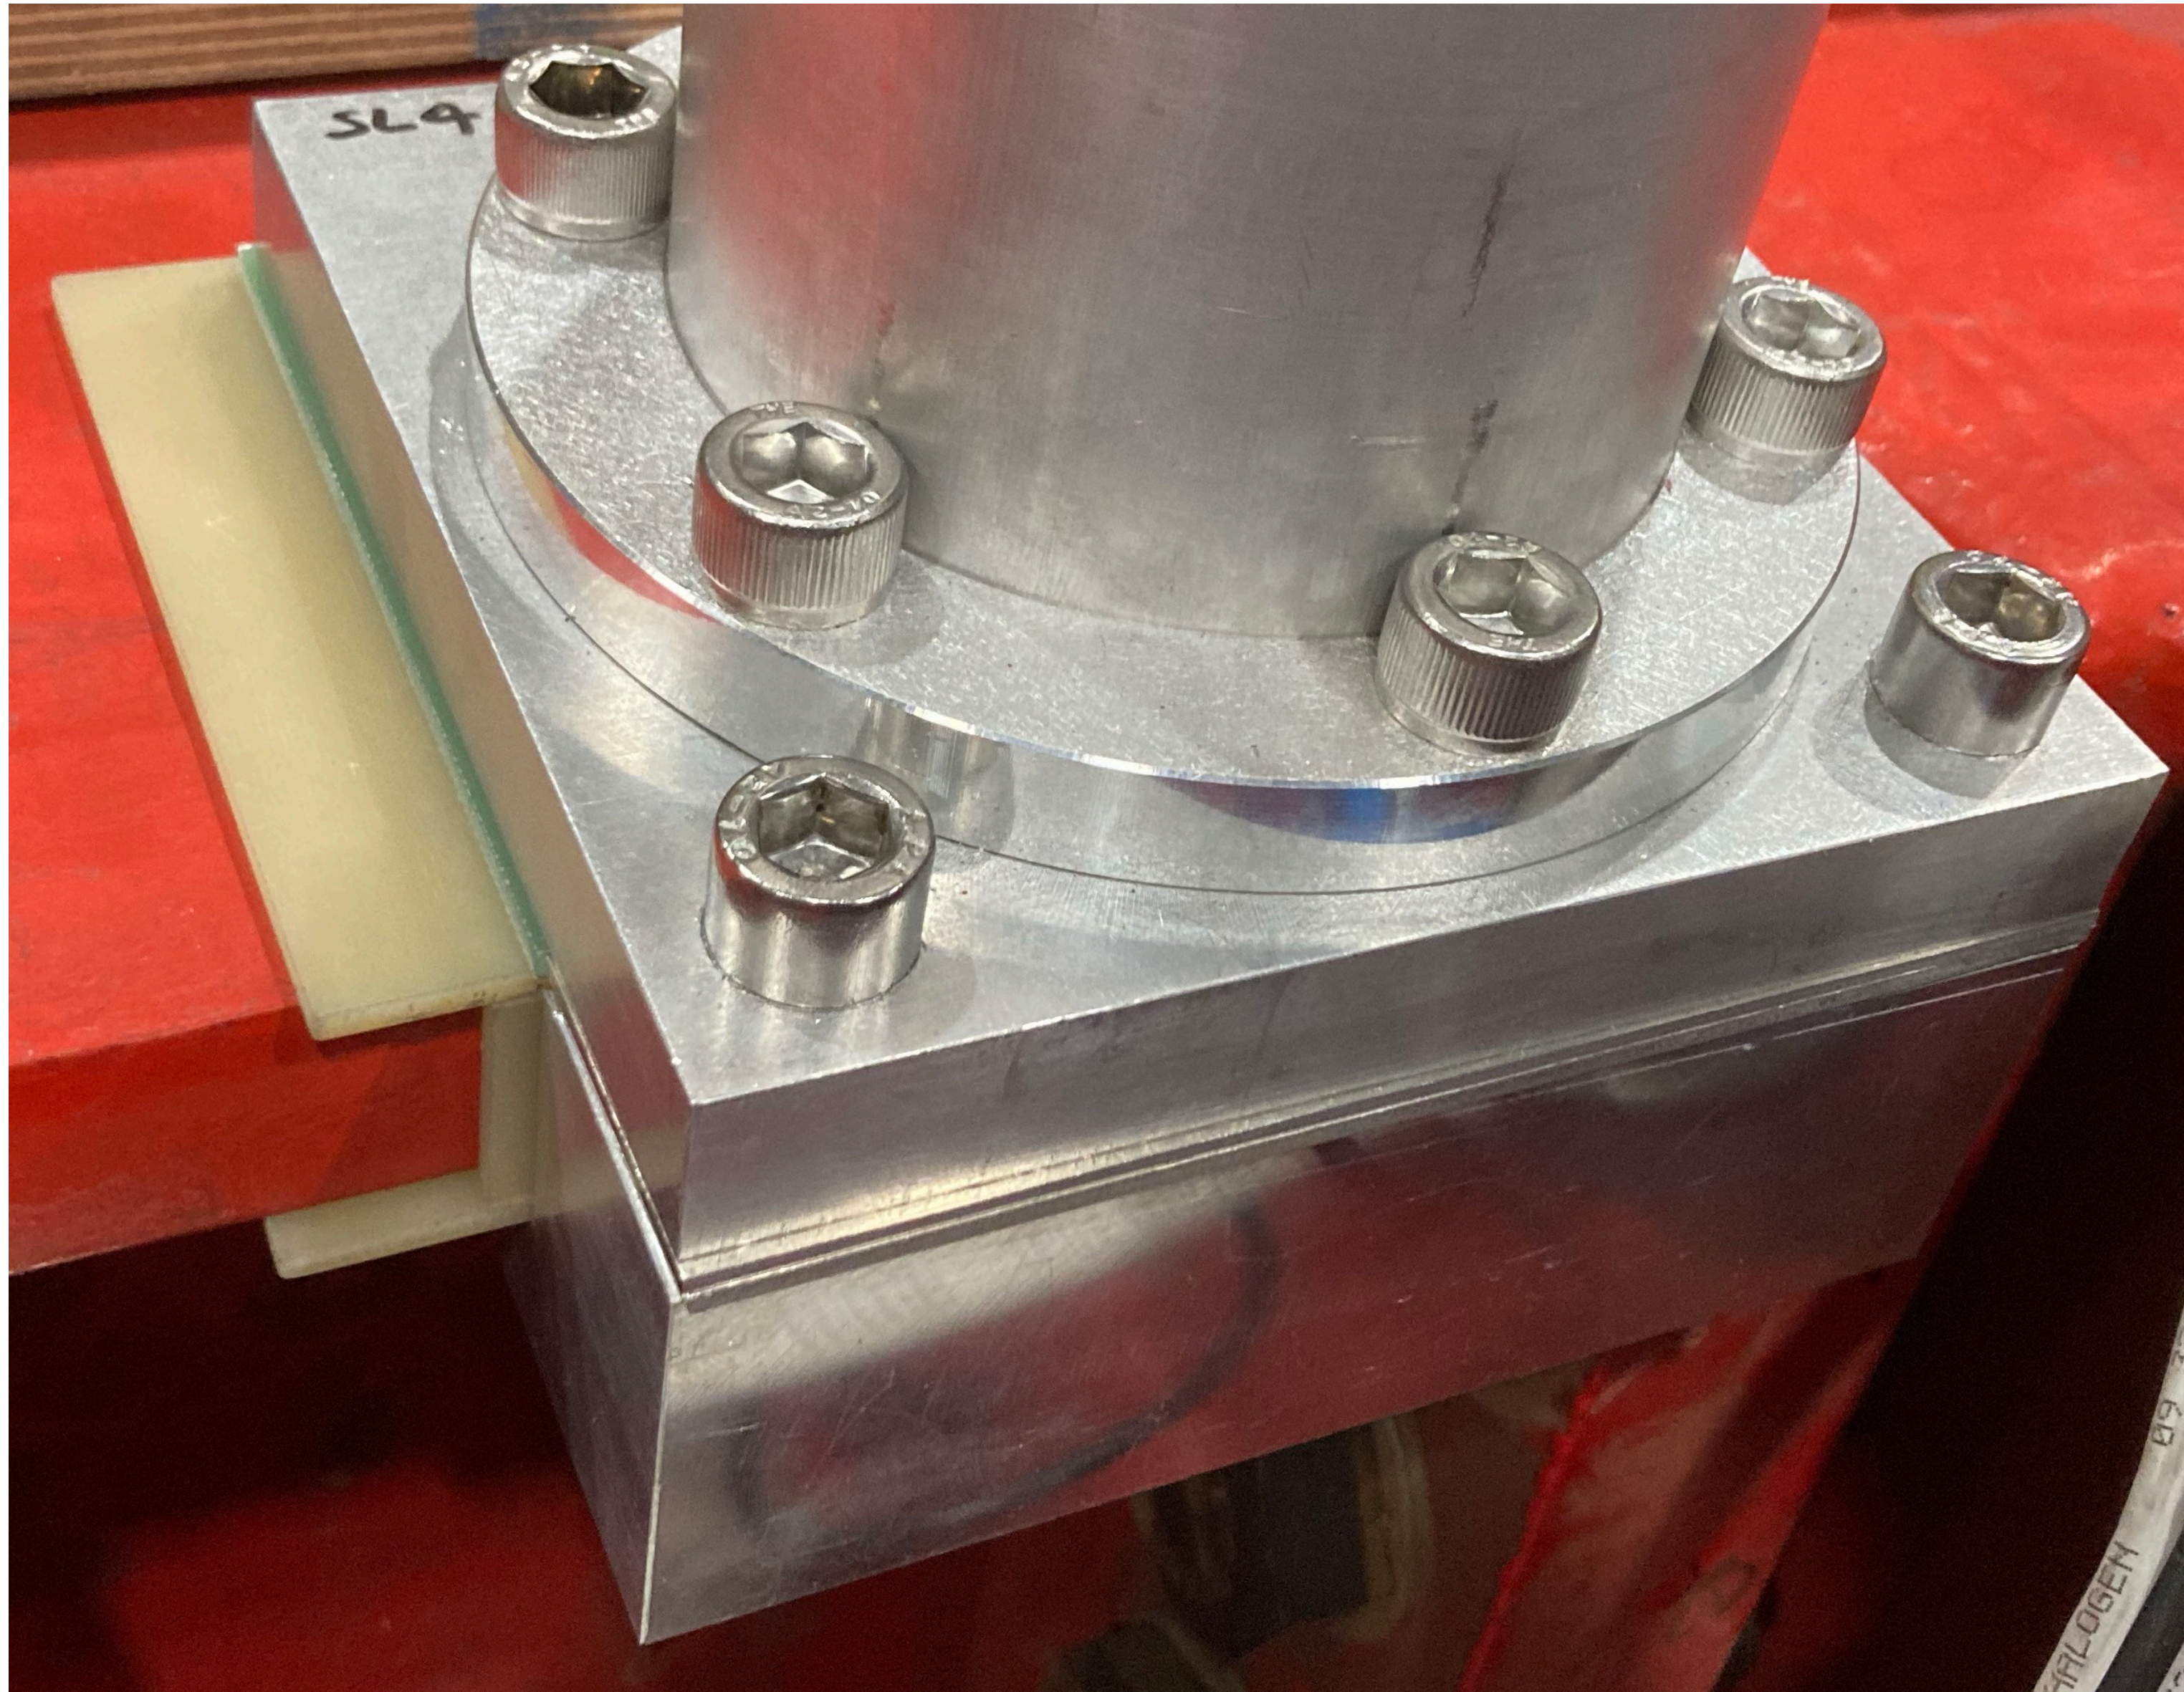
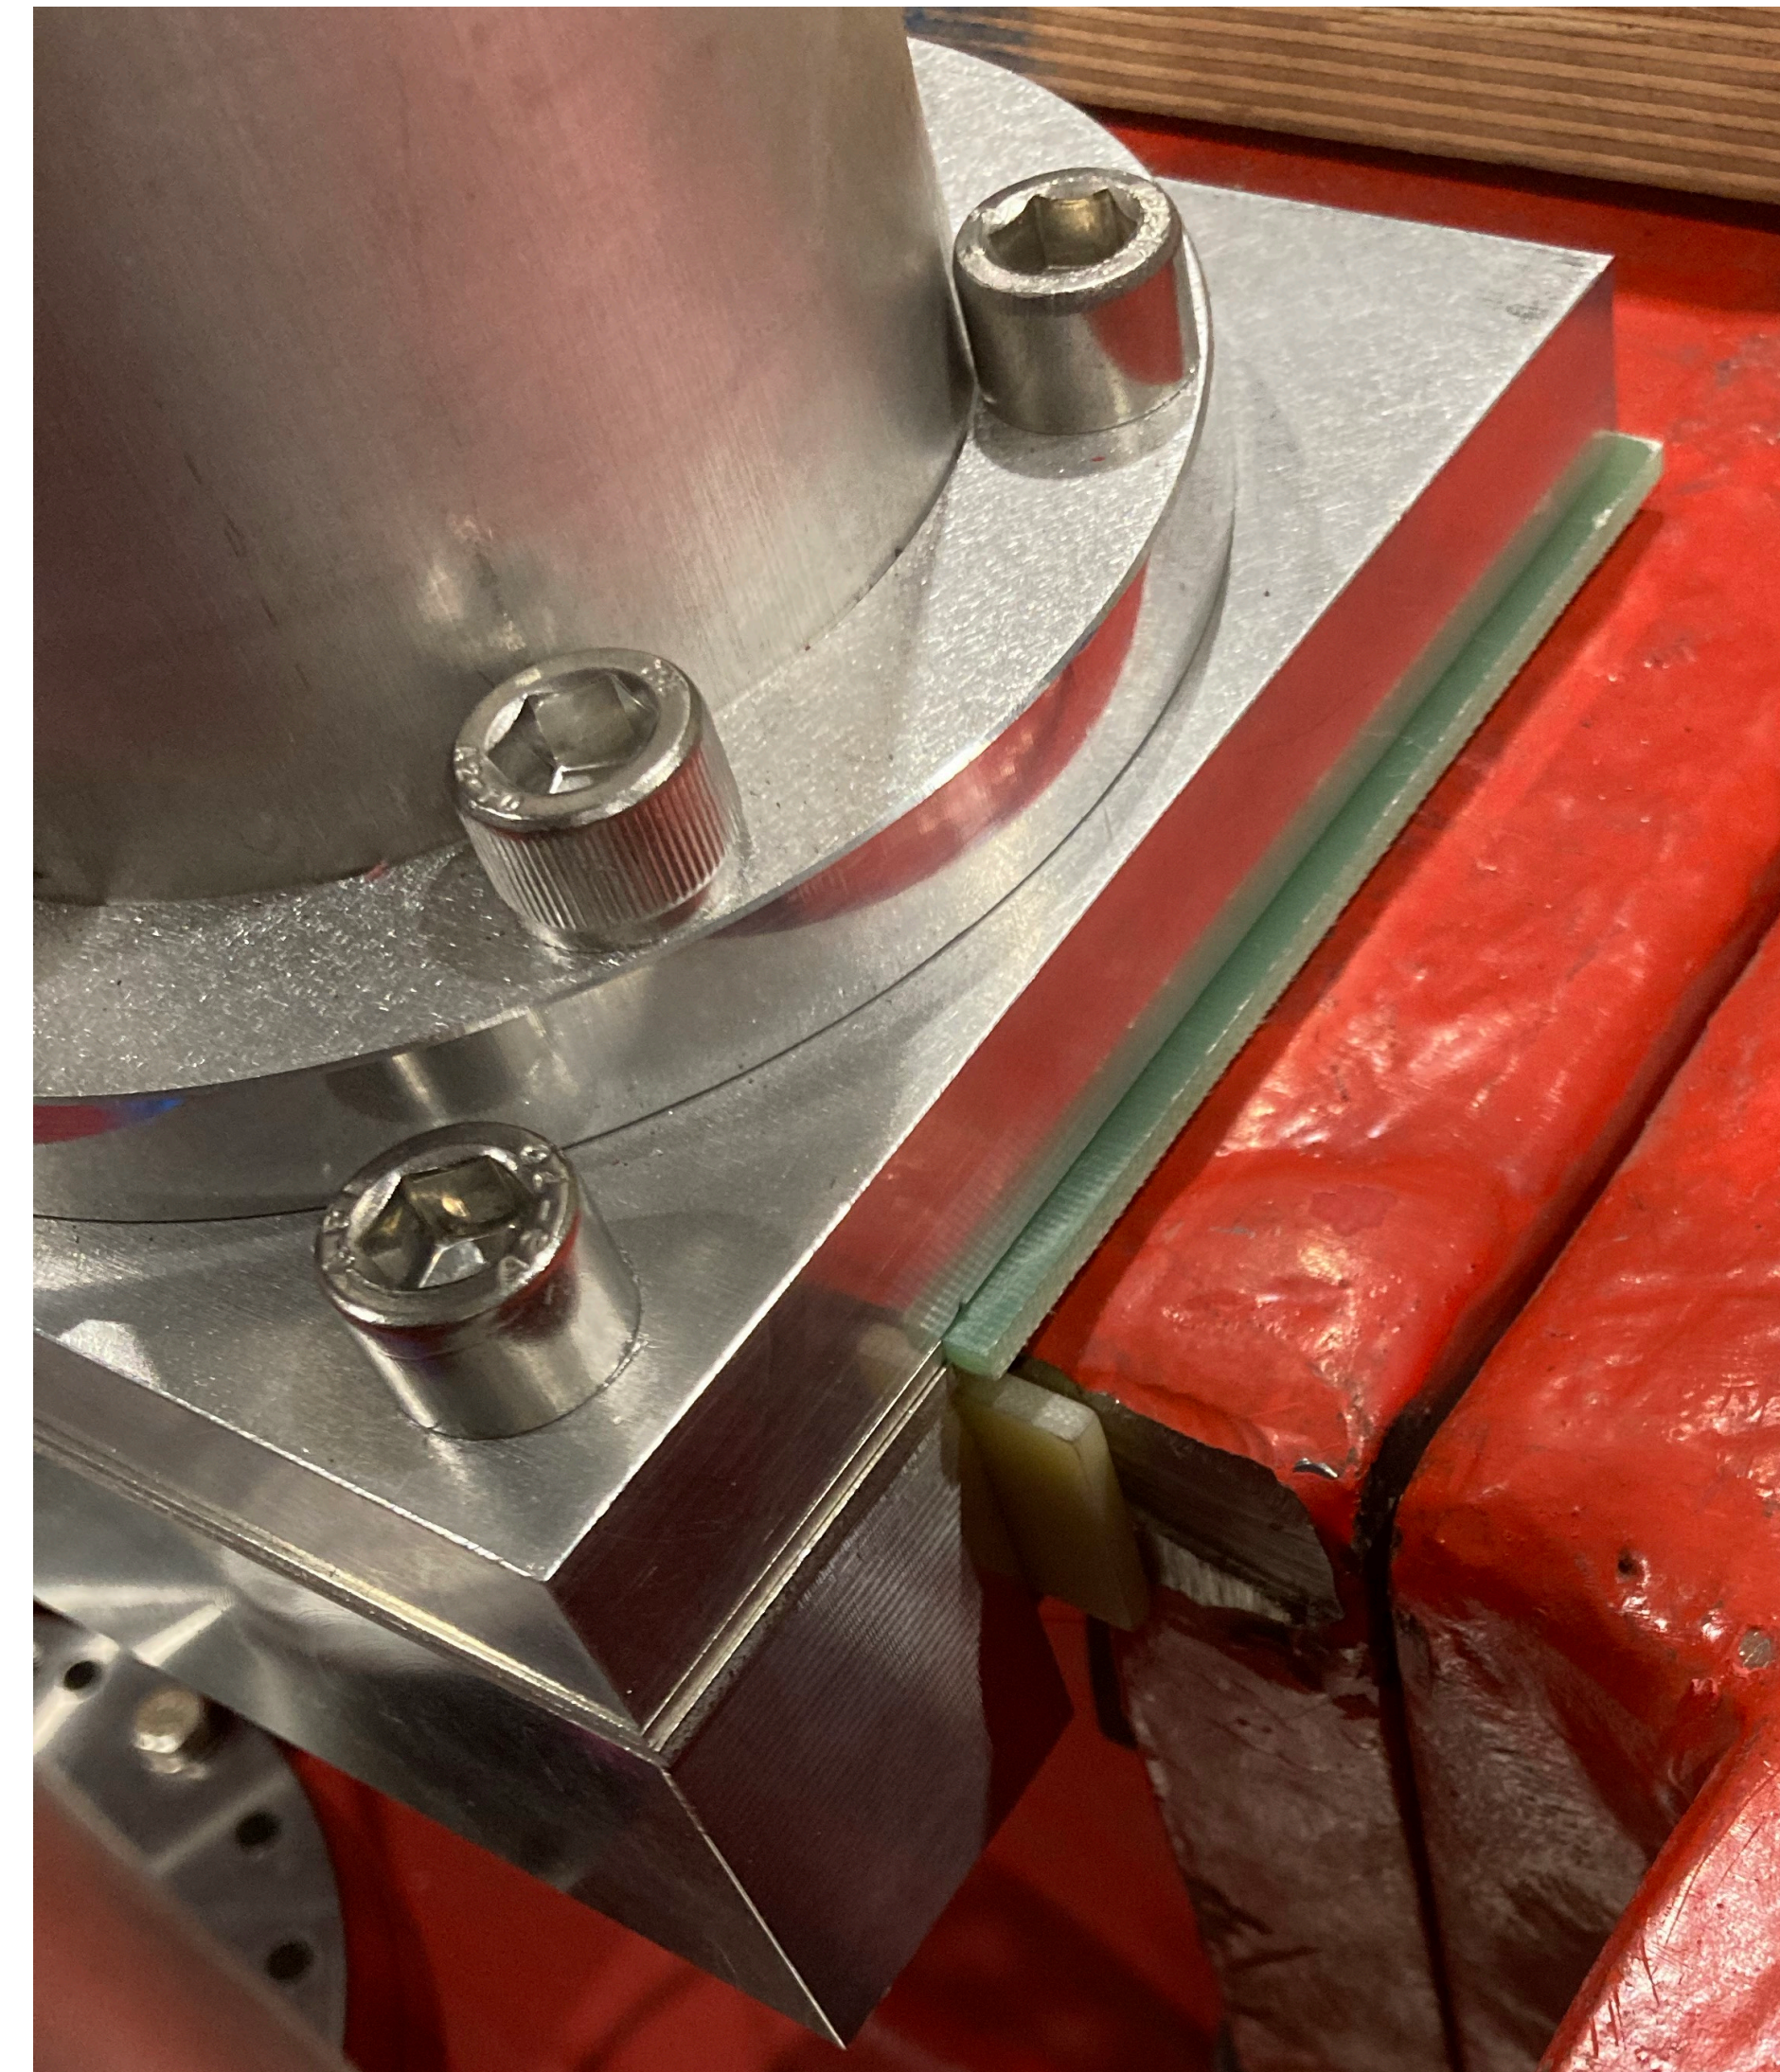
P-2 Short Leg (right side)

- 2x 2-mm Alu plates
- 1 additional GF10 plate
- Vertical GF10 does not fully shield Alu structure
 - Need to order a new one

Electrical
insulation
OK
