Update on Ionization Laser System (IoLS) activities at CERN

Mattia Fani - Los Alamos National Laboratory

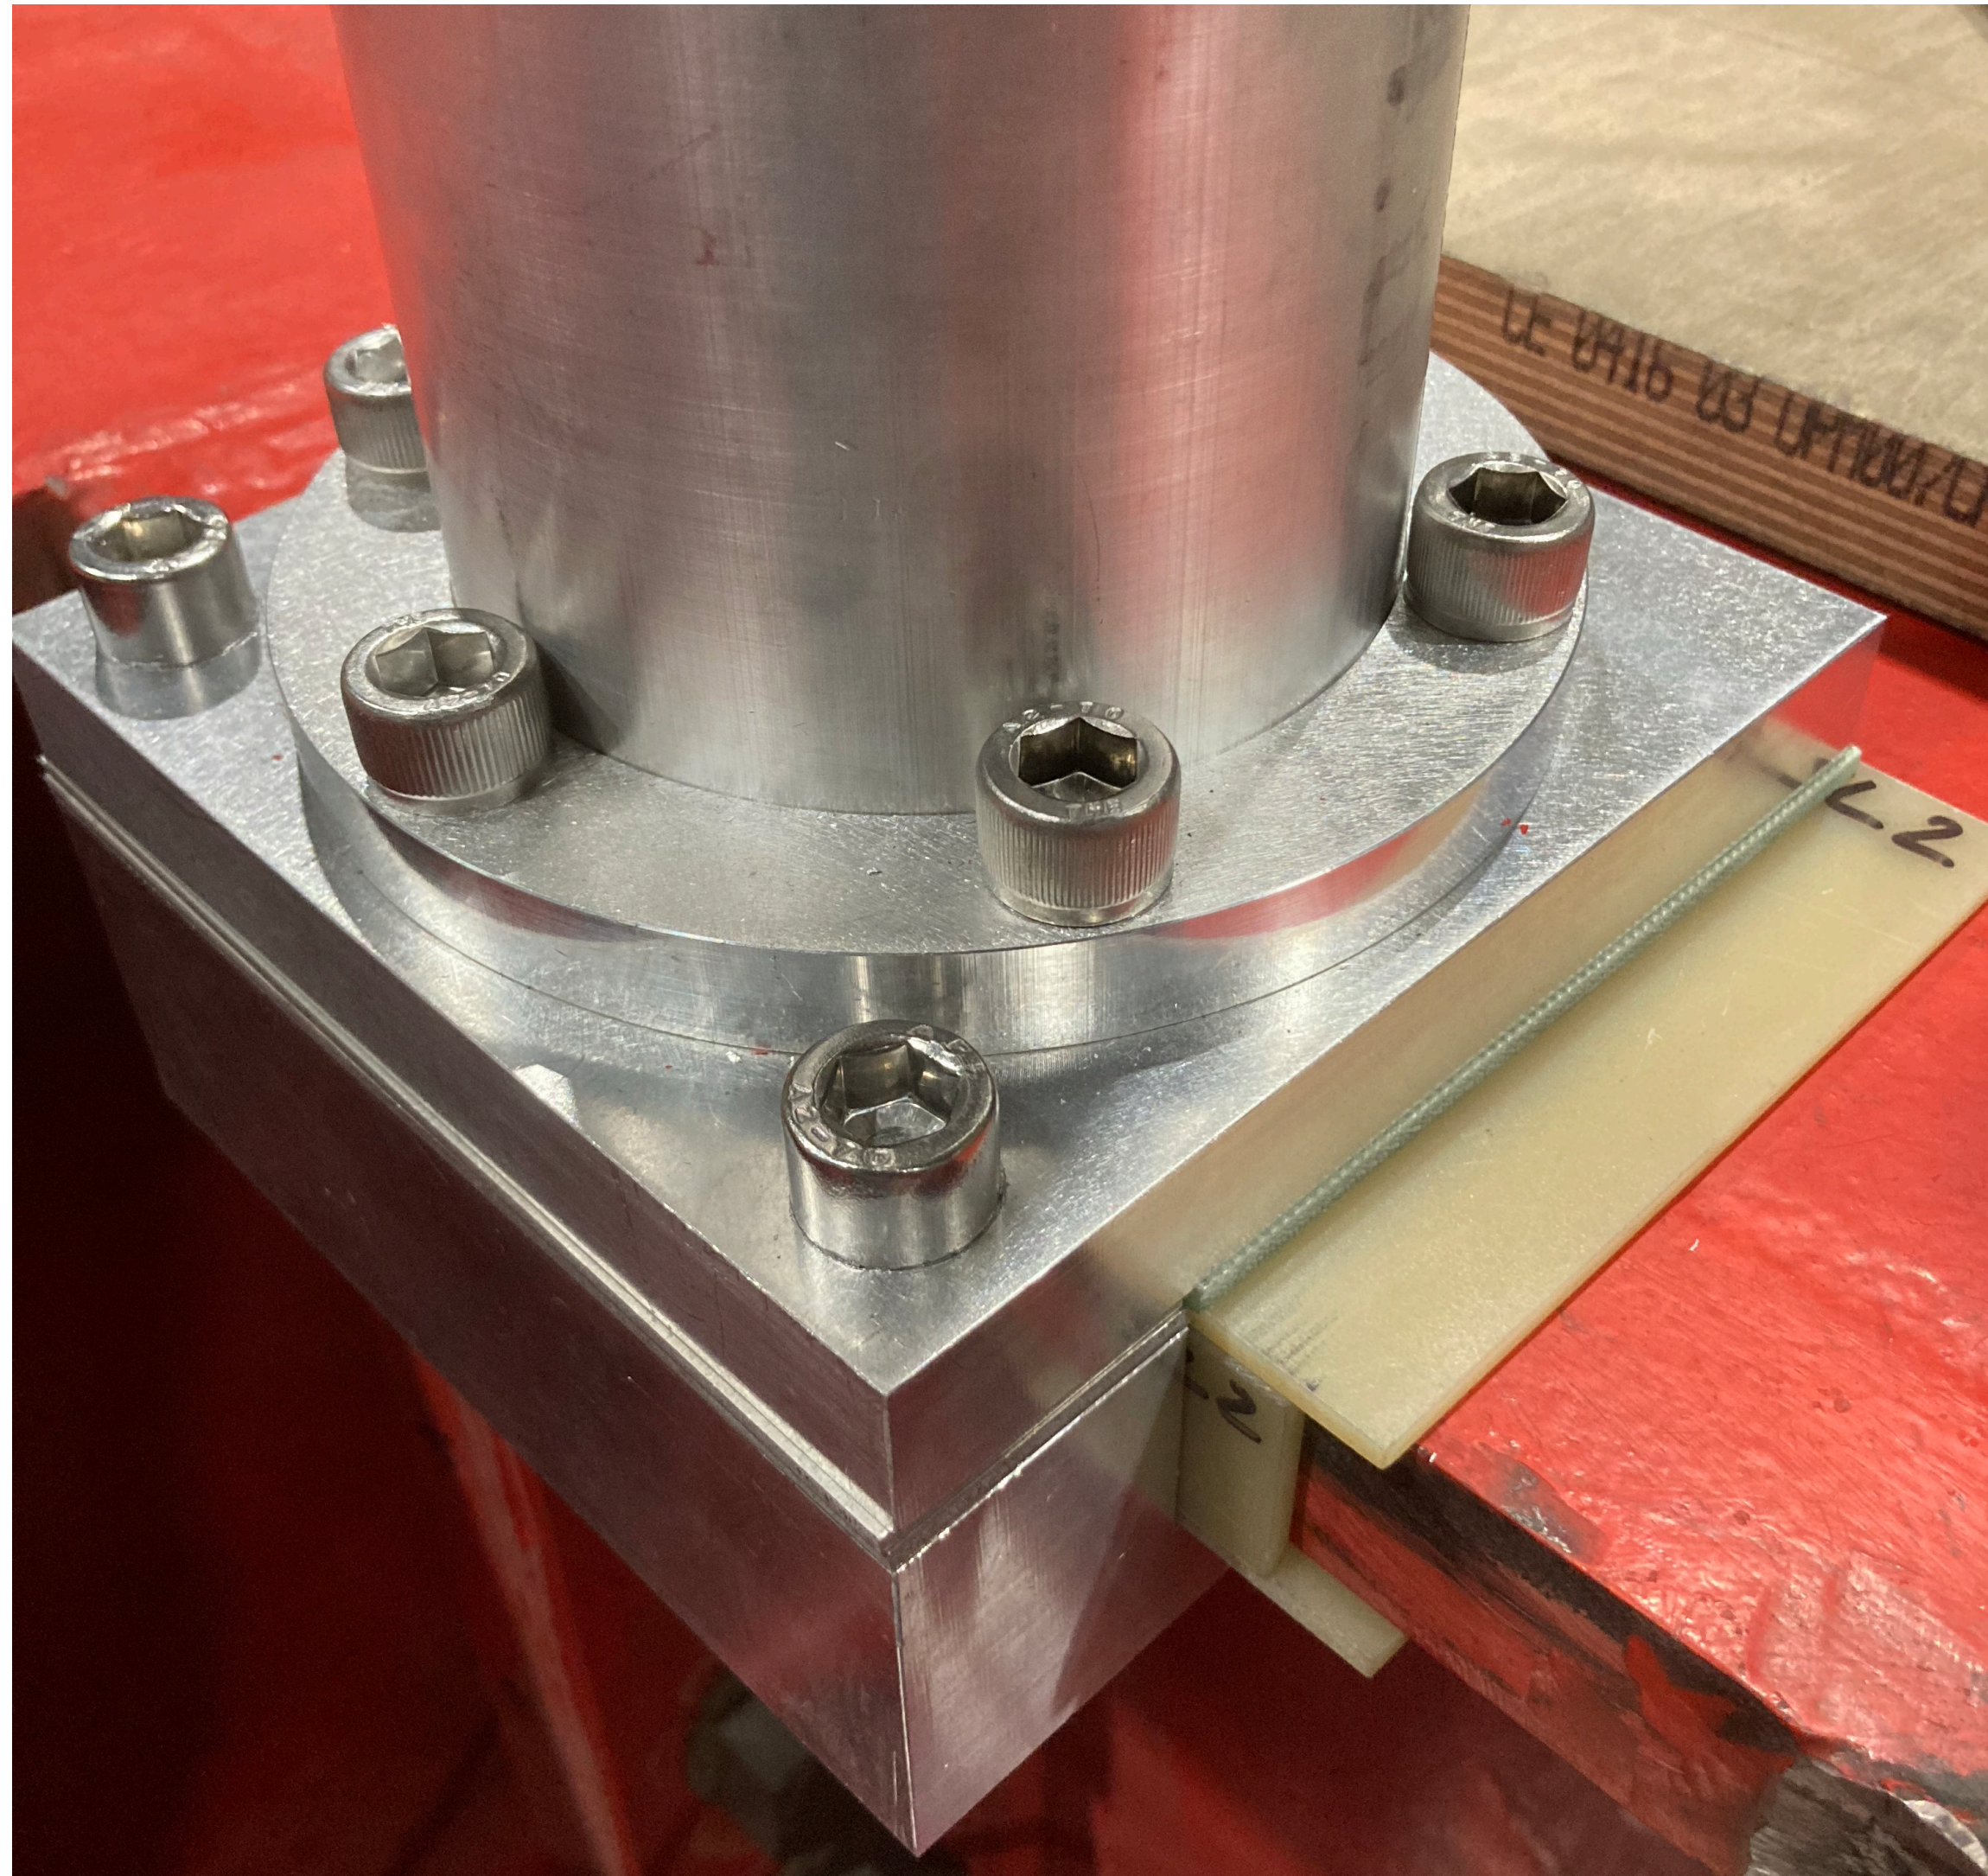
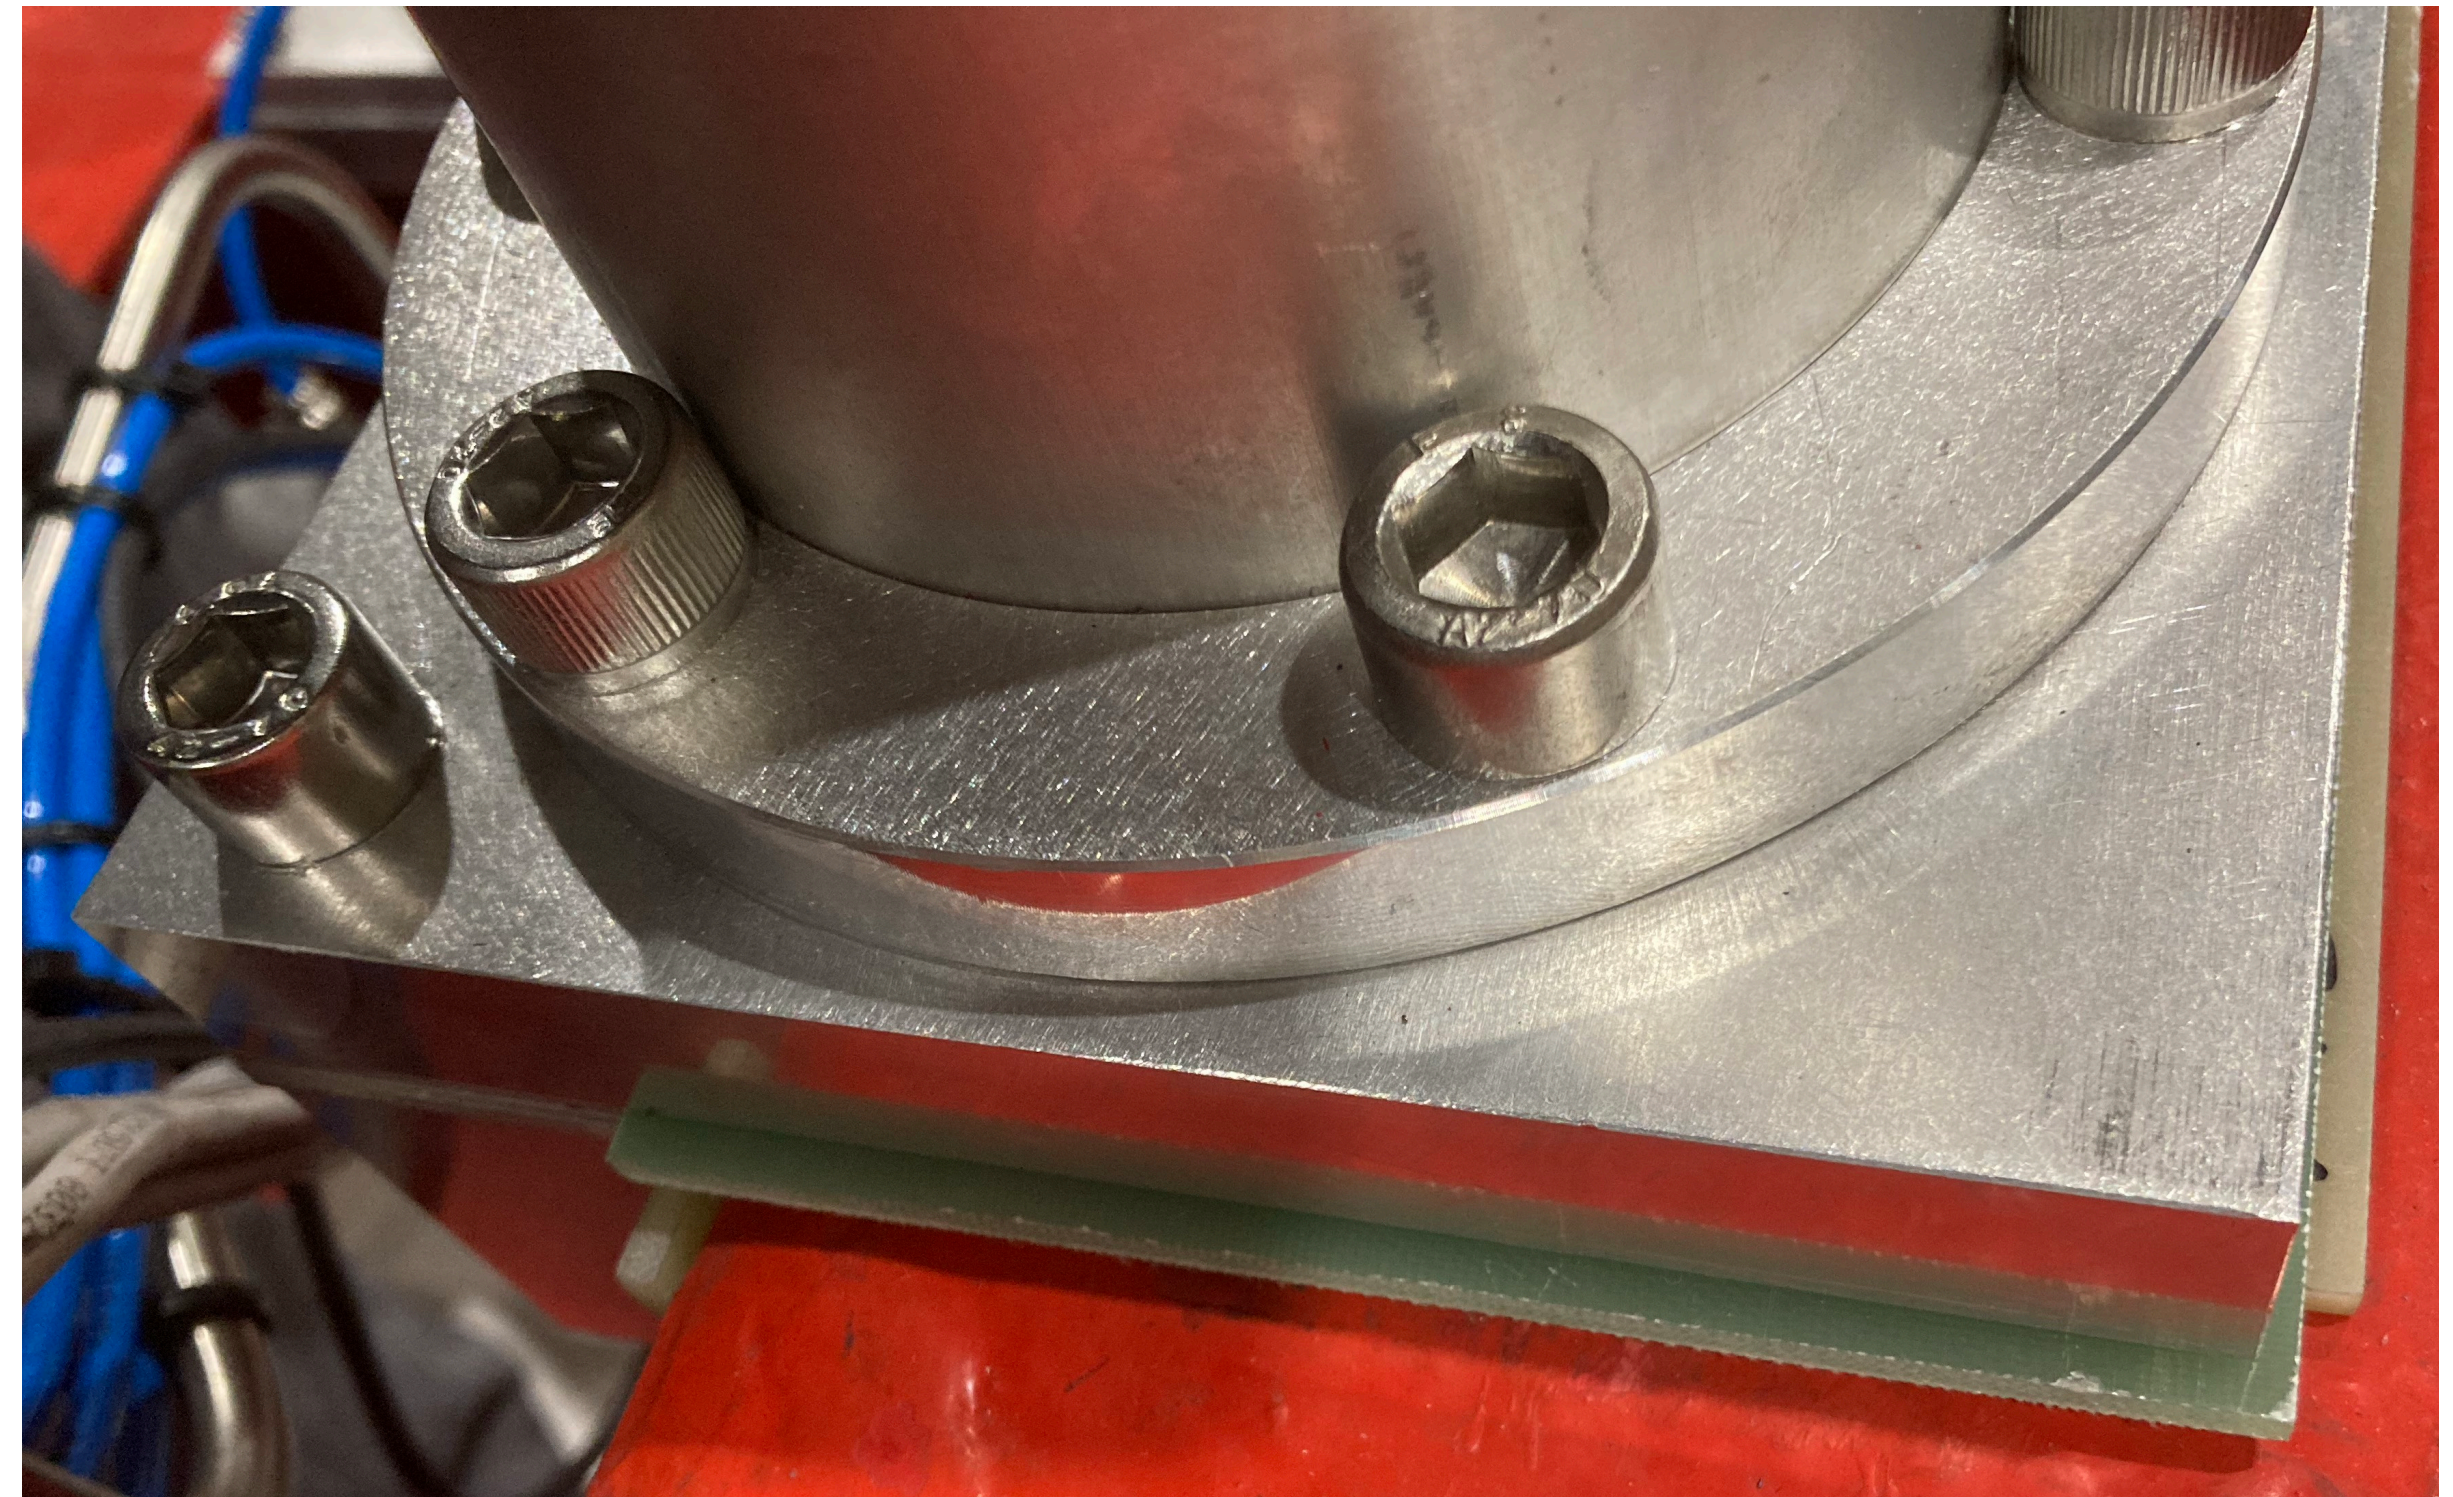
P-2 Short Leg (left side)

- 2x 2-mm Alu plates
- 1 additional GF10 plate
- Vertical GF10 does not fully shield Alu structure
 - Need to order a new one

Electrical
insulation
OK

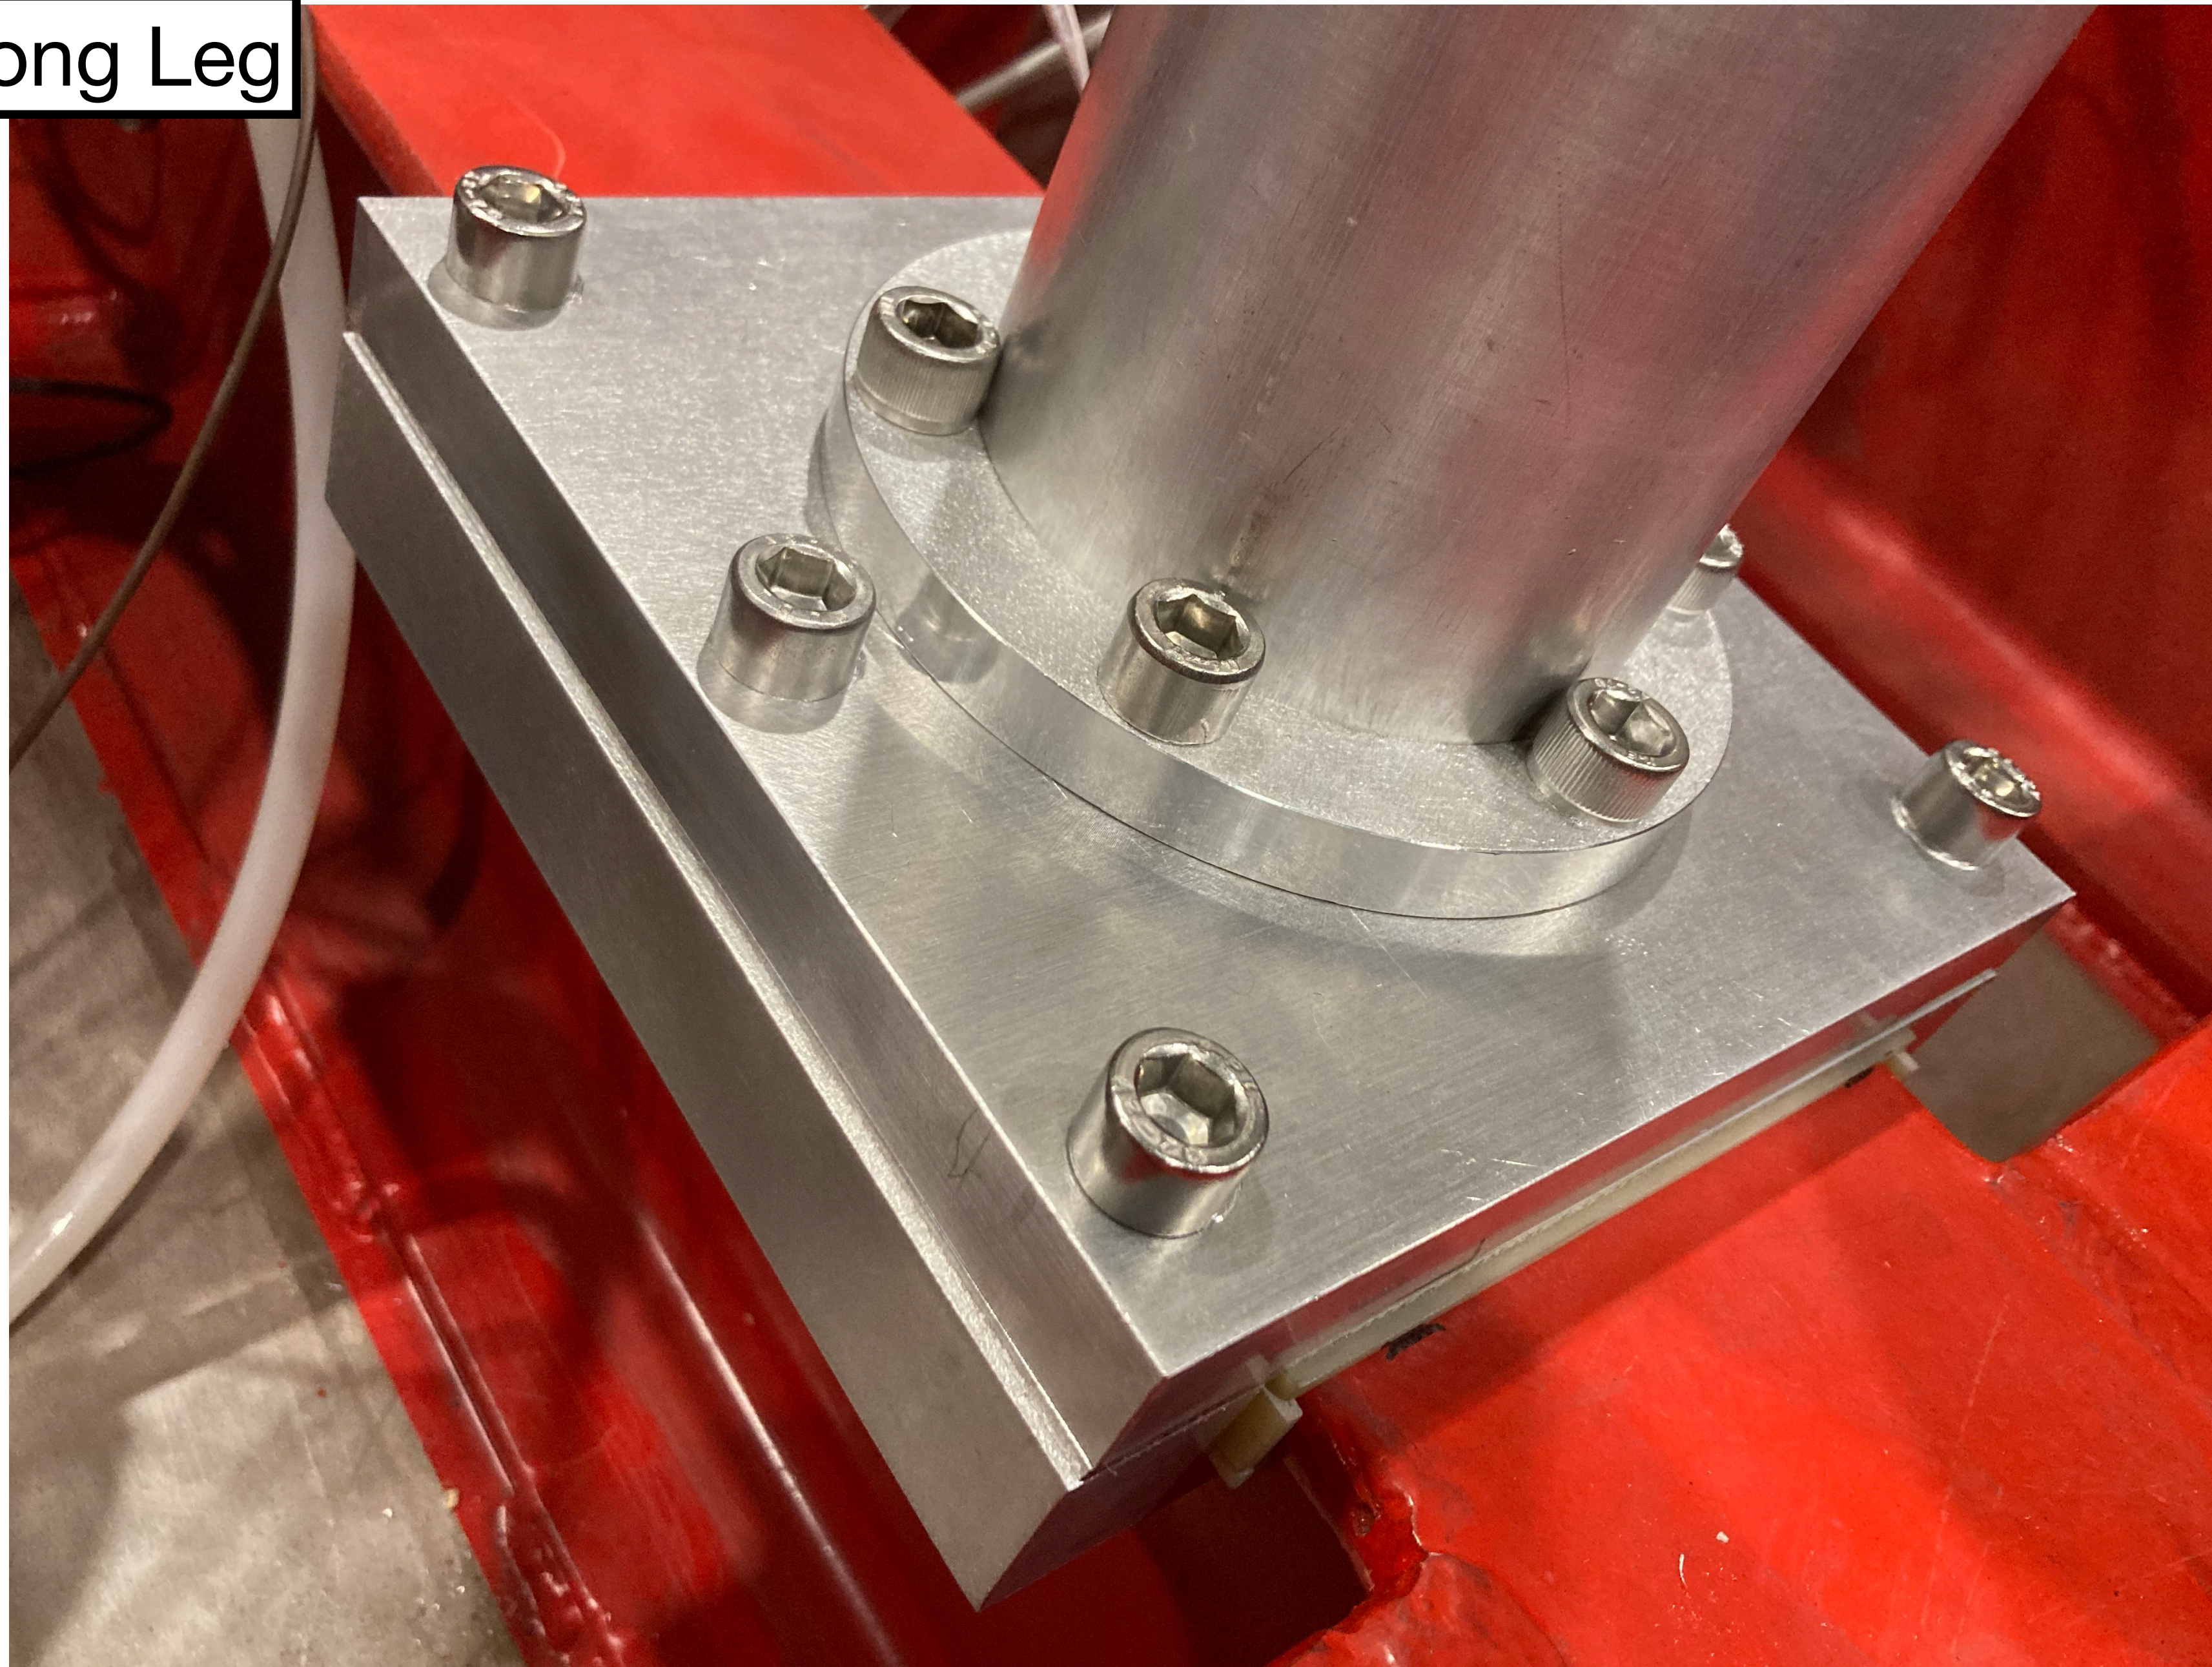
P-2 Long Leg

Electrical
insulation
OK

- One additional Alu plate to take into account the increased thickness of short legs

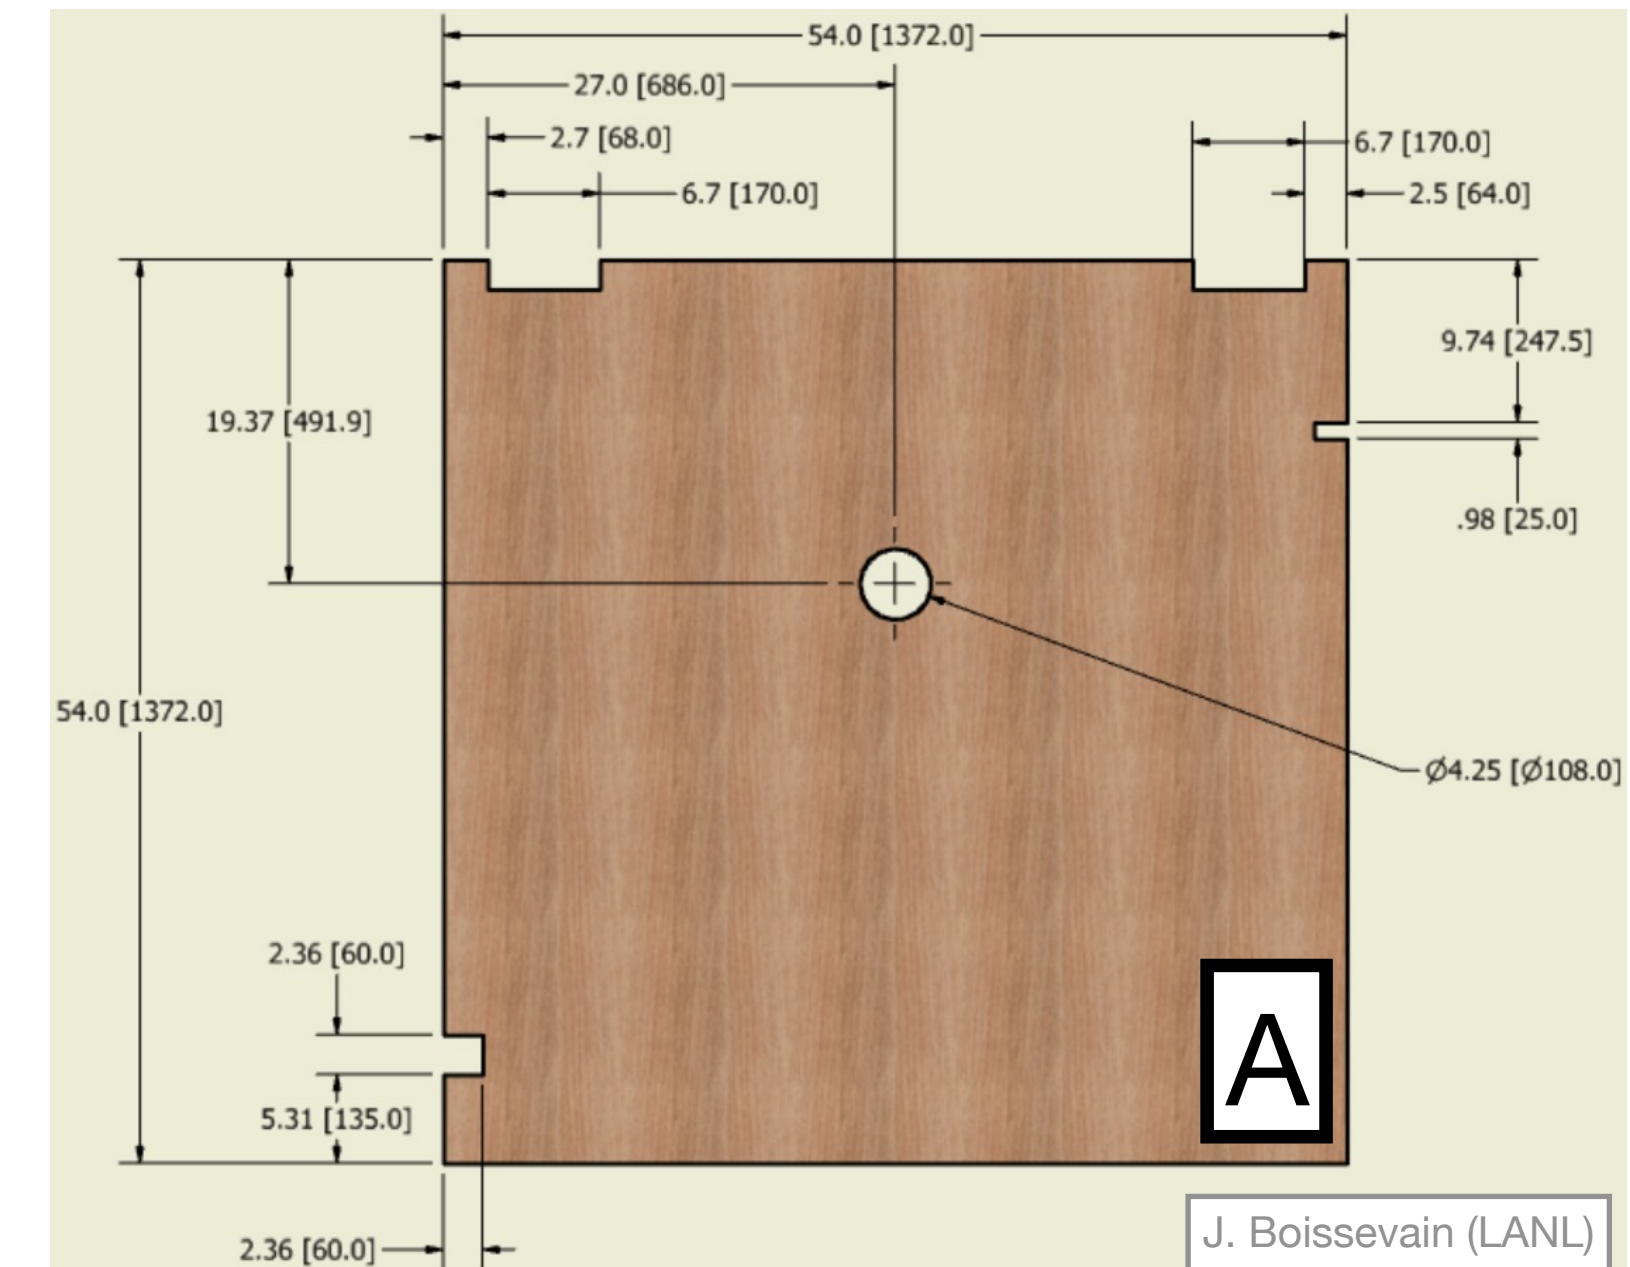
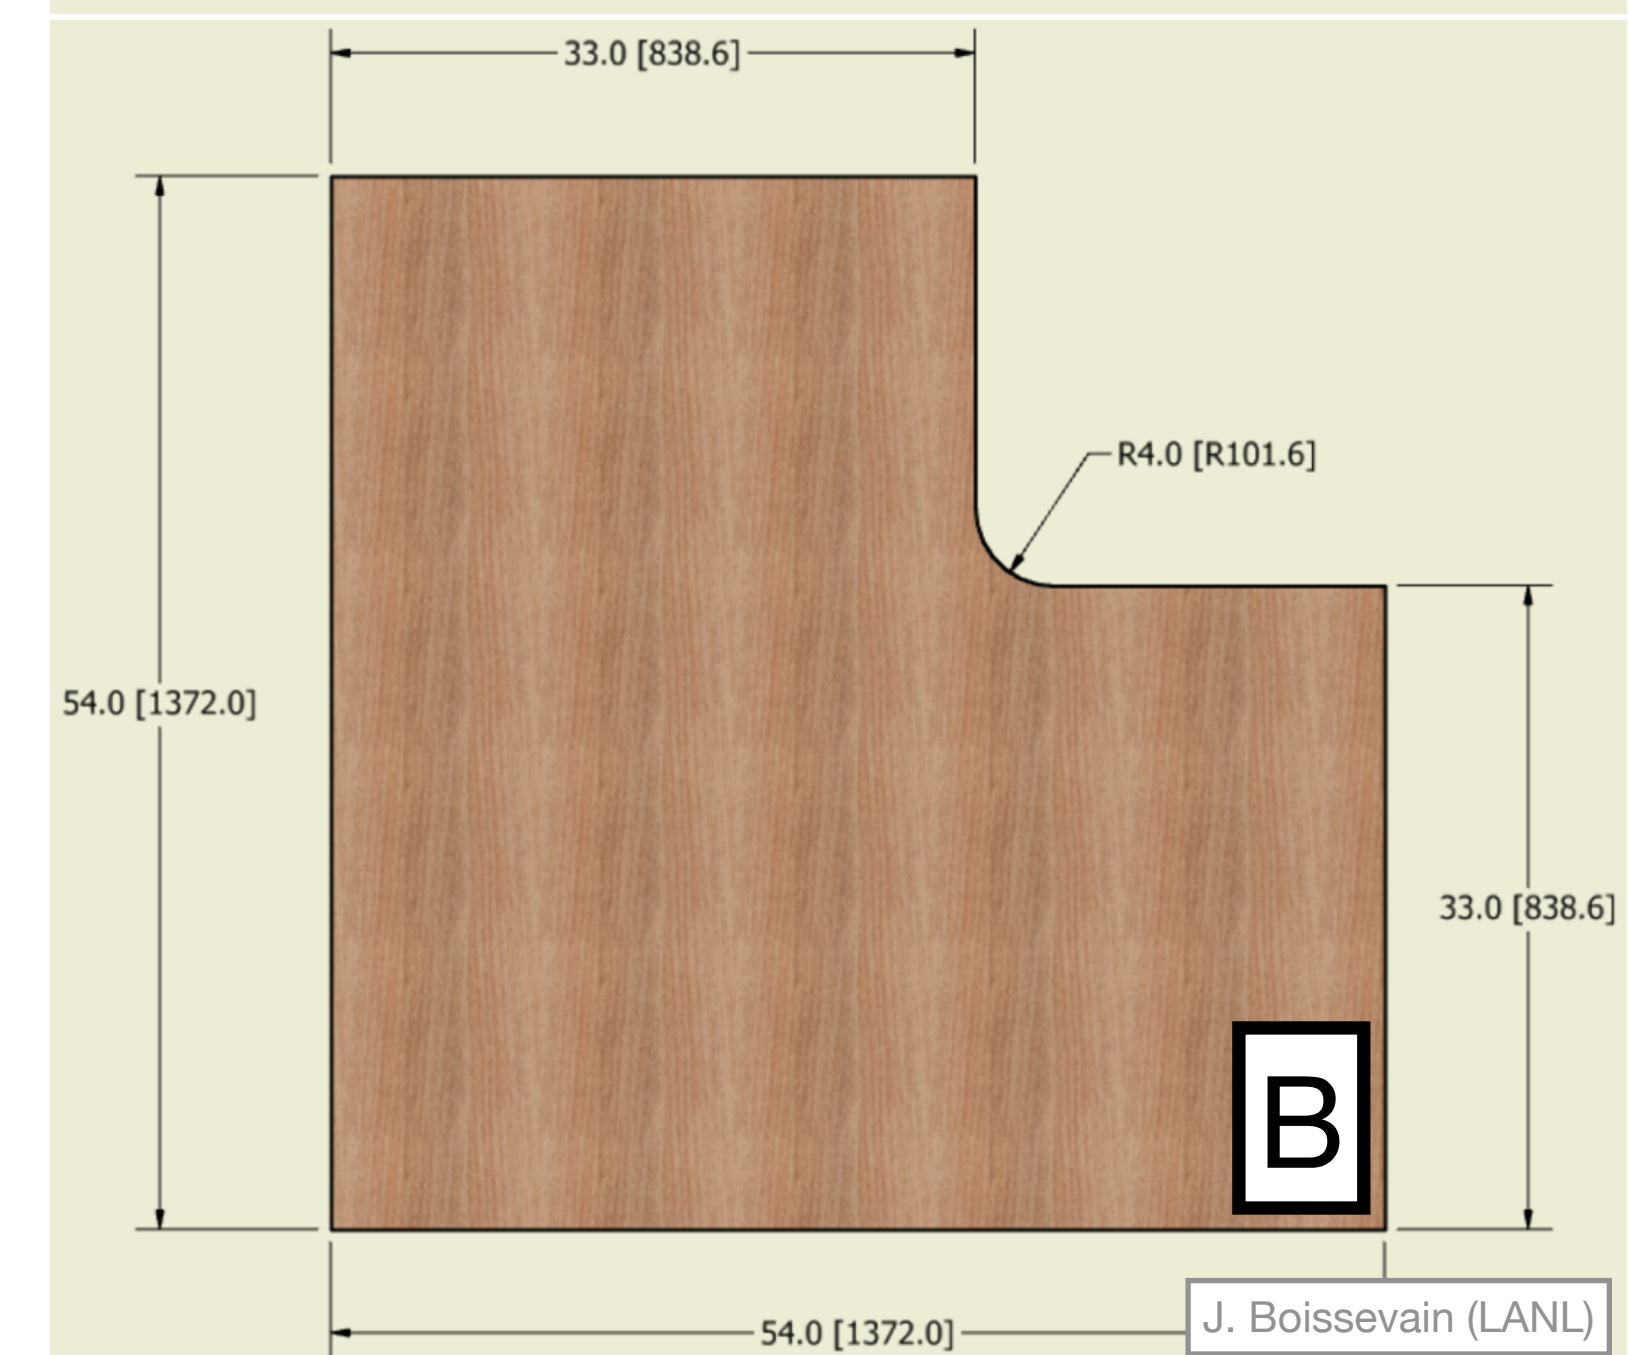
Floorboard installation

- Floorboard supports on I-beams modified in July
- Floorboard modification requested earlier this month, after completion of laser stand support installation
- A buffer space was added to allow corrections
- Sufficient room for cable routing from elect. racks
 - Possibility of additional openings
- Additional modification required - currently under way
 - Allow access to underneath the laser stands
 - Floorboards need to be split
 - Requires installation of additional supports

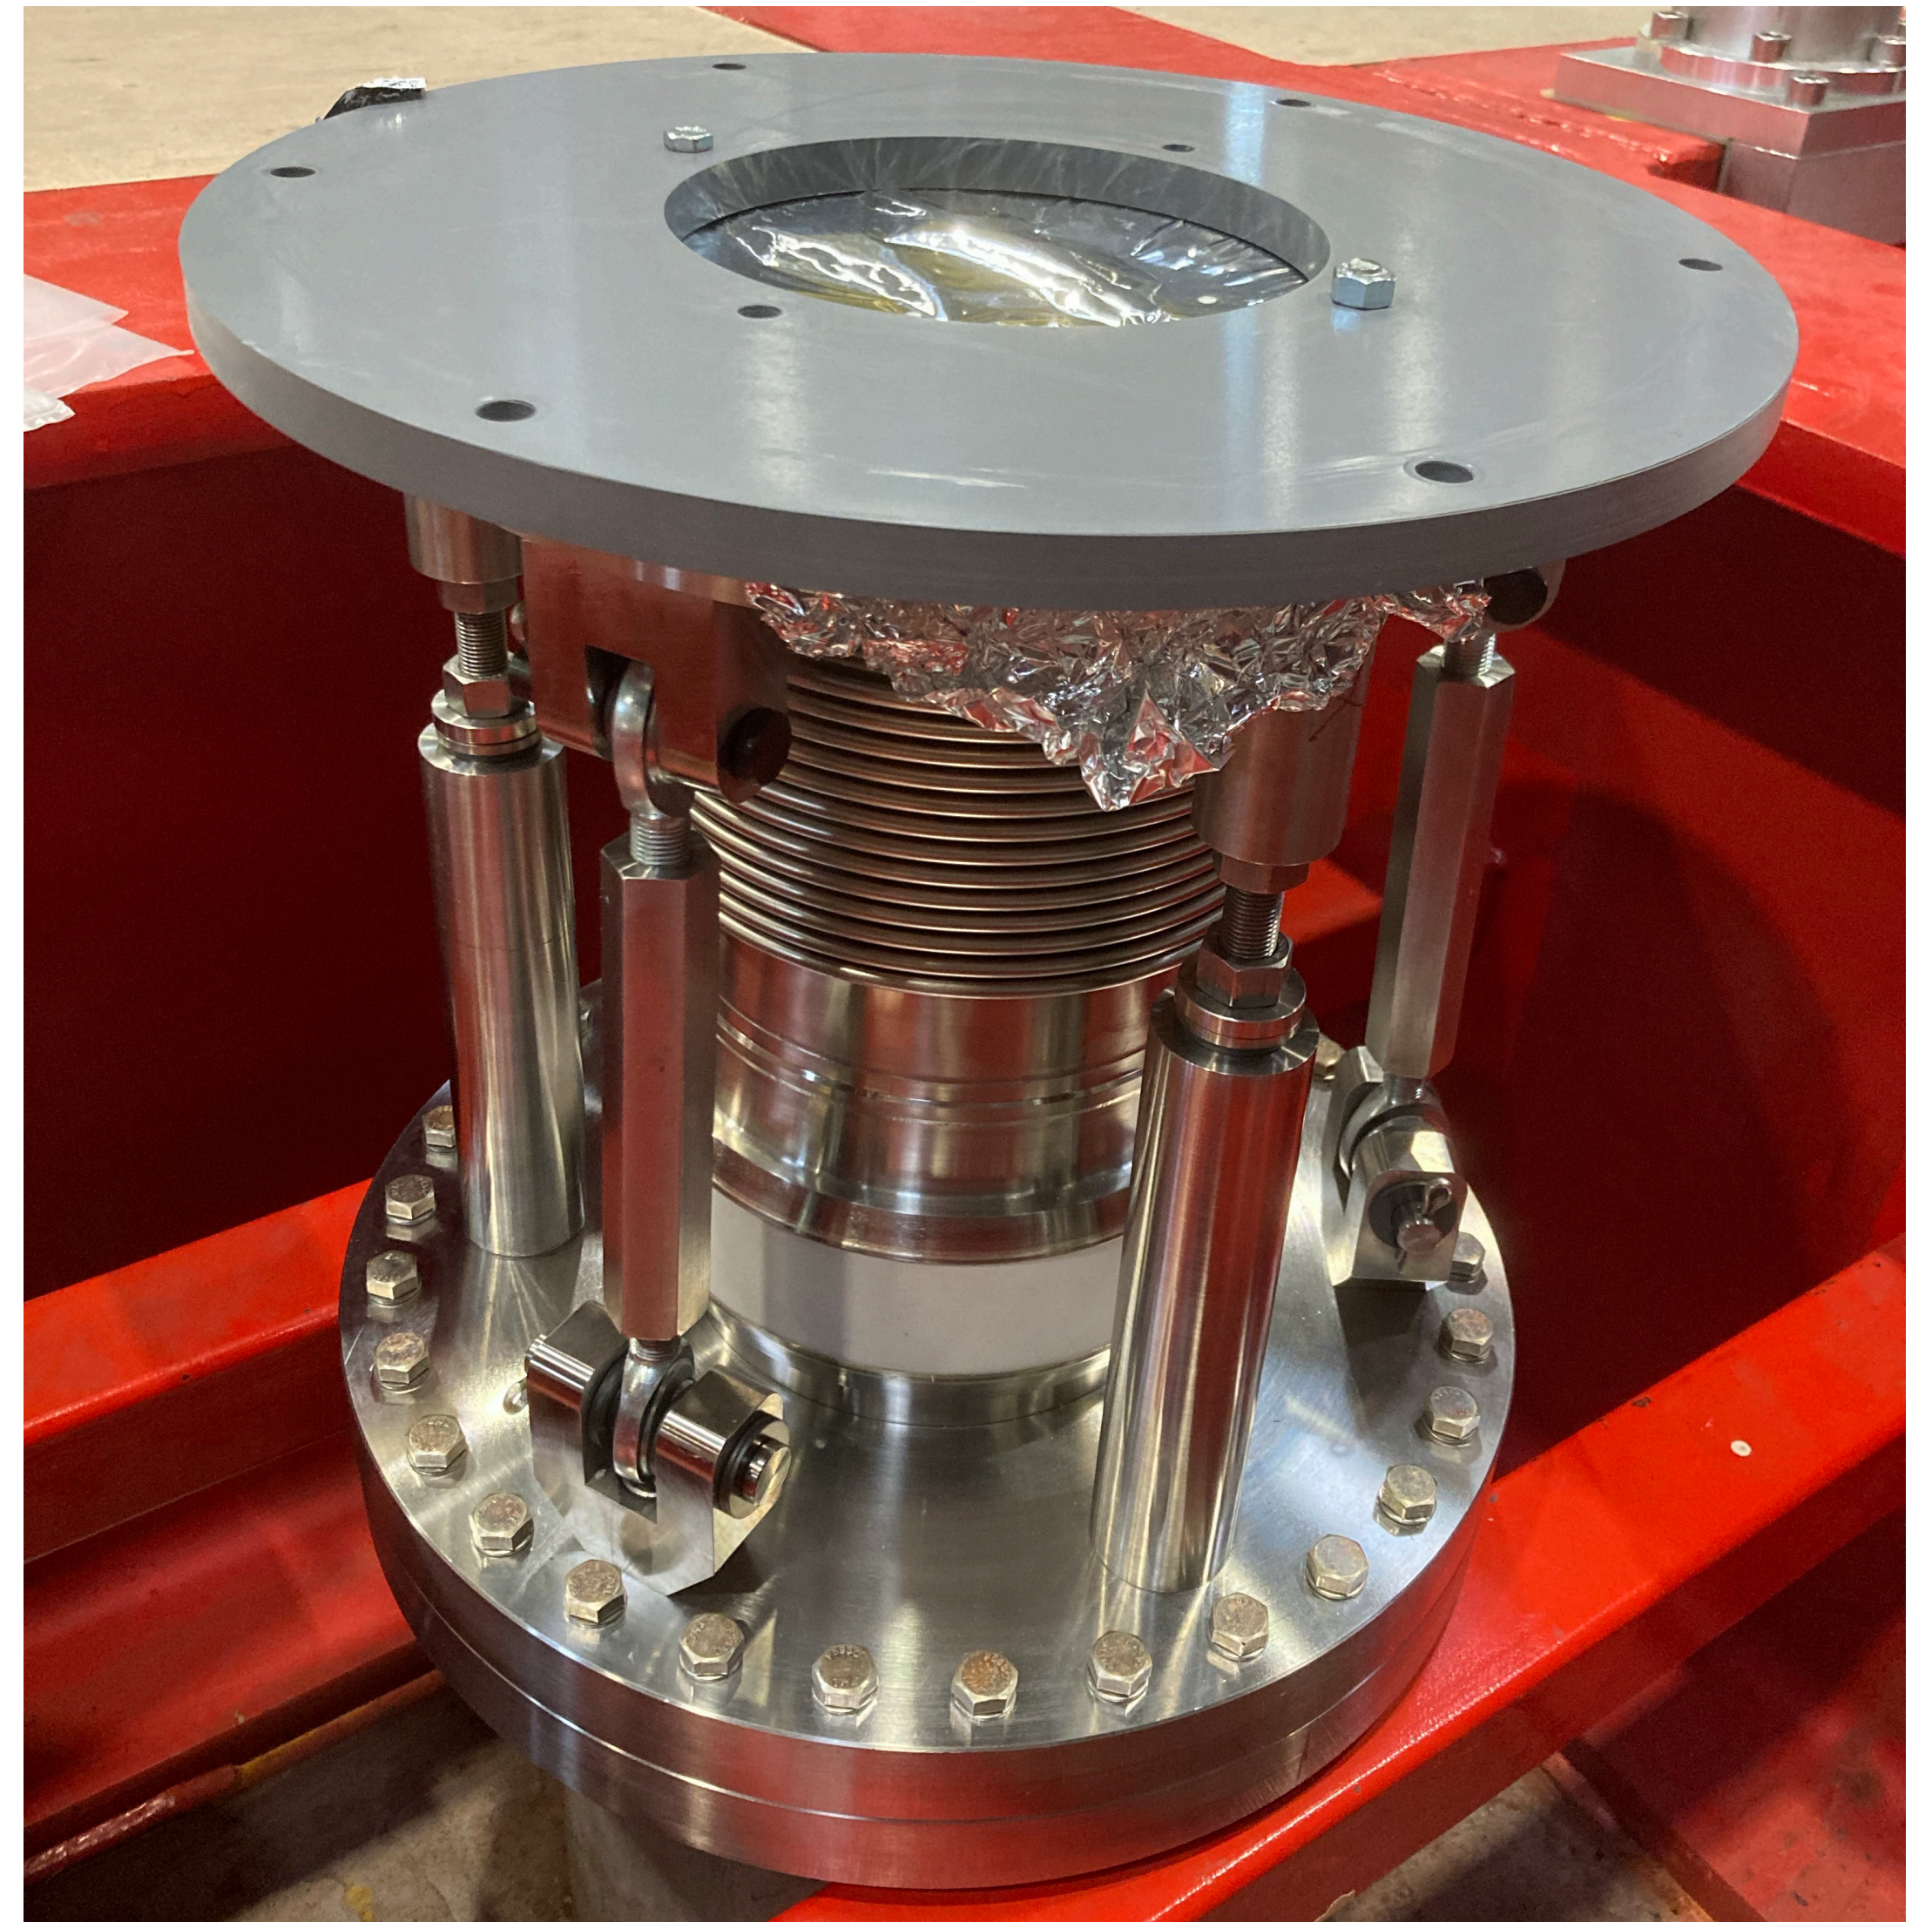
P-1 Electrical Break installation

- Installation OK!
- Reused bolts from previous installation
- Bolts not completely tightened down
- Brand new bolts will arrive from LANL
- Dimensions are imperial (confirmed)
