Update on Ionization Laser System (IoLS) activities at CERN

Mattia Fani - Los Alamos National Laboratory

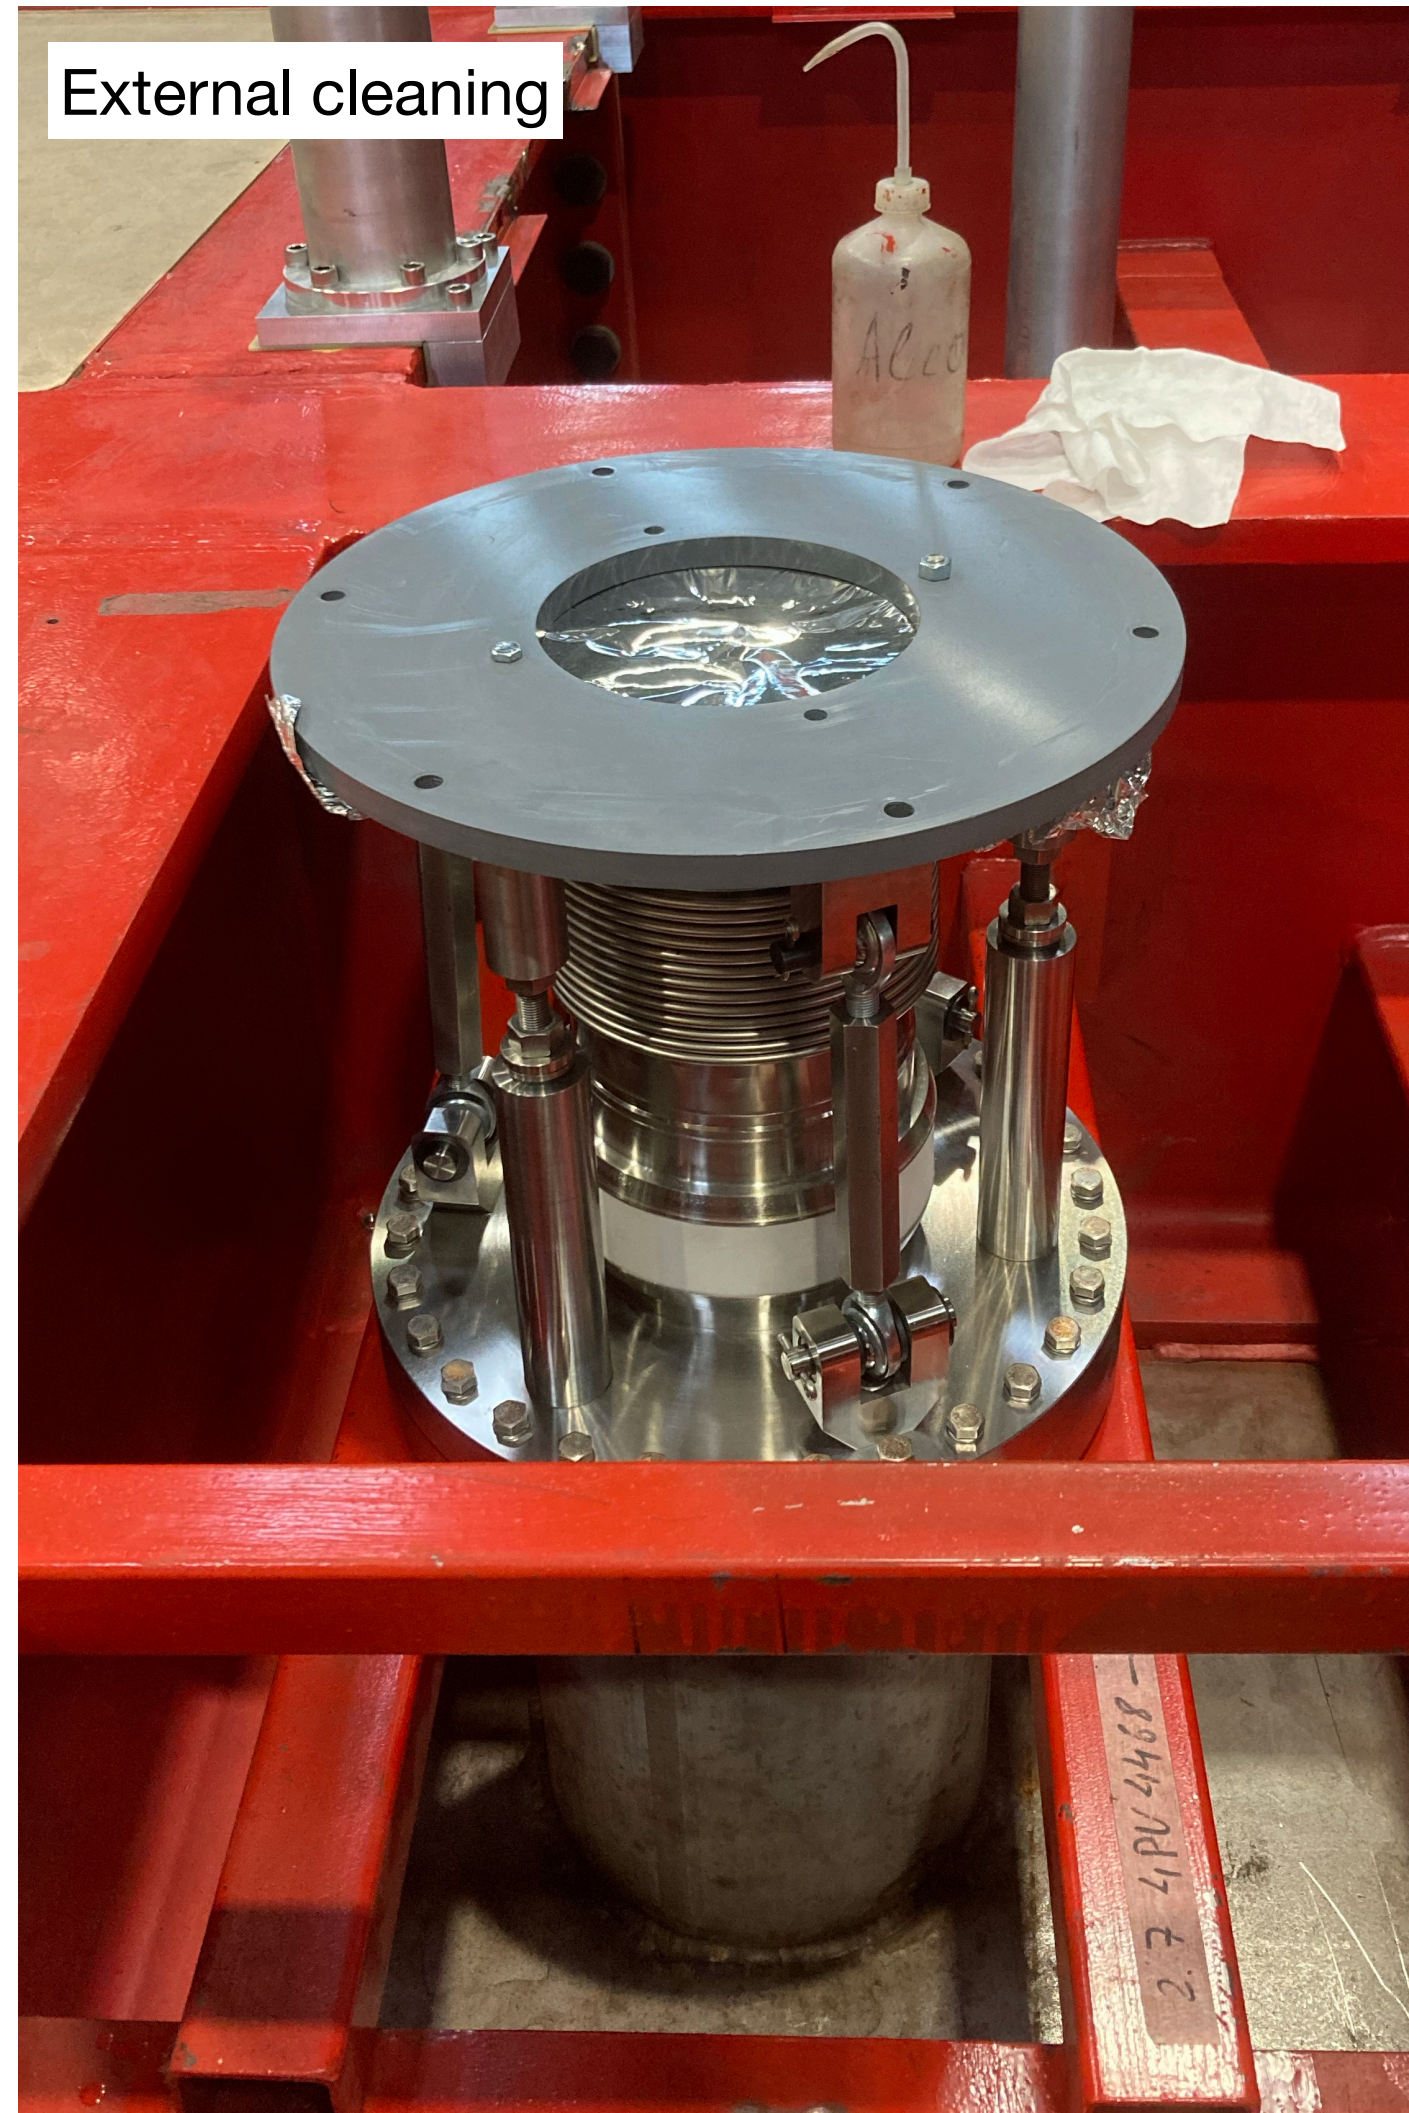
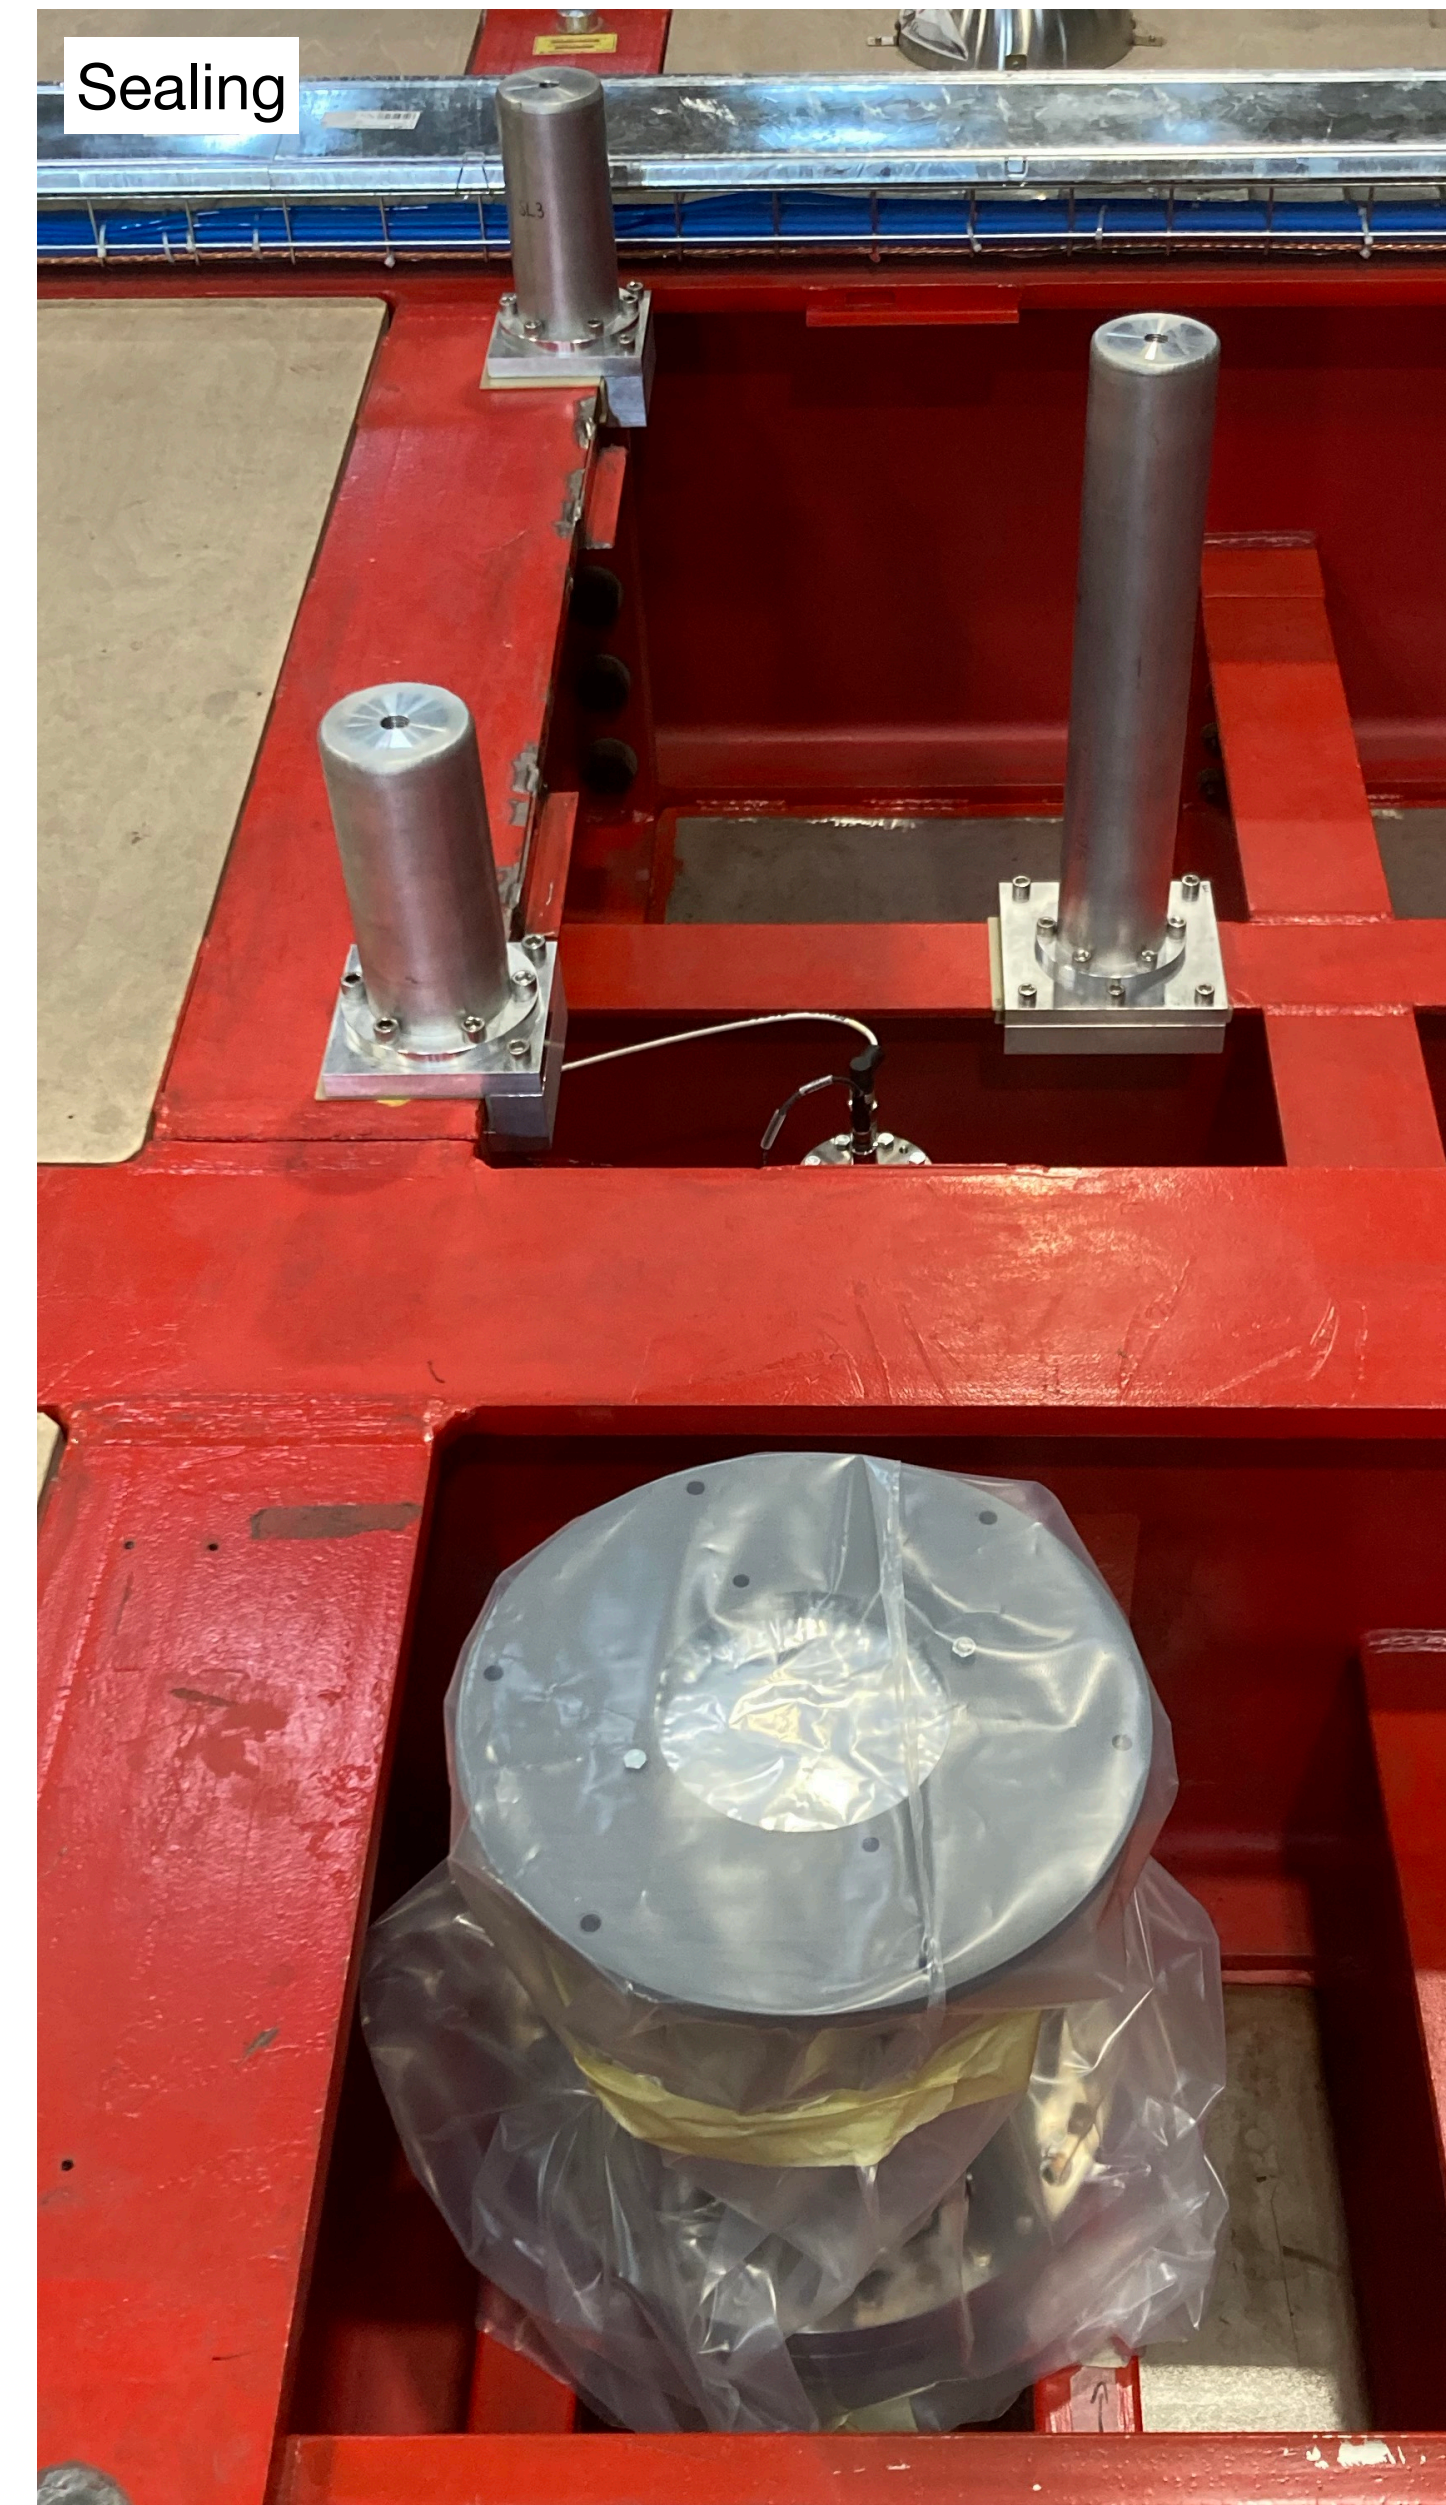
P-1 Electrical Break installation

- Significant air flow was present at the flange opening
- No perceivable air leak already with electrical break in place, w/o plastic bag
- Plastic bag to prevent dust deposit, also sealed at the bottom

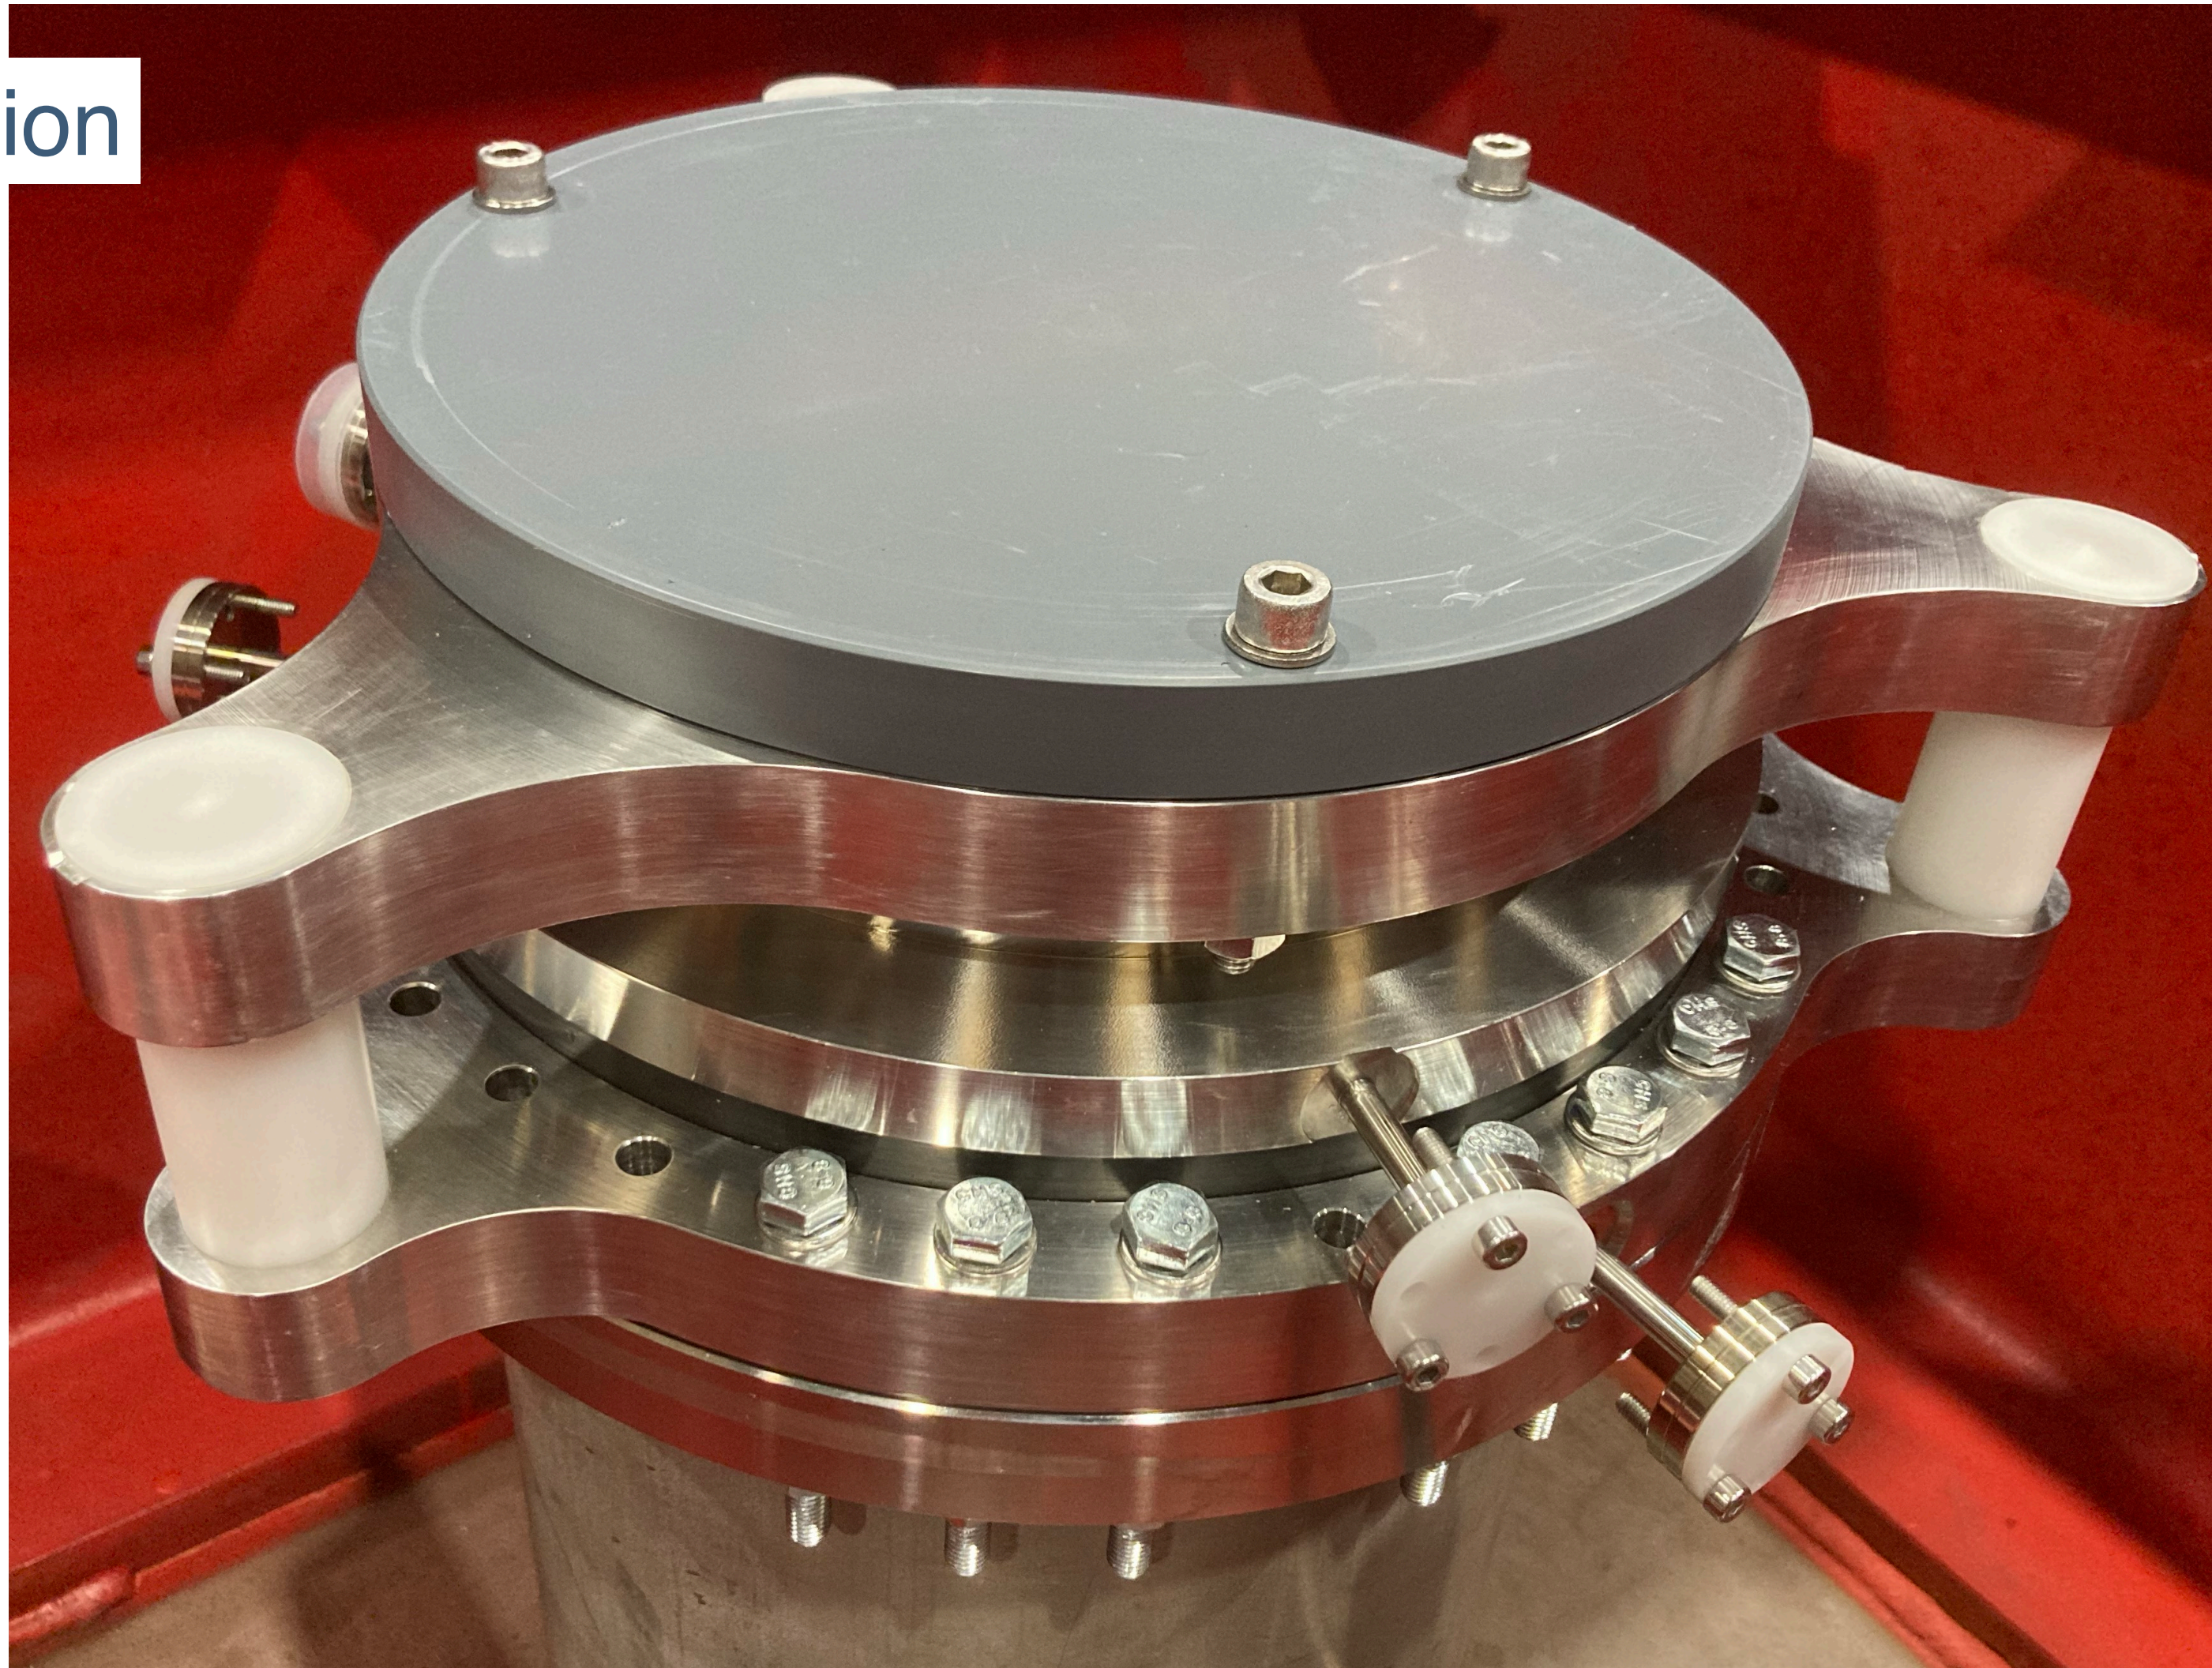
P-2 Electrical Break installation

- Significant air flow was present at the flange opening
- No perceivable air leak with electrical break in place
- Bolts not fully tightened down
- Needed 10 shorter bolts (now in place)
