loLaser Update

David Rivera ioLaser Group Meeting November 1, 2022

Ongoing activities at LANL

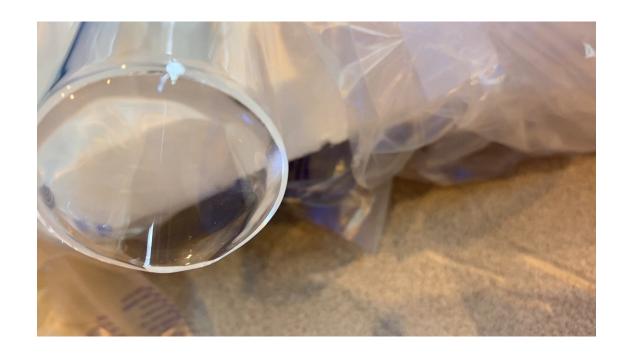
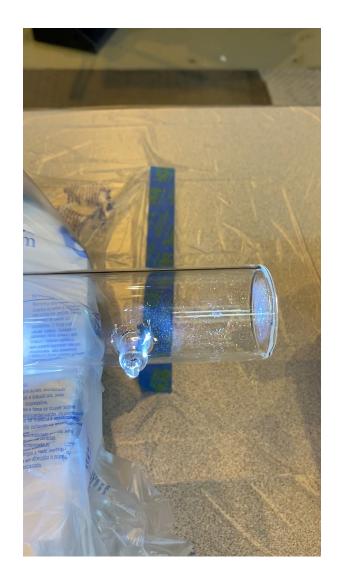
Q4

- 6 total
- 1 largely unused
- 1 used heavily (Quartz tube #4)
 - Cold tests
 - Installation tests
 - This one shows contamination or striations on the inner surface – noted at the time of first inspection (April 1st)
- 4 tubes used for periscope tests of P1 and P2

Coated twice w/ the polymer spray

- Over time, tubes have collected dust and some show "water spots" and other contaminants on their surface from their handling during installation and through testing
- Will show more videos and pictures next time
- The same cleaning agent from Photonic Cleaning Technologies, LLC identified for cleaning the quartz glass windows will be employed for cleaning the tubes

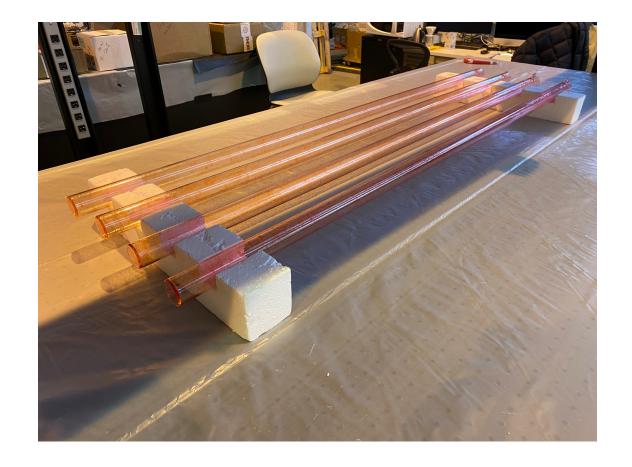
Q4 after first peel

- Peeled the polymer coating for Q4 incident side
- Water spots observed to remain both on the window and where the tube holder ends
- As with the MDC flanges, a water spot treatment was applied

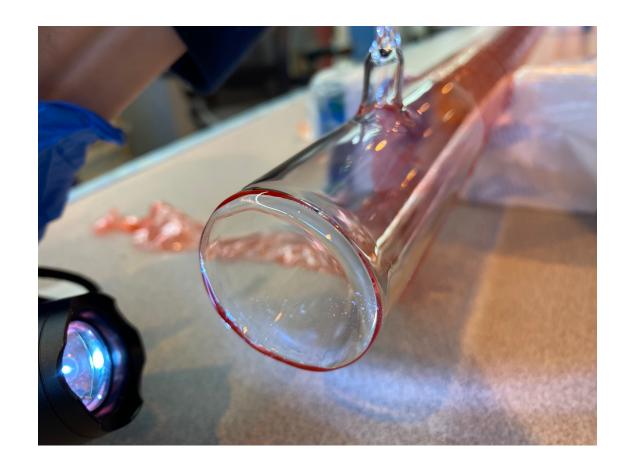
Q4 after water spot treatment peel

- Allowed the polymer coating to dry for a couple of hours
- Water spots removed
- Marking where the tubeholder "gripped" the tube, remained
 - Incident and outgoing faces of the tube are the most critical

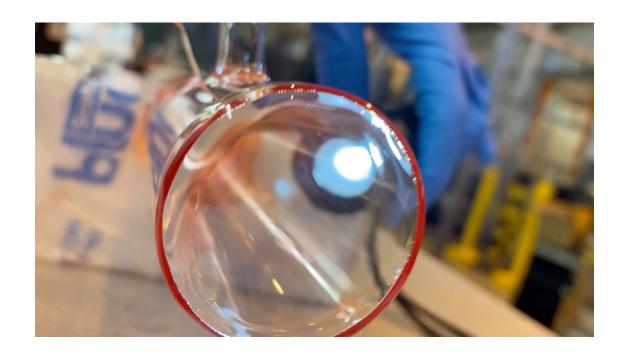
Q6

- This tube will go inside the liquid (P2) Torlon)
- The first coating was fully peeled to remove all excess dust and contaminants
- Water spot treatment performed on the incident face, the outgoing face, and on a couple of places where large collections of water spots were noted along the length of the tube
- Ends were peeled and treated a second time w/ water spot treatment to be as thorough as possible.

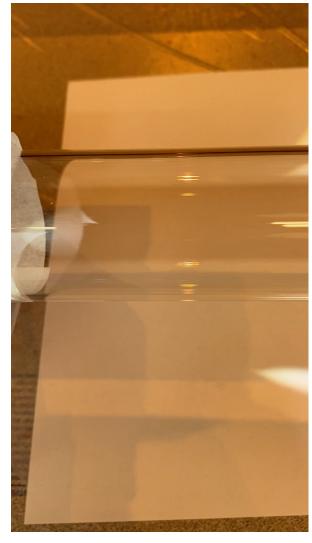
Q6 after first, full peel

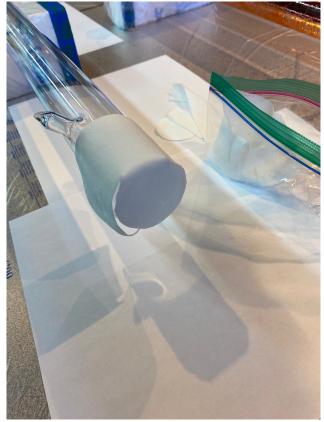
Q6 water spot treatment application to "endcap"
